*“The Six Sides of Building Enclosure  
Restoration - A Jacket of Protection”*  
Presentation #1

# Stop Water Intrusion on Existing Structures

*with a Focus on Performance, Energy Efficiency, & Resiliency*

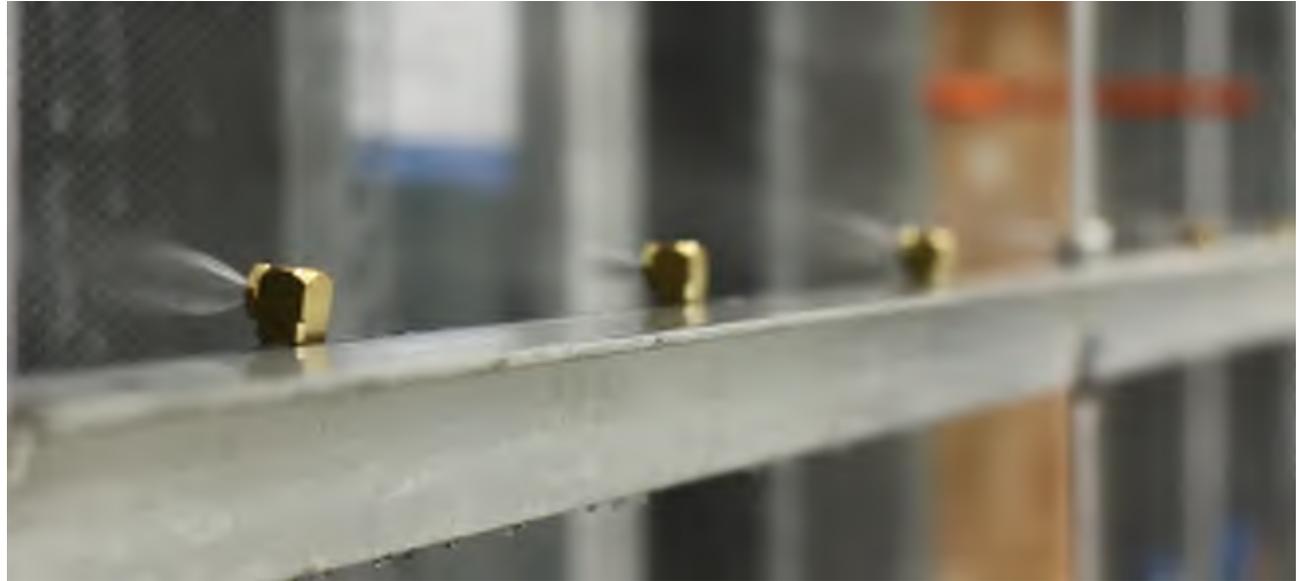
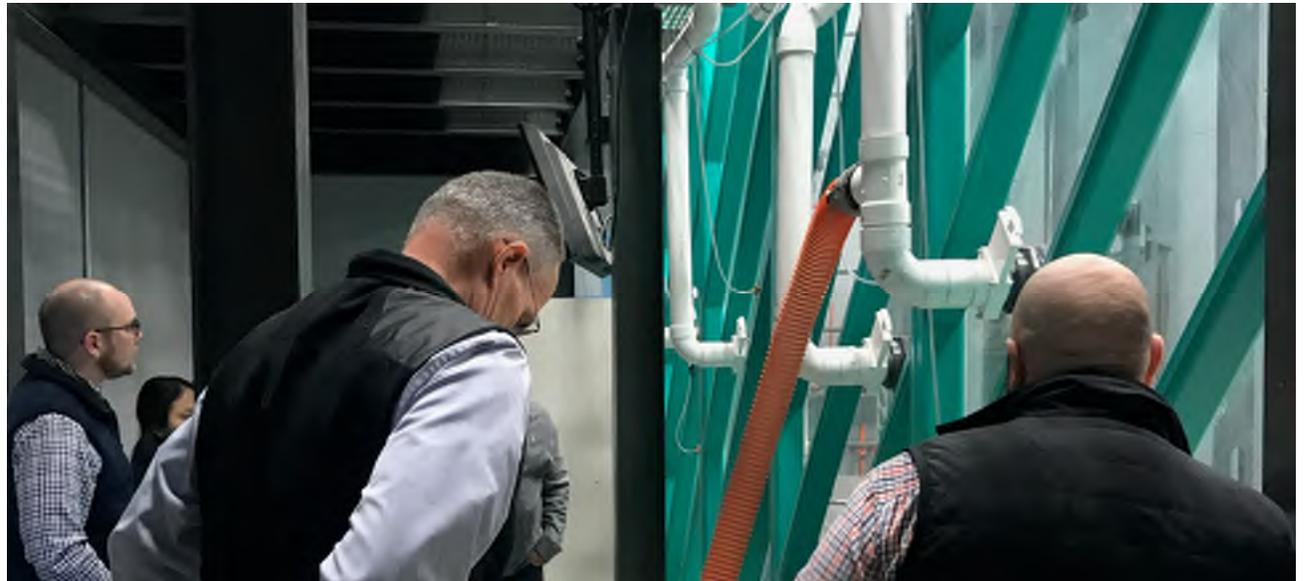
CAN/ULC S 742

ASTM E 283 / E 2357

Air Leakage of *ASSEMBLIES*

ASTM E 331 Water Leakage

Window - Façade Installed & Evaluated

Water Leakage of *ASSEMBLIES*

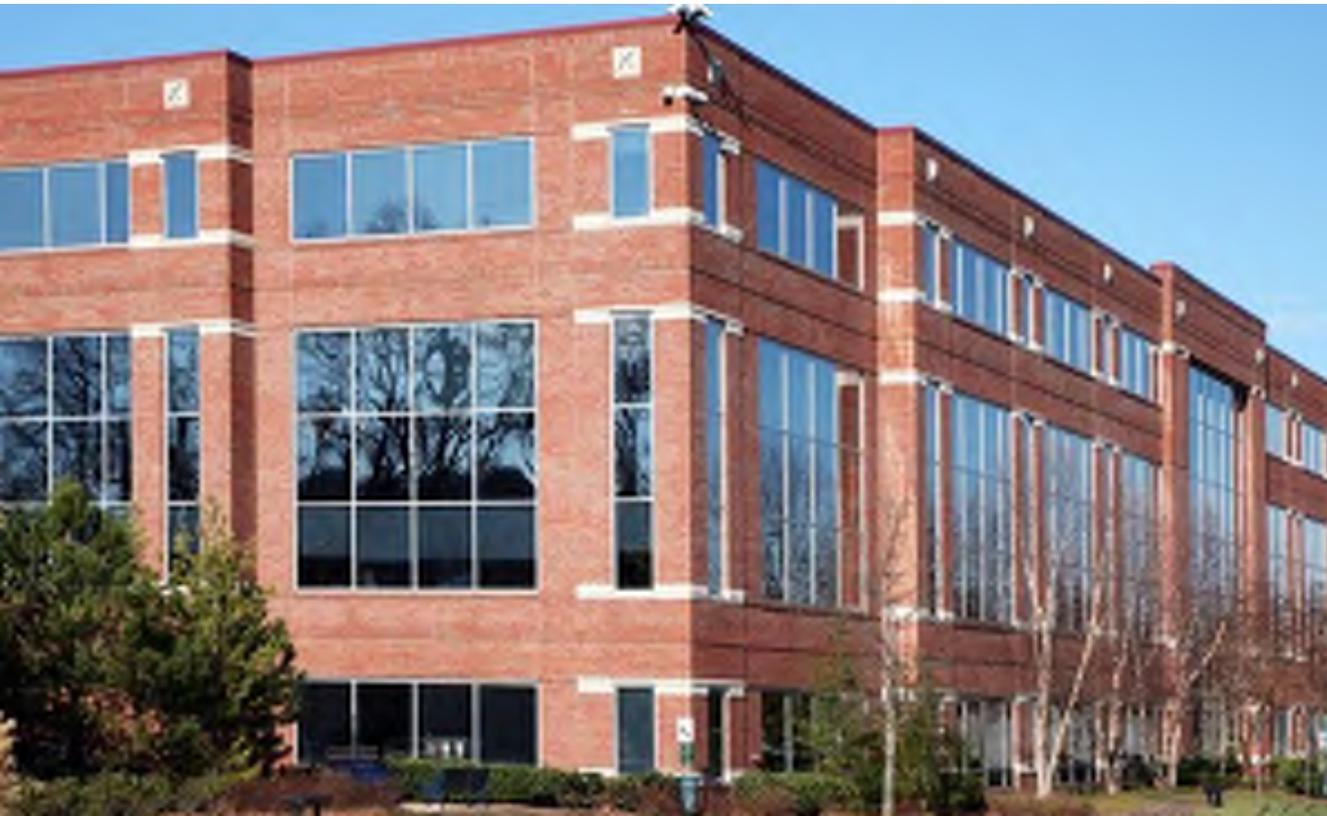
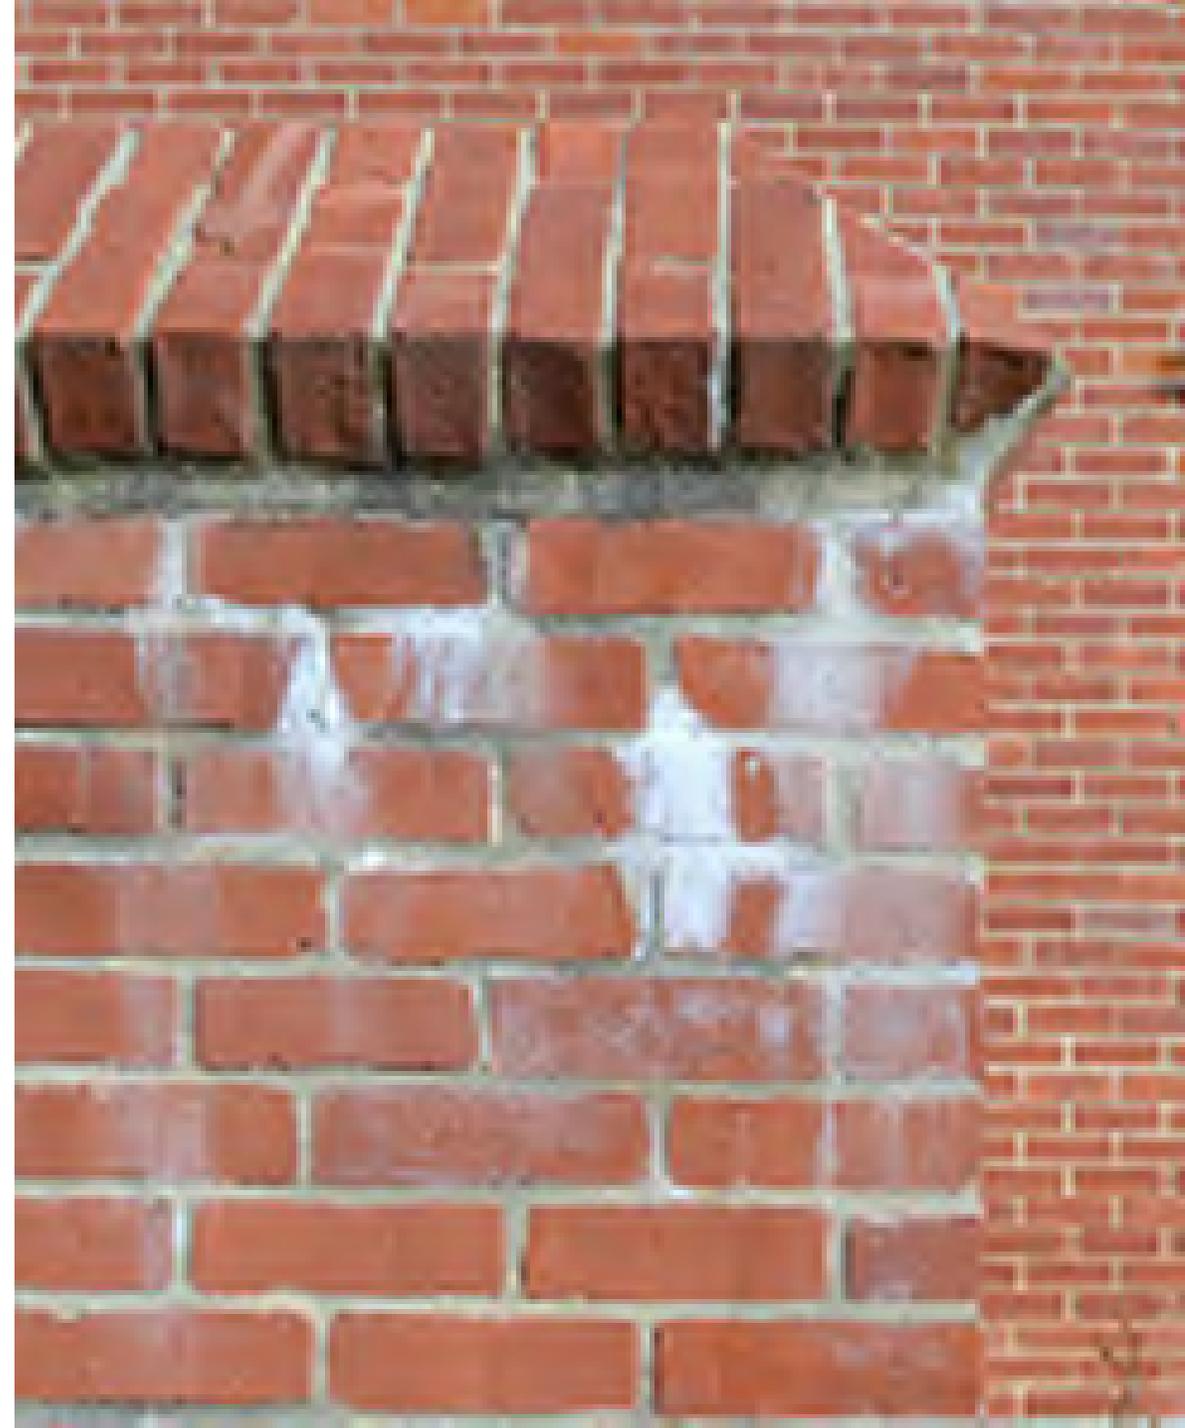
## Efflorescence & Staining

- Common Problems Related to Water Infiltration

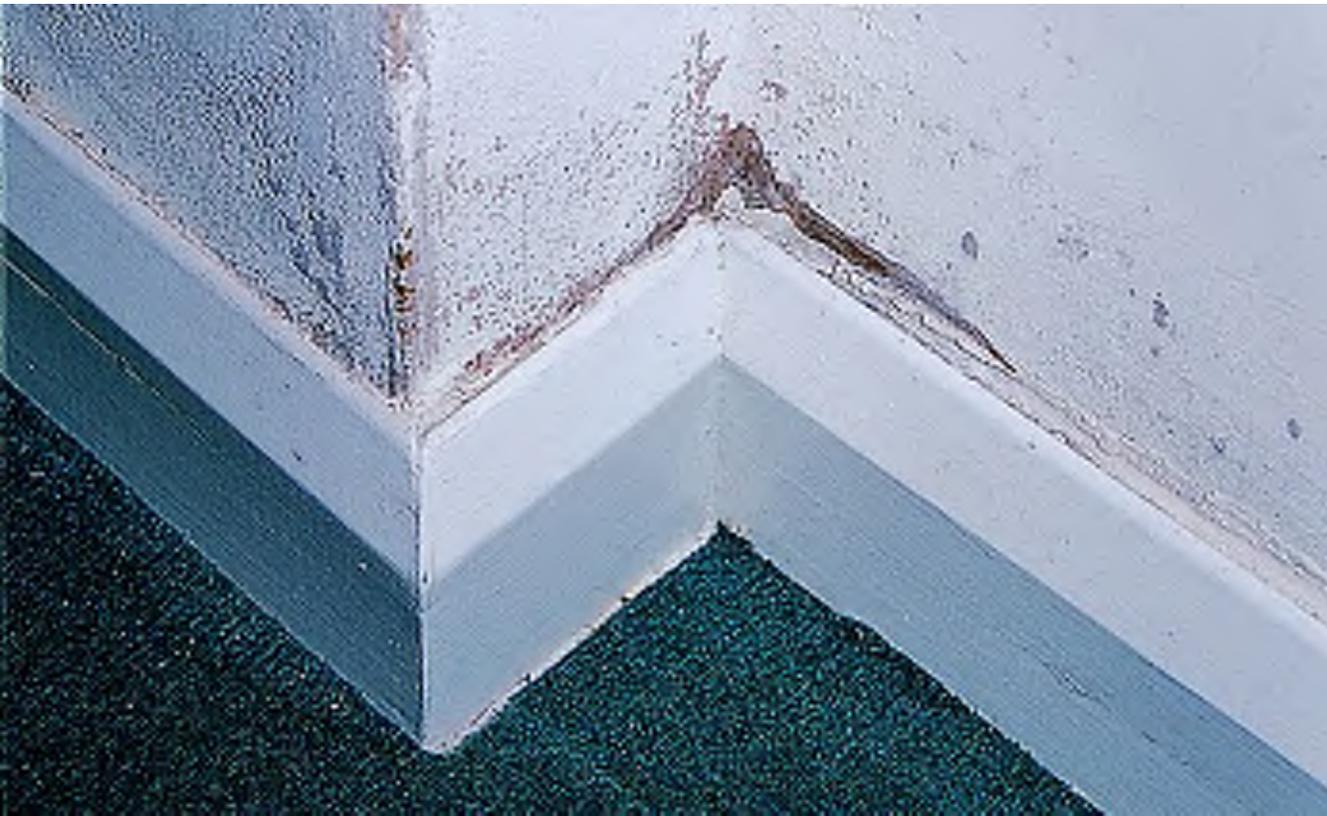
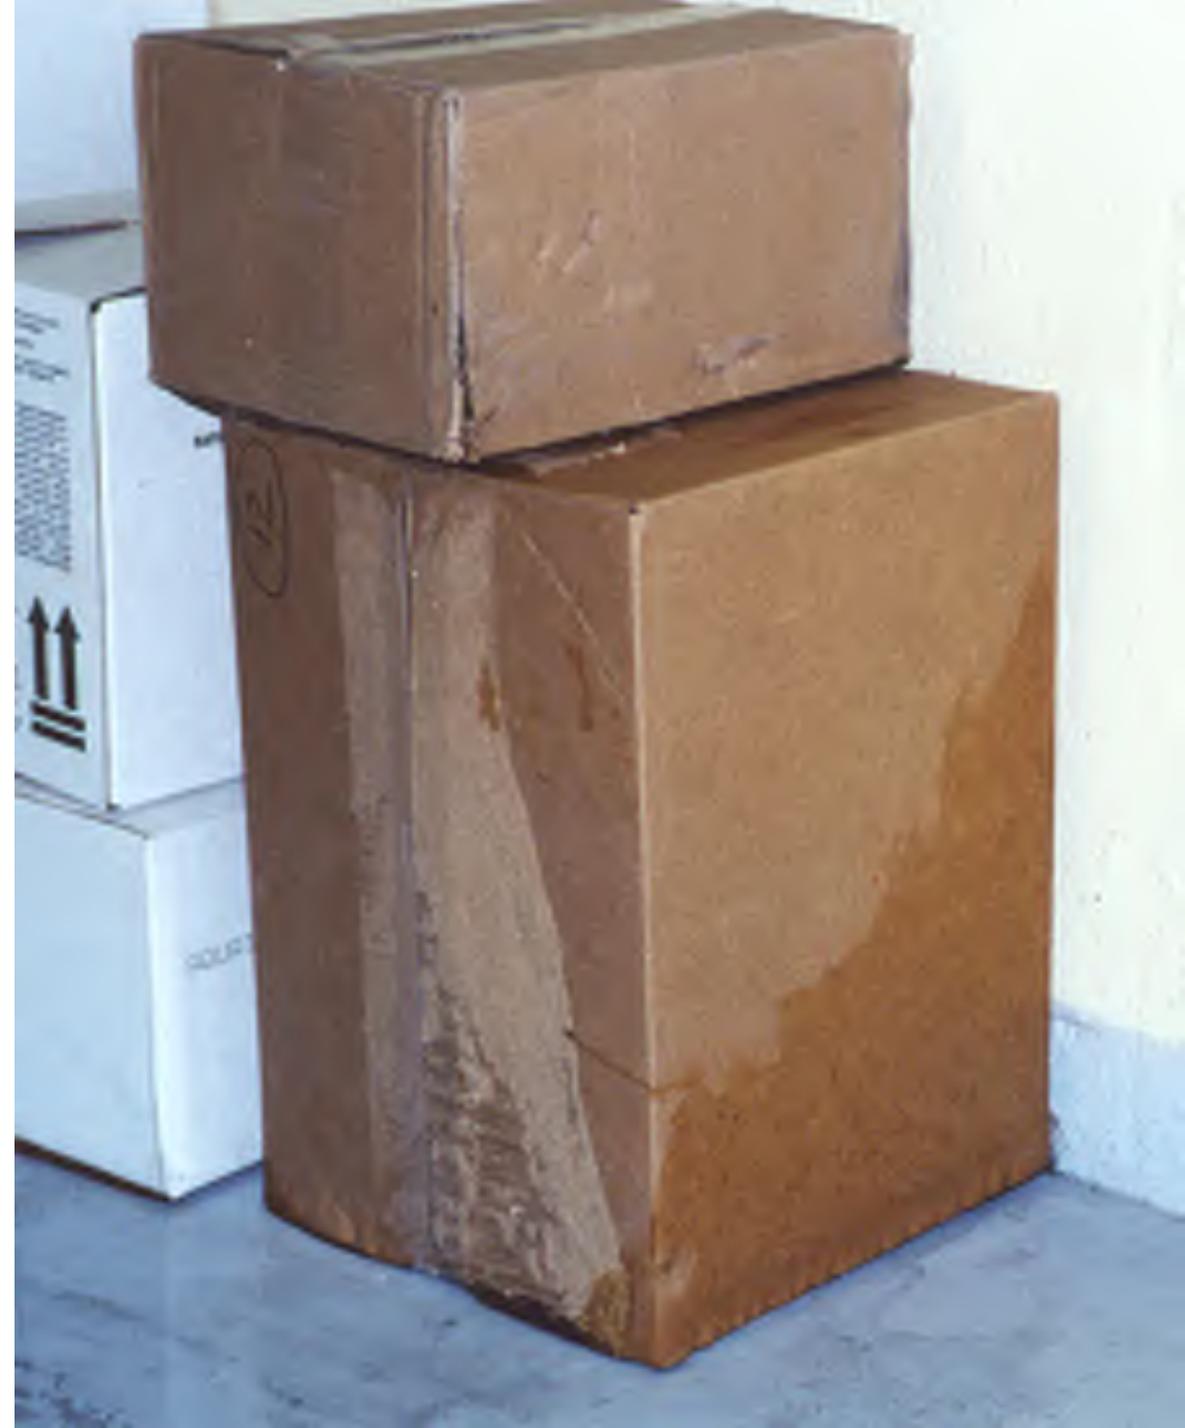
## Interior Water Leakage

- **Common Problems Related to Water Infiltration**

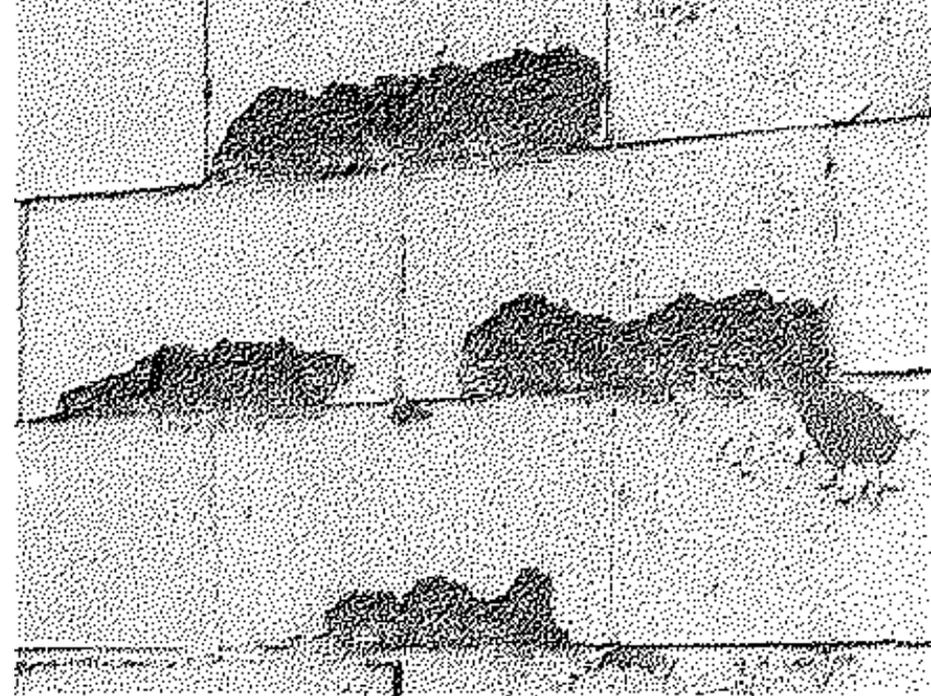
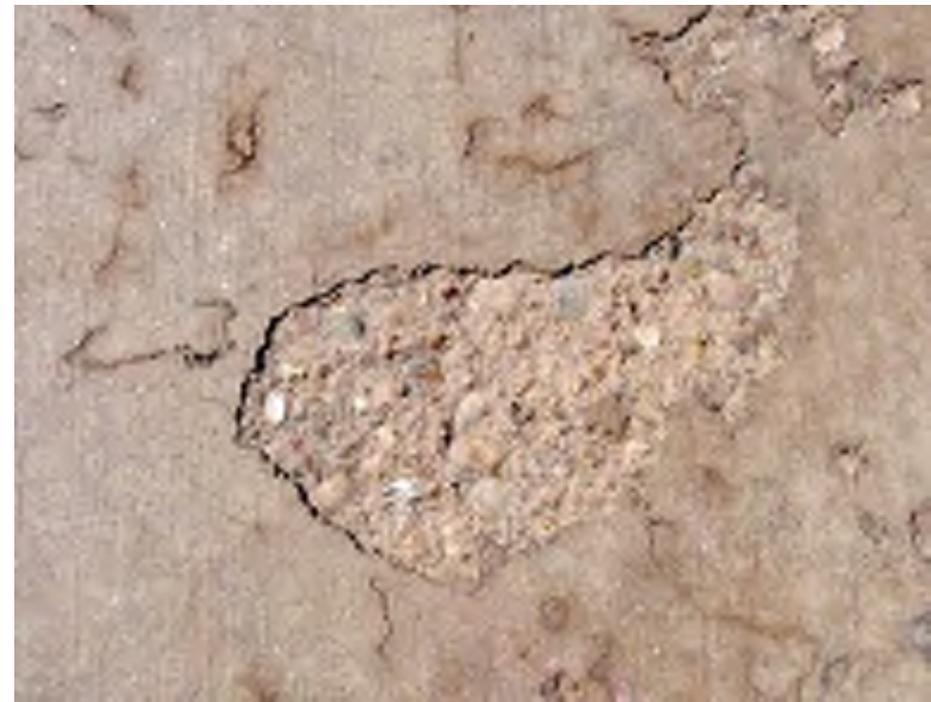
## Freeze/Thaw Deterioration

- **Common Problems Related to  
Water Infiltration**

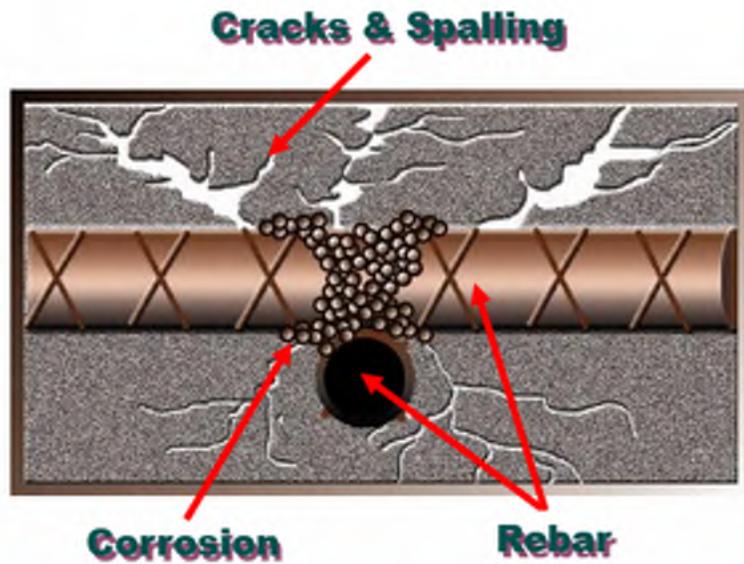
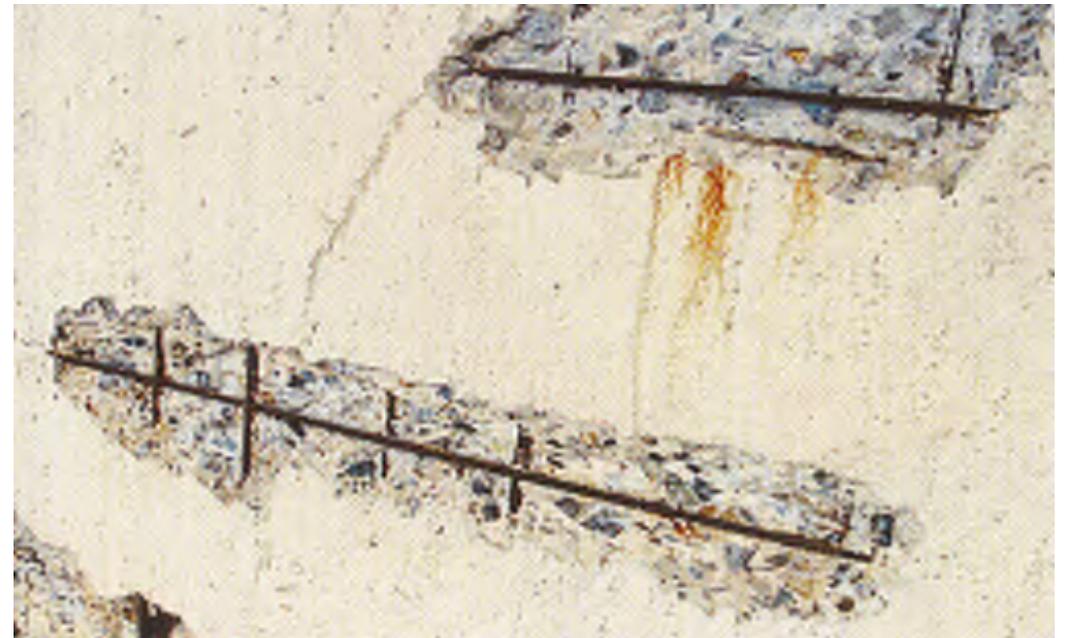
# Internal Steel Member Corrosion

- Common Problems Related to Water Infiltration

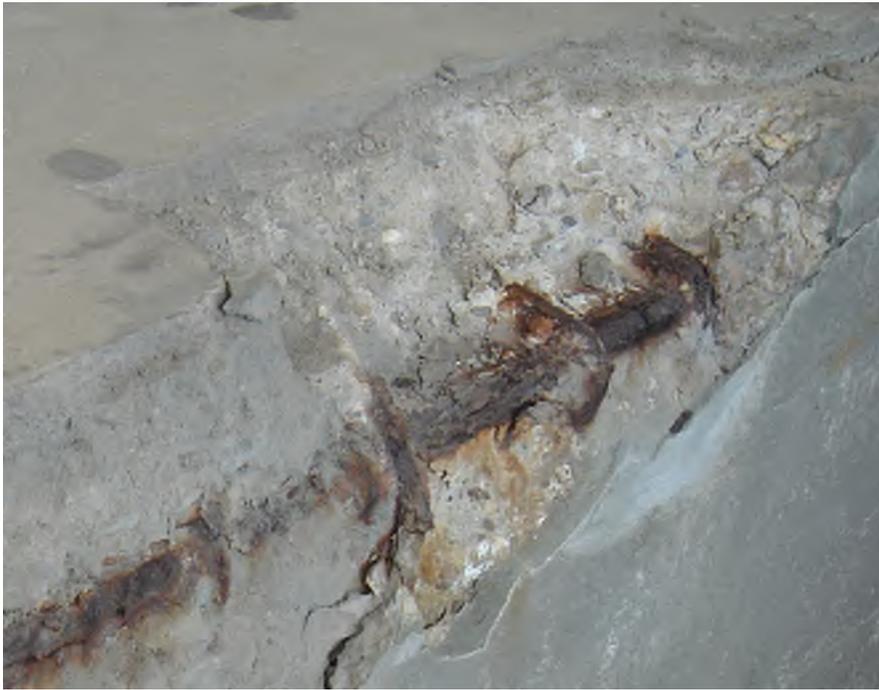
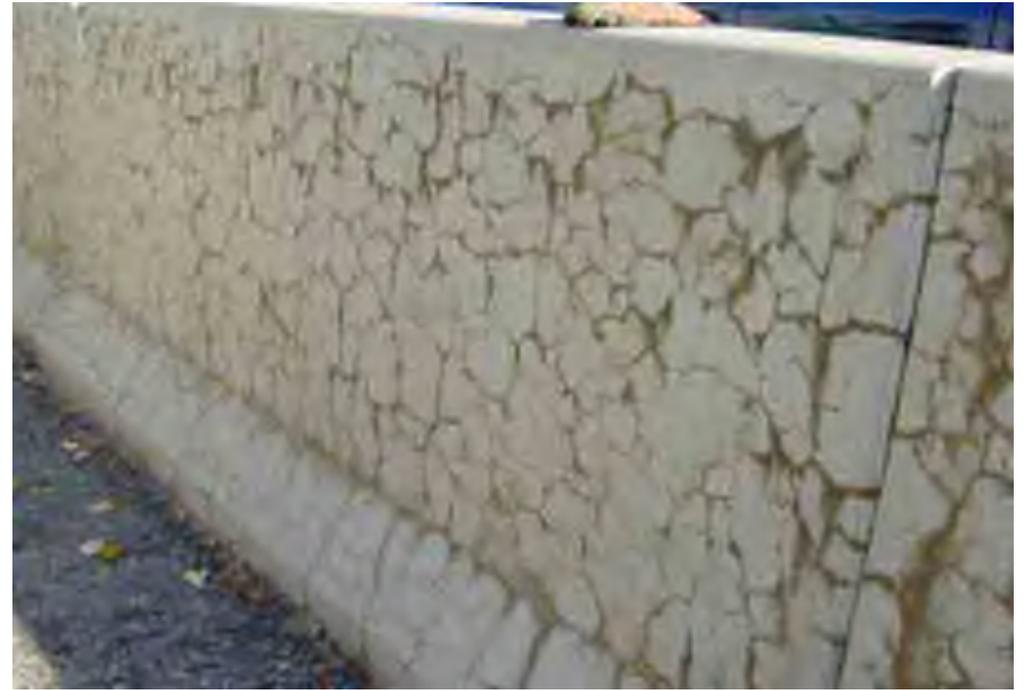
# Carbonation of Concrete

- **Common Problems Related to Water Infiltration**
