# The Six Sides of Building Enclosure Restoration – A Jacket of Protection #2

Presented by: John Breidenbach, AIA  
Bob Moretti, MBA, CDT, CSI  
Tremco Roofing & Building Maintenance  
Credits: 1 AIA LU

## Course Description

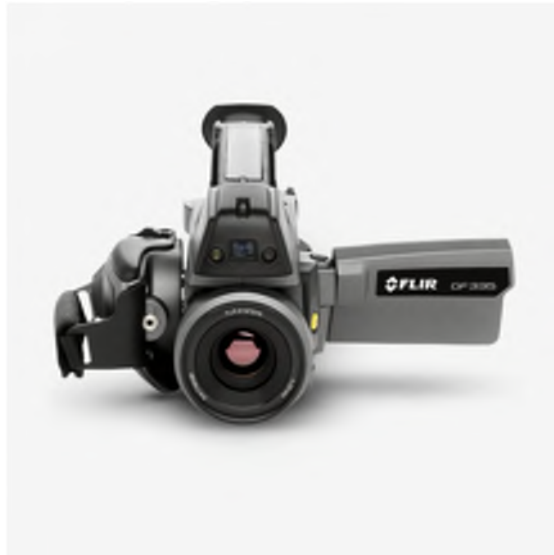
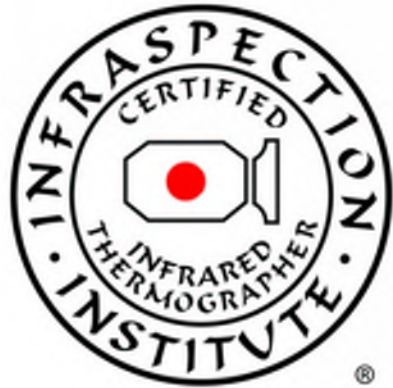
### Infrared Analysis/Thermal Imaging

“When performing infrared inspections of smooth surfaced roofs, a shortwave (midwave) thermal imager can significantly outperform a longwave imager.

Although longwave imagers can be used for smooth membranes, they can significantly understate the size of moisture-damaged areas or miss them entirely.”

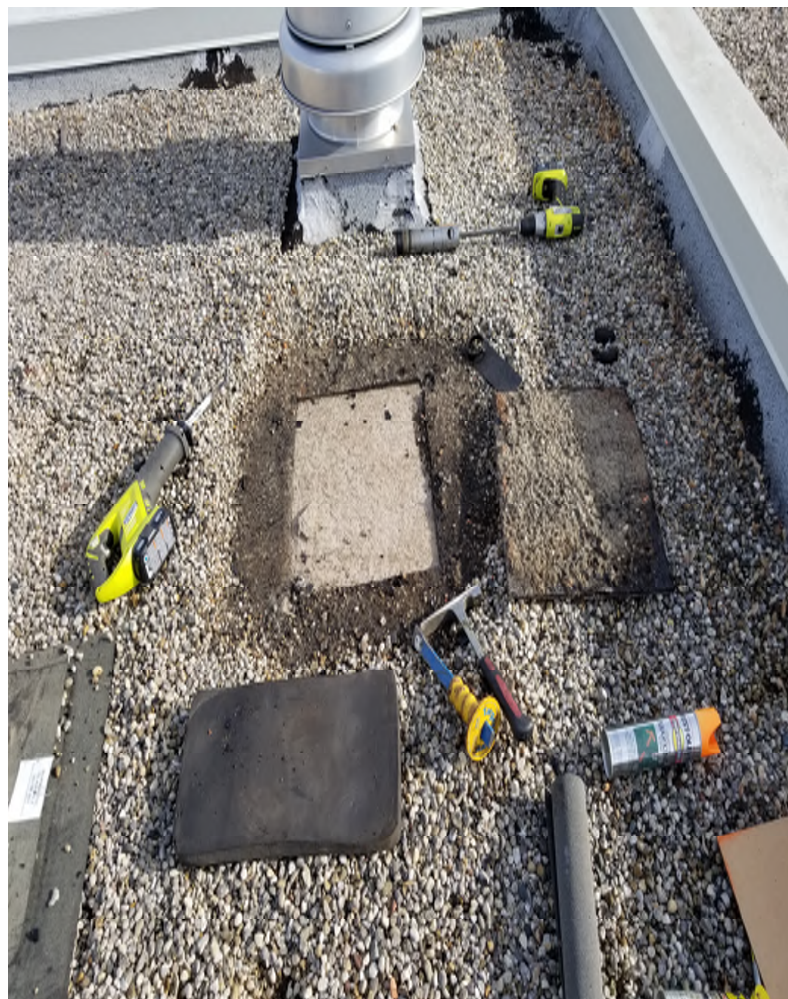
Core: \_\_\_\_\_, Roof 10  
Identification Number: 2001TH019

<u>Analysis</u>	<u>Procedure</u>	<u>Result</u>
Core Size:	ASTM D 2829-95	18.00 X 14.00 in <sup>2</sup>
Estimated Weight of Membrane:	ASTM D 2829-95	183 lbs/100 ft <sup>2</sup>
Surfacing Bitumen Type:	SOLVENT TEST	Asphalt
Surfacing Bitumen Weight:	TRC 875	24 lbs/100 ft <sup>2</sup>
Softening Point of Surfacing Bitumen:	ASTM D 3461-85	287 °F
Penetration of Surfacing Bitumen: (@ 77 degree F)	ASTM D 5-95	3 dmm
Interply Bitumen Type:	SOLVENT TEST	Asphalt
Softening Point of Interply Bitumen below the First Ply	ASTM D 3461-97	240 °F
Penetration of interply Bitumen below the First Ply (@ 77 degree F)	ASTM D 5-95	8 dmm
Ply Type	ASTM D 2829-95	Fiberglass & Polyester
Number of Plies	ASTM D 2829-95	3
Interply Bitumen Weight	ASTM D 2829-95	31 lbs/100 ft <sup>2</sup>
Tensile Strength, Machine Direction (@ 0 degree F, 0.05 in/min)	ASTM D 2523-78	175 lb/ft <sup>in</sup>
Tensile Strength, Cross-Machine Direction (@ 0 degree F, 0.05 in/min)	ASTM D 2523-78	134 lb/ft <sup>in</sup>

Comments: Core construction is one polyester felt over two fiberglass felts.

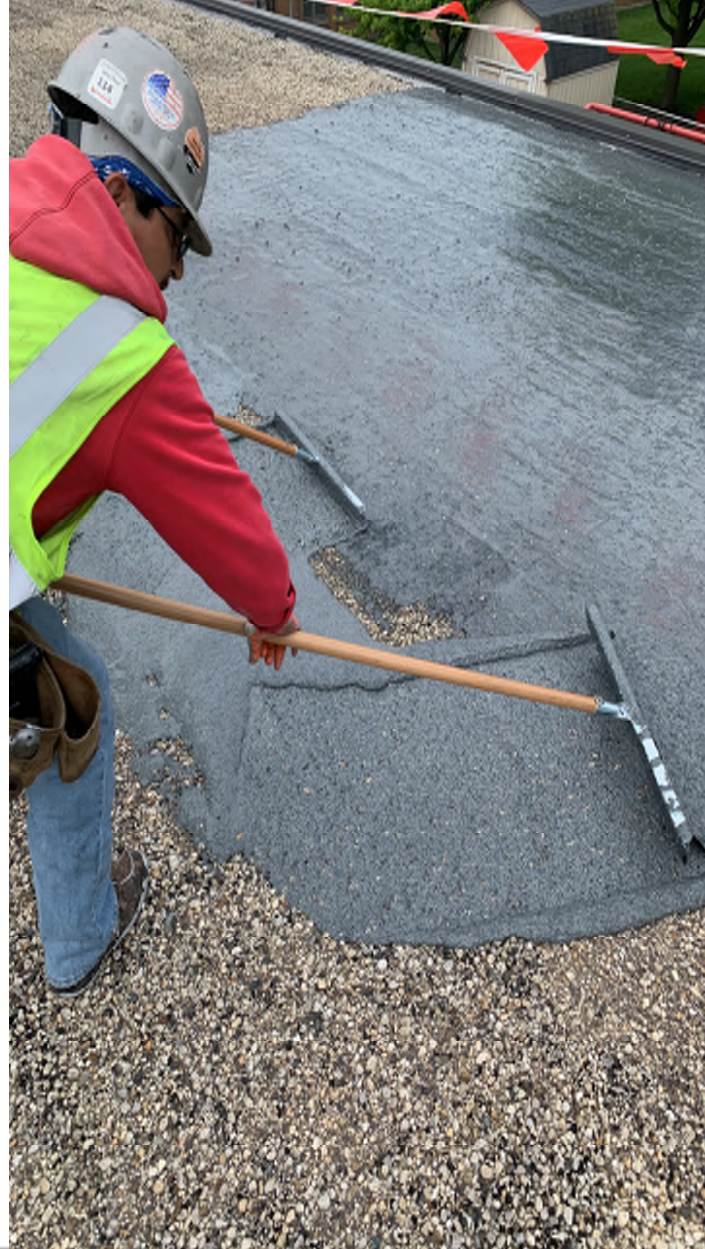
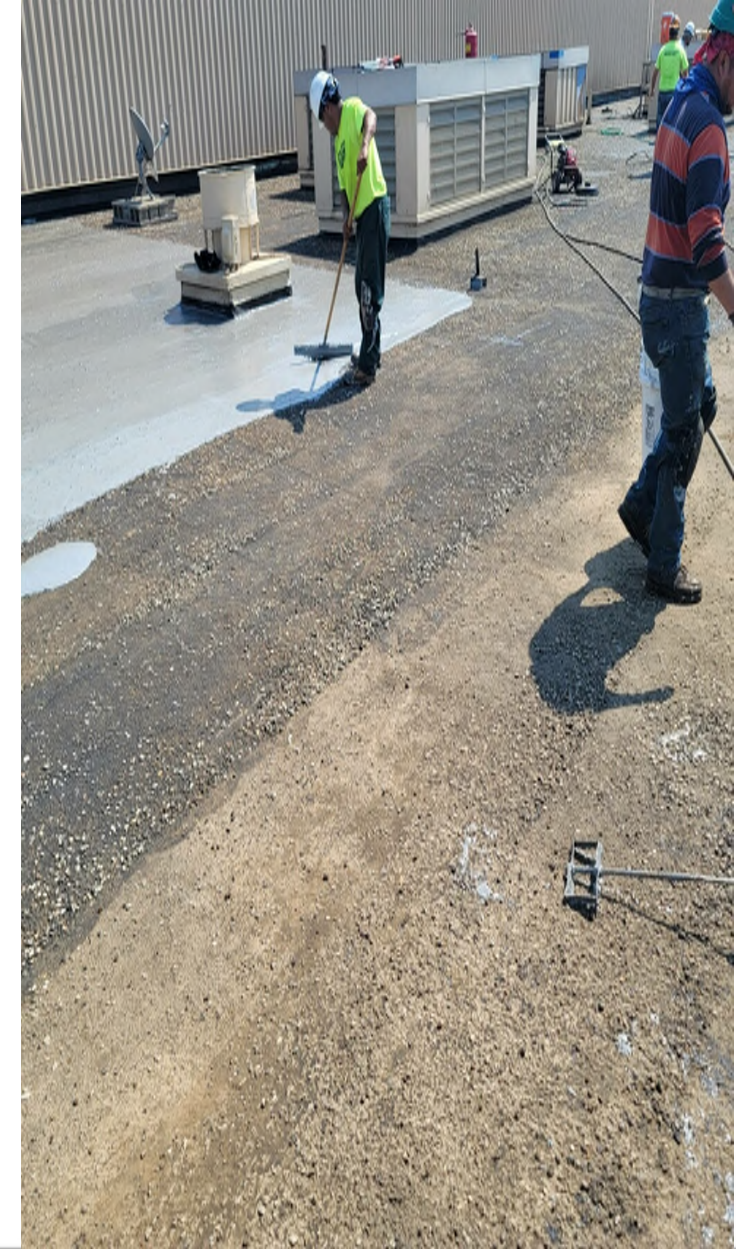
# Fluid Restoration 2.0

- Existing roof membrane must provide a solid substrate
- Not dependent on performance of the BUR membrane – acts independently
- Seamless, no laps
- Virtually odorless
- 400 to 500 mils of Waterproofing
- Bonds to clean, swept surface

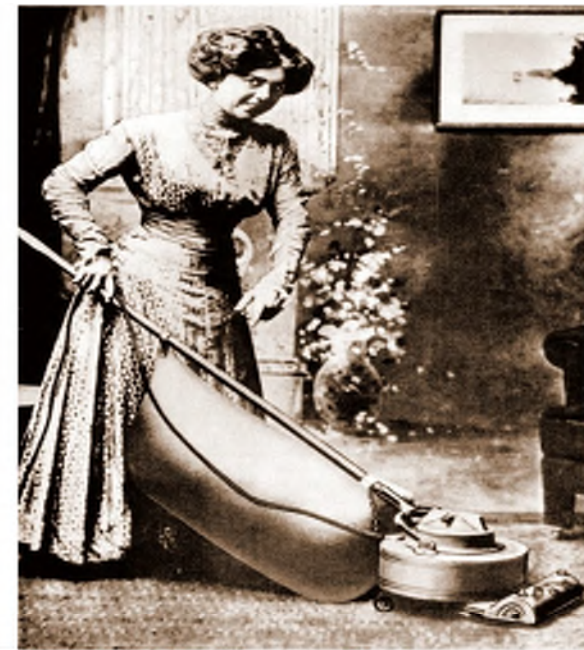
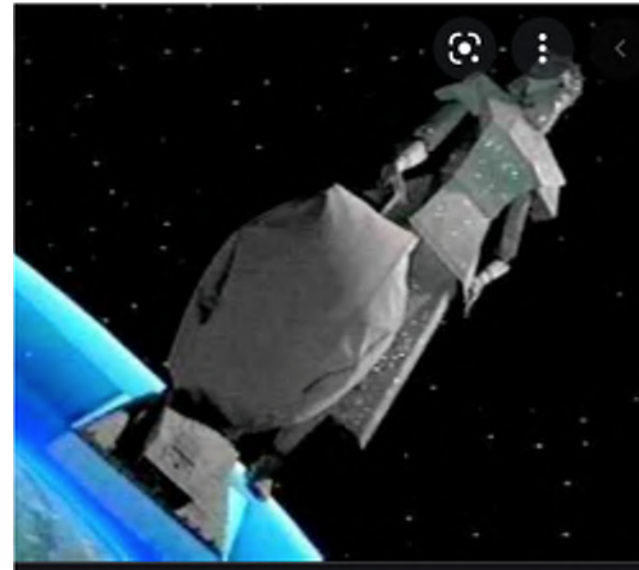
## *Can Wet Roof Insulation Be Dried Out?*

*“We have succeeded in drying fibrous glass insulation in a roof by removing the water with a vacuum cleaner. In a series of tests with a total duration of 134 h, about 0.42 m<sup>3</sup> (110 gal) of water was removed from a 180 ft<sup>2</sup> area of 38-mm thick insulation. Before the water was removed the insulation had only 21 percent of its dry insulating ability; afterward it had 83%.”*
