The Underground Chemistry Behind Middle Point Landfill

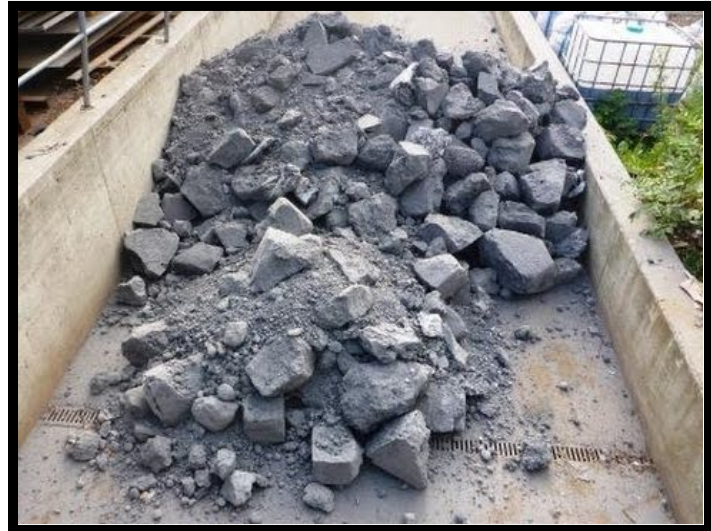
Image: Crushed aluminum dross saltcakes

The EPA has attributed these elevated temperature reactions to the deposition of [aluminum dross](#) at Middle Point Landfill. Aluminum dross — often referred to as “saltcake” — is a reactive industrial byproduct of aluminum smelting and recycling composed of oxidized aluminum, residual metallic aluminum, and various salts. The aluminum nitride compounds present in these saltcakes are highly sensitive to moisture; when exposed to rainwater or landfill leachate, they undergo chemical reactions that release heat and generate ammonia gas. These exothermic reactions can significantly raise internal landfill temperatures and intensify gas production.

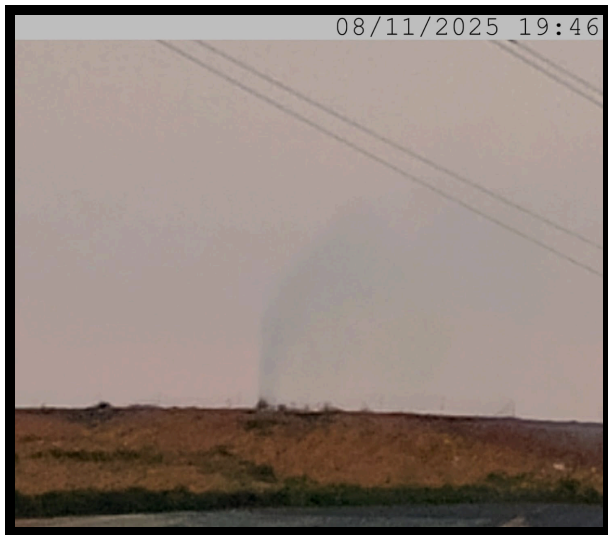
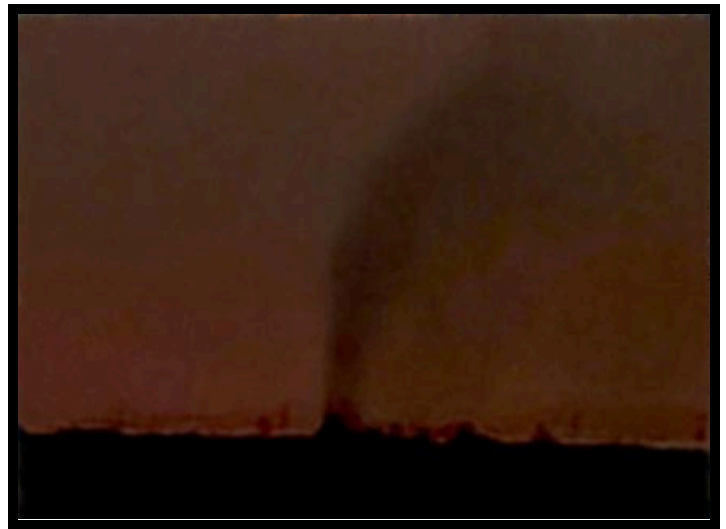
Left Image: Photograph of landfill gas plume from MPL in August 2025. Credit: Rutherford Forward. Right Image: Enhanced contrast photograph of landfill gas plume from MPL in November 2025. Credit: Rutherford Forward.

When a thick plume of landfill gas was documented in August 2025, it renewed concerns that the landfill's underlying chemical and structural issues had not been fully resolved, and that the conditions contributing to past fires may still be present. [Rutherford Forward](#), a local advocacy organization focused on raising awareness about air and water contamination from Middle Point, recorded and shared images of the incident. Eyewitnesses shared that the plume spewed yellowish gas for around 30 minutes. When concerns regarding the plume were shared with TDEC, they allegedly responded that it must have been due to a bush fire on the southern side of the landfill, despite the images strongly suggesting the plume stemmed from a gas collection well. However, there appears to have been no detailed public documentation of the event released by Middle Point or the Tennessee Department of Environment and Conservation (TDEC), leaving residents and local officials with unanswered questions.
