## CASE HISTORY

### Exterior Insulation Finish System (EIFS) Restoration

### BOND STREET OFFICE PARK

Farmington Hills, MI

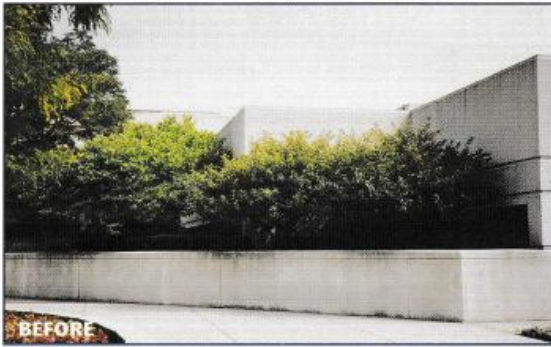
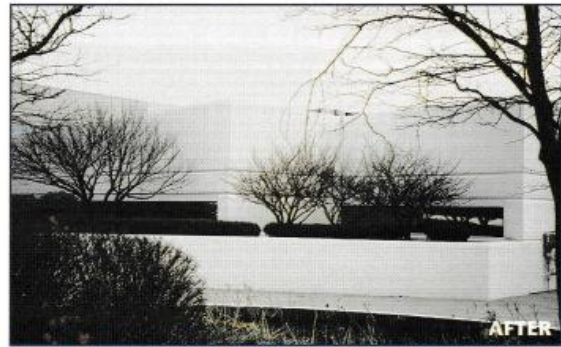
EIFS panel un-uniformity, fading, chalking, staining, mold and mildew growth, dirty and overall aesthetically unappealing.

EIFS finish coat delamination, exposed mesh and insulation, punctures, horizontal and vertical cracking, water absorption/infiltration and window termination cracking.

EIFS expansion joint failure, glass to glass butt-joint failure, glass glazing gasket failure, and window frame perimeter to EIFS sealant failure.

EIFS Failure Repairs .....	Dow Corning 795
Perimeter Caulking .....	Dow Corning 791
Glass Re-glazing .....	Dow Corning 791
EIFS Expansion Joint Re-sealing .....	Dow Corning 123
Exterior Building Cleaning .....	Waterblasting
EIFS Priming .....	Dow Corning Allguard Primer
EIFS Elastomeric Waterproof Coating .....	Dow Corning Allguard Coating
Concrete Wall Restoration .....	Dow Corning 790 and Dow Corning Allguard Coating
