Bearing Parasitic's Due to VFD'S

This test was conducted to demonstrate how much voltage and current is passing through the bearings on the electric motor while being drive by a VFD. The motor we are testing has had both bearings insulated from the end bells on the motor. The end bells were bored over size and then a Delron bushing was pressed into each end bell. The Delron bushings were machined to spec for the bearings to be reinstalled into the bearing housings. The two bearings in the motor were equipped with a lead wire that was soldered onto the bearing shield. By soldering the two lead wires onto the bearings shields, we were able to measure the bearing voltage and current. See the photo below.

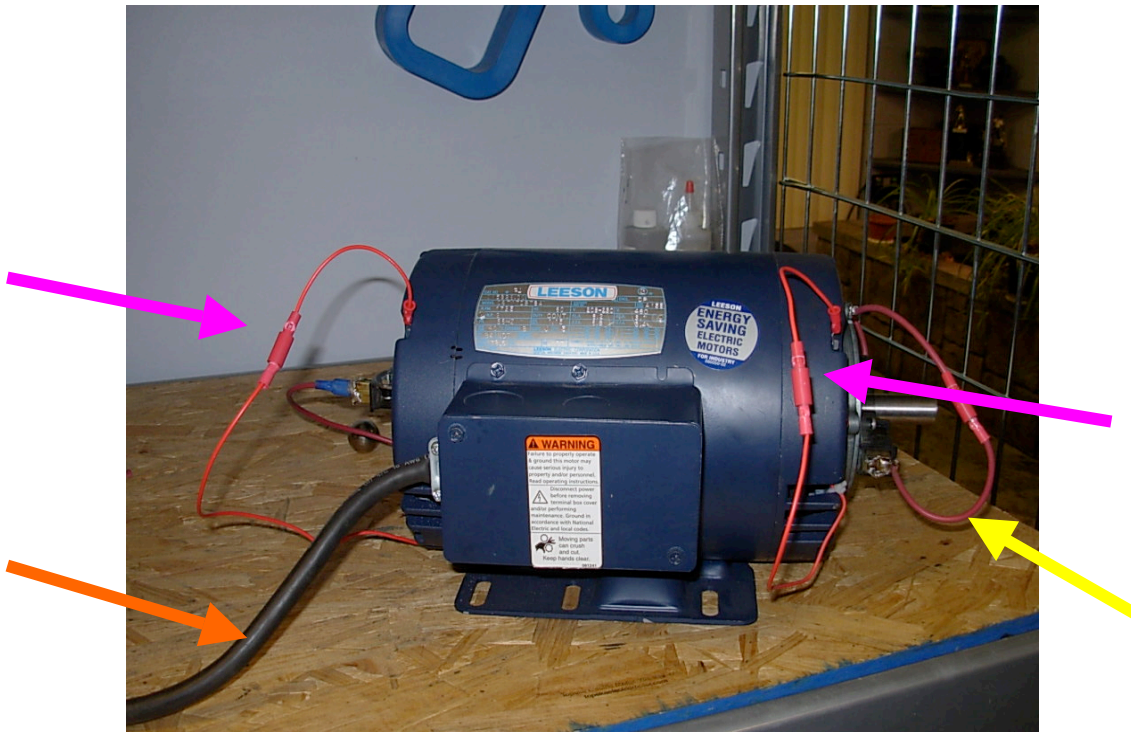
The two pink arrows show the two leads wires that were soldered to the bearings and that come out of the end bells and to ground on the case.

The orange arrow is the power cord from the VFD, common mode lead.
The yellow arrow is the shaft grounding brush.

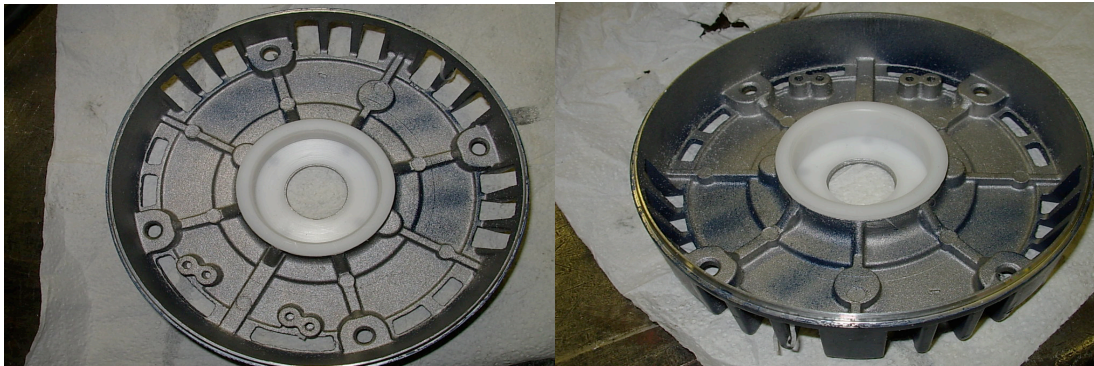
The above photos show that the end bells are both insulated with Delron sleeve inserts. The Delron sleeves keep the outer race of the bearings from conducting any voltage, current or parasitic's to ground through the end bells.

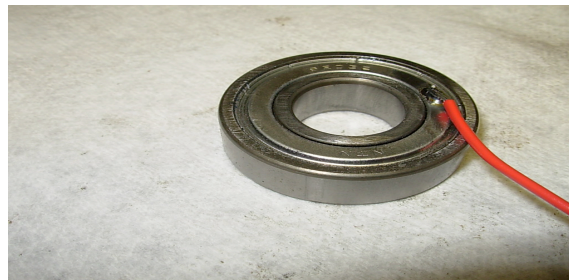
The above photo shows how the lead wire was attached to the bearings. The lead wire was soldered onto the bearing shield. The bearing shield only makes contact with the outer race so the path of voltage, current or bearing parasitic's is through the shaft to the inner race of the bearing, through the layer of grease, through the ball in the bearing, through another layer of grease, through the outer race to the lead wire, then to ground on the case of the motor.

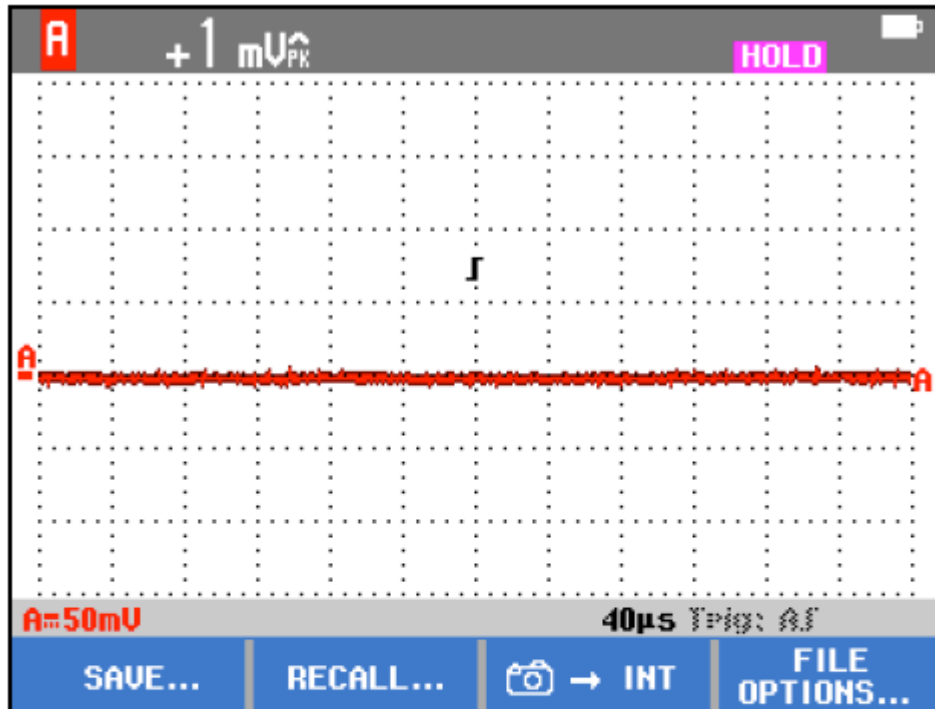
test# 23 motor was running on
 230 v with no VFD or CoolBlue or
 NaLa cores.measurement taken on
 lead wire attached to opp. drive
 bearing.
 1-4-16

The above figure shows the motor running on 230 volt across line. There was no VFD in the circuit and there were no CoolBLUE® or NaLA® cores in the circuit. The reading was taken on the lead wire that is connected to the shield on the opposite drive bearing. The Rogowski coil was looped through the lead wire from the bearing to ground.

Note that there is not any High Frequency current readings or EMI noise. This is what the results should look like. However, VFD'S do not have the ability to deliver power this clean because of the way they operate.

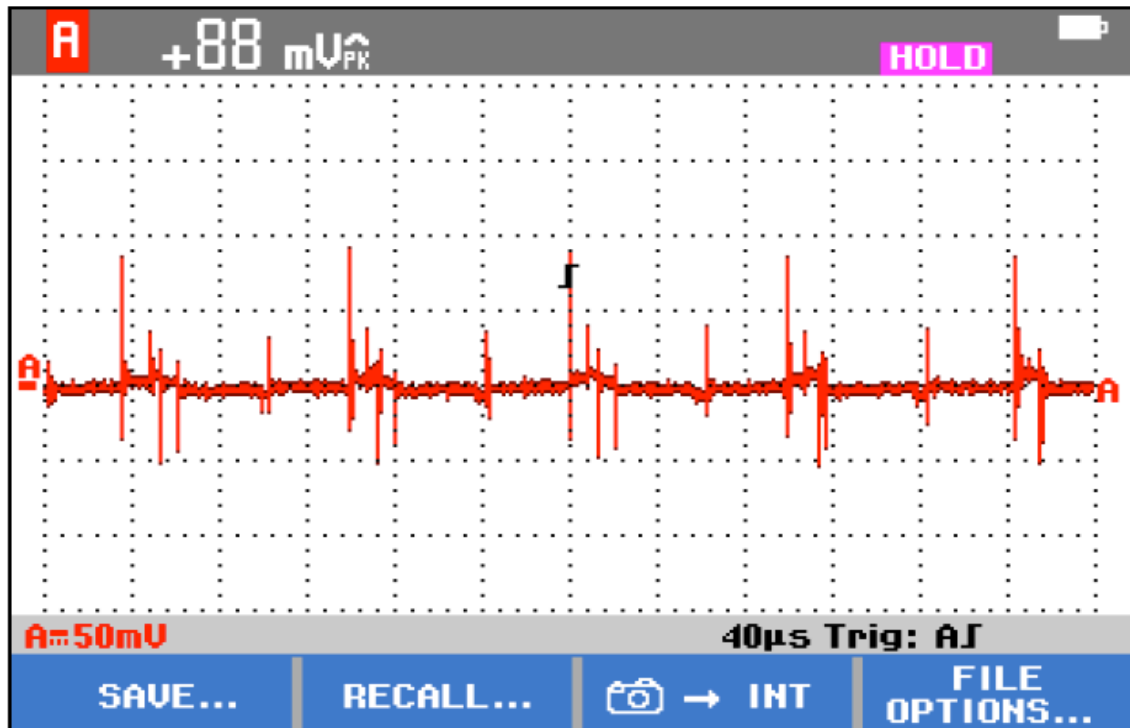
test# 25 motor was running on VFD
 with no CoolBlue or NaLa cores
 shaft grounding brush was applied
 to output shaft.
 1-4-16

The above figure shows the motor running on the VFD with no CoolBLUE® or NaLA® cores and with the shaft grounding brush applied to the output shaft. The reading was taken with the Rogowski coil looped through the lead wire that is attached to the bearing that then is attached to the case, to ground.

The reading was 0.088 v. The reading is then converted to amperage by dividing by 0.05. 0.088 v divided by 0.05 = 1.76 amps of current on the lead from the bearing to ground.

As you can see in the figure, we are still having lots of spikes in the reading. These spikes are also very damaging to the stator windings and to the ball bearings.

The reading was 0.012 v. This is calculated to: $0.012 \text{ divided by } 0.05 = 0.024 \text{ amps of current}$. The difference between test # 25 and test # 26 is a reduction to 86.3% of High Frequency current.

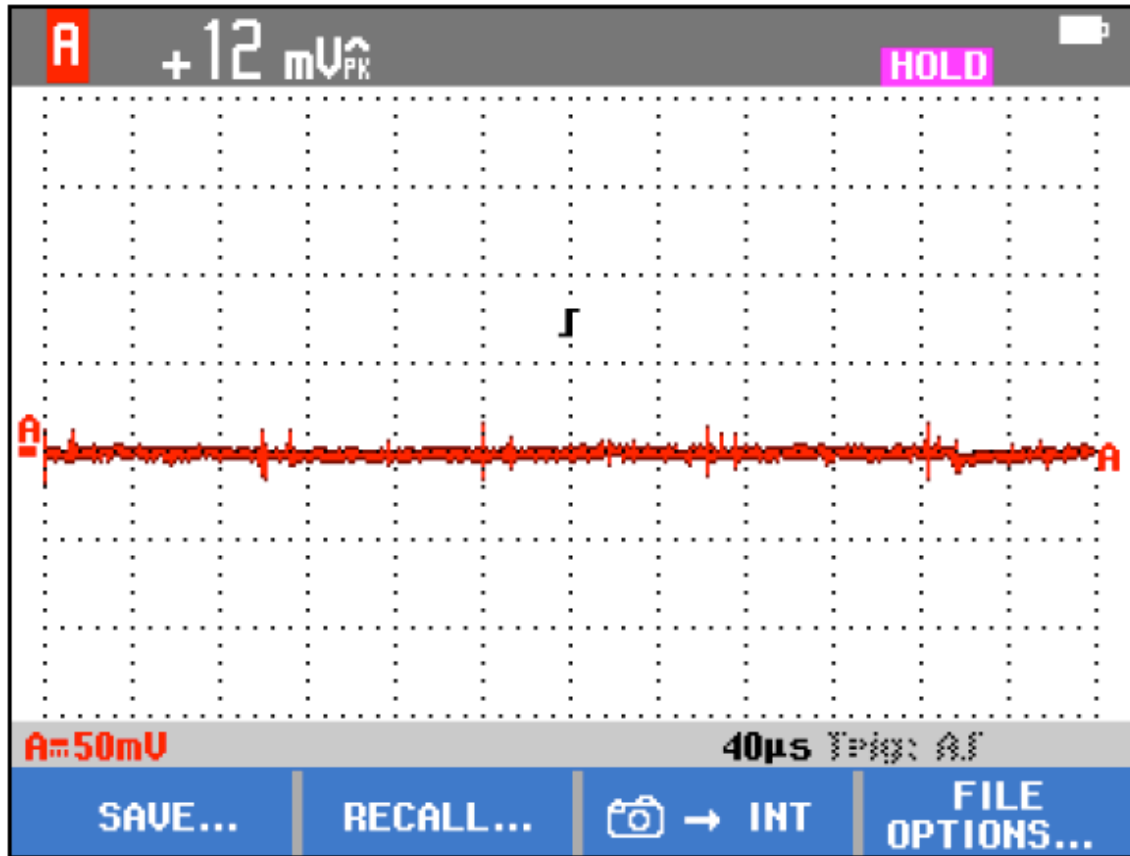
test# 26 motor was run on VFD with CoolBlue and NaLa cores. reading taken on lead from bearing, no shaft grounding brush
1-4-16

The above figure shows the motor running on the VFD and with CoolBLUE® and NaLA® cores installed on the common mode leads to the motor from the VFD. There was no shaft grounding brush being applied to the output shaft.
