***INDUSTRY WHITE PAPER***

# Inverter-Driven Induction Motors Shaft and Bearing Current Solutions

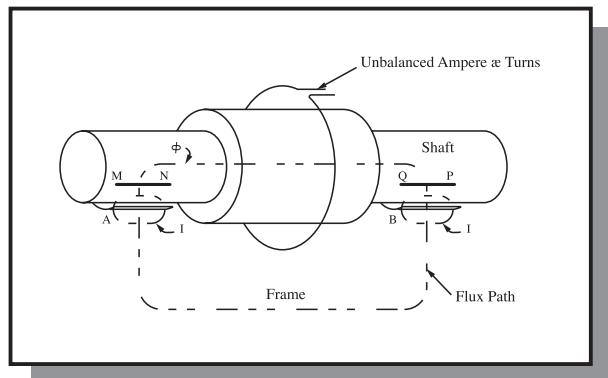
Figure 1: Homopolar flux condition creating bearing currents.

The homopolar flux condition describes the flow of flux down the motor shaft, through the bearing system, and back through the frame. Generally seen in high-speed, fast-rotating machines, this axial shaft flux is created by unbalanced ampere turns that encircle the shaft, a broken rotor bar, residual magnetization or, occasionally, an eccentric air gap. It most commonly occurs in sleeve bearings. Currents are usually localized to the bearing so there is no way to provide measurement. The effects of homopolar flux induced bearing currents are generally minor and are remedied by providing a homopolar flux barrier such as a nonmagnetic shaft or insulated bearings.

currents in sine wave driven motors are 1) homopolar flux, i.e. flux flowing down the center of the motor shaft and 2) alternating flux linking the motor shaft. The second cause is much more common than the first. Consider the homopolar flux condition as shown in Figure 1.

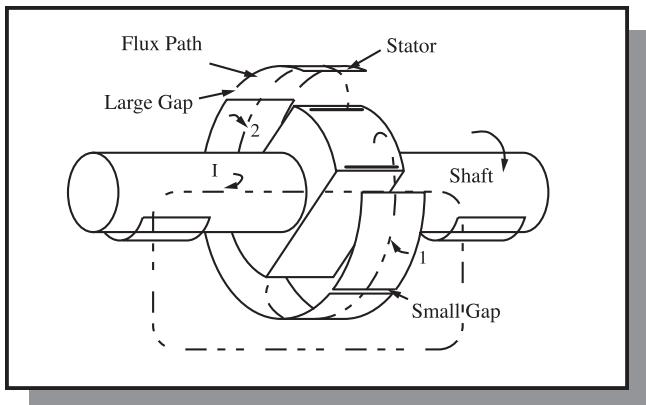
Figure 2: Alternating flux linking the shaft.

The resulting current is not localized within the bearing. Its driving voltage can be measured on motors with at least one bearing that is electrically insulated from the motor frame. (See Institute of Electrical and Electronics Engineers' (IEEE) Standard 112-1996). When both bearings in the current path are conducting, the impedance of this path is small; therefore, an axial shaft voltage as little as 500 millivolts rms can create a current of up to 20 amps rms through

The more common type of bearing current is caused by alternating flux linking the motor shaft, as a result of asymmetrical magnetic properties of the stator or rotor core. Electric steel is not totally homogenous therefore flux paths in the motor are not entirely symmetrical. Asymmetrical flux through the steel results in flux lines that enclose the shaft. This can drive a current down the shaft, to the bearings, through the frame and back again through the bearings as shown in Figure 2.

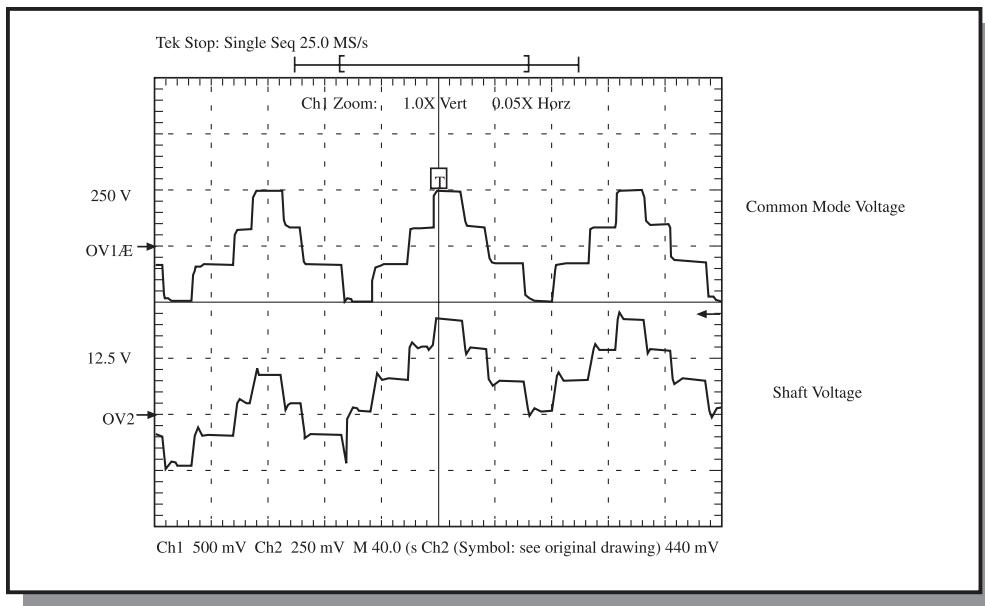
**Figure 3: Typical common mode voltage and motor shaft voltage wave forms. (Horizontal scale - 40 microsec per div)**

and the motor ground. It contains high rates of change of voltage with respect to time (i.e. high  $dv/dt$ ). The high  $dv/dt$  creates frequency content in the common mode voltage in the MHz range.

See Figure 3 for a typical wave shape of the common mode voltage of an inverter-fed motor. This voltage exists between the motor windings

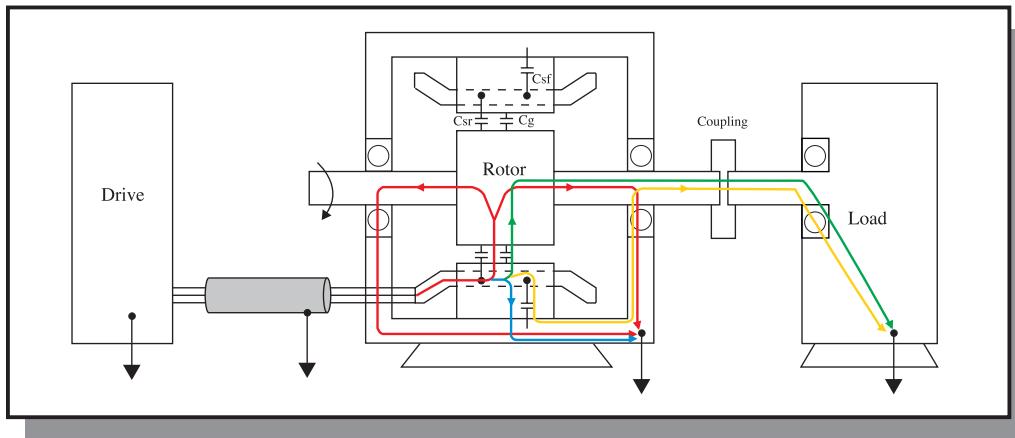
Figure 4: Current paths of capacitively coupled currents.

In Figure 4, the various current paths of capacitively coupled current are presented. The high  $dv/dt$  created in the stator winding couples capacitively with the stator core and frame and with the rotor. The relative magnitude of the currents flowing in these paths is strongly dependent upon the impedance of these paths. As will be shown later, bearing damage can be reduced or eliminated by creating low impedance current paths that route these currents away from the bearings. Let's first take a look at each current path shown.

The preferred path for all these currents, to reduce bearing damage, is the blue path (—) in Figure 4. Here, no current flows through the motor or load bearings.

The current paths shown in Figure 4 are shown as lumped circuit currents. In fact, the capacitively coupled current flow is distributed along the stator winding. This implies that current “leaks” from the winding over the length of the winding, so that the axially directed current at the winding input is more than at the winding exit point. The result of this phenomenon is shown in Figure 5, where a net axial current is shown flowing in the motor stator winding.

Figure 4), one due to capacitive coupling across the air gap (green) and the other due to common mode current from the stator core to the load (gold). Current flow to the load bearings can be eliminated through the use of an insulated coupling (see Figure 15). Notice that by

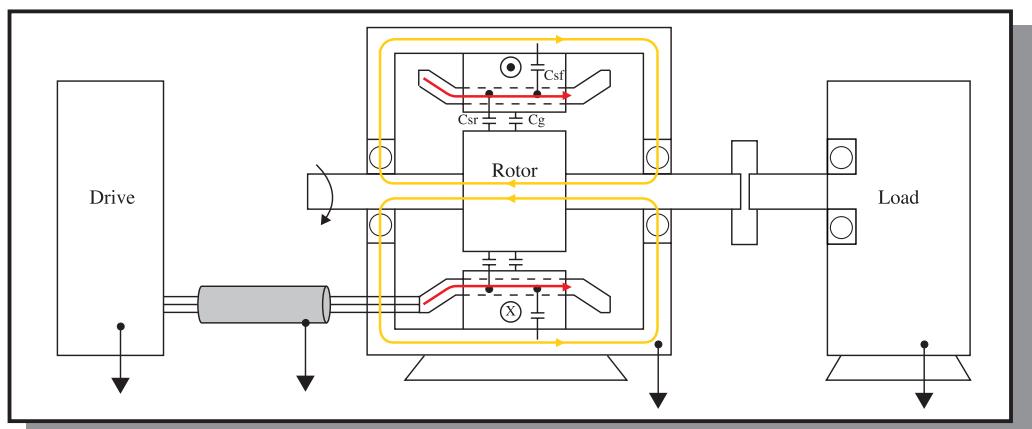
Figure 5: High frequency flux encircling the rotor causing shaft and bearing current.

Figures 4 and 5 earlier in this document schematically showed bearing current paths that exist in inverter driven electric motors. A number of solutions are available to reduce or eliminate these current flows, the appropriateness of each depending upon the type and source of the bearing current found. Eliminating or reducing the common mode voltage and current addresses the problem at its source. This, however, is a drive design issue and therefore cannot be easily addressed in existing applications. Drive designs that reduce or eliminate common mode voltage and common mode current flow will be discussed at the end of this paper. In all cases, a drive with reduced common mode voltage is more costly to manufacture than typical PWM voltage source inverters that are widely marketed today. Since elimination of the source of the high frequency bearing currents is not likely due to this increased drive cost, improvements in the system grounding and/or modifications of the motor are often the preferred method to reduce the potential for bearing current damage.

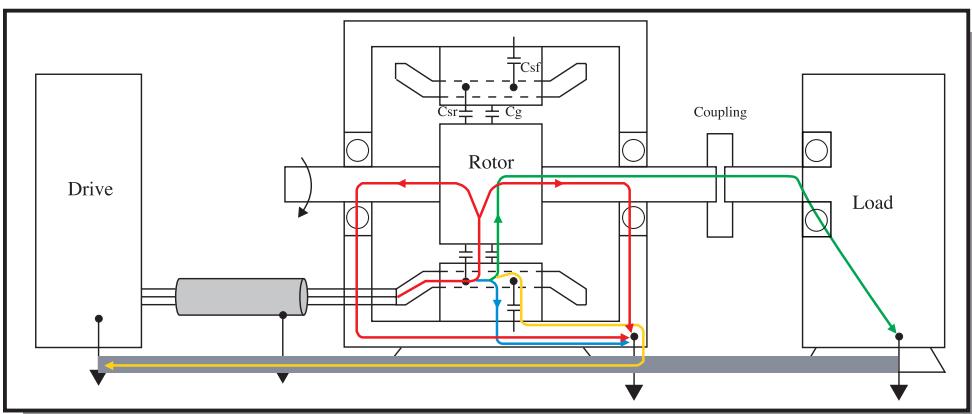
**Figure 7: Good grounding reduces shaft current.**

pulse of high frequency current, all various paths available will be used, and the current will split in inverse proportion to the impedance offered by the respective paths. With equal impedance – for a desired path from the motor back to the drive and for the undesired one through the bearings to the driven equipment – the situation arises in which half the current might be carried by each path, creating an undesirable situation. The current generated by the common mode voltage (the  $I$  in the  $I = C \frac{dv}{dt}$  equation) is the common mode current. It is important to provide low impedance grounding paths for the common mode current to keep current from flowing through the bearings.

(see Figure 21) or, better yet, good high frequency grounds between the motor and drive and motor and load (see Figure 7).

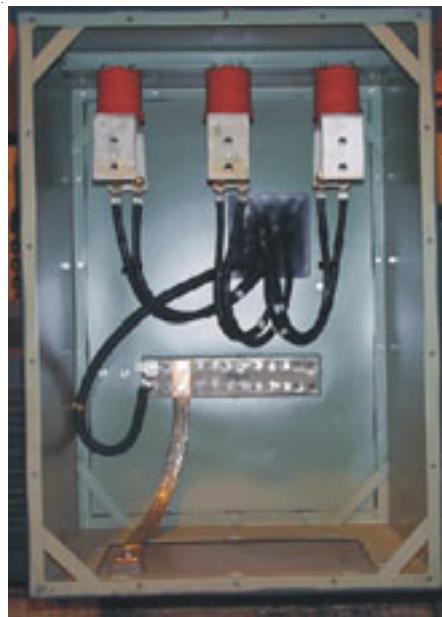
Figure 8:  
Ground bus  
connection  
pad in  
variable  
speed motor  
conduit box.

surface contact between the cable sheath and the connector and the connector and the motor and drive frame are recommended to provide this low impedance path. The ground conductor(s) within the cable should ideally be symmetrically spaced with respect to the three power conductors. Connection of both the shield / sheath, as well as the ground conductors at both the motor and the inverter ends, creates a high frequency, low impedance path for pulses of common mode current. The termination of the ground conductors and the sheath / shield should avoid adding impedance in the connections themselves. Landing these connections on a prepared ground surface intended for this

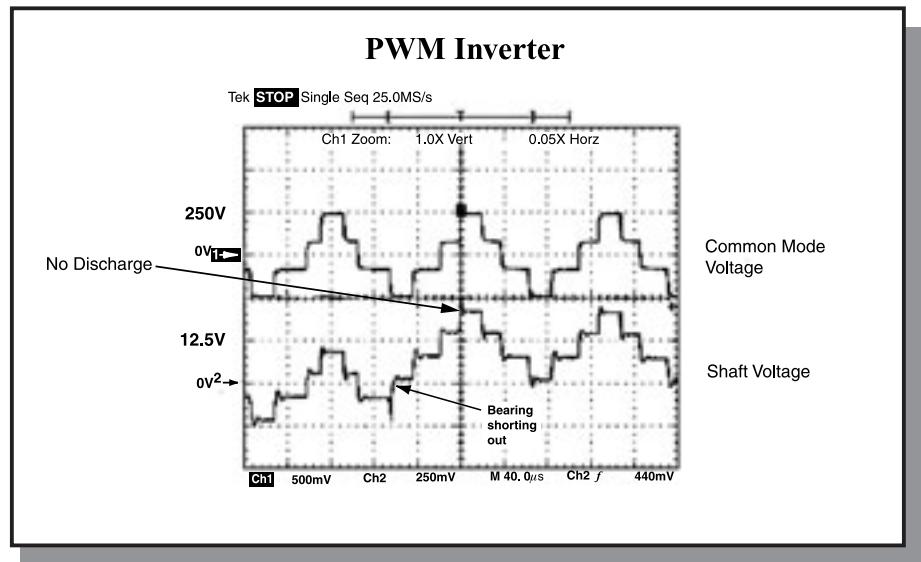
Figure 9: Typical common mode voltage and motor shaft voltage wave forms.

shape (but with reduced amplitude) for most time ranges. In this case, there may be sudden occurrences of zero shaft to frame voltage after a voltage charge-up (see Figure 9), which implies a bearing conducting mode and a pulse of bearing current. The current that flows during this conducting period can damage the bearing.

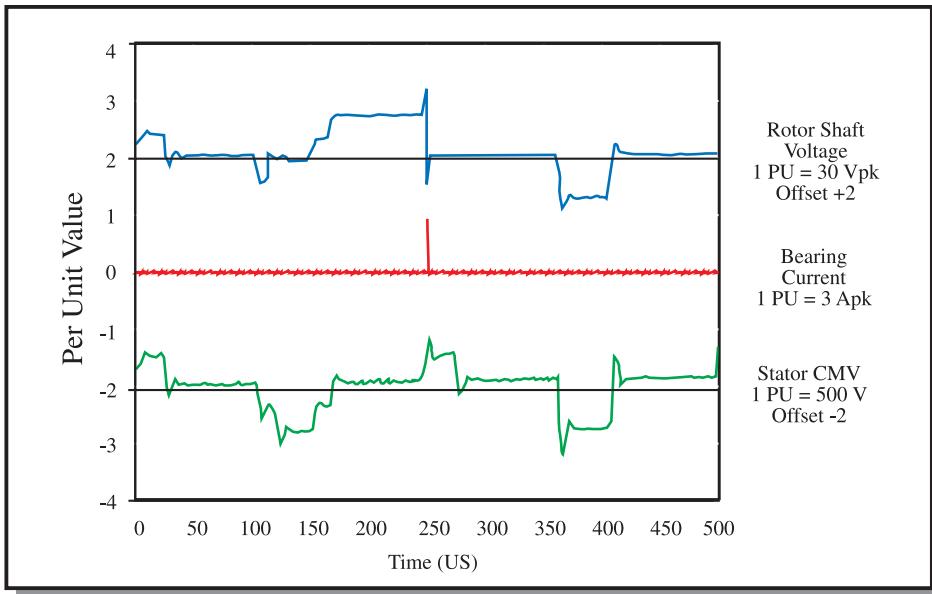
**Figure 10: Bearing current due to rotor voltage discharge.  
(Stator Neutral Voltage = Common Mode Voltage)**

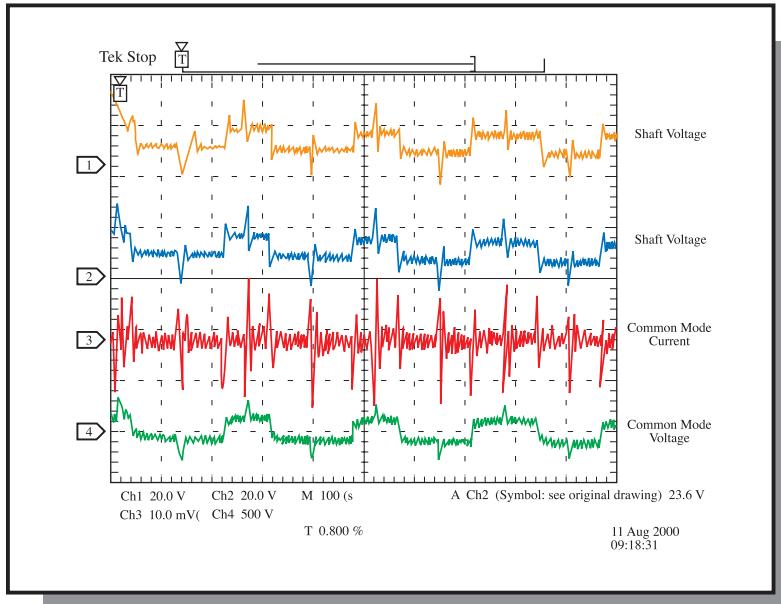
If the ground conductors are the preferred ground paths, they should carry all of the common mode current. Figure 11 shows measured common mode current into a motor. Common mode current pulses occur at each transition of the common mode voltage (the dv/dt capacitively coupled effects). A difference between the ground conductor current and the common mode input current can lead to a diagnosis of a grounding system problem. Another technique to

Figure 11: Measured common mode current wave.

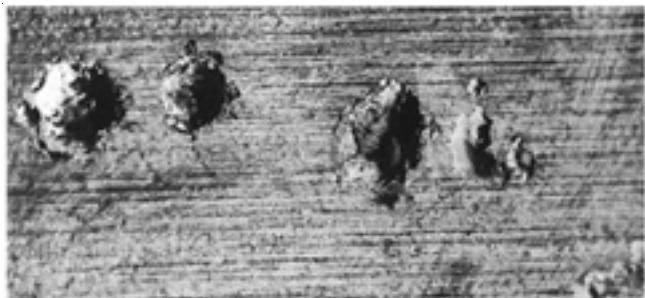
Figure 12: Fusion craters in a bearing race from Scanning Electron Microscope image.

Initial damage is, in fact, relatively minor (see Figure 12). Bearing damage begins with the formation of small pits or fusion craters in the bearing races. As this progresses, mechanical defects arise that make the damage more the bearing balls run through the craters in the races for a time, a fluting pattern develops (see Figure 13) that may or may not incorporate fairly regular

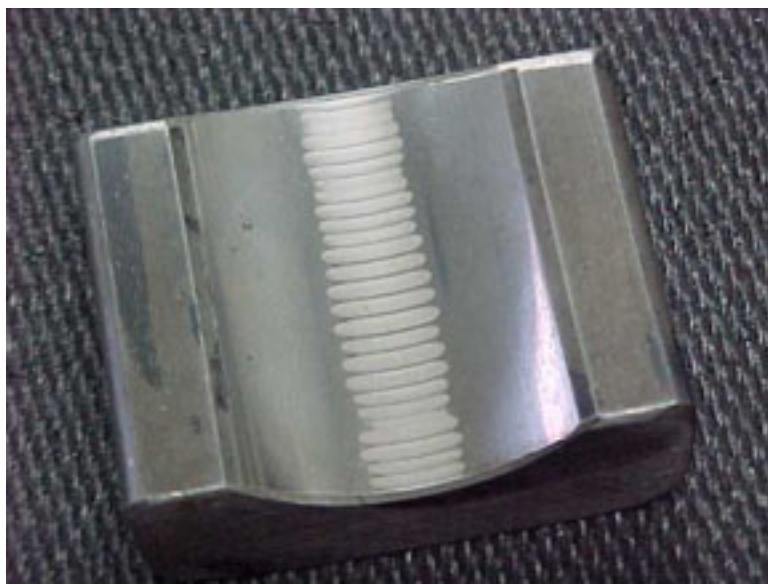
Figure 13: Bearing race fluting.

spacing. This fluting is common in most current related bearing damage. The resulting lubrication breakdown and mechanical wear ultimately lead to bearing failure.

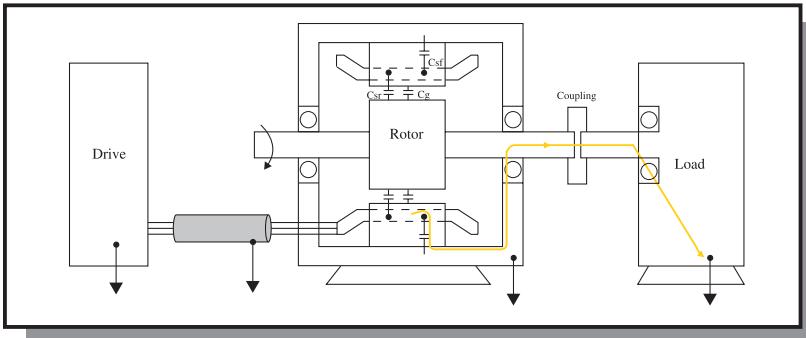
(the gold current in Figure 14). Providing a low impedance path from the motor ground to the

Figure 14: Common mode shaft current.

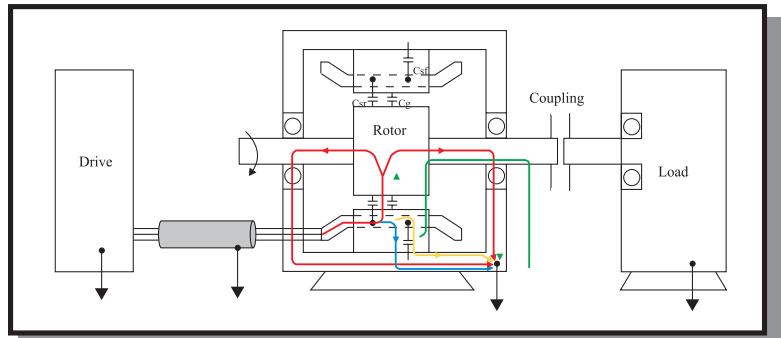
Figure 15: Insulated coupling eliminates shaft current.

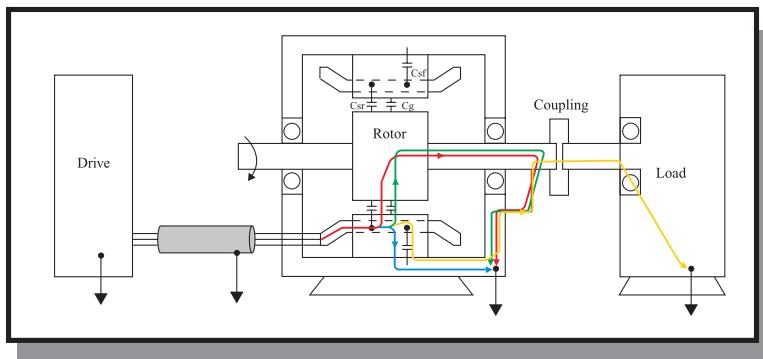
Figure 16: Shaft grounding brush on drive end bearing.

without the brush. Figure 16 shows the current flow paths with a brush on one bearing. Notice that, without good high frequency ground connections in the system, the brush has the potential to increase current flow down the shaft by providing a better current path than through the bearing itself. Adding a brush to a motor also reduces the impedance seen by any circulating currents within the motor that may be sine wave induced (see Figure 2). Since sine wave bearing currents are most common in larger motors, it is not recommended to add a shaft brush to a motor above a 400 frame size that does not have insulated bearings.

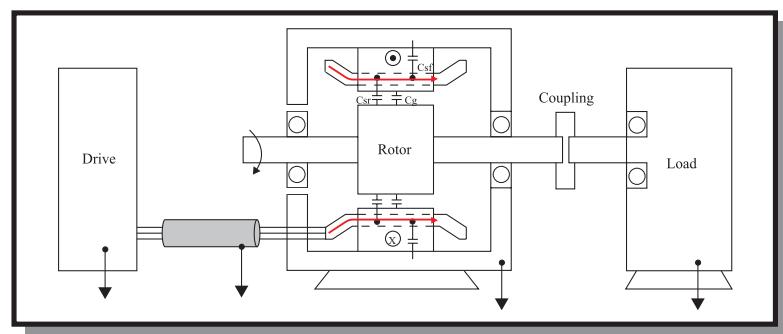
Motor bearings can be insulated to break the high-frequency current paths from the shaft to ground. For inverter induced bearing currents, usually an insulated bearing is combined with an opposite end shaft grounding brush. It is wrong to add a shaft brush at the same end of the motor where a single insulated bearing has been applied, as this could facilitate internally sourced (sine wave type) current flow in the uninsulated bearing at the opposite end. A single insulated bearing will not prevent shaft to ground current flow in the uninsulated bearing at the other end of the motor. A single insulated bearing, however, is effective in preventing circulating currents from flowing, either from sine wave excitation or from high frequency flux induced bearing currents

Figure 17: One insulated bearing to eliminate high frequency induced current.

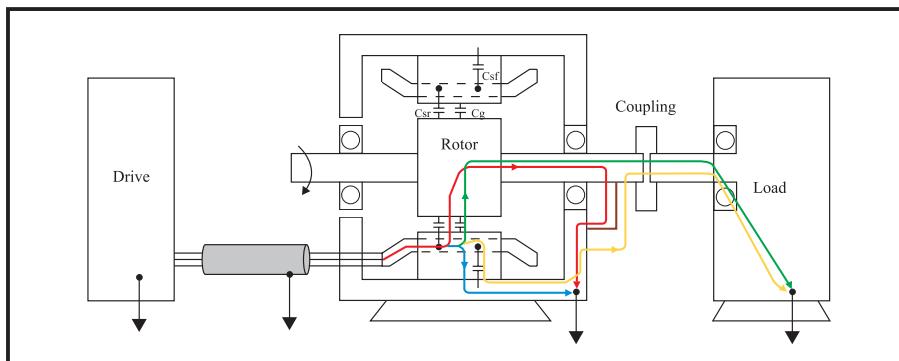
Shaft grounding brushes are more commonly applied in combination with insulated bearings. The opposite drive end bearing is typically insulated and a drive end shaft grounding brush is applied for a single insulated bearing system.

Figure 18: Drive end shaft grounding brush and opposite drive end insulated.

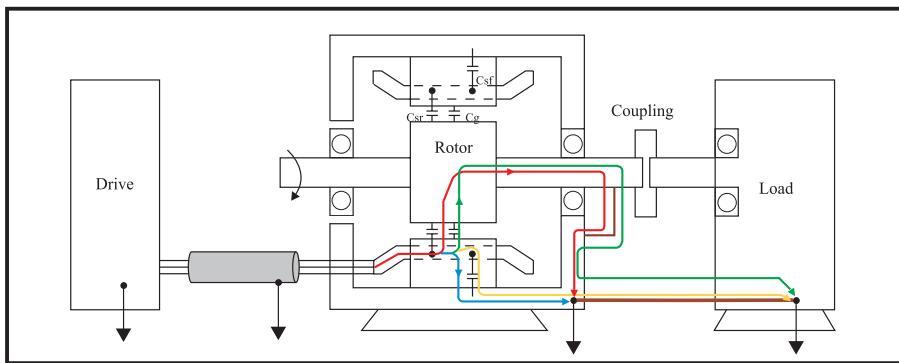
Figure 19: One insulated bearing, shaft brush and ground strap.

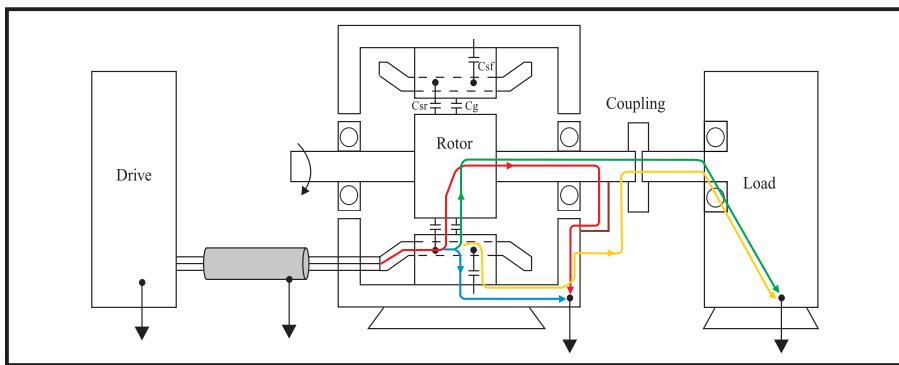
Figure 20: Two insulated bearings and shaft grounding brush.

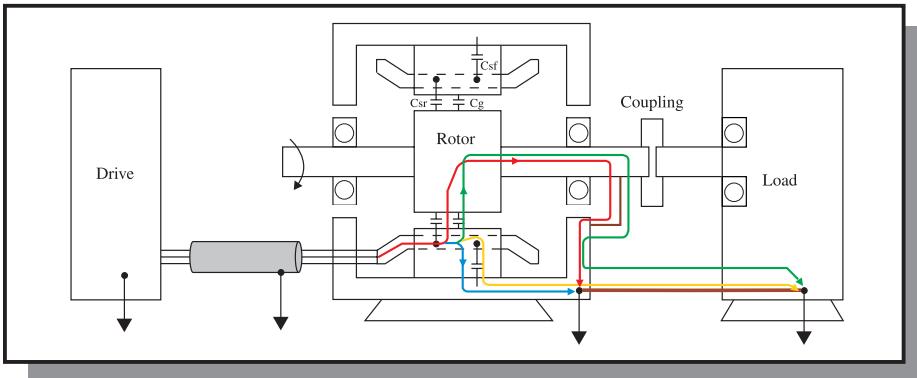
It is possible, of course, to insulate both bearings on the motor, protecting both from current flow. In this instance, the bearings are protected even if the shaft grounding brush should fail. Figure 20 shows this remedy. To eliminate current flow down the shaft with this system, a good high frequency ground from motor to load is required.

Figure 21: Two insulated bearings with shaft ground brush and ground strap.

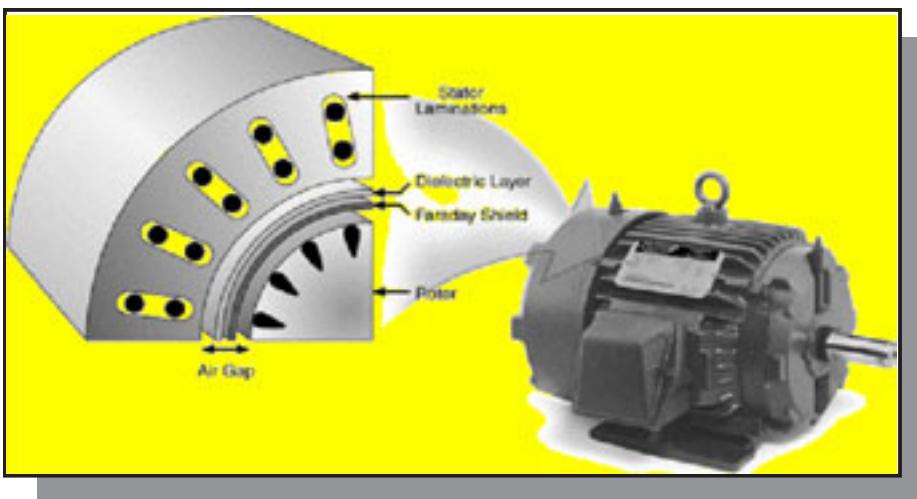
An electrostatically shielded induction motor (ESIM) can prevent rotor charge and discharge in installations where the motor is not coupled in a conductive way to driven equipment (see Figure 22).

Figure 22: Electrostatically shielded induction motor (ESIM).

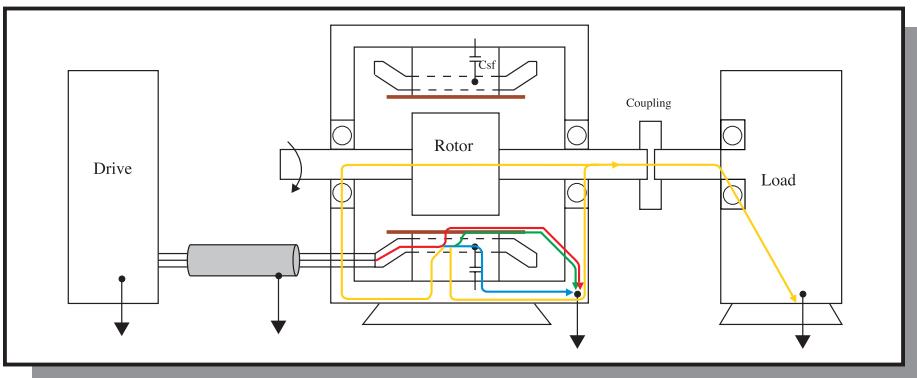
Figure 23: Bearing currents with ESIM.

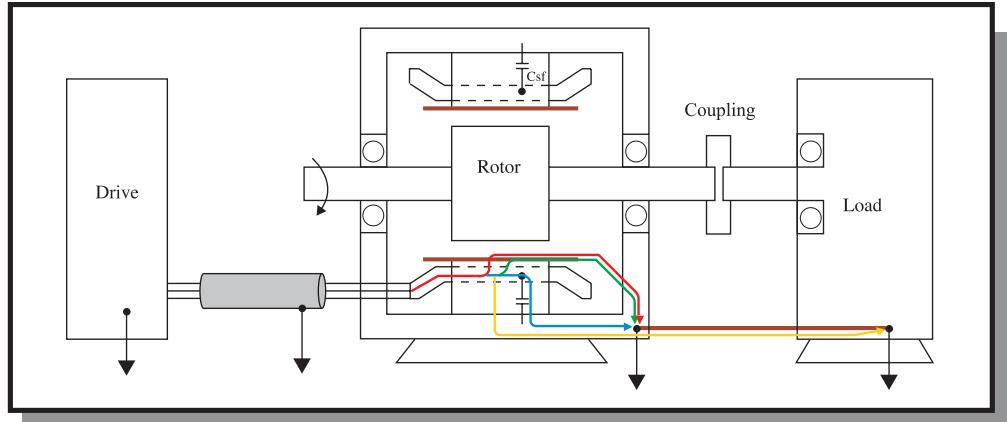
Figure 24: ESIM motor with motor to load groundtrap strap.

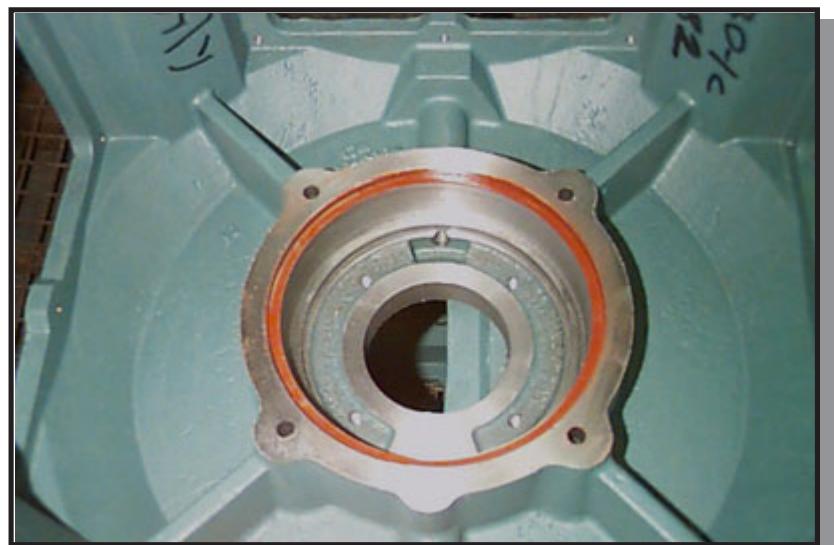
Baldor-Reliance provides a variety of insulated bearing technologies that create an insulating barrier between the frame of the motor and the outer race of the bearing (see Figure 25). The

Figure 25: Insulated bearing.

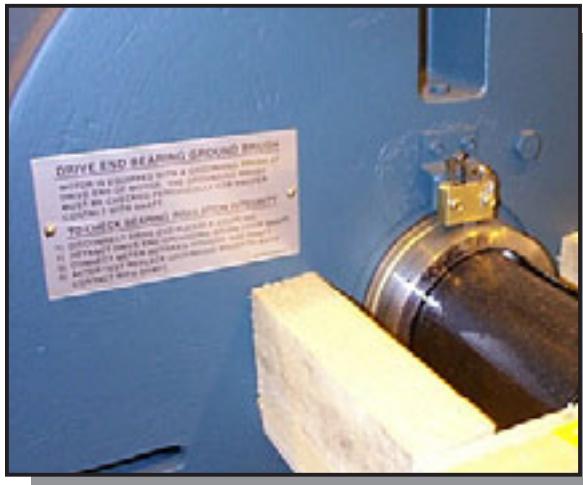
A typical shaft brush installation is shown in Figure 26.

Figure 26: Shaft grounding brush.

Baldor-Reliance has standards in place for preventing bearing current damage with inverters. On large AC motors, insulated bearings are provided on the drive end and opposite drive end, as well as a grounding brush (see Figure 26), on either the drive end or opposite drive end. For large AC applications, the grounding brush is typically installed on the drive end. Enhanced ground

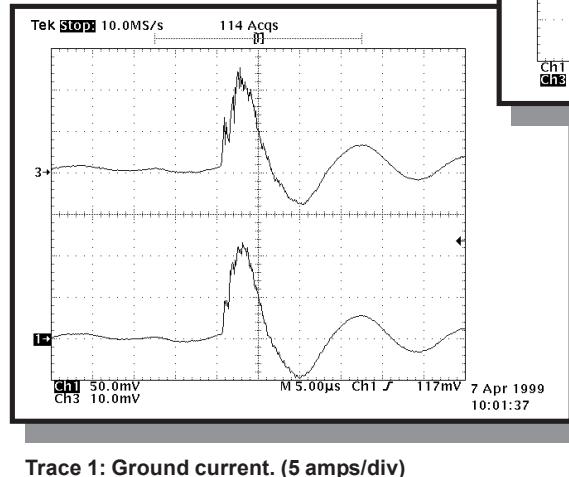
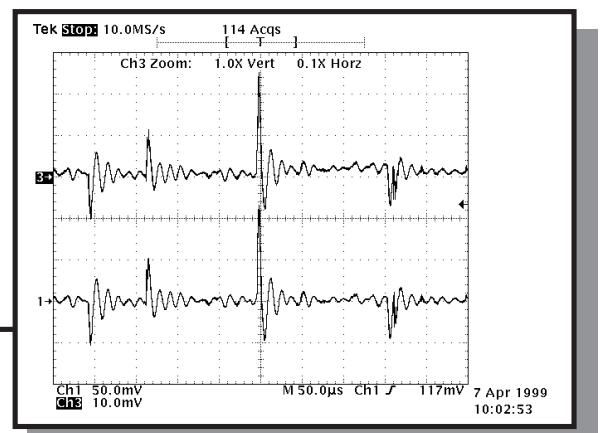
bonding at installation was also investigated. To illustrate the common mode currents (CMC) measured at this preferred installation, upper and lower traces in Figure 27 are the CMC and the ground currents, respectively. In both of these traces, the currents very accurately track one another, implying that the ground current / CMC is not taking any undesirable paths. It is in fact returning through the cable ground conductors, as is desired.

Trace 3 : Common mode current. (5 amps/div)

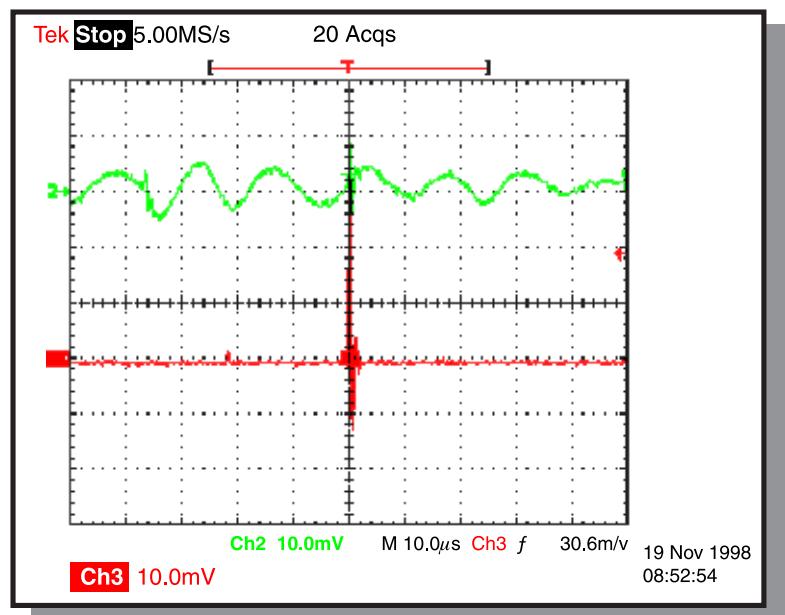
There was also the potential for those drive end bearings to fail because a portion of the common mode current was not flowing through the preferred path, but rather one which included the motor bearing and shaft extension and coupled equipment. Thirty amp pulses of current were measured in the shaft extension (Figure 28), which would imply that some of the common mode current was taking paths other than through the cable grounds. Since the common mode current (Trace 2) shows only a smaller spike at the time of the 30 amp pulse (Trace 3) in the shaft, it is likely that a portion of this shaft current

**Figure 28: Common mode current (Trace 2) and shaft current (Trace 3) in systems/process line application.  
(Trace 2 - 10 Amps/div, Trace 3 - 10 Amps/div)**

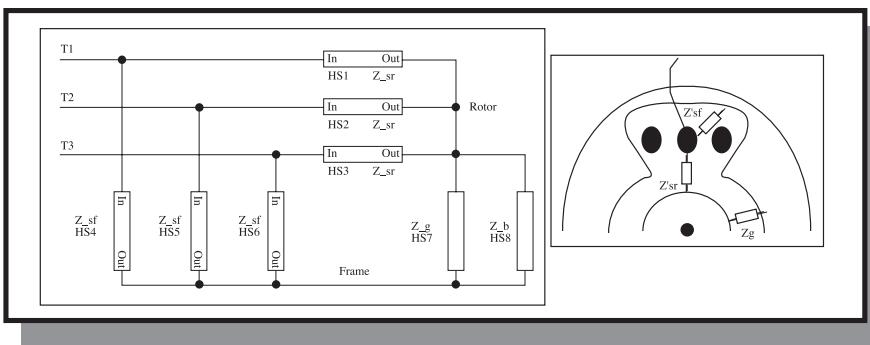
Figure 29: Motor shaft voltage equivalent circuit model.

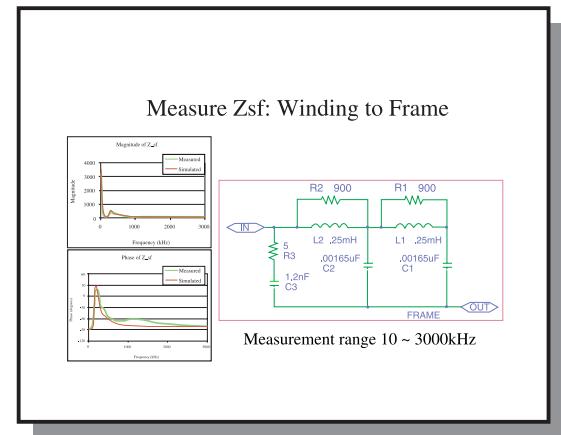
The measured magnitude and phase of  $Z_{sf}$  is shown in Figure 30.

Figure 30: Stator winding to frame impedance.

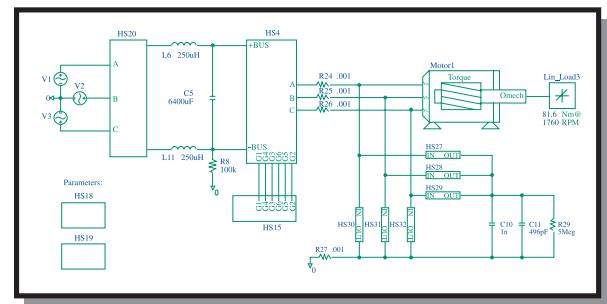
must be incorporated into the drive system circuit model in order to predict the shaft voltage on the motor. The whole drive system diagram is shown in Figure 32. The simulated common mode voltage and shaft voltage are compared with measured results as shown in Figure 33. A very close correlation is clearly demonstrated.

Figure 32: Drive system model for shaft voltage prediction.

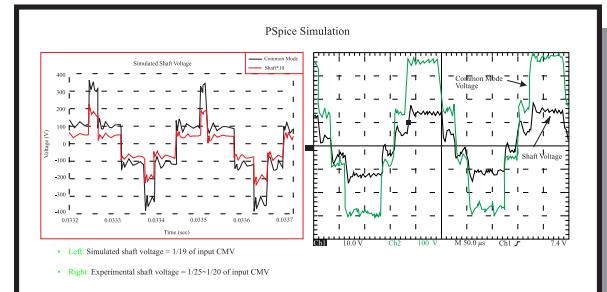
Figure 33: Comparison of simulated and measured shaft voltages. CMV = Common Mode Voltage.

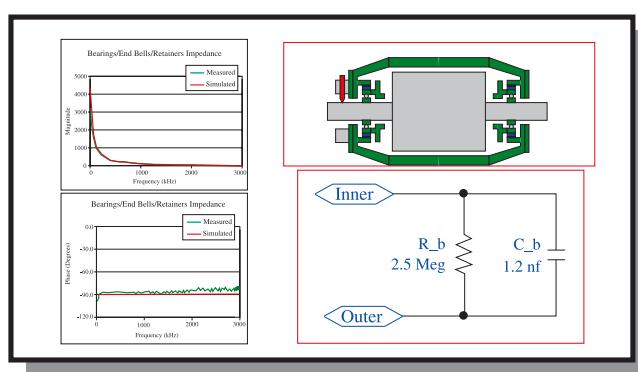
Figure 31: Motor bearing and end bell equivalent circuit.

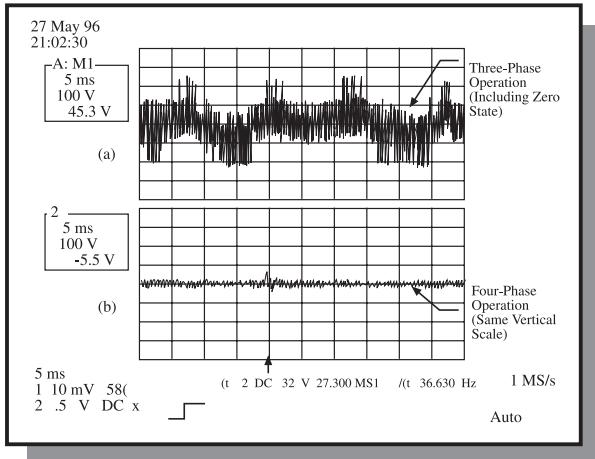
Figure 34: Common mode voltage reduction with four-phase inverter system.

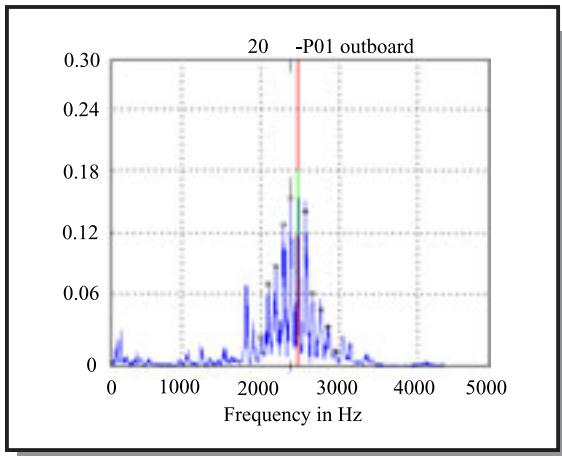
Figure A2-1: Vibration frequency spectrum with bearing damage.

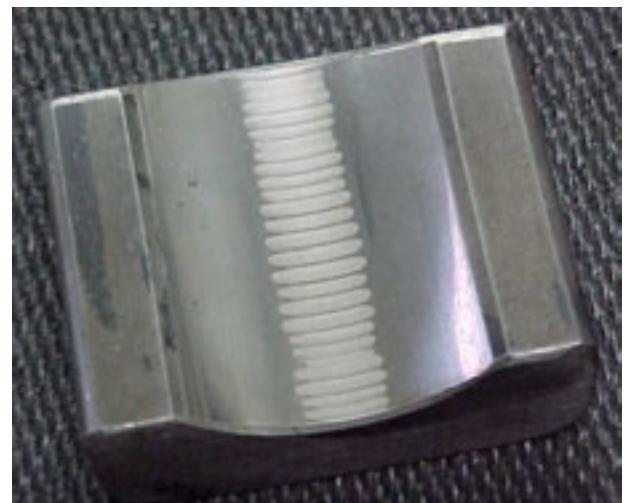
Figure A2-2: Fluting on a ball bearing outer race.

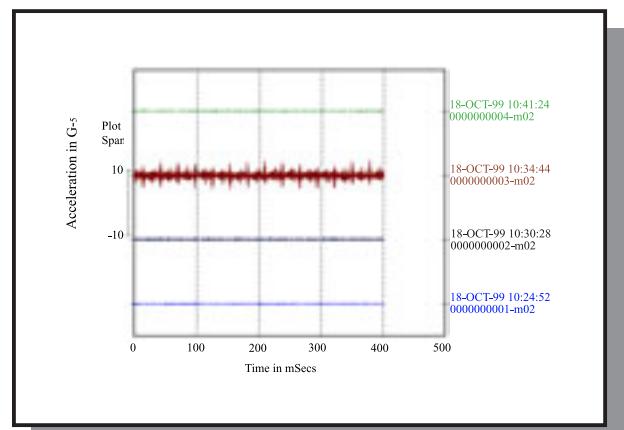
Figure A2-3: High frequency impacting in the time domain (four different motors). Obviously, second from the top is bad.

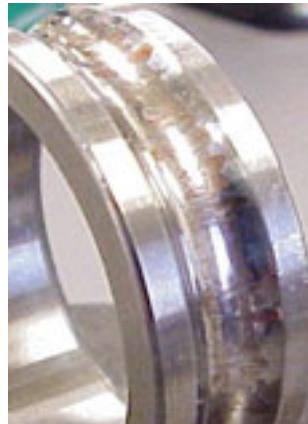
While the characteristic “fluted” pattern of damage is a characteristic common to bearings which have experienced current flow, it is not correct to assume that any bearing exhibiting this feature necessarily had current flow as the root cause of the damage. In fact, damage from subsequent running after false brinelling can exhibit a pattern such as shown in Figure A2-4.

Figure A2-4: Bearing damage from running after false brinelling.

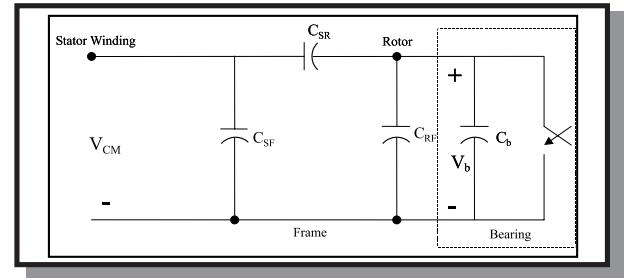
Figure A3-1: Simplified common mode circuit model of a motor.

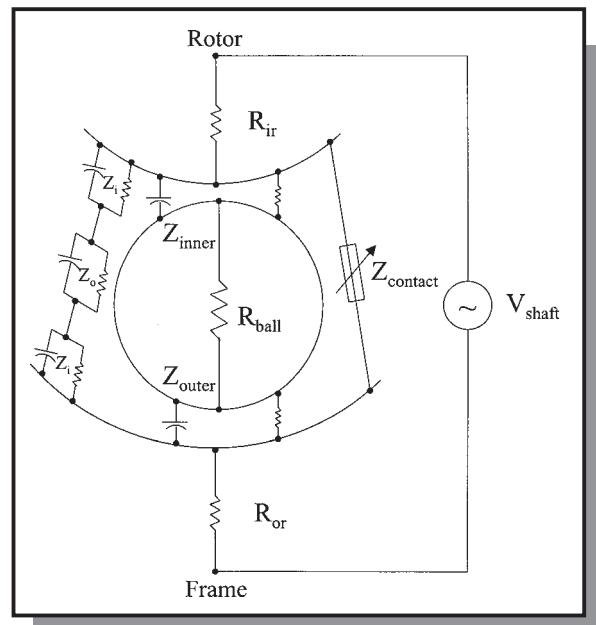
Essentially, the bearing acts like a resistive-capacitive (R-C) circuit when a voltage is applied across it. In a rotating bearing, the location of the bearing balls and resistive state of the bearing lubricant causes the bearing resistance and capacitance to change with time. The random contact of the bearing balls to the races as well as the highly unpredictable resistance behavior of the bearing grease make reliable prediction of bearing current difficult, even if the shaft to frame voltage is known.

**Figure A4-1: General electrical behavior of a rolling**
