Lady Chapel Roof

After nearly a year of fundraising and receipt of a grant from Valencia Communities Fund work was able to commence February this year and is all complete, keeping the Lady Chapel dry and the building structure protected from water damage.

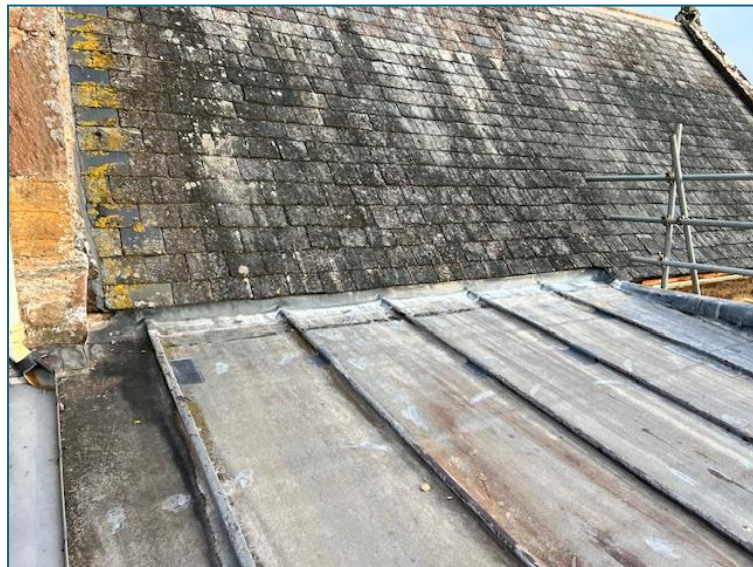
The lead roof coverings had deteriorated over the years allowing water to seep underneath as well as well as pointing to flashing areas along the castellations.

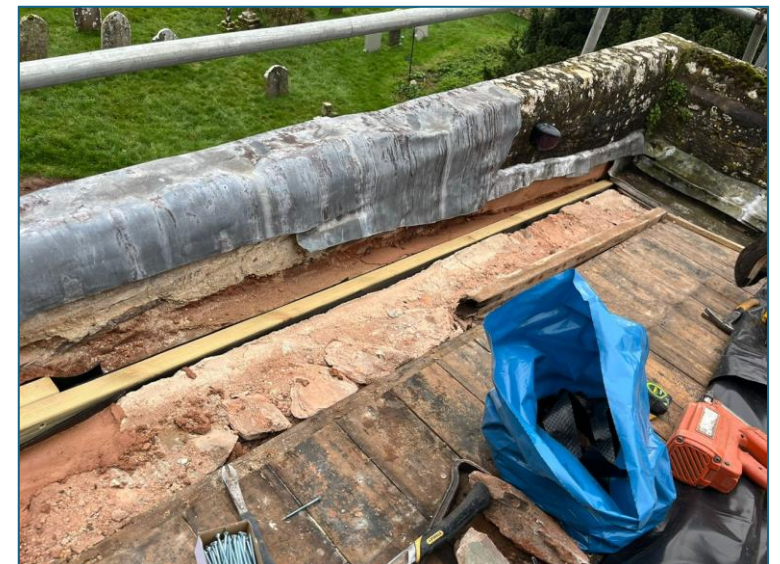
With the lead removed, any damage from water ingress was able to be addressed as part of the works.

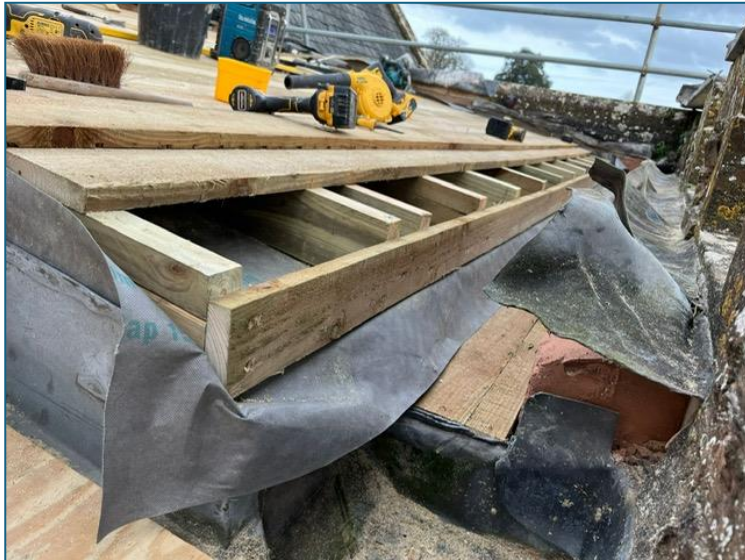
Replacement timbers and aluminium rainwater systems installed.

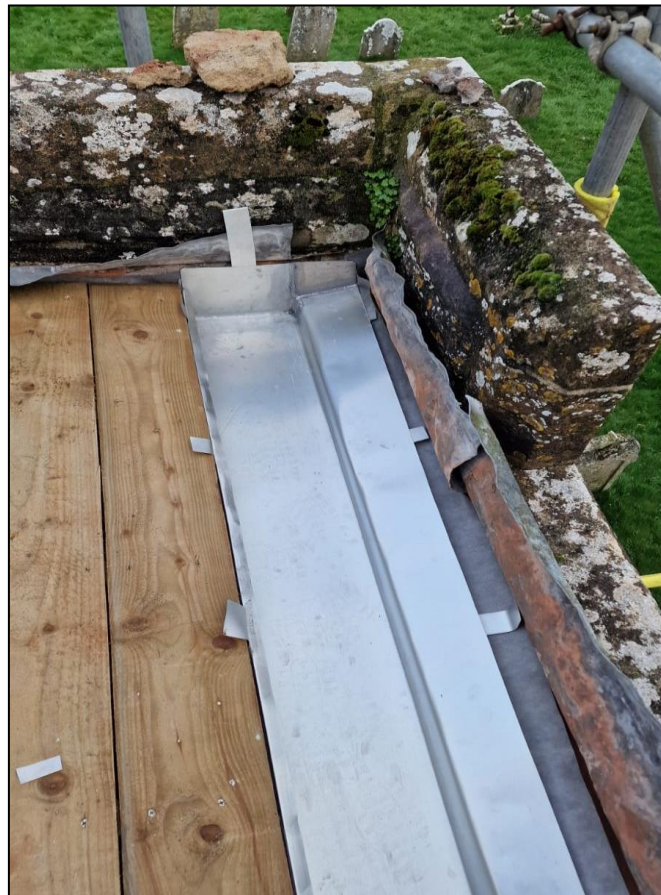
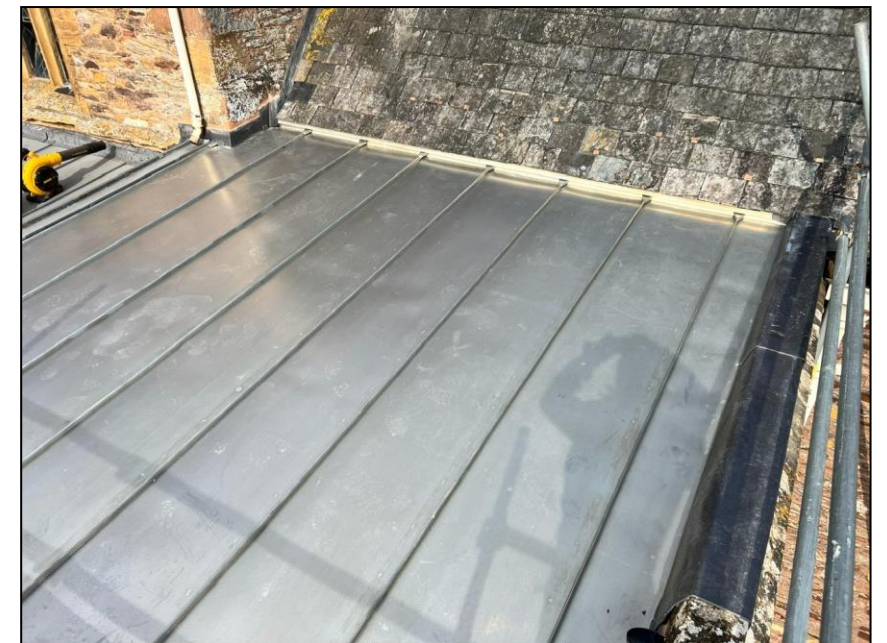
New stainless steel roof coverings and flashings installed in line with other areas of the church roofs.
