DOWNTOWN WILMINGTON PEDESTRIAN IMPROVEMENT PLAN

2018

Executive Summary

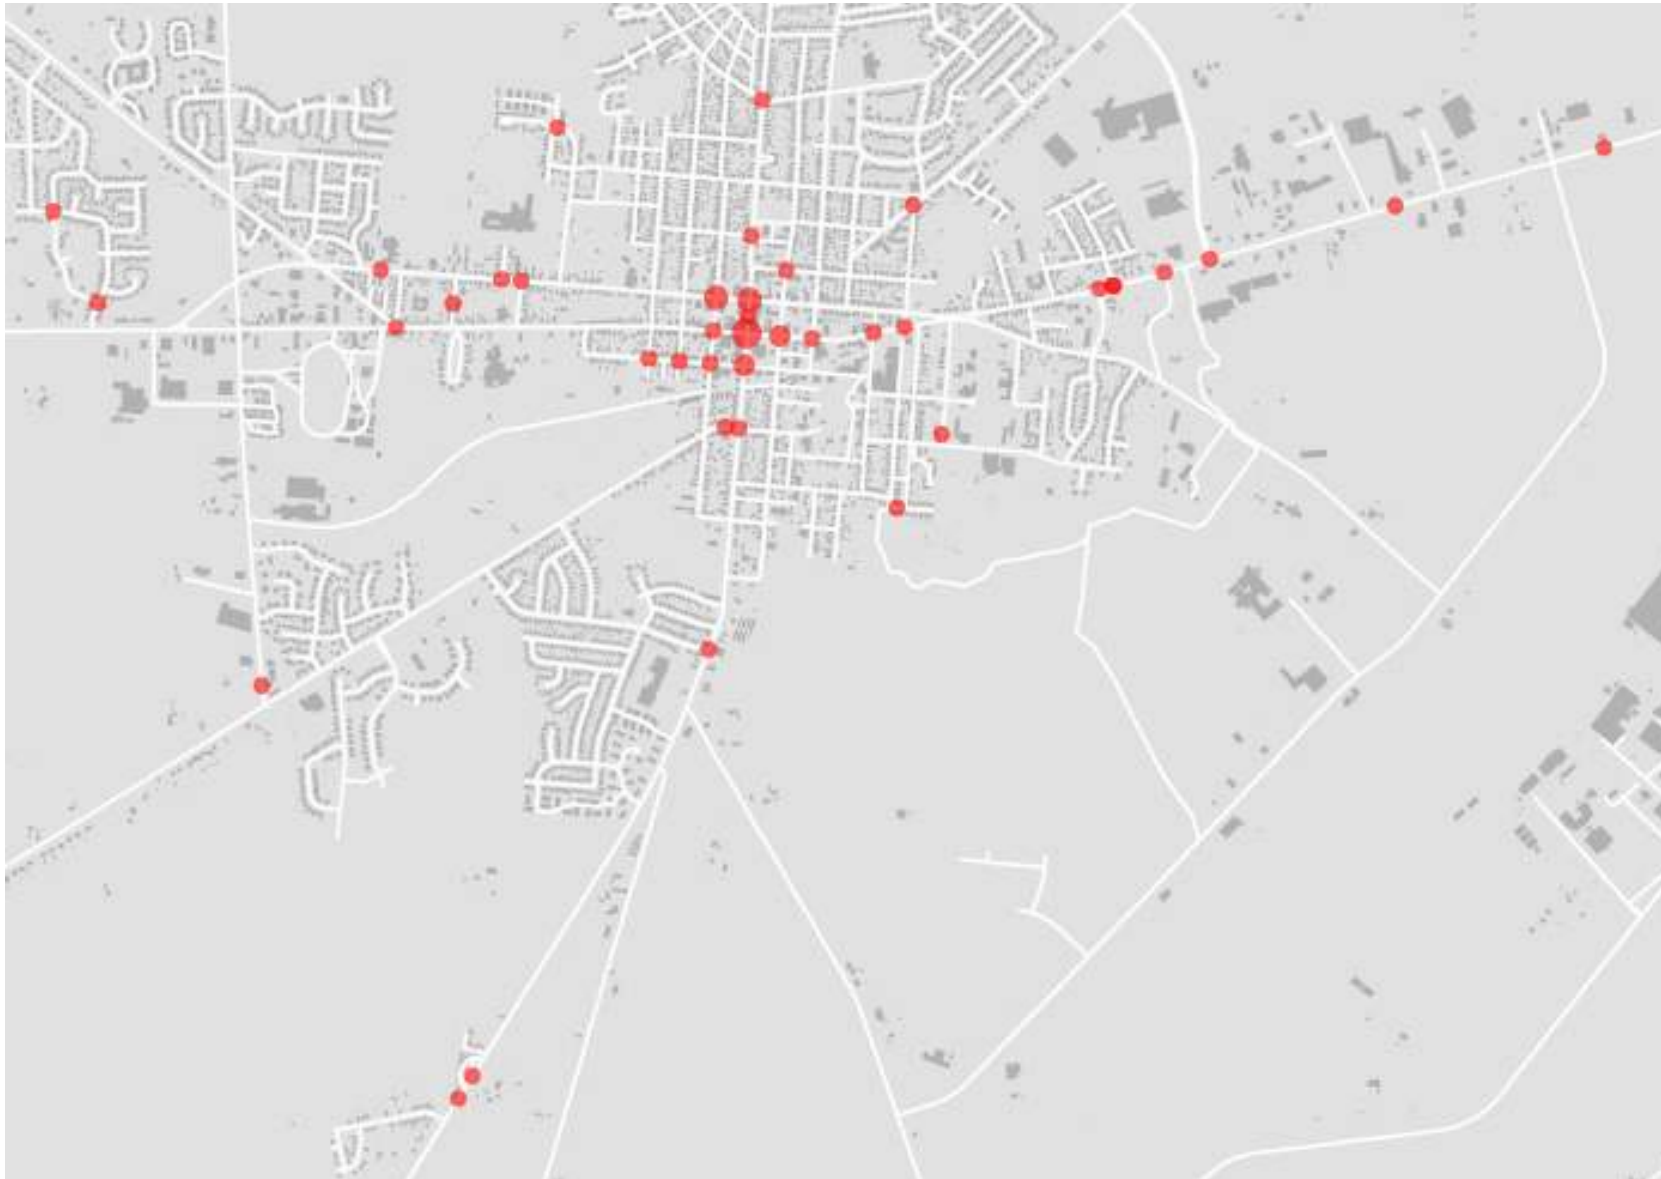
Pedestrian accidents in the City of Wilmington (Ohio Department of Transportation 2003-2015)

*Larger dots equate multiple accidents in the same location

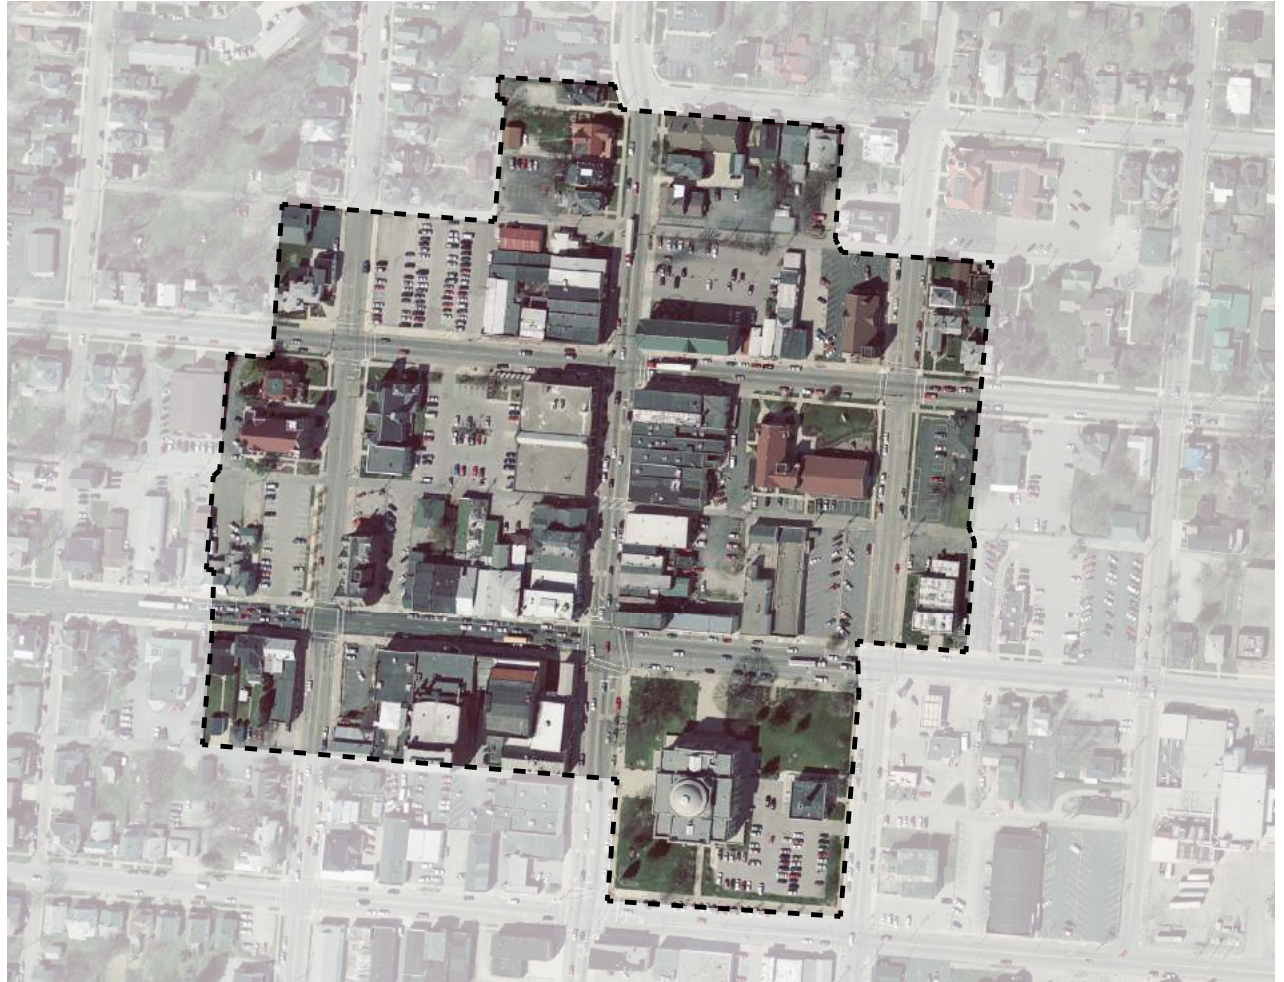
Historic Downtown Boundary

The boundary for downtown Wilmington that is used in this plan is consistent with the “Downtown Historic Zone” present in the City’s zoning code. This area is subject to certain restrictions under the City’s zoning code. The entire downtown is in a walkable 25.5 square acre zone, complete with a mix of land uses in its 148 parcels.

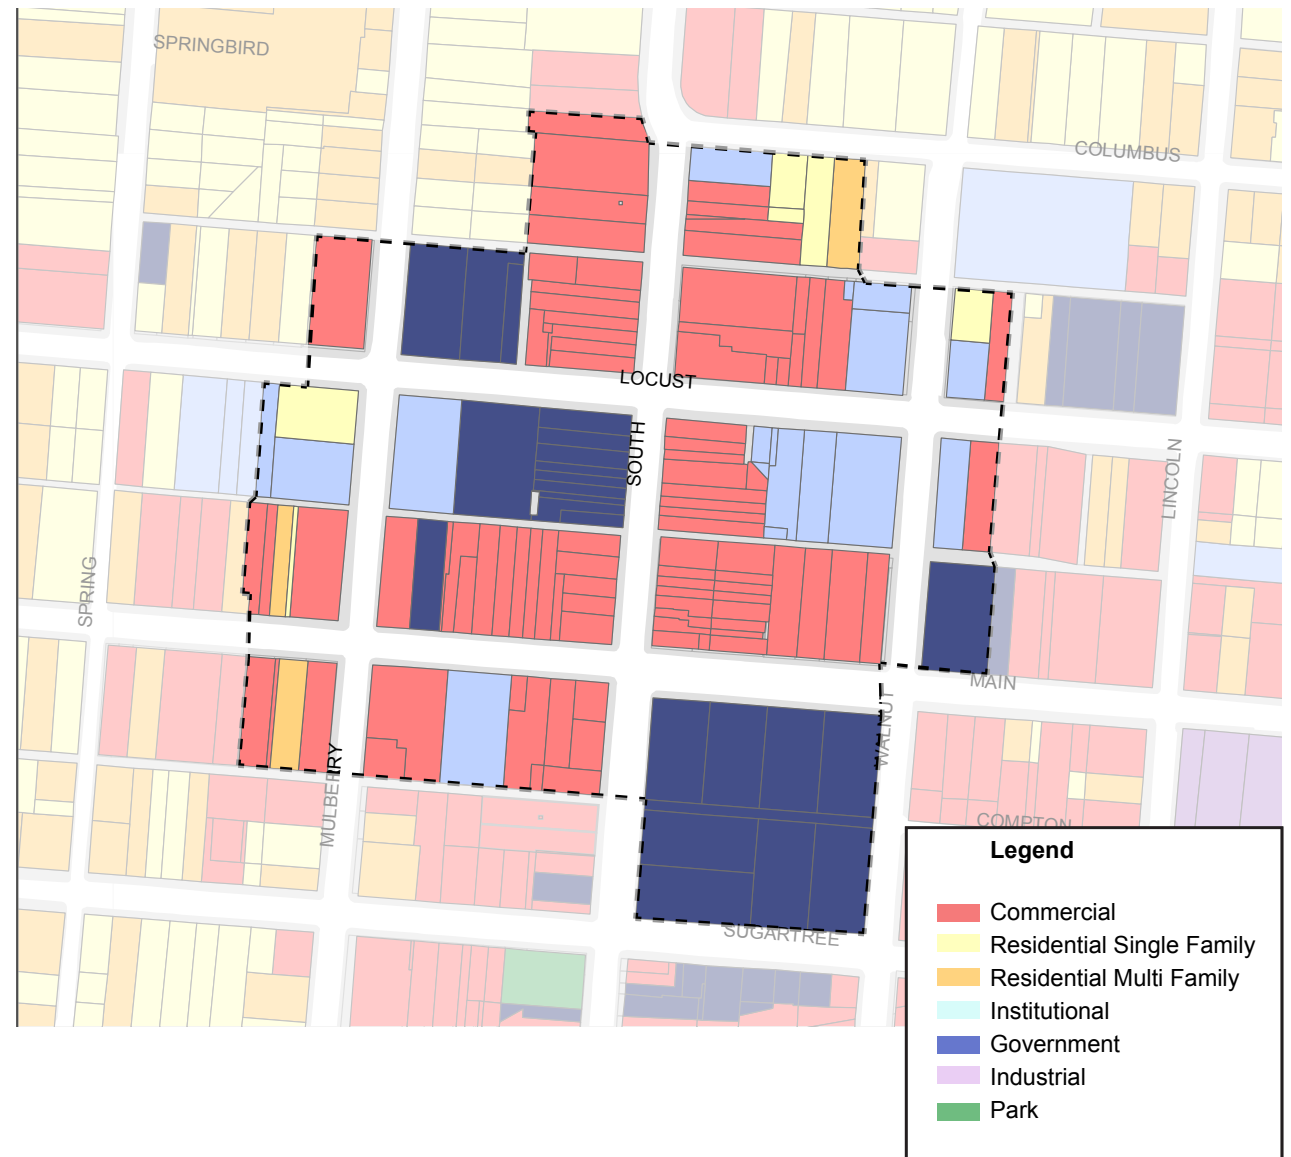
Existing Land Use Map

While the historic district is flexible for allowing commercial, residential, office, and institutional uses on the street level, the majority of property is leased as commercial and office. The highest concentration of commercial uses are located on Main Street between Mulberry and South Street, and South Street between Locust Street and Main Street.

There is a prevalence of government uses, with the largest being the historic Clinton County Courthouse, which consumes an entire city block along Main Street. The Wilmington Municipal Building covers half of a city block on South Street south of Locust Street. There are six churches that are within the historic district, mostly located along Locust Street on the periphery. Additionally, the Murphy Theatre serves as the primary institutional use downtown, which hosts a large number of events at its location on Main Street.

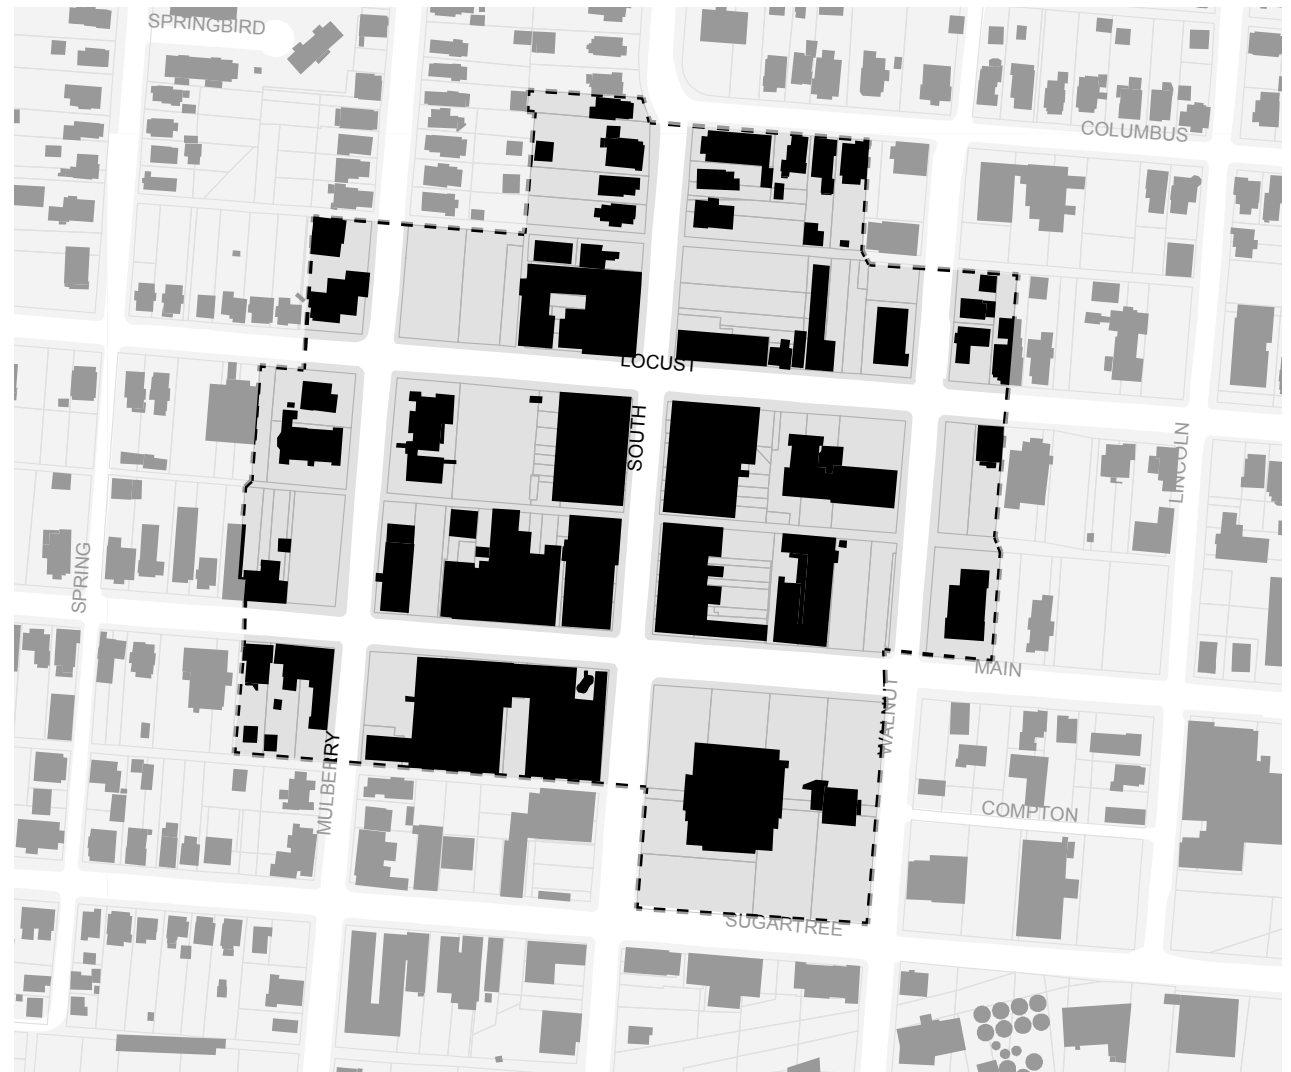
FIGURE GROUND

The figure ground shows the existing built form of the downtown. The largest clusters of buildings are along Main Street between South and Mulberry and South Street between Locust and Main. The peripheral streets are mostly consumed with parking to support the active land uses. Many of these parking lots were once buildings, but the increased demand for downtown parking called for the demolition of them.

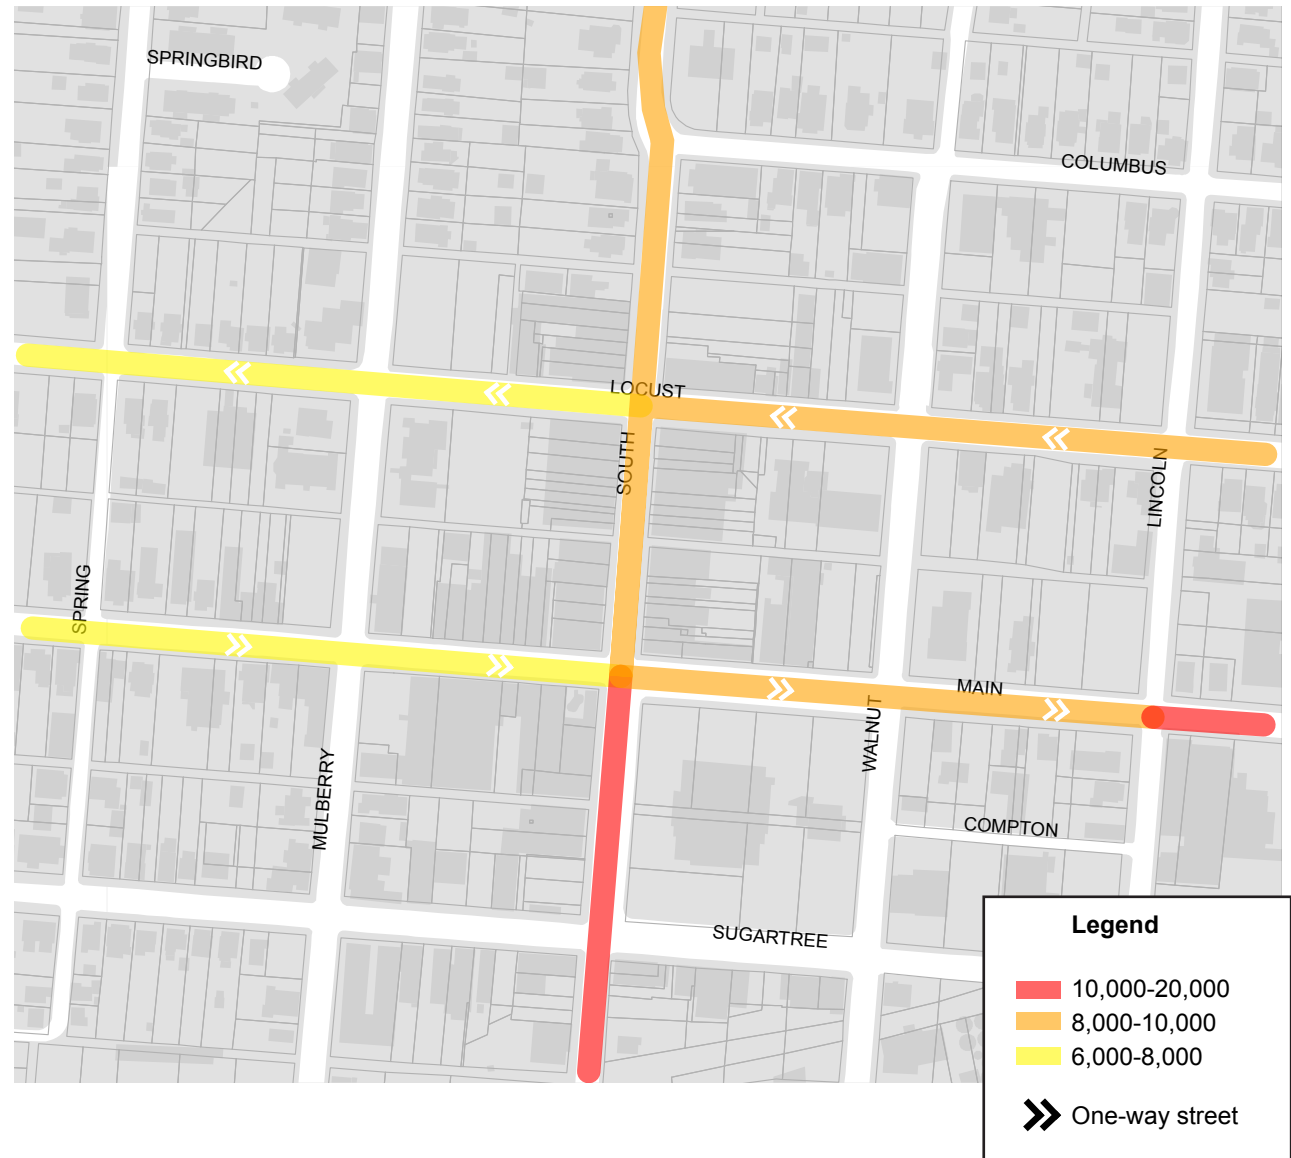
Average Daily Traffic (ODT 2012)

According to the average daily traffic (ADT) counts for 2012, a high level of traffic is recorded traveling north up South Street and terminating at Main Street, suggesting that through traffic will split here and either travel north or east out of Wilmington. The lowest traffic counts are recorded west of South Street on Main and Locust, which is consistent with the lower noise levels in this region.

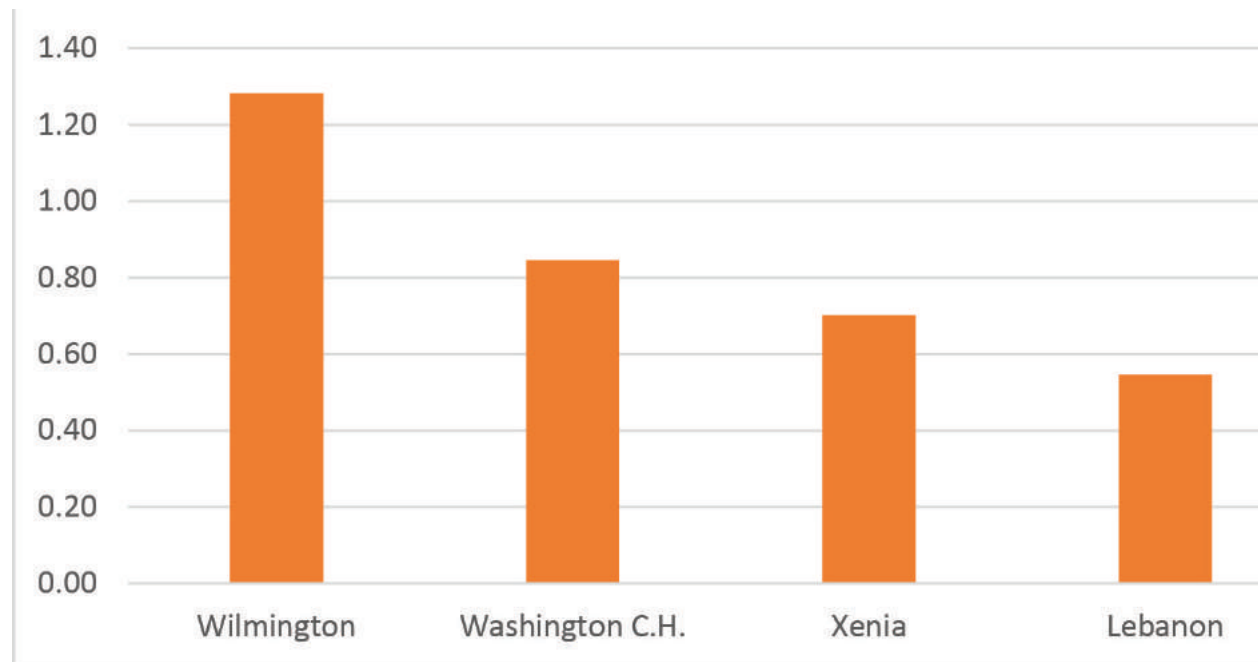
Pedestrian accidents per 1,000 population (ODT 2011-2015)

When comparing the rate of pedestrian accidents with similar cities, Wilmington ranks the highest. Using State data from 2011 to 2015, Wilmington was found to have an accident rate of 1.3 accidents per 1,000 people during a 5-year period. This rate was followed by 0.9 for Washington Court House, 0.7 for Xenia, and 0.6 for Lebanon.

The low rates of pedestrian accidents in Xenia and Lebanon could be due to a number of factors, namely that these towns have higher rates of people walking and biking downtown to access bike trails, shopping, and dining. Lebanon also employs various urban design principles that have been proven to impact safety, such as narrow streets, striped crosswalks, and extended curbs (bumpouts).

Another factor to be considered is that Wilmington is the only city on the list with one-way streets throughout the downtown.

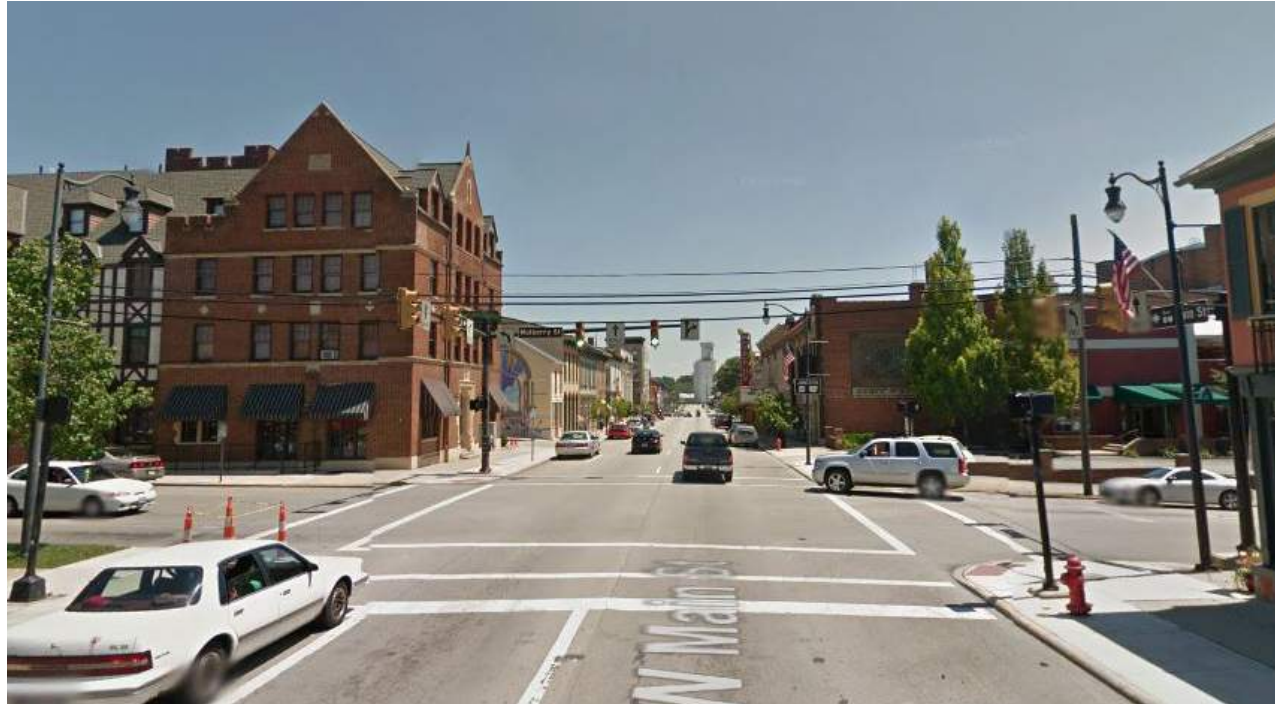
Main and Mulberry

Excellent intersections are safe for pedestrians by having clearly-marked crosswalks and an adequate amount of time given for crossing the street. These three intersections exhibit well-maintained infrastructure combined with narrower streets, therefore making a safe crossing experience.

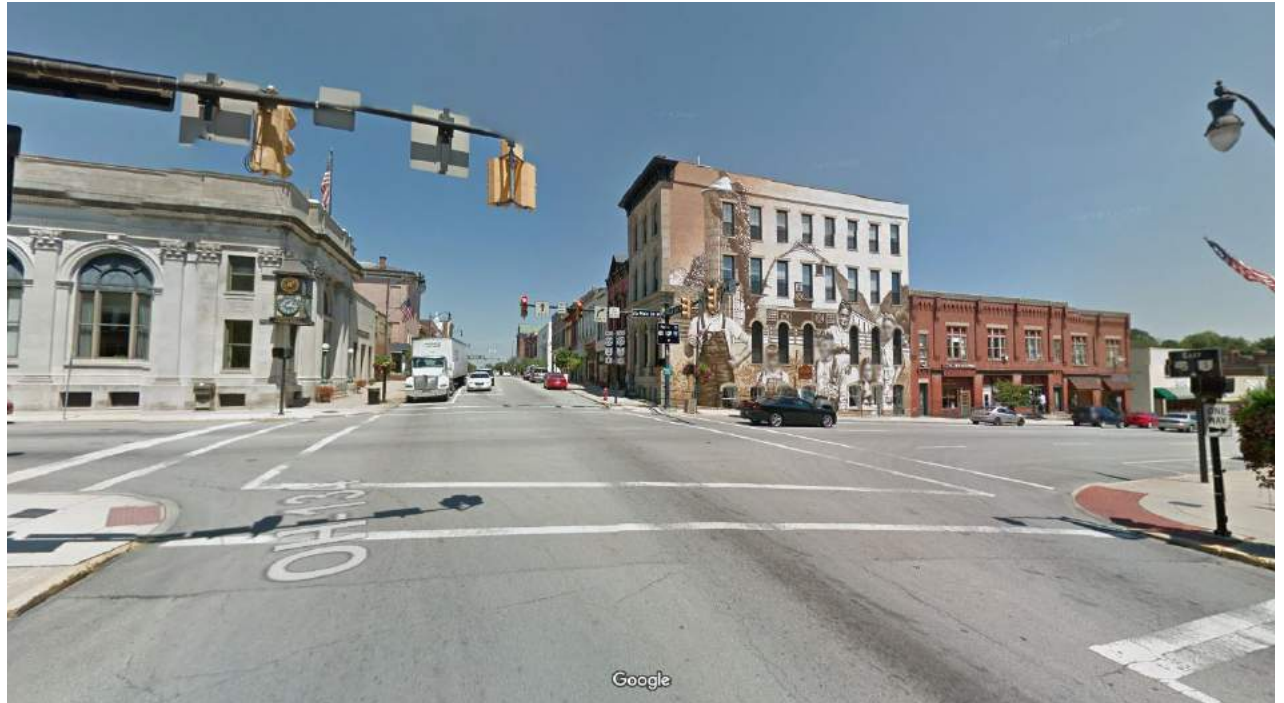
For example, crossing Main and South on the south and east sides requires a longer distance than the north and west sides. On a street with the highest volume of traffic in the study area, this increases the risk of an accident.

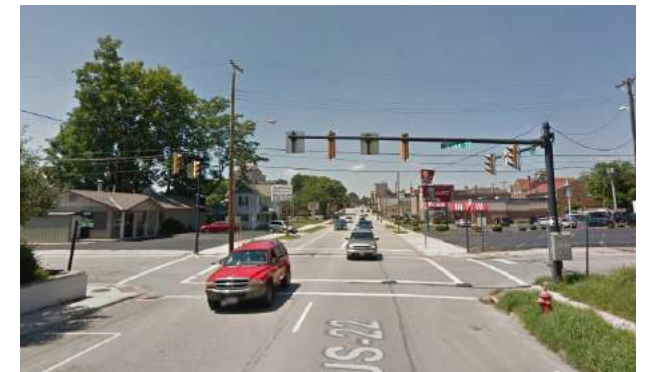
With the Sugartree and South example, the crosswalks are not highly visible. The intersection of Main and Lincoln has well-maintained infrastructure, but is lacking a walking light.

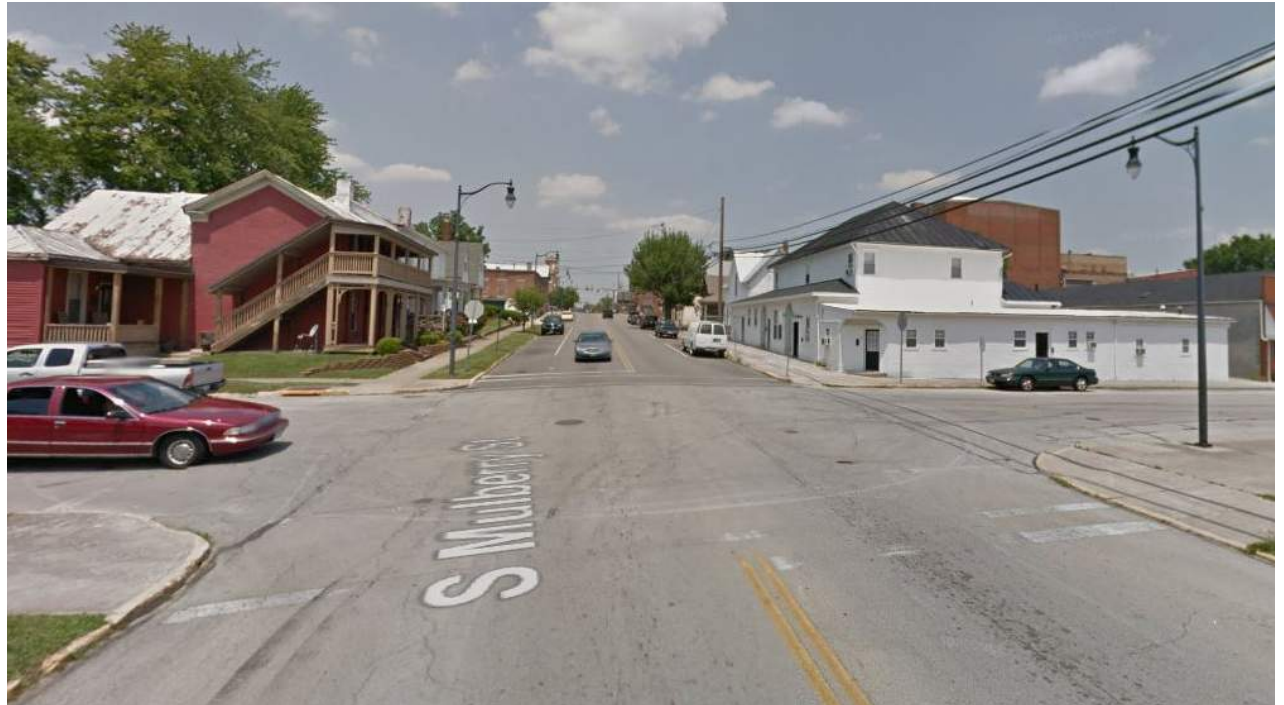
Sugartree and Mulberry

In all three examples, crosswalks are nonexistent, along with crossing lights and signage. There is also an absence of ADA (Americans with Disabilities Act) ramps, making it difficult for those with disabilities to cross the street.

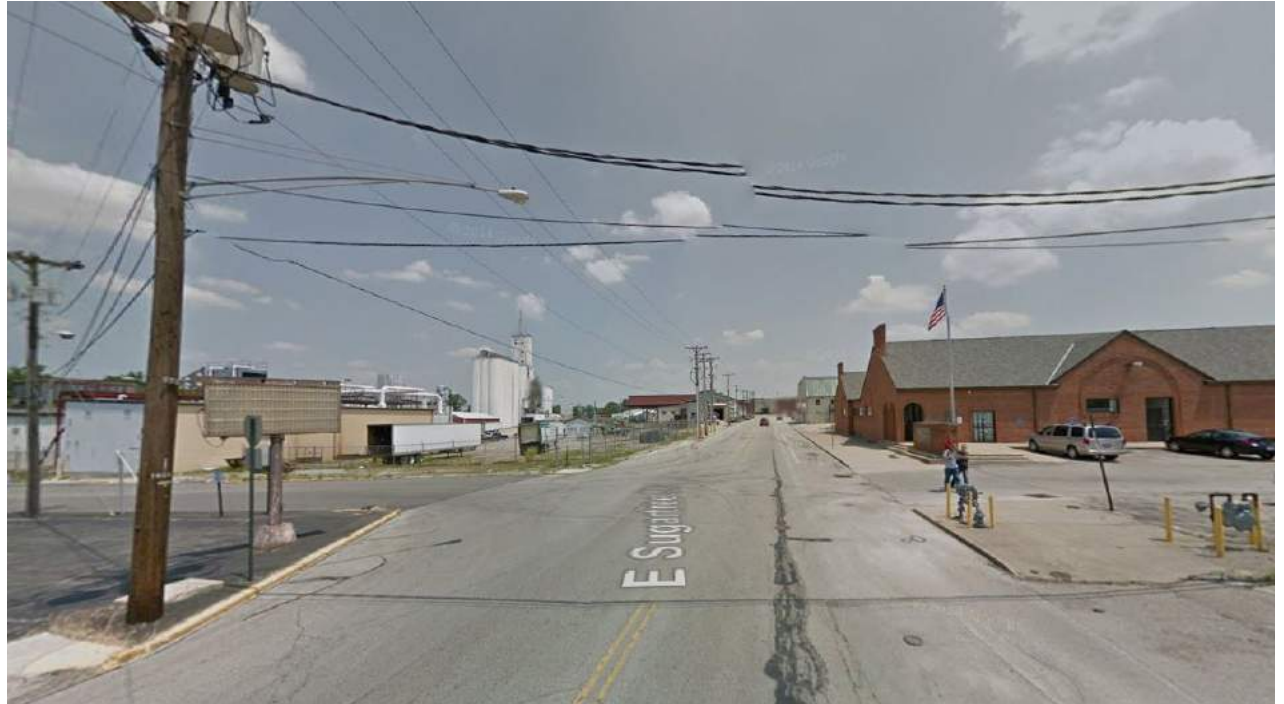
The intersection of Sugartree and Lincoln has a low volume of traffic but lacks in every aspect of safety-related infrastructure. There is an absence of crosswalks, signage, walking lights, ADA ramps, and sidewalks are incomplete.

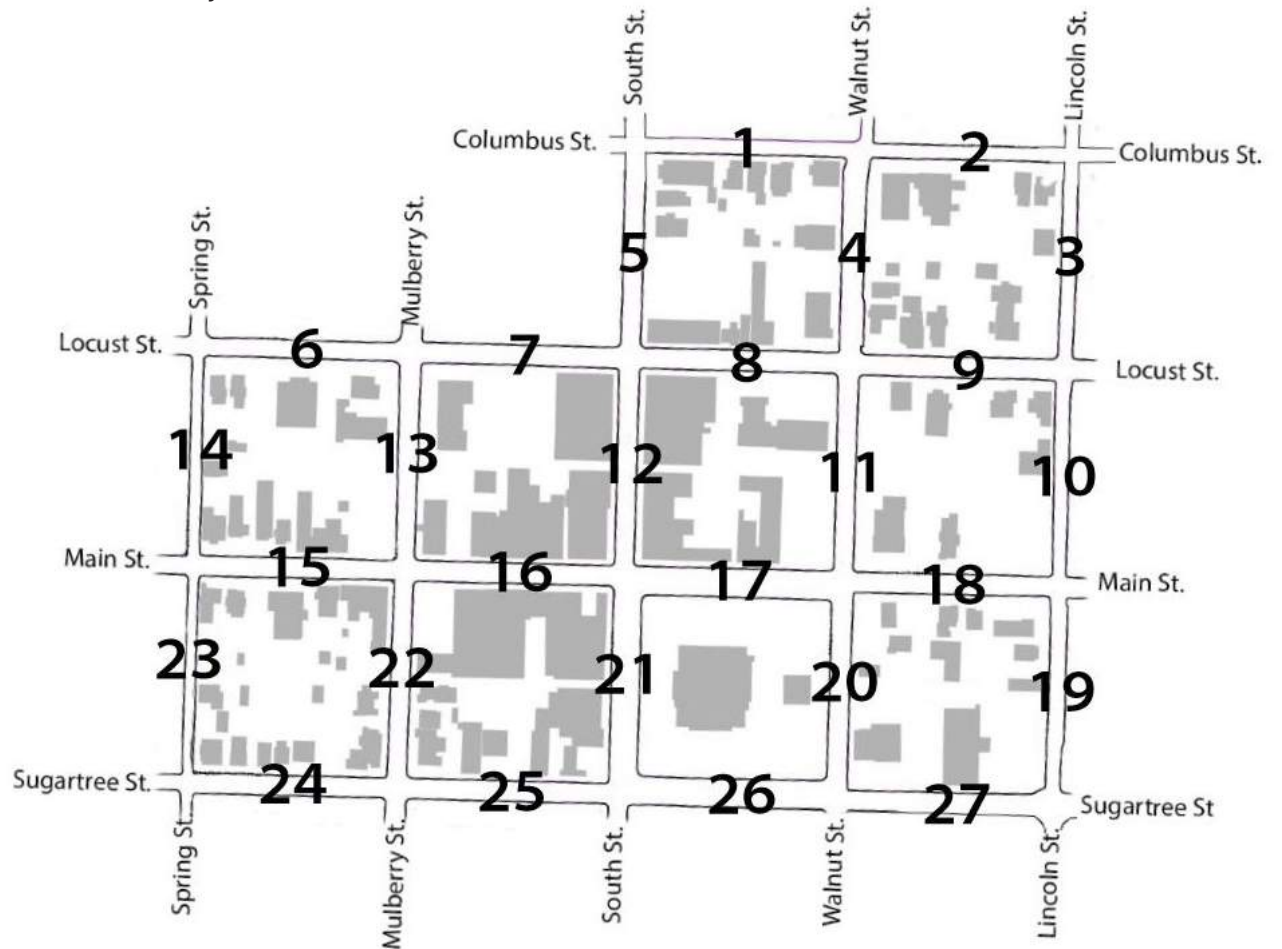
Blocks in study area

Same as the intersection audit, the blocks were evaluated based on safety, condition of infrastructure, and aesthetic quality.

1. Sidewalk condition
2. Lighting
3. Speed of traffic
4. Landscaping
5. Shade trees

Each block received a maximum of 25 points if it scored the highest for each indicator and a minimum of 5 if it received the lowest-possible score for each indicator.

The audit produced a total of 9 excellent, 17 good, 19 fair, and 6 poor blocks.

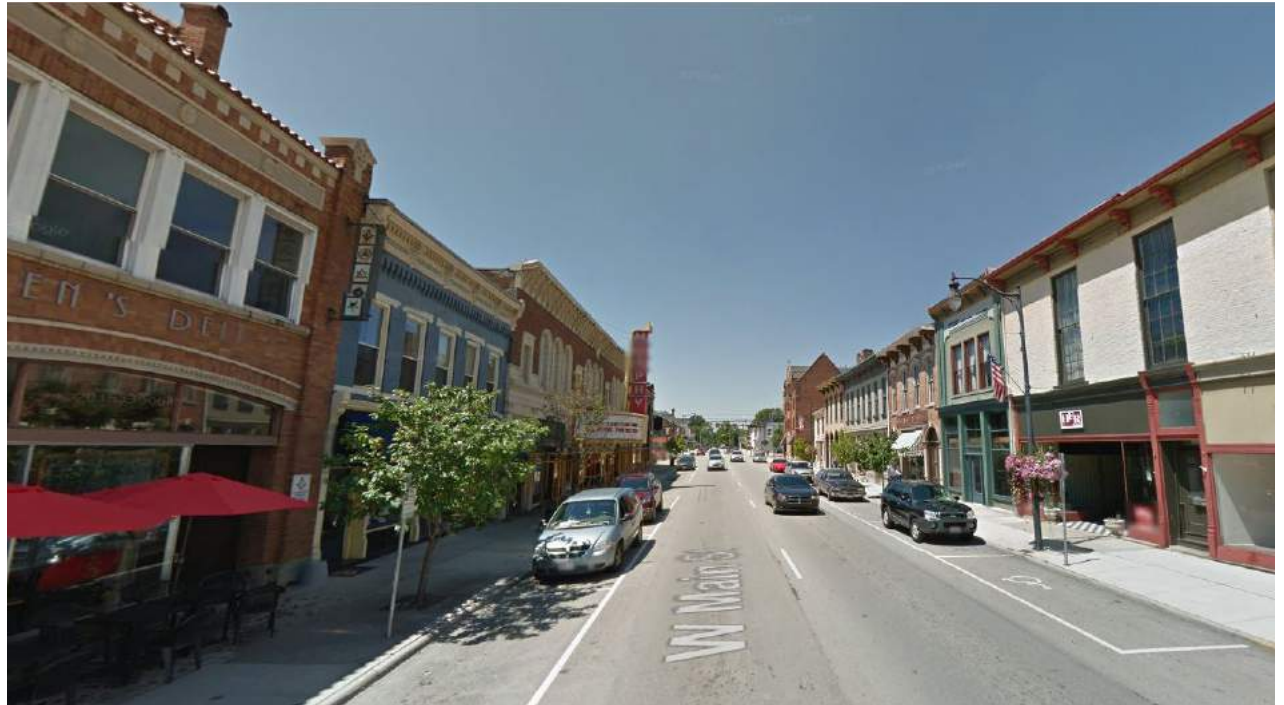
These blocks offer shade trees, landscaping, adequate lighting, maintained sidewalks, and a variety of businesses to interact with. These elements help to buffer the above-average volume of traffic on these streets. Although noise was not measured in this study, Main between South and Mulberry has much lower levels of noise than the other two examples. This is due to the lack of through trucks at this location.

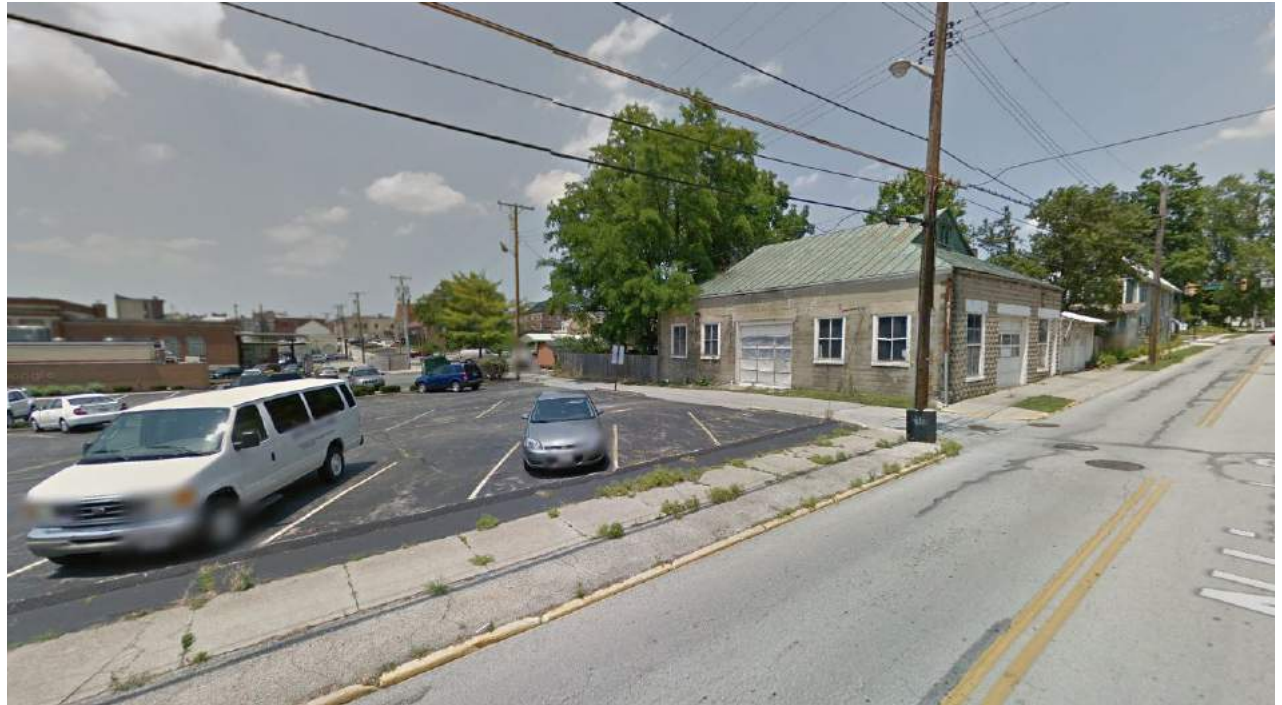
Lincoln between Locust and Main

In each of these examples, manicured greenery is almost nonexistent on the street. Traffic does not pose much of an issue, but the condition of sidewalks is very poor.

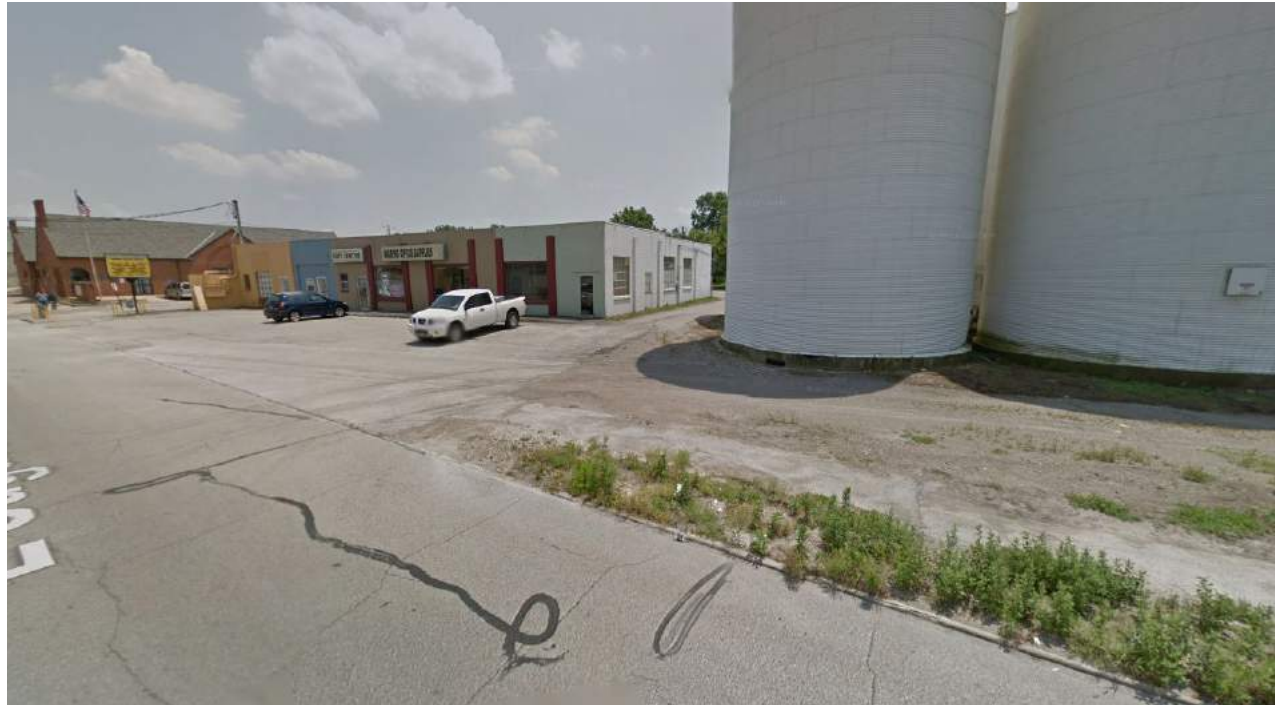
Sugartree between Lincoln and Walnut

These blocks are uninviting for pedestrians because they are composed of pavement, gravel, and parking lots, as opposed to greenery and safe sidewalks to walk on.

1. **BRING SIDEWALKS AND CROSSWALKS UP TO STANDARD:** This is critical to improving pedestrian safety. Currently, every crosswalk along Sugartree is either faded or nonexistent. The condition of the sidewalks degrades dramatically traveling west from Walnut Street, to the point that it disappears completely near and on Lincoln Street.

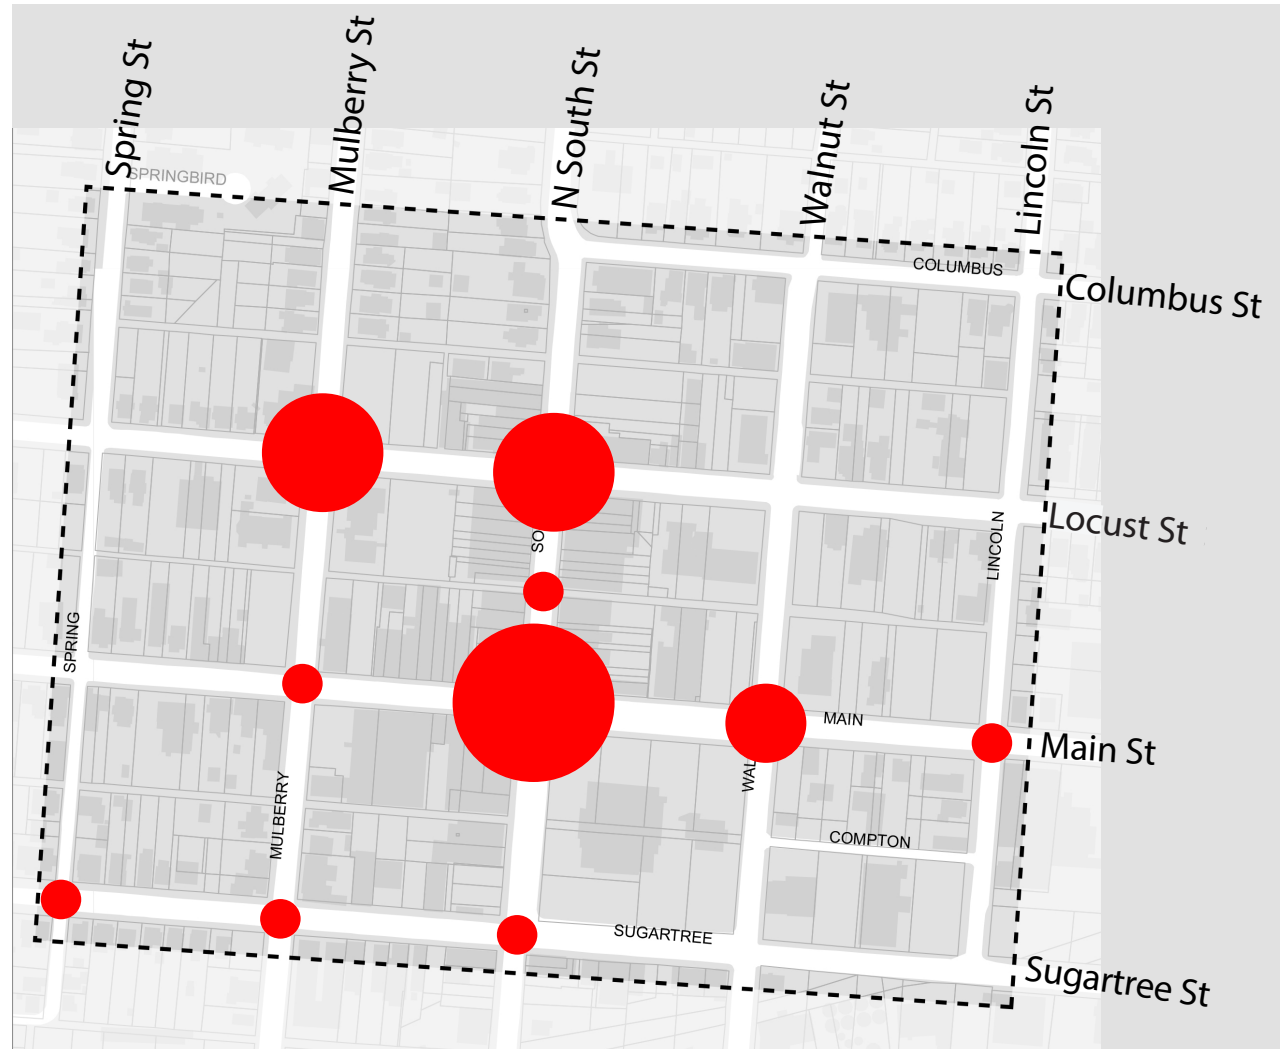
Map of Pedestrian Accidents (ODT 2003-2015)

*Larger dots equate multiple accidents in the same location

In addition to traffic speed and volume, one-way streets are a likely contributor to accidents. Of the 20 recorded pedestrian accidents downtown, 16 of them occurred on one-way streets (80% of downtown accidents). Only a total of three accidents were recorded on intersections with poor crosswalks, all of which are on Sugartree Street.

There is currently a lack of data on the safety impacts of converting to one-way streets. Further research should be conducted to investigate the benefits of converting to two-way streets in the context of Wilmington.

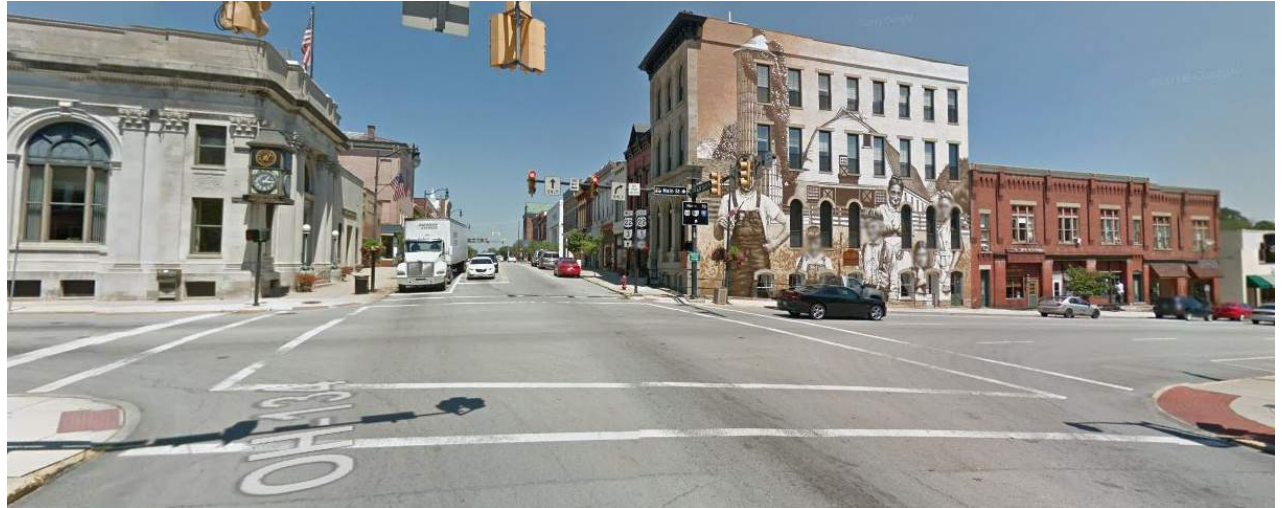
Looking North from South Street

Six pedestrian accidents occurred at the intersection of South and Main between 2003 and 2015. This is the highest rate in the entire City of Wilmington, and requires further analysis. This intersection is significant because the three-lane width of Main Street going east from South Street affects a variety of safety conditions.

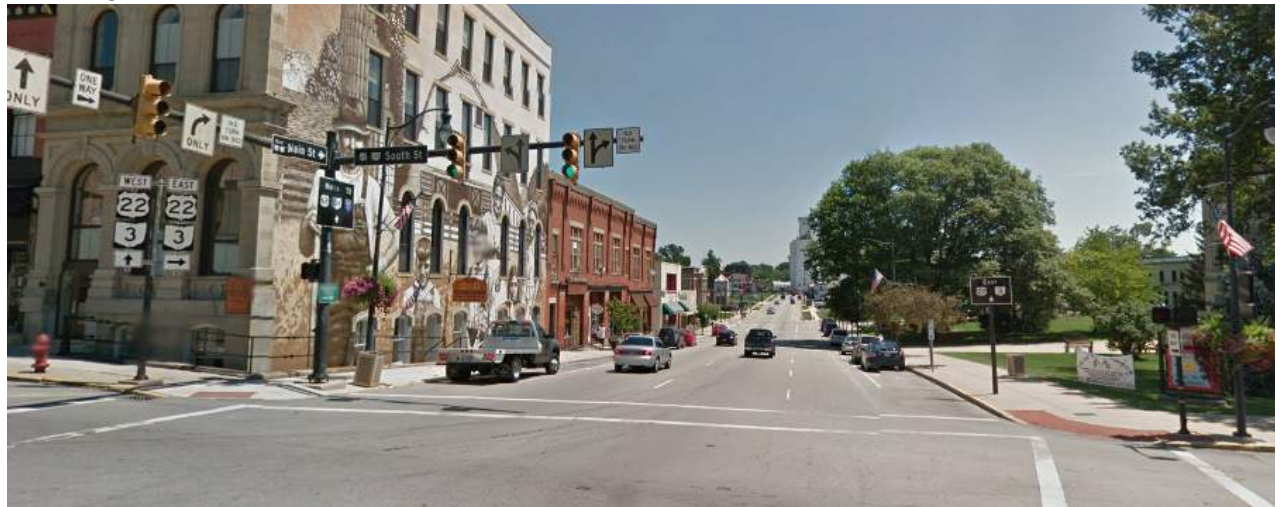
Looking East from Main Street

This portion of Main Street initiates the widest street in the downtown: three lanes. Vehicles travel noticeably faster once they enter this area, especially due to the declining slope. This condition is a likely contributor to accidents at the next intersection of Main and Walnut.

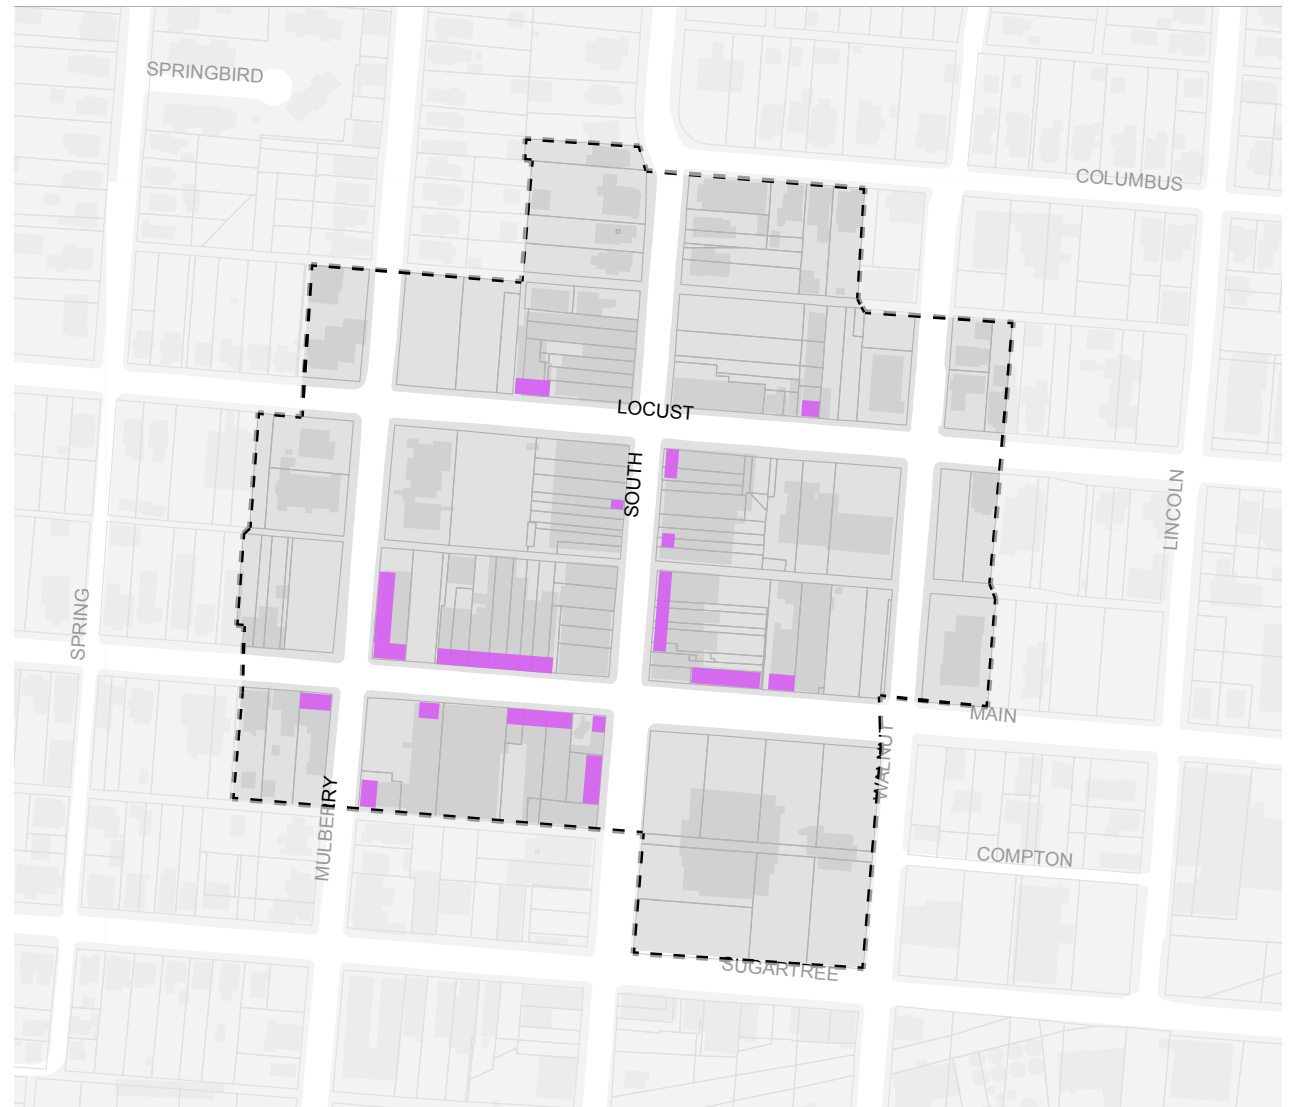
Building facades with transparent windows

Downtown Wilmington scores very poorly on the transparency factor. The most transparent street segment is along Main St. between Mulberry and South, where the historic Murphy Theatre and many local businesses are situated.
