DOWNTOWN WILMINGTON PEDESTRIAN IMPROVEMENT PLAN

2018

Executive Summary

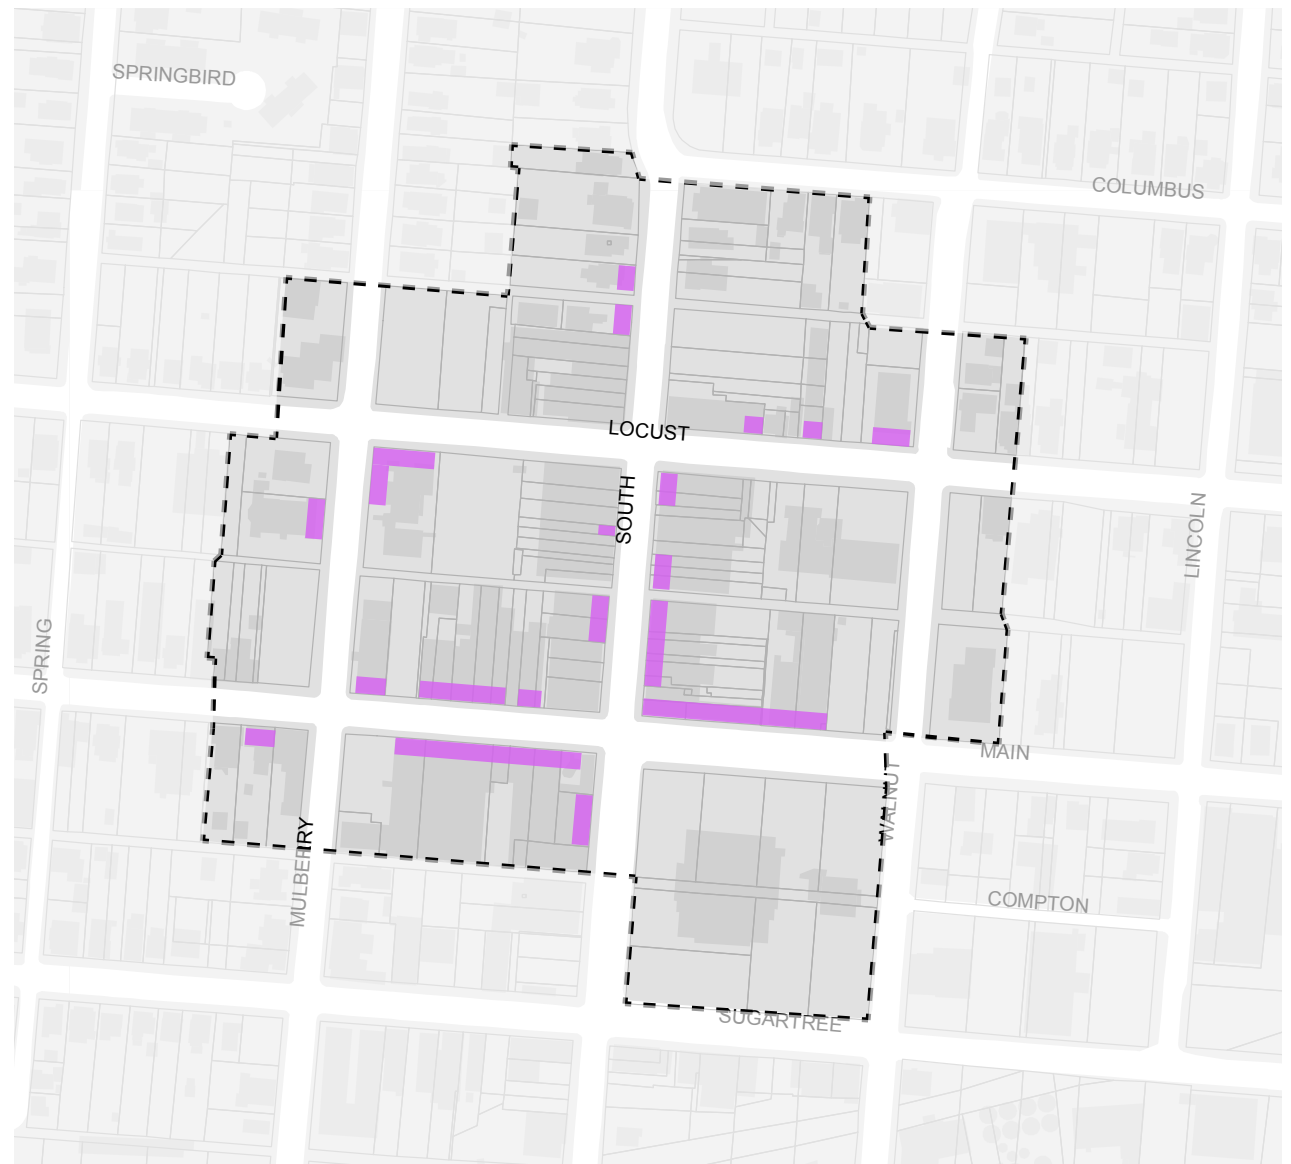
Active street frontages

For downtown Wilmington, the results showed a slight correlation to buildings with windows, seeing that active uses would be more likely to have a transparent facade to attract customers. There was, unsurprisingly, a large number of active uses on the South Street segment with the Murphy Theatre, which also scored best for transparency. Another notable pattern is the large number of active uses along Main Street and South Street on the same block.

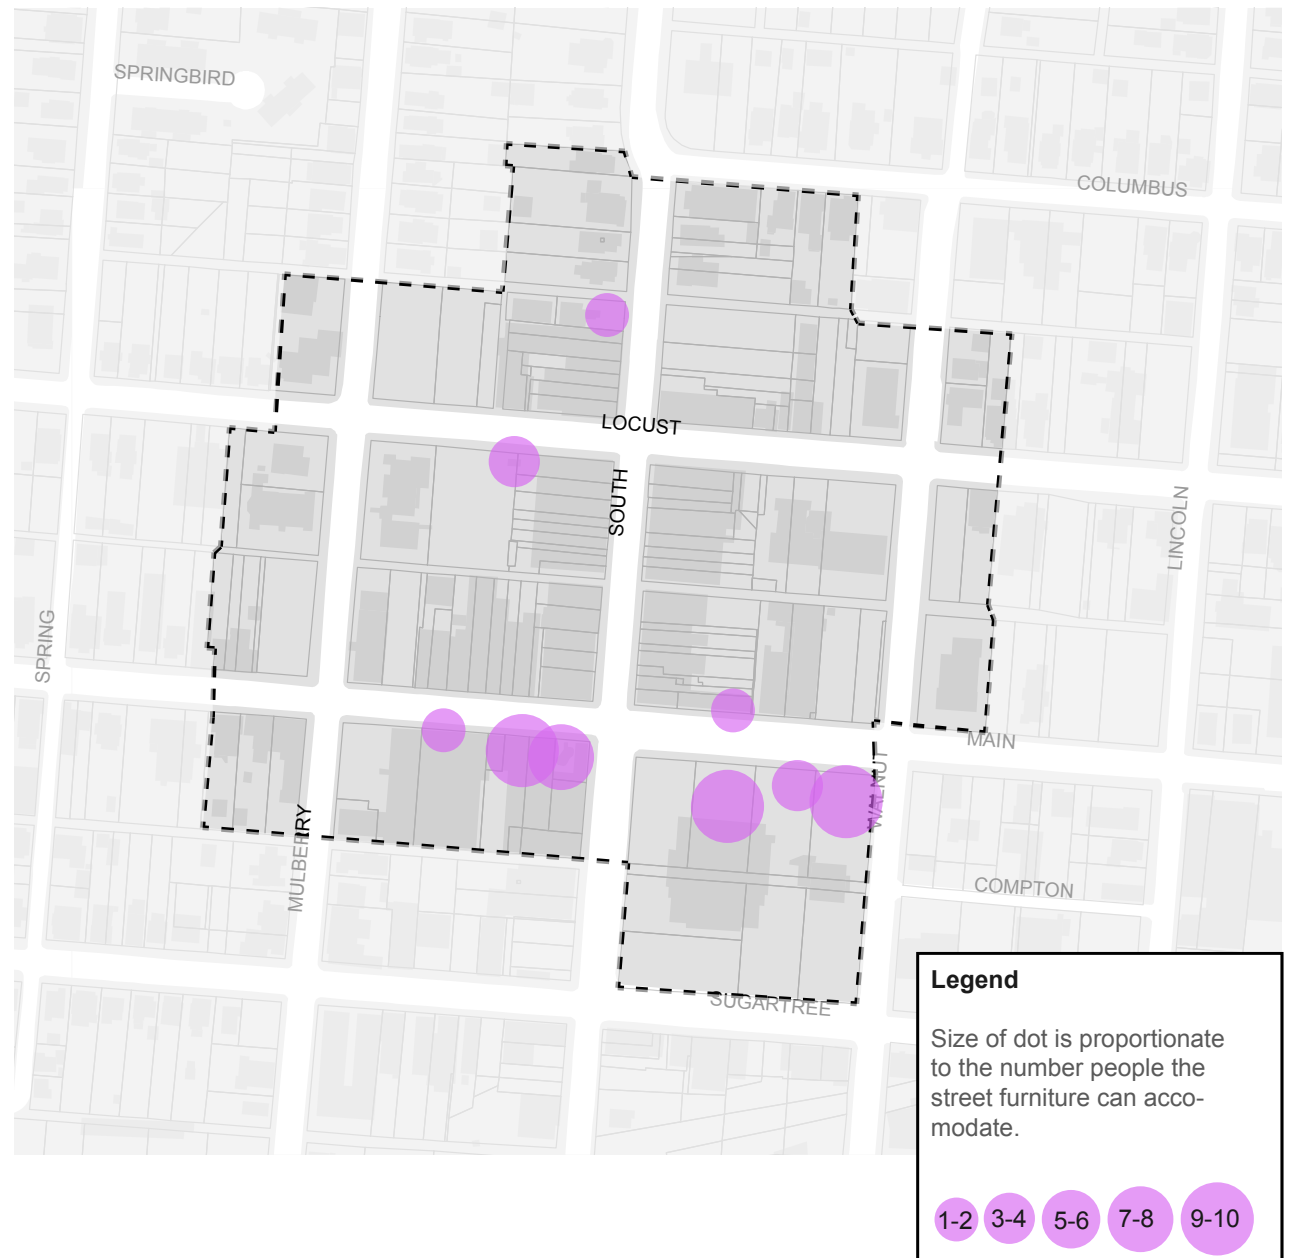
Seating

Wilmington has a large deficit in the amount of seating options downtown. The most seating options are along Main St. which are supplied by public and private owners. While the Clinton County Courthouse has a high proportion of seating, it received only moderate levels of use to do the single use of the entire Courthouse block.

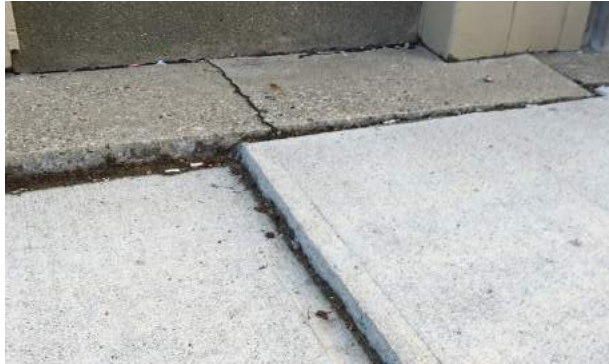
Uneven sidewalk found during tour

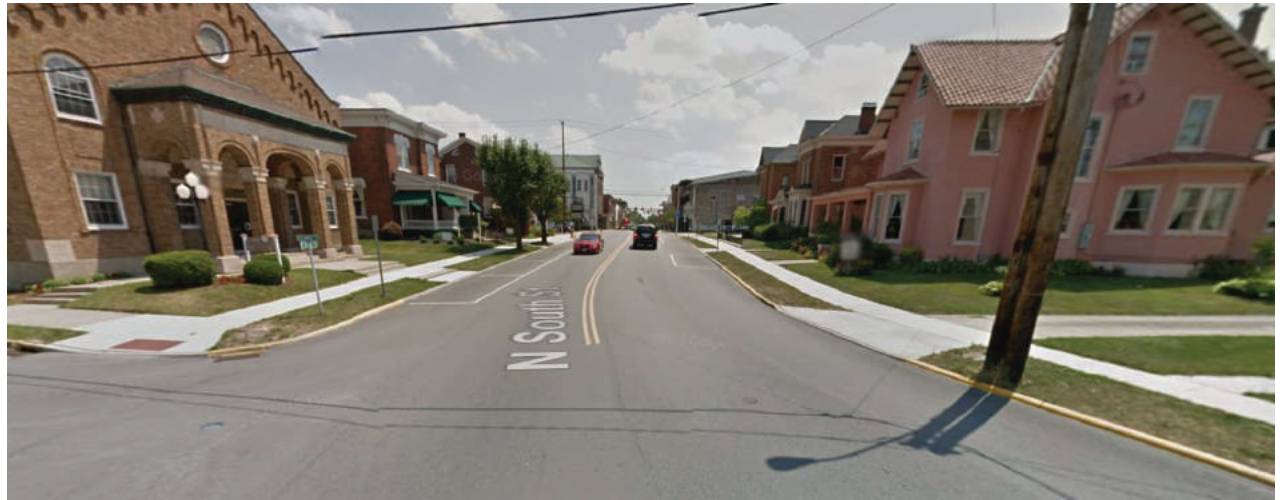
Before

Placing a striped crosswalk at this location will provide pedestrians a safe place to cross the street and give a cue to drivers that they are entering downtown. Multiple accidents have been reported at the next intersection of South and Locust. Therefore, any measures to slow traffic beforehand should be taken.

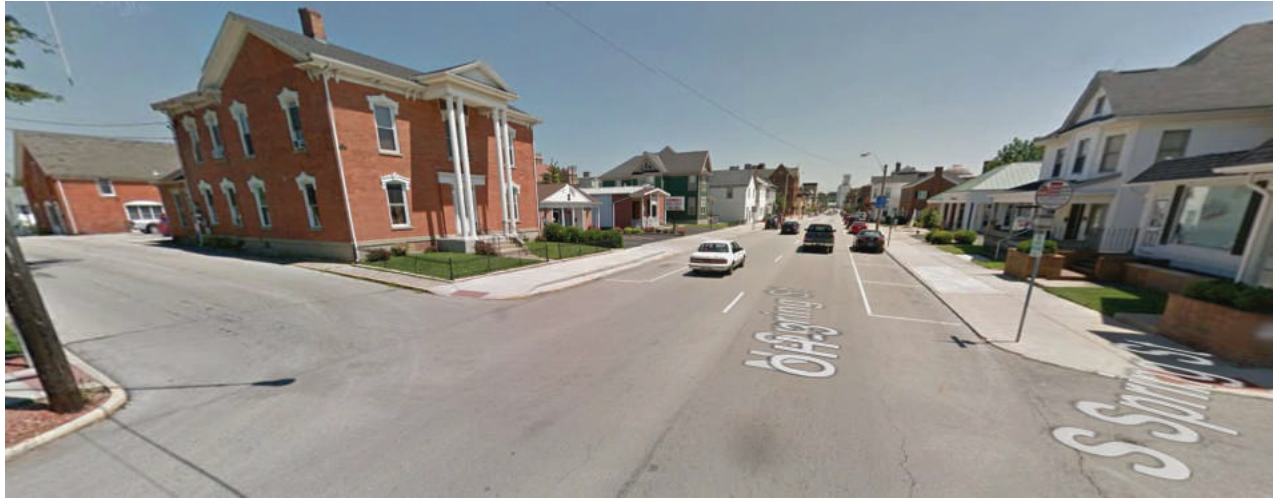
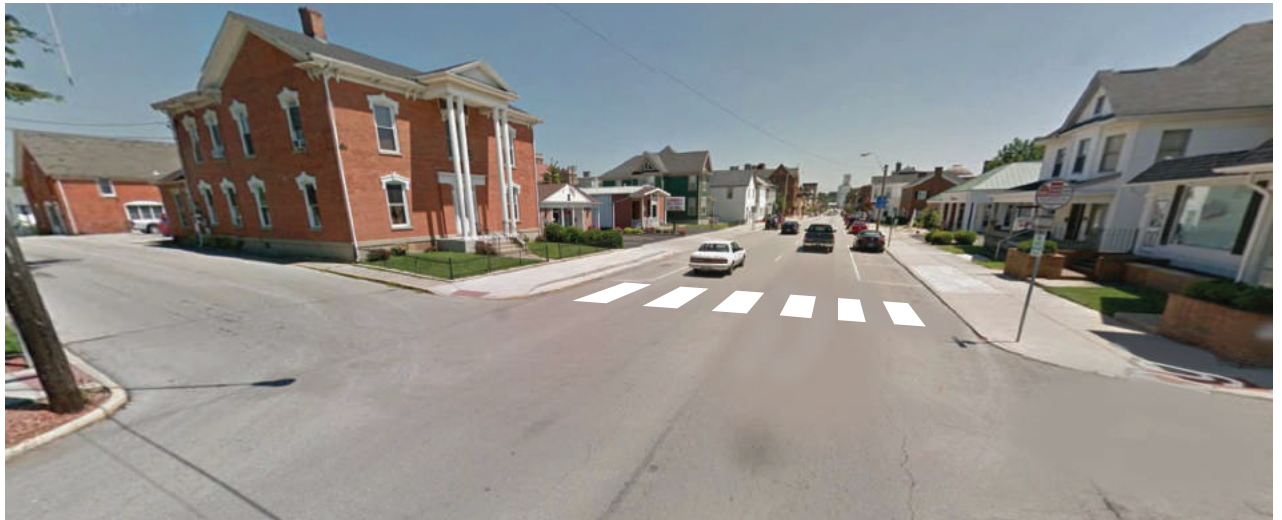
In order to prevent jaywalking and give pedestrians a designated place to cross the intersection, a crosswalk should be placed at Main Street and Spring Street. This also functions as a gateway to downtown, similar to the proposed crosswalk at South Street and Columbus Street.

Before

After

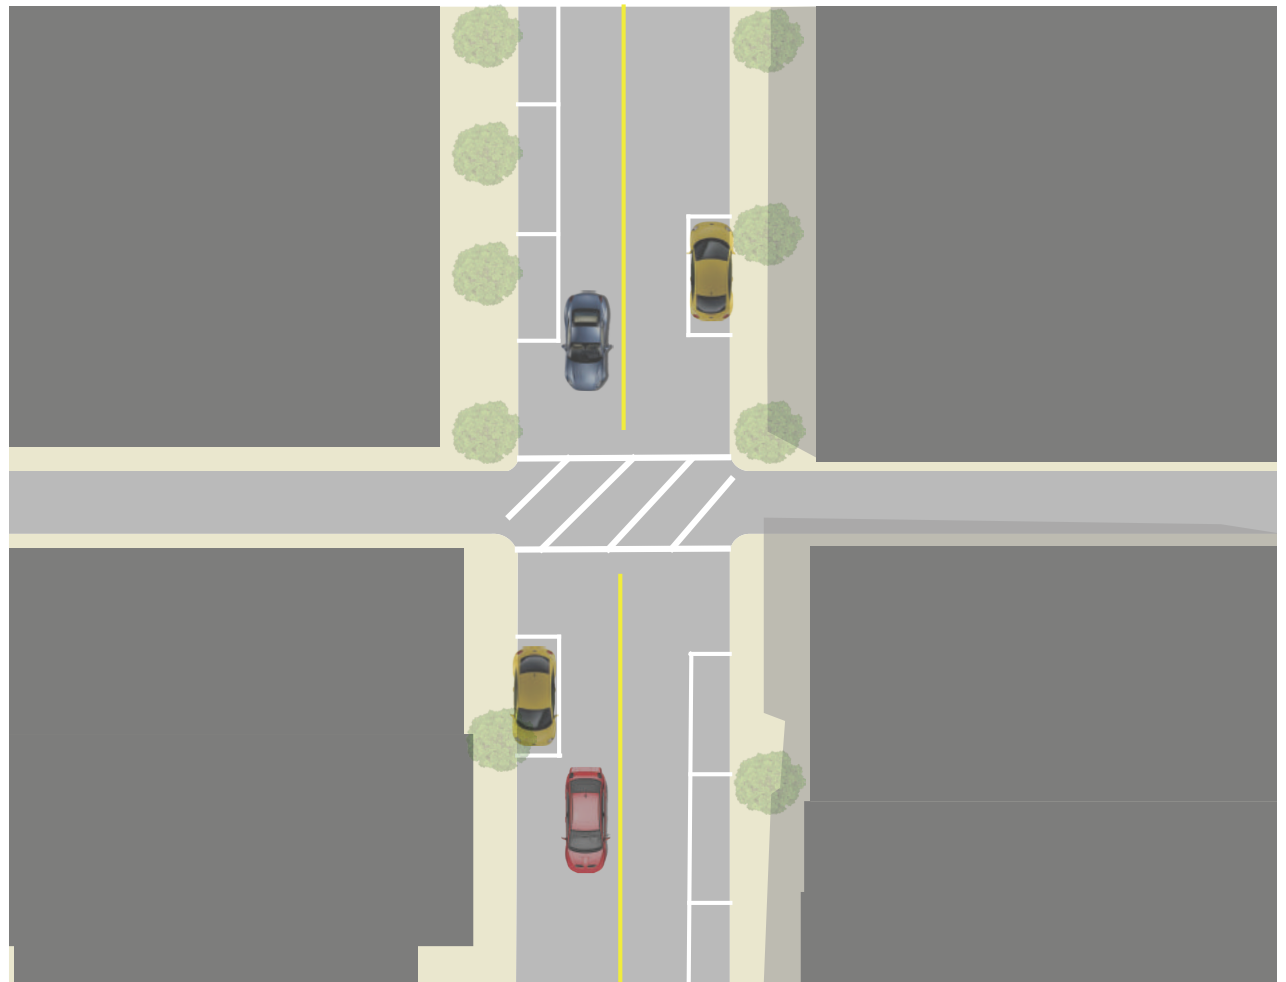
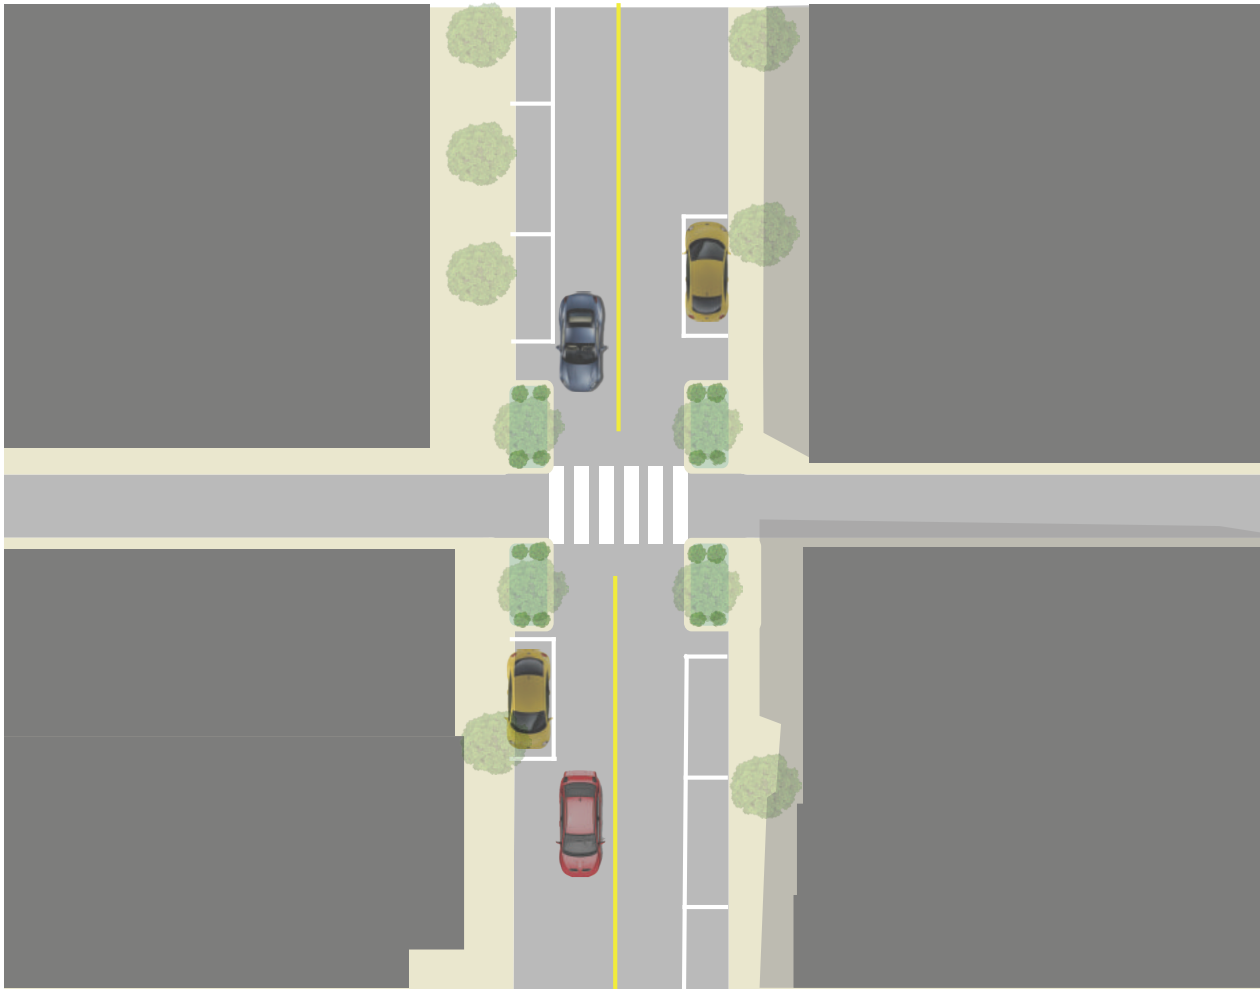
The crosswalk on South Street between Locust and Main was identified as a place where many people felt unsafe crossing. Low visibility was one of the largest issues with the crosswalk due to the parallel parking on both sides of the street and that pedestrians preparing to cross are often hidden from drivers behind parked cars.

In addition to adding bumpouts, the crosswalk would be restriped with the “zebra” style crossing with higher visibility.

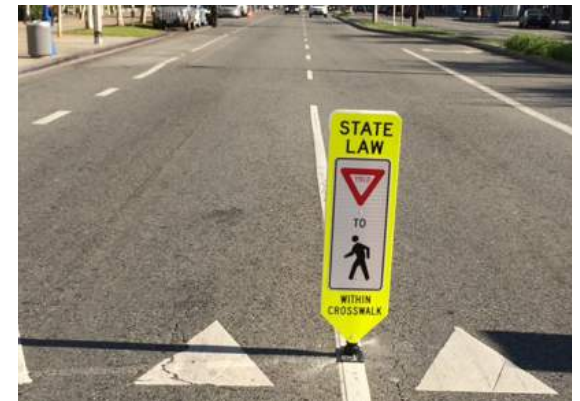
Low-cost pedestrian crossing sign

A pedestrian crossing sign would also be placed in the middle of the crosswalk to contribute to driver awareness and pedestrian safety.

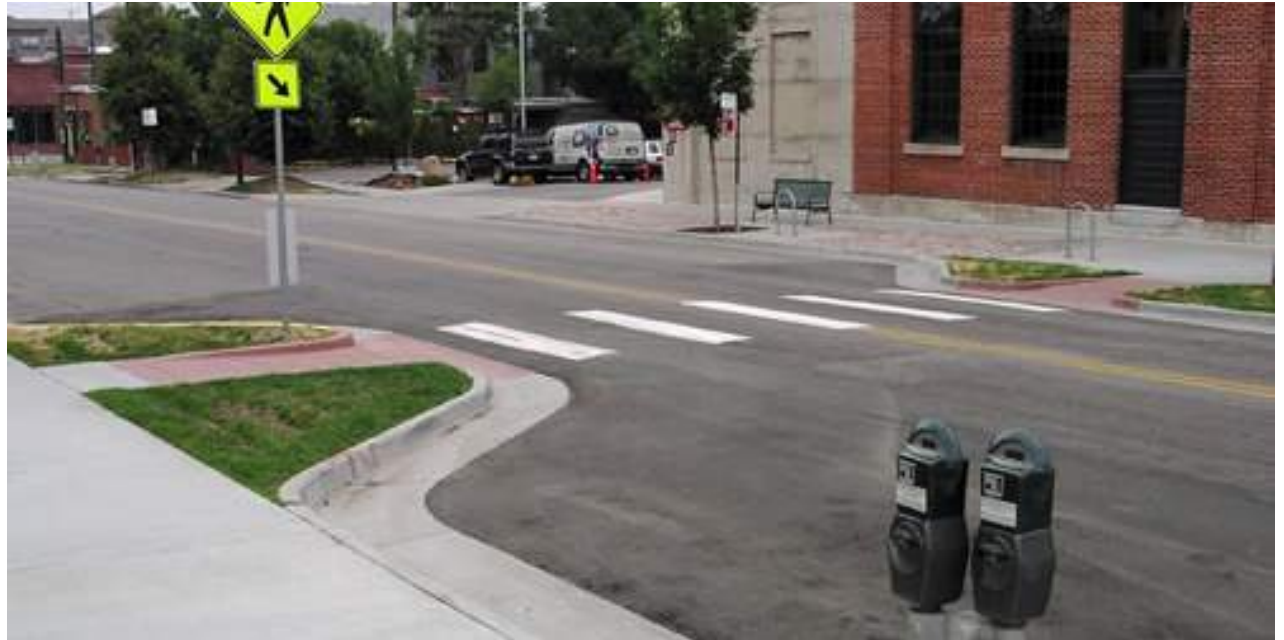
Permanent bumpout

The cost of a permanent bumpout can vary from \$10,000-\$30,000 each, with the average being \$13,000. Alternatively, the painted bumpouts with knockdown sticks would come at a minimal cost and could be used at more intersections.

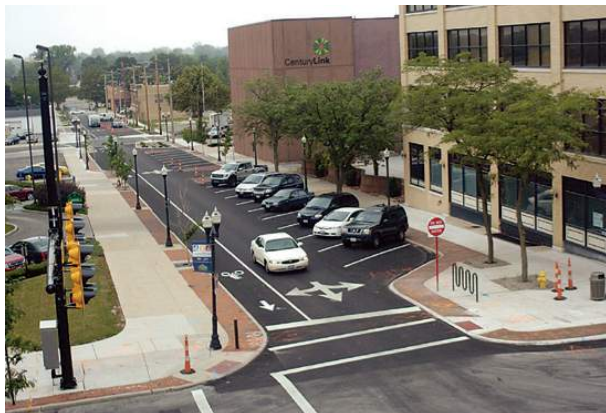
Reverse-angle parking with bumpouts

The reverse-angle parking proposed for the north and south sides of the Courthouse is safer for drivers and easier than the existing parallel parking. The safety benefits include the following:

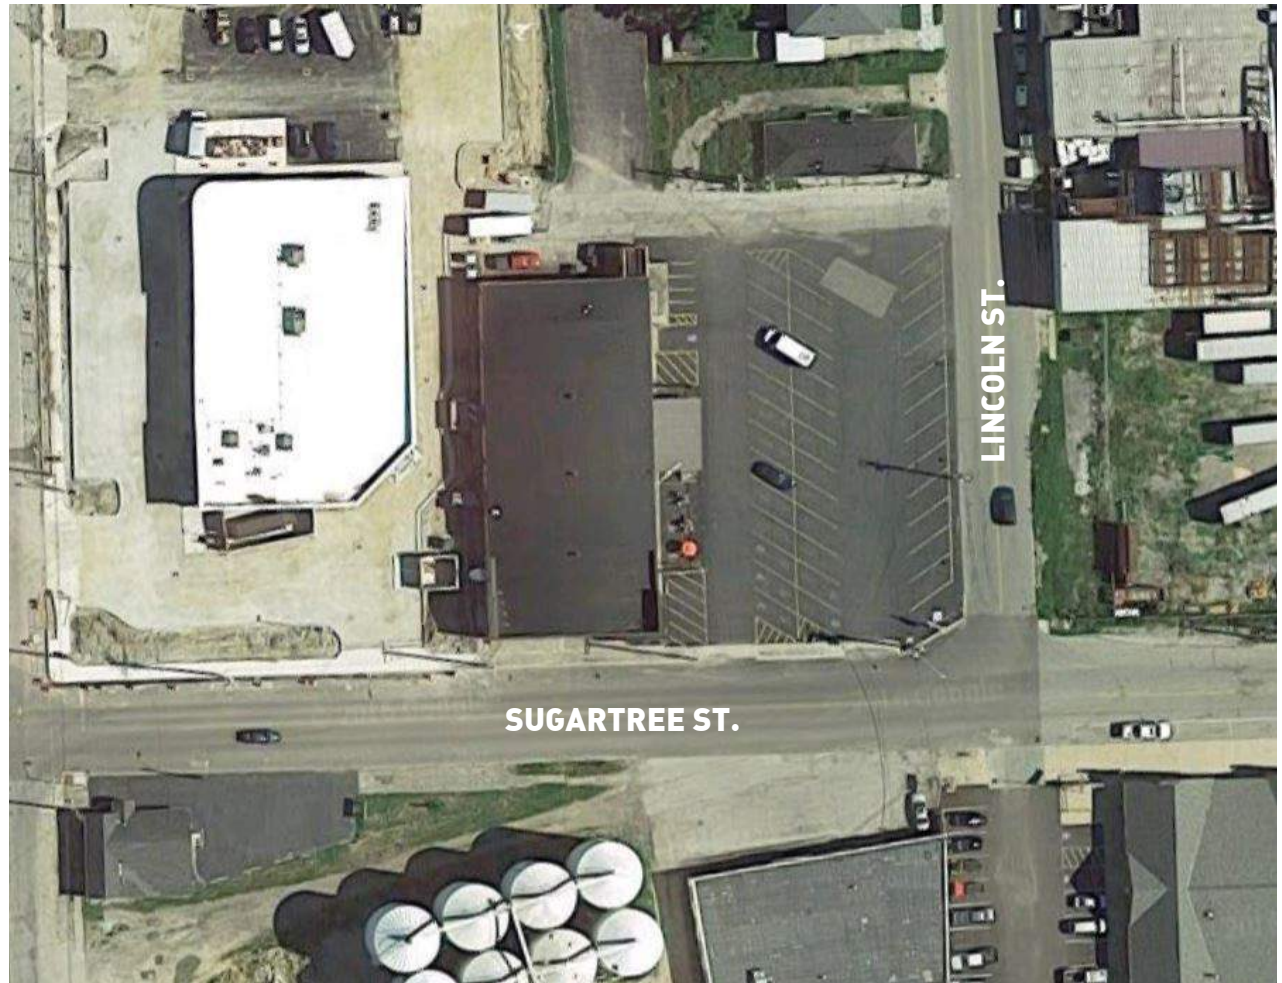
Eastern portion of Sugartree St. and Lincoln St.

One of the challenges with the corridor is that it transitions to industrial land uses east of Walnut Street with businesses such as Buckley Brothers and the Champion Bridge Company, which do not cater to walkability. The street also shows no signs of residential living until west of Mulberry. In addition to these factors, Sugartree Street has a negative perception of safety at night, likely due to the lack of active storefronts and residential properties.

1. **BRING SIDEWALKS AND CROSSWALKS UP TO STANDARD:** This is critical to improving pedestrian safety. Currently, every crosswalk along Sugartree is either faded or nonexistent. The condition of the sidewalks degrades dramatically traveling west from Walnut Street, to the point that it disappears completely near and on Lincoln Street.

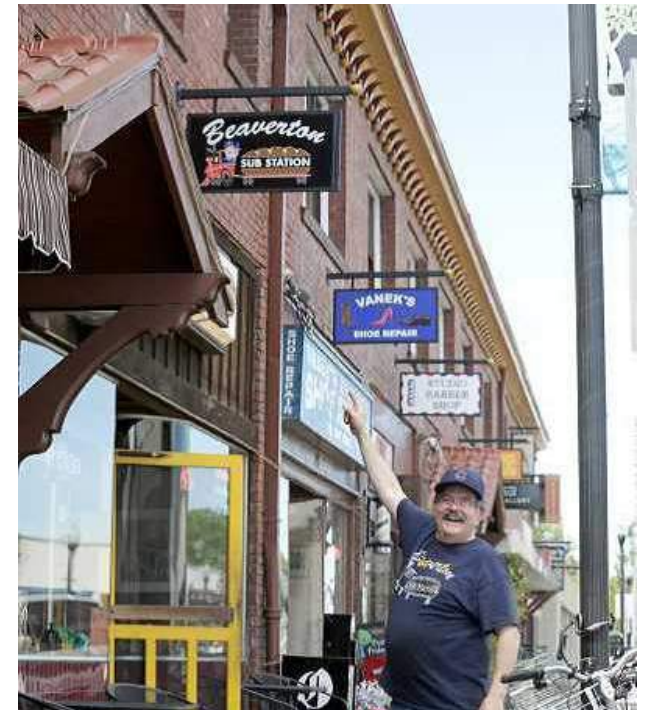
Perpendicular hanging signs

One of the points made during the public engagement portion of this study was that businesses’ signs are difficult to see while driving through downtown. Even as one is walking down Main Street, for example, they would have trouble identifying a sign until they are right across from the building. A good way to counter this is to encourage business owners to hang signs perpendicular to the building, similar to the sign in front of The General Denver. As long as new signs conform to the historic downtown character, they can help heighten the profile of each business.

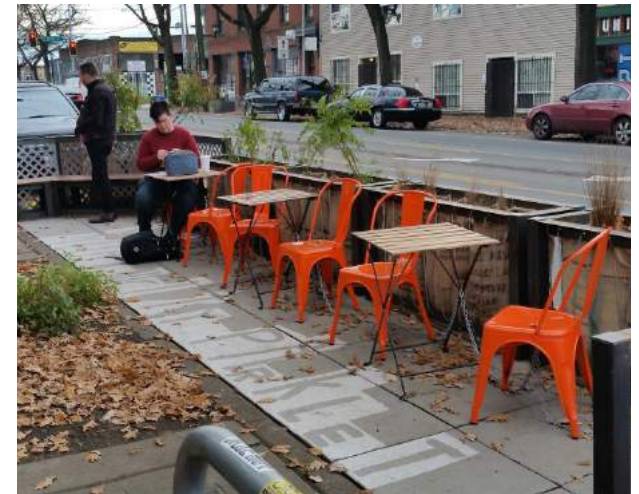
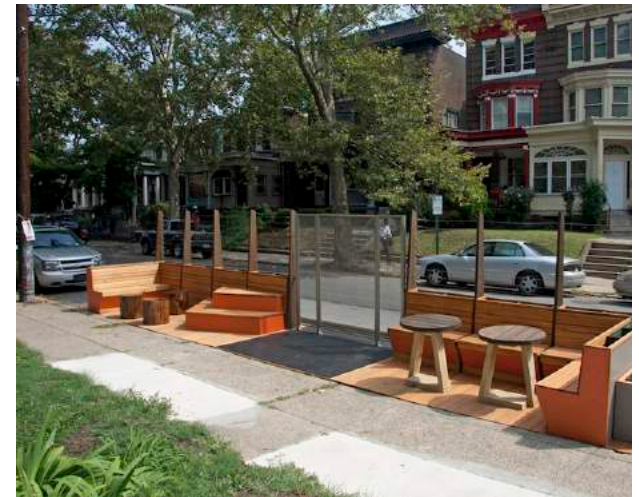
Parklet examples

Before investing in permanent seating, it may prove beneficial to study these areas by placing temporary seating to gauge whether seating would be utilized or not. This is also known as tactical urbanism, which uses methods of low-cost improvements to the built environment that can potentially turn into permanent changes led by a city administration. One of the most popular initiatives of this movement is the “parklet”, which is a temporary public space that is constructed in a parking space.

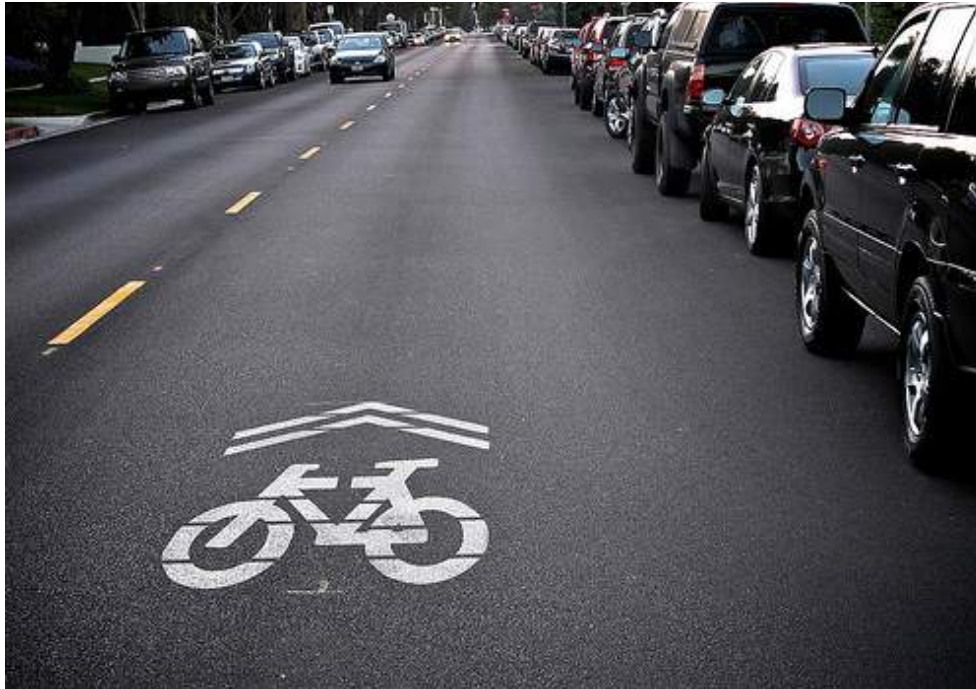
According to police reports collected between 2003 and 2015, 35% of pedestrian accidents downtown involved individuals on bicycles. With increasing use of the Luther Warren Peace Path and the Urban Trail Connector in close proximity, the volume of bicycle traffic will reasonably grow. An affordable and effective method of protecting cyclists are “sharrows” painted on the pavement of roads. These symbols are widely used in cities worldwide to remind drivers that they must be aware of cyclists and share the road with them.

These sharrows would be painted on the three most-traveled streets: Main, South, and Locust. Bike racks should also be installed along these streets to provide places to lock up bicycles.
