Re: Warning Letter
Site No. 388517 / Project Nos. 420197 and 421018
Man-Altered Waterbody, Class III waters
Parcel No. 412126103010 – Greenbelt area adjacent to 9149 Lane Ct, Port Charlotte,
Florida 33981
Charlotte County – SLERC

Florida Department of Environmental Protection
 SOUTH DISTRICT COMPLIANCE ASSURANCE PROGRAM
 ERP Inspection Report

Site Inspection Figures and Photos

**Test Point 1 Photo Log – Greenbelt area adjacent to 9149 Lane Ct – Charlotte County Parcel ID:
412126103010**

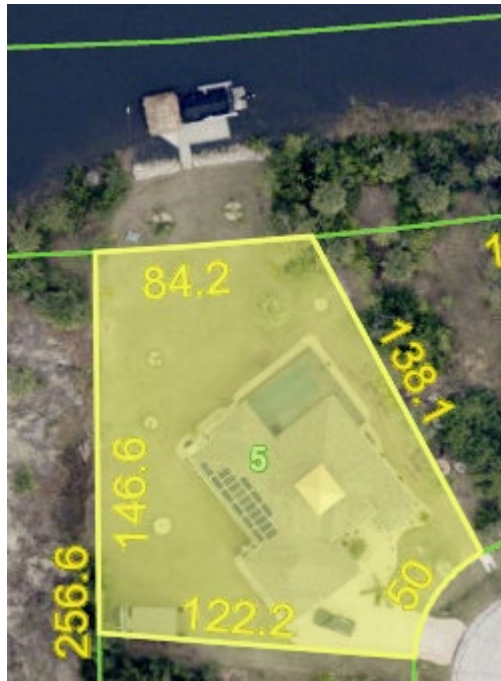
Figure 1: 2024 aerial photograph of Property 1 (outlined in green) and Property 2 (shaded in yellow). Taken from Charlotte County Property Appraiser website.

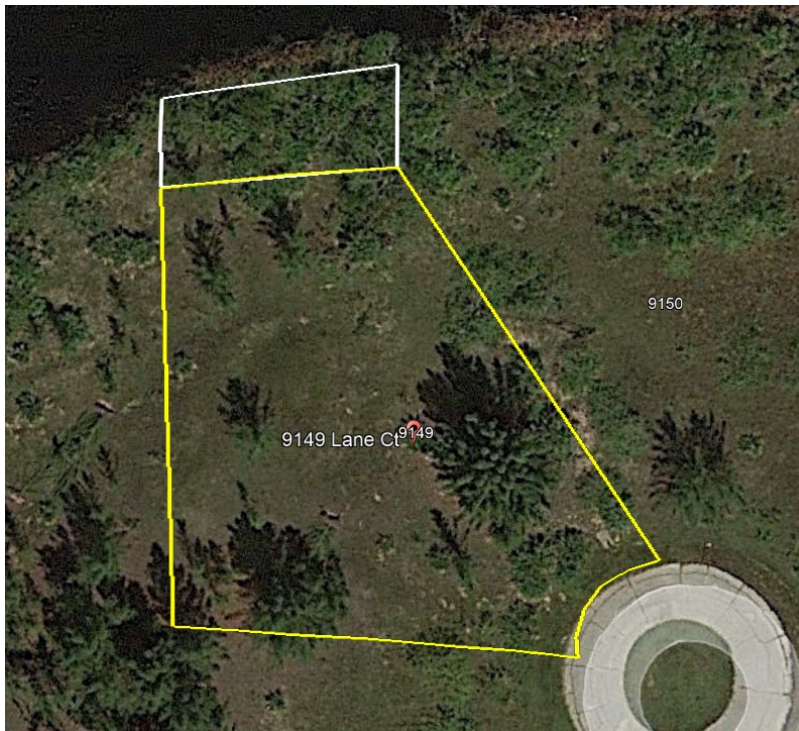
Figure 2: 2017 aerial photograph of Property 1 (outlined in white) and Property 2 (outlined in yellow). Taken Aerial photograph taken from Google Earth.

A section of Parcel ID 412126103010 that is adjacent to 9149 Lane Ct, Port Charlotte, FL 33981 Parcel ID 412123151002 and outlined in white in Figure 2 below (Property 1)

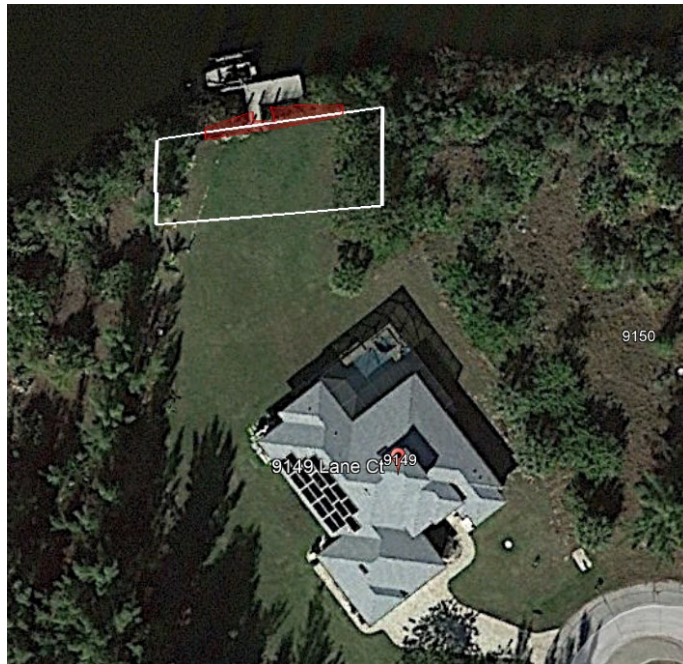
Figure 3: 2021 aerial photograph showing the unauthorized rip rap (shaded in red) on Property 1 (outlined in white).

prior to 01/2021: A review of aerial photographs of Property 1 by department staff (Kelly Dino) indicates that approximately 50 linear feet of rip rap was installed along the shoreline of Property 1 (see Figure 3).

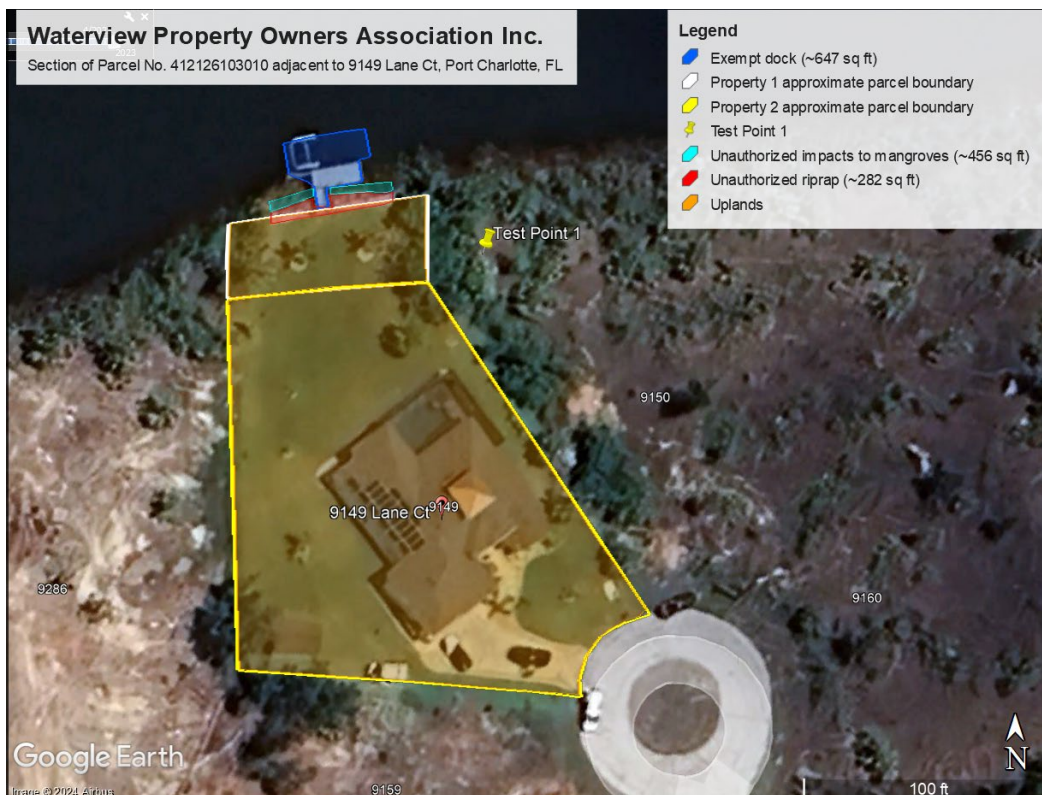
Figure 3: Figure showing the approximately property boundaries of Property 1 (outlined in white) and Property 2 (outlined in yellow), the uplands boundary (shaded in orange), exempt docking structure (shaded in blue), unauthorized rip rap (shaded in red), unauthorized impacts to mangroves (shaded in aqua) and location of Test Point 1 (indicated by the yellow pin). 2023 aerial photograph taken from Google Earth.

Pursuant to Chapter 62-340, F.A.C., Property 1 was determined to be uplands. Additional information on how this determination was made is attached in the 62-340, F.A.C. Data Form (Test Point 1). This determination was made using reasonable scientific judgement, conducting a review of historical aerial maps of this area, on site visual inspection, ground truthing, and the altered site methodology described in Chapter 62-340, F.A.C. Wetland delineations pertaining to potentially non-compliant activities do not consider the alterations as they exist but rather what they were immediately before the non-compliant activities took place. Thus, the information used for the wetland determination was collected from 1 test point (Test Point 1) and used in a forensic manner.

Test Point 1 is a location where the canopy, sub-canopy, and ground cover vegetation was left undisturbed by recent filling activities. In addition, the ground surface at Test Point 1 was left undisturbed and at original grade. Test Point 1 was determined to be uplands under the guidelines provided by Chapter 62-340, F.A.C. Additional information on how this determination was made is in the attached 62-340, F.A.C. Data Form.

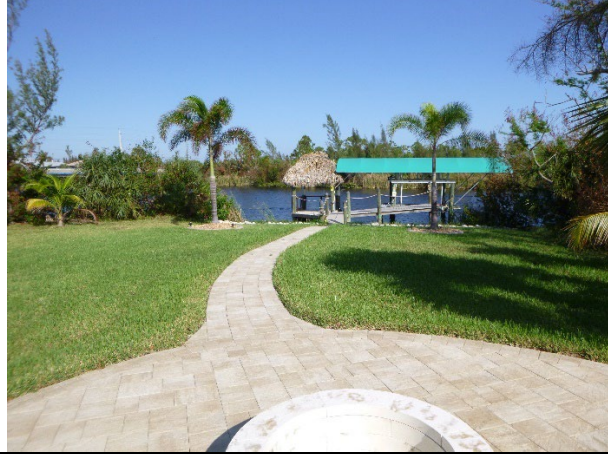
At the time of inspection, department staff observed that Property 1 had been cleared and filled. Department staff observed a docking structure with a covered boatlift and measured the total overwater surface area to be approximately 647 square feet.

Photo 1: View of Property 1. Facing north.

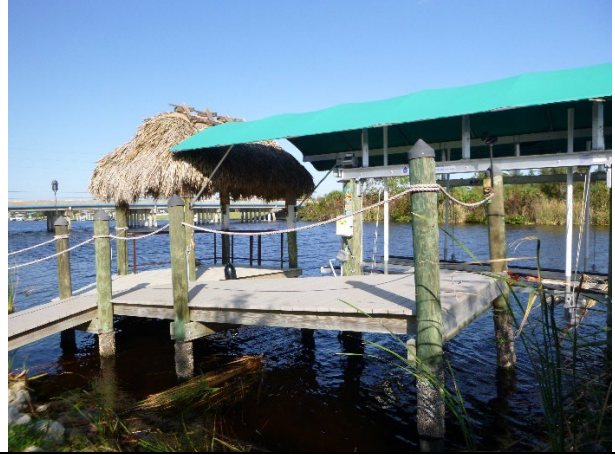
Pursuant to Chapter 62-330.051(5)(b), Florida Administrative Code (F.A.C.) and Section 403.813(1)(b), Florida Statutes (F.S.), construction of a dock with an overwater area of 1,000 square feet or less, with a minimum distance of 65 feet from another dock, is exempt from the need to obtain an ERP permit. **Therefore, the docking structure is considered exempt.**

Photo 2: View of exempt docking structure along the shoreline of Property 1. Facing north.

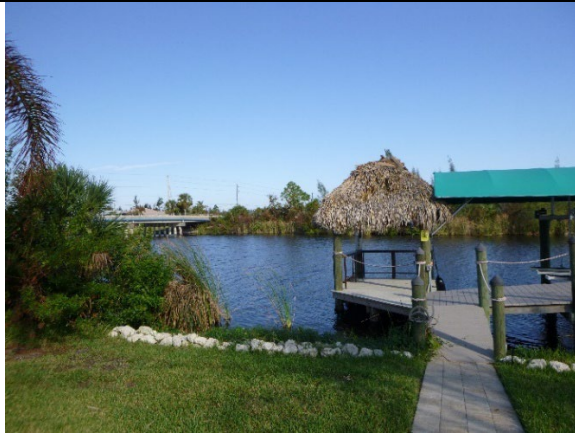
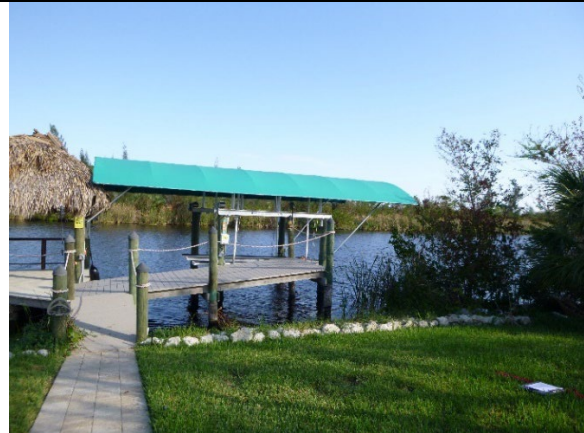
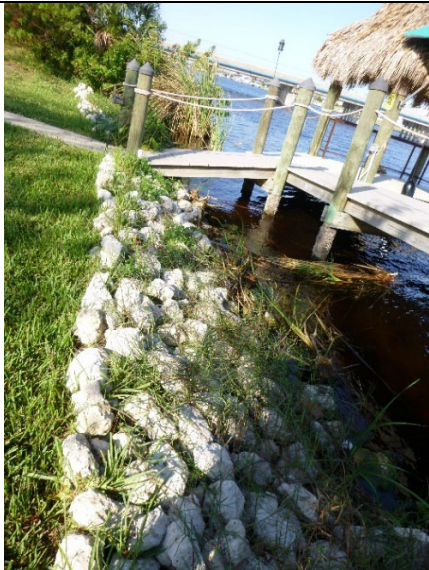
At the time of inspection, department staff also observed approximately 282 square feet of rip rap installed along the shoreline of Property 1.

Installation of riprap along the shoreline of Property 1 does not meet the exemption criteria outlined in Chapter 62-330.051(12)(a) F.A.C.

Pursuant to Chapter 62-330.020, F.A.C., installation of riprap in a man-altered waterway required a permit from the department. The department has no record of a permit being issued for Property 1.

Photo 3: View of unauthorized riprap along the shoreline of Property 1. Facing north.

Photo 4: Additional view of unauthorized riprap along the shoreline of Property 1. Facing north.

Photo 5: Additional view of unauthorized riprap along the shoreline of Property 1. Facing west.

1. Cease all unauthorized mangrove trimming and alteration on Property 1; and
2. Cease any further unauthorized activities, construction, and discharge of fill materials in wetlands and/ or other surface waters on Property 1; and
3. Enter into a Consent Order with the department to resolve the unauthorized riprap and mangrove

alteration on Property 1; and

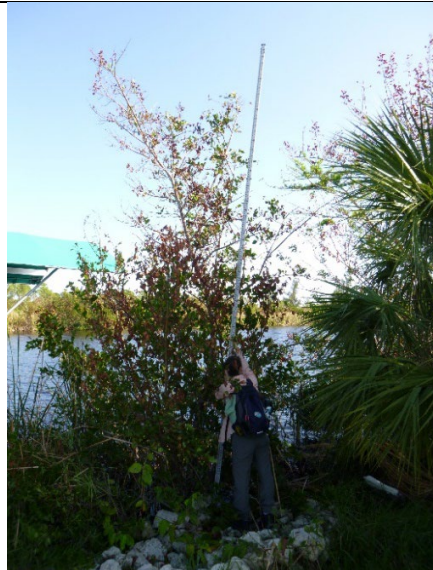
Additionally, at the time of inspection, department staff observed mangroves along the shoreline of Property 1. Department staff observed that approximately 76 linear feet of mangroves had been removed from along the shoreline of Property 1. The remaining mangroves consisted of approximately 50% red mangroves (*Rhizophora mangle*) and 50% white mangroves (*Laguncularia racemosa*). Department staff measured the remaining mangroves to range between 10-16 feet in height, as measured from the substrate, with an average diameter at breast height (DBH) of approximately 1-3 inches. The remaining mangrove fringe was measured to be approximately 6 feet in depth.

Pursuant to Section 403.9328, F.S., these mangrove alteration activities required a permit from the department. The department has no record of a mangrove permit being issued for Property 1.

Photo 6: View of remaining mangroves along the shoreline of Property 1. Facing east.

4. Conduct any future work involving mangroves in accordance with the 1996 Mangrove Preservation and Trimming Act ([link below](#)) or obtain appropriate regulatory authorization from the department prior to any future mangrove trimming or alterations pursuant to Sections 403.9321-409.9333, F.S.; and
5. Obtain the appropriate regulatory authorization from the department for any future construction in wetlands or surface waters, pursuant to Chapters 62-330 and 62-331, F.A.C.

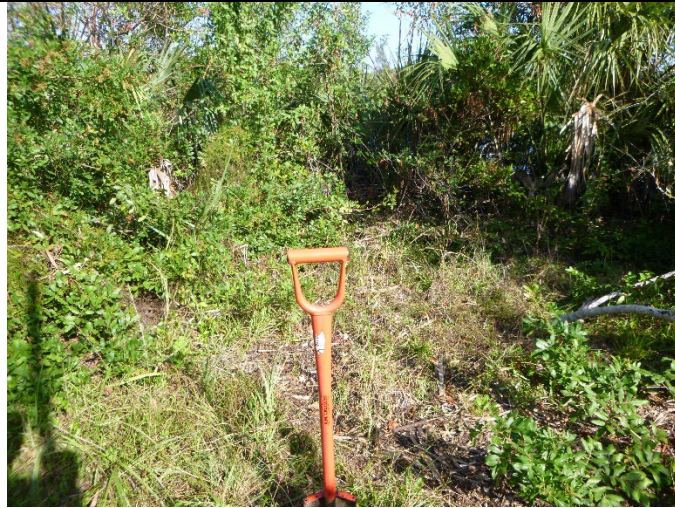
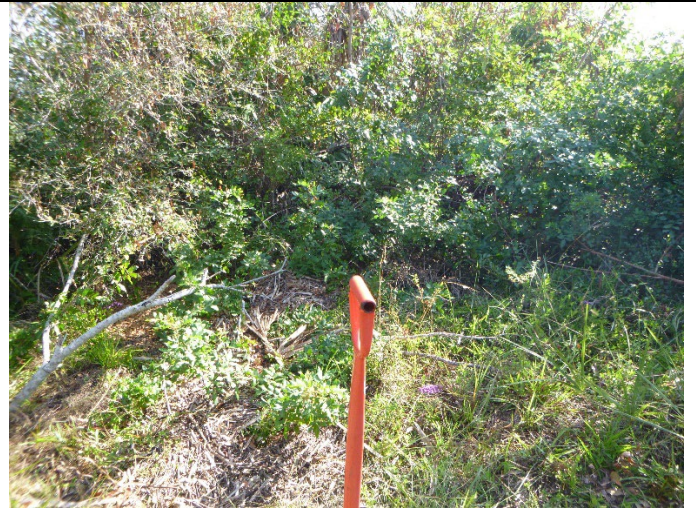
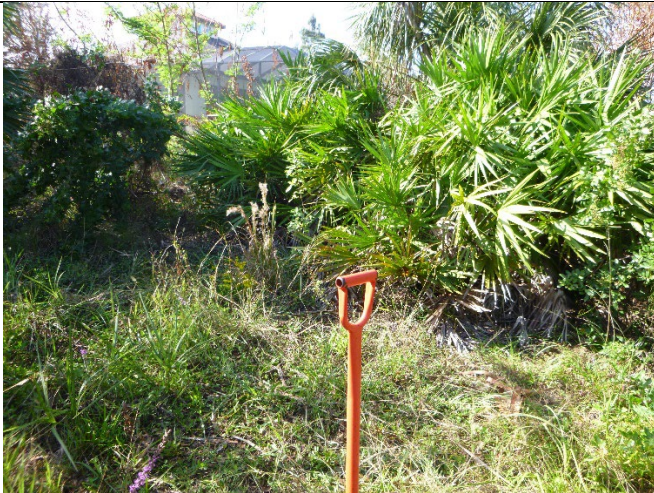
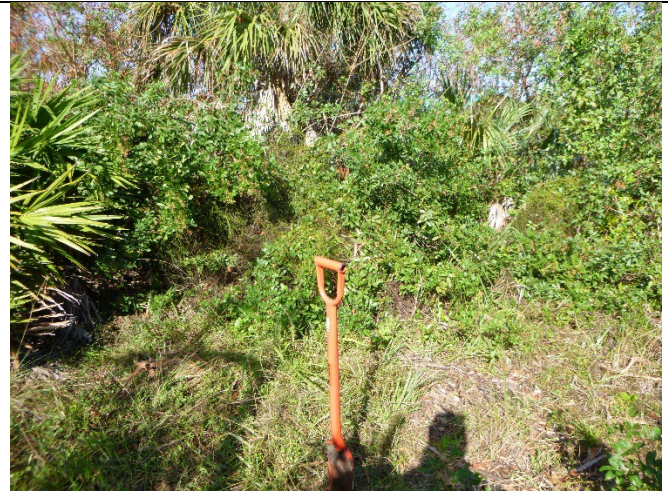
1. Representative vegetative community at Test Point 1, facing north.

2. Representative vegetative community at Test Point 1, facing east.

3. Representative vegetative community at Test Point 1, facing south.

4. Representative vegetative community at Test Point 1, facing west.

#	Binomial of Observed Species	Status	Canopy	Subcanopy	Groundcover	Upland	Facultative	Fac. Wet	Obligate
1.	Serenoa repens	U			30				
2.	Sabal palmetto	F	40				40		
3.	Liatris aspera	U			2				
4.	Schinus terebinthifolius	F	10	50			10		
5.	Myrsine guianensis	F	5				5		
6.	Setaria geniculata	F			1				
7.	Andropogon virginicus	F			3				
8.	Phyla spp	F			1				
9.	Spermacoce verticillata	U			1				
10.	Dactyloctenium aegyptium	U			2				
11.	Flaveria linearis	FW			3				
12.									
13.									
14.									
15.									
16.									
17.									
18.									
19.									
20.

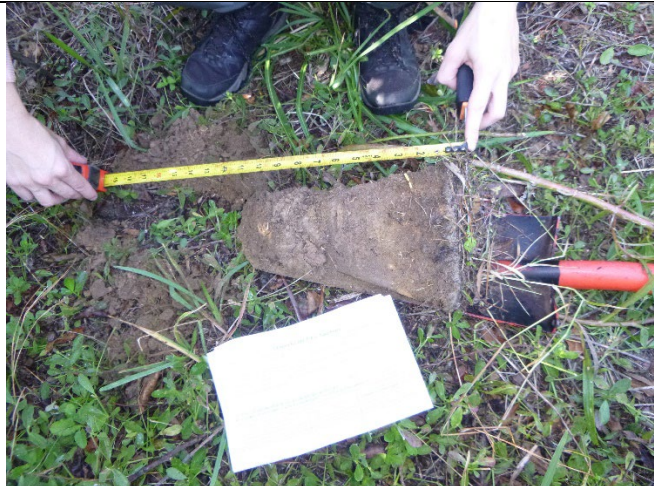
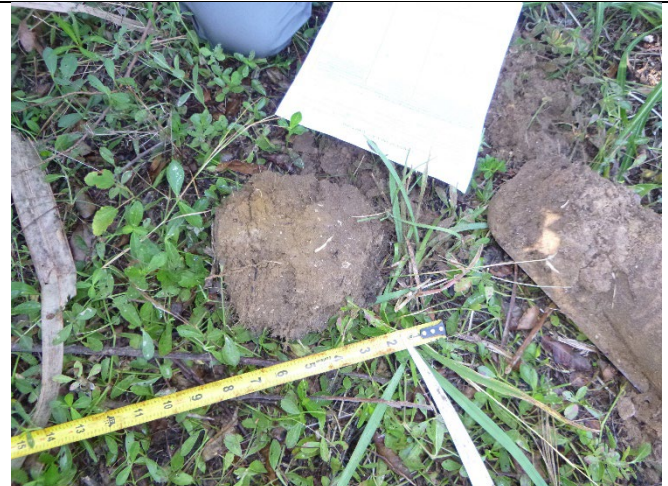
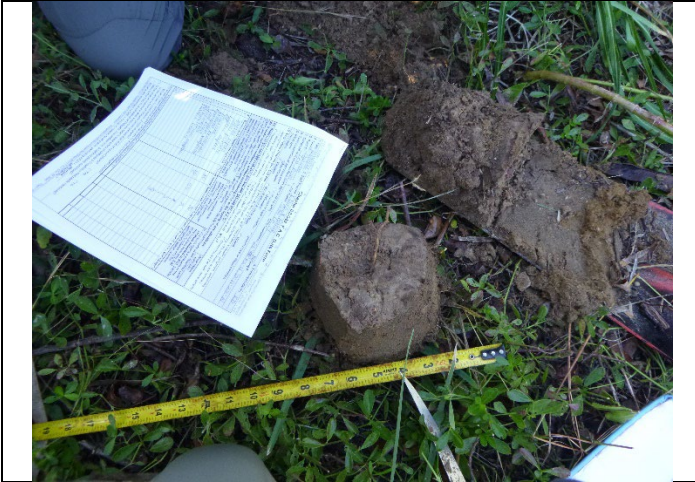
20. Is the depth of the soil profile 20 inches or greater from the soil surface? Yes No
If no, depth of soil profile is: 10 inches Why? loose sand
(e.g., root refusal, nonsoil, water table, loose sand, heavy texture, compaction, weather conditions, inspection interrupted)

5. View of soil profile taken at Test Point 1.

6. View of soil profile cross-section at 1.5 inches below soil surface at Test Point 1.

7. View of soil profile cross-section at 4 inches below soil surface at Test Point 1.

Horizon	beginning to ending Depth (inches)	Matrix Texture	moist condition Matrix Hue Value/ Chroma	for sandy matrix horizons w/ value ≤ 3: % Organic Coating	- Describe soil features: DA (areas darker than matrix), LA (areas lighter than matrix), RC (redox concentrations): Record in moist condition hue value/chroma ; % volume in horizon ; boundaries (sharp/clear/diffuse); shape (rounded/linear/angular). - OB (organic bodies): Record texture (muck or mucky mineral), % volume in horizon . - H₂S (hydrogen sulfide odor): Indicate shallowest depth where detected - Note if horizon is Physically Mixed (PM) , Nonsoil (any material not listed in "Textures" above), or Fill and describe.
1	0-2.5	sand	10 YR 4/4	N/A	LA: 10 YR 4/6, round/diffuse, 20% LA2: 10 YR 6/4, round/diffuse, 2%
2	2.5-10	sand	10 YR 5/3	N/A	LA: 10 YR 4/3, round/diffuse, 8% DA: 10 YR 6/4, round/diffuse, 10%
3					
4					
5					
6
