## I. OPTIONAL SYSTEMS

### A. Swimming Pools, Spas, Hot Tubs, and Equipment

Type of Construction: Concrete, "PebbleTec" type finish

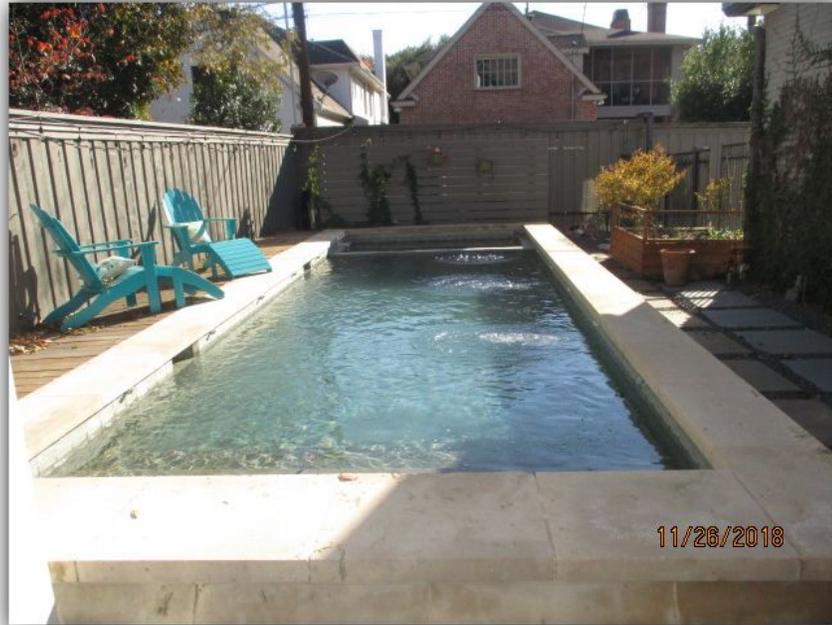
Lighting for pool/spa was operational at time of inspection, and was GFCI protected.

Pool and/or spa appear to have multi-drain system in place. This safety feature is designed to prevent possible injury or drowning. Determination that this device is adequate for water flow/suction of pool/spa equipment is beyond the scope of this inspection.

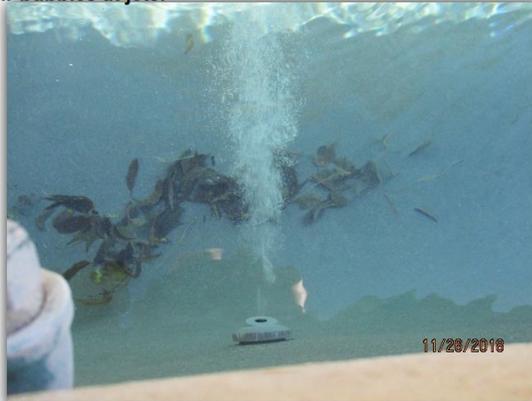
- Recommend that the pool/spa and equipment be inspected and evaluated by a licensed and qualified pool company to determine extent of needed repairs.
- The pool pump/circulation system has large amount of air bubbles present at pool jets with system operating. This indicates some type of leakage on the suction side of the system.

Air bubbles at jets.

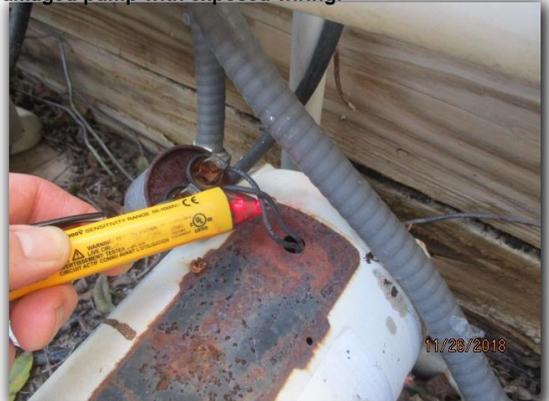
- The pump(s) have damaged wiring connections with live exposed wiring.
- The pool equipment has damaged "pool level equipment" panel. Unit is damaged.
- The pool skimmer inlet does not appear to have the proper weir door installed. This device is designed to prevent debris from re-entering the pool from the skimmer area.

Damaged pump with exposed wiring.

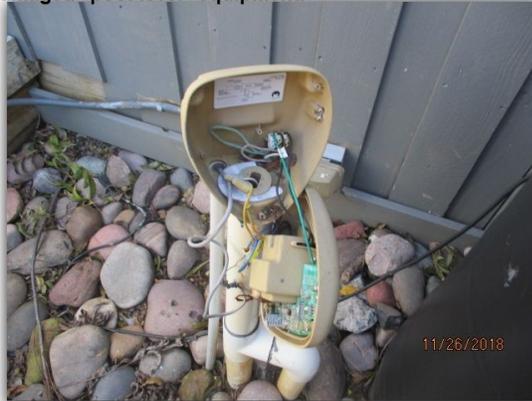
Damaged "pool level" equipment.

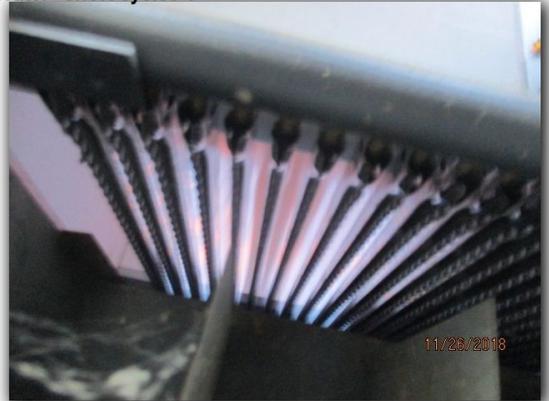
- The pool heater was "short cycling" during inspection. Unit would light and run for short period of time and then shut off. Unit would repeat this process until turned off.

Heater "short cycles".
