HOME INSPECTION REPORT - HOUSE INSPECTION SERVICES COPY

111 Sample Report Way
Dallas TX 75000

PROPERTY INSPECTION REPORT

09/02/2021 8:00 am

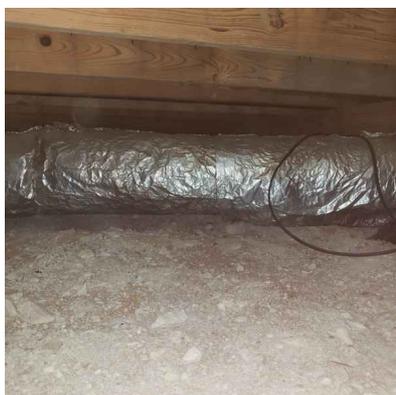
1: Foundation Movement - Minor

The foundation appears to be providing adequate support to the structure at the time of the inspection, however, has signs of minor movement and/or settling. Movement appears to be minimal, and does not appear to be excessive at time of inspection. These may be due to accumulated affect of normal seasonal movement. Evidence of this movement includes: Foundation movement. Specific evidence for this inspected property will be itemized in each specific category (ex.- walls, doors). Recommend monitoring these areas over time to ensure no future movement is occurring.

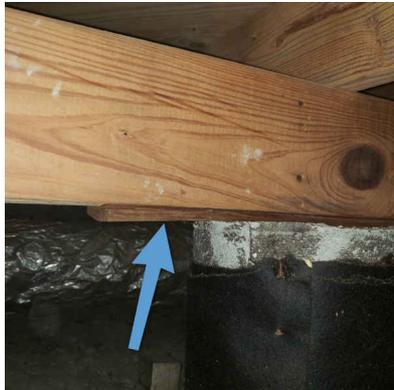
Observed wood shims in use at foundation piers. These have been known to deteriorate over time. Current common practice is to use metal shims.

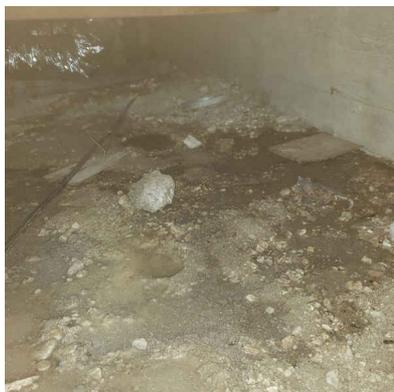
3: Crawlspace - Perimeter standing water

The crawlspace perimeter has excessive moisture conditions, with standing/ponding water. This may be due to improper drainage at exterior.

Right beam wall during rains.

Recommendation: Contact a qualified professional.

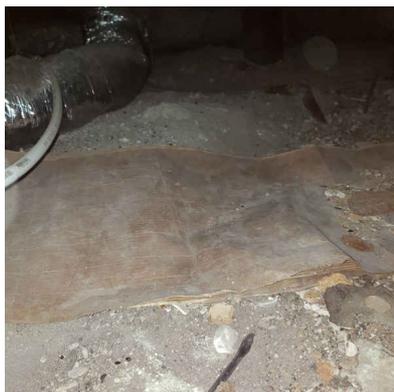
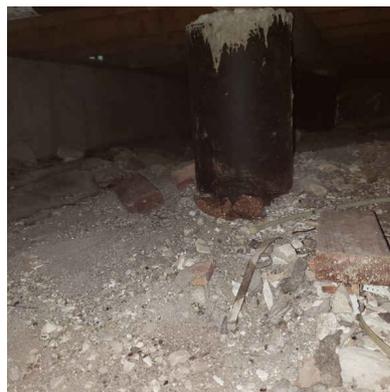
4: Crawlspace - Debris

Observed areas of debris in the crawlspace. Wood debris is conducive to WDI infestation. Other debris may be a hindrance to crawlspace inspection, or future repair or work.

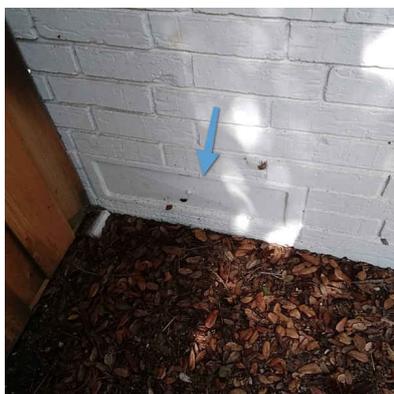
5: Vent Screens Closed/Obstructed

Covered and/or obstructed crawlspace vents should be opened for proper ventilation of crawlspace. It is recommended for vents to remain open (weather permitting- i.e. freezing temps) for ongoing ventilation.

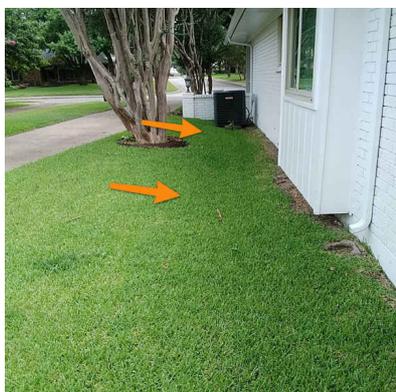
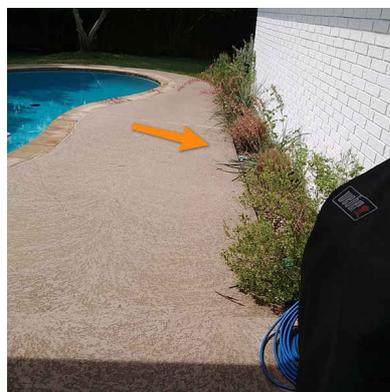
Observed negative drainage slope (moves water toward structure) at foundation area(s). This may cause water to drain toward property, causing excessive moisture conditions in soil. Excessive moisture around

foundation may affect foundation performance or cause high soil lines. In severe conditions, negative slope and high soil lines combined may allow for water intrusion into the property. **Evaluation by drainage professional may be necessary for correction of these conditions.**

Right Exterior

Back Garage

Recommendation: Contact a qualified professional.

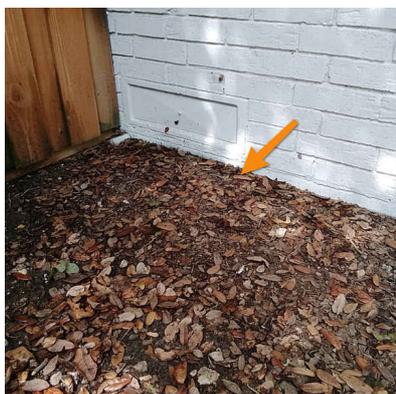
2: Drainage - High soil line/Improper grade beam

The foundation soil line has improper grade level, and is too high at some locations of property. Current standards call for at least 6+ inches of foundation slab or beam wall exposed below bottom of exterior wall (brick, stone, etc.). High soil lines may cause moisture retention in exterior walls, and are conducive for possible WDI infestation if they are up to, or covering, exterior cladding (brick, siding, weep holes, etc). **Evaluation by drainage professional may be necessary for correction of these conditions.**

Left Exterior

Recommendation: Contact a qualified professional.

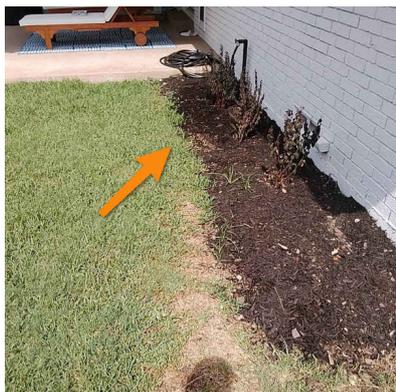
The exterior has low spot area(s) that may pond water and not properly drain. This area(s) may need landscaping maintenance to allow for proper drainage of water. **Evaluation by drainage professional may be necessary for correction of these conditions.**

Back Exterior

Recommendation: Contact a qualified professional.

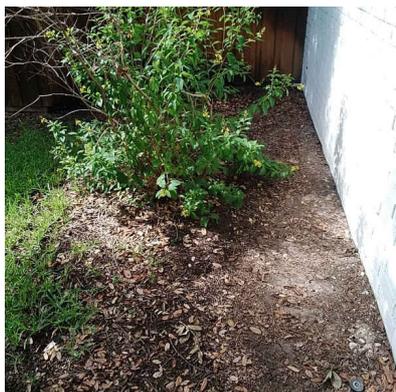
4: Drainage - Flat yard/planter bed locations

Drainage slope at yard areas and/or planter/flower beds around property are essentially flat/not well defined at some areas. This may allow for water to pond/pool near foundation. Recommend monitoring over time to ensure water is not pooling at or near foundation.

Left Exterior

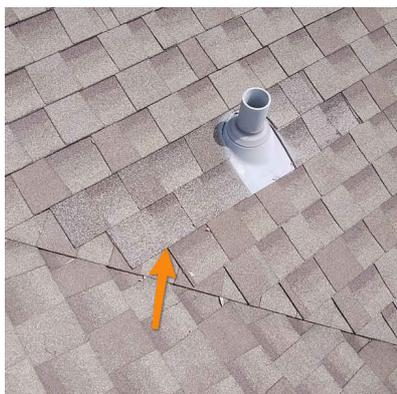
The roof has evidence of previous patching/shingle replacement. Recommend consulting with seller regarding reason and scope of work completed.

Back roof area

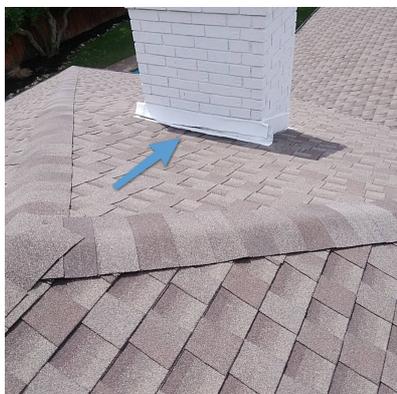
No cricket (saddle) in place on chimney wider than 30 inches (small drainage roof now commonly installed behind chimney to move water around chimney). This may be by original design of property.

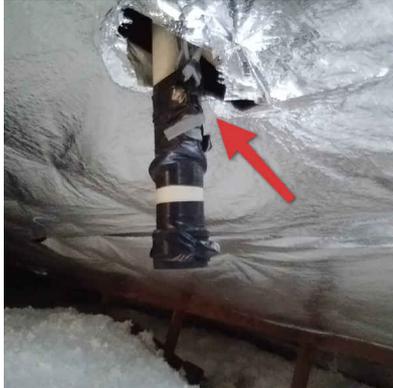
Observed disconnected vent stack in attic which still exists roof surface. Vent stack has makeshift rubber cap to prevent water from entering attic space.

Disconnected vent stack in attic

Recommendation: Contact a qualified professional.

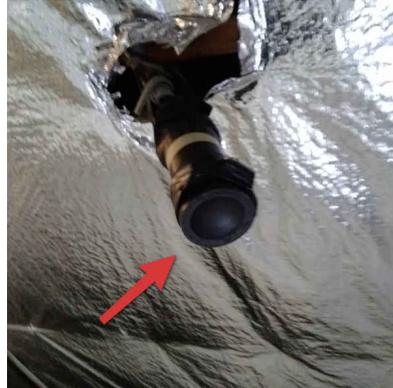
Makeshift rubber cap to prevent water entry

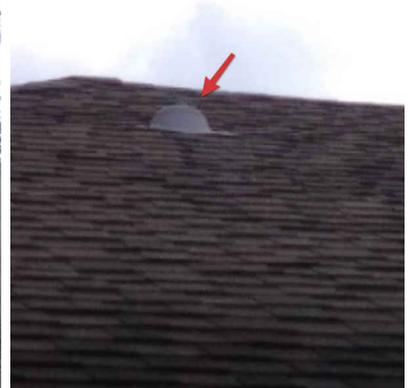
Vent stack appears to be at right side roof.

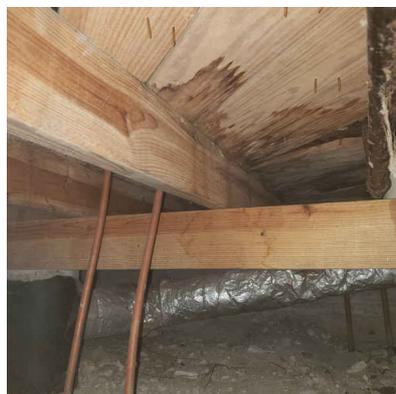
Observed water stained sub-floor in crawlspace. Staining appears to be "old", "faded", and did not appear "wet" at time of inspection. Recommend consulting with owner/seller of property regarding history of structure.

Half Bath

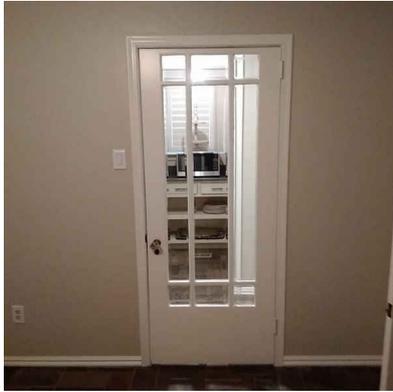
Door out of square, not latching

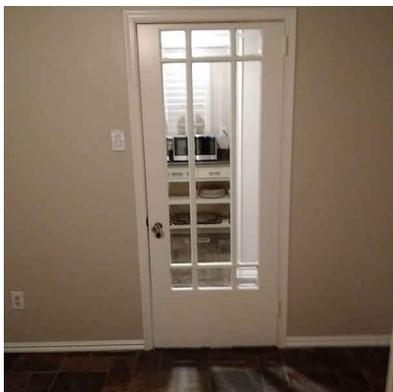
No evidence of safety (tempered) glass in door glass locations. This is considered a hazardous location. See TEXAS REAL ESTATE CONSUMER NOTICE CONCERNING HAZARDS OR DEFICIENCIES listed in preamble of report.

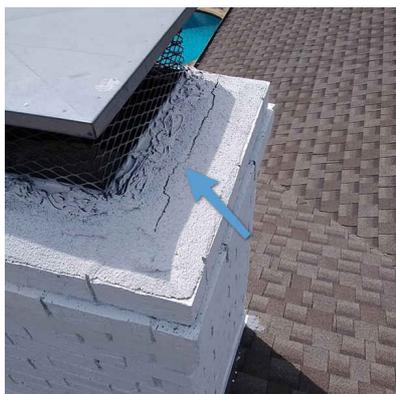
The chimney mortar crown is deteriorating, and may allow for water penetration into bricks. The chimney mortar should be shaped/constructed to shed water off the top of the chimney.

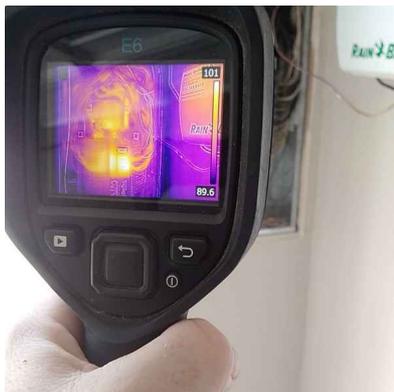
The electrical panel(s) at property did not appear to have any unusual "thermal anomalies" when inspected with infrared camera at time of inspection. No unusual heat anomalies seen at breakers or wiring connections. Normal and routine "thermal load" at wiring may be visible during infrared inspection, however, this did not appear unusual with available property systems being active at time of infrared inspection. "Nominal load warming" is common in panels due to electrical current being active. In addition, any Arc-Fault/GFCI type breakers present in panel will show additional heat due to electronics installed in these devices.

Nominal load warming

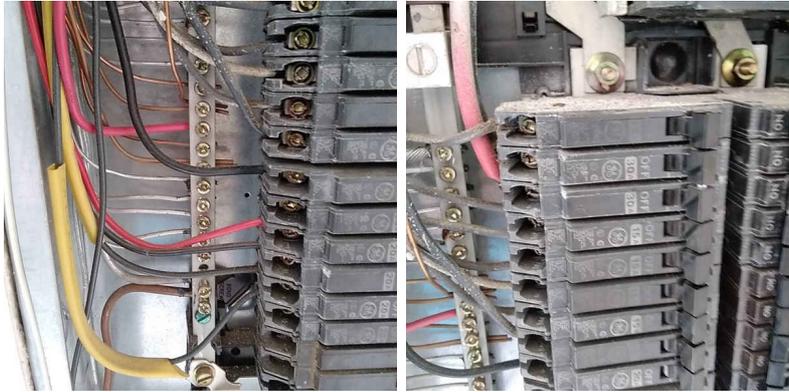
The property appears to have original aluminum wiring at some breaker connections. **Recommend having electrical system evaluated by licensed and qualified electrician due to aluminum wiring having a reputation for being problematic.** Current standards call for conductor material to be copper. This aluminum wiring installation may be by original design of the property.

Note- panel appears to have proper cu/al breakers

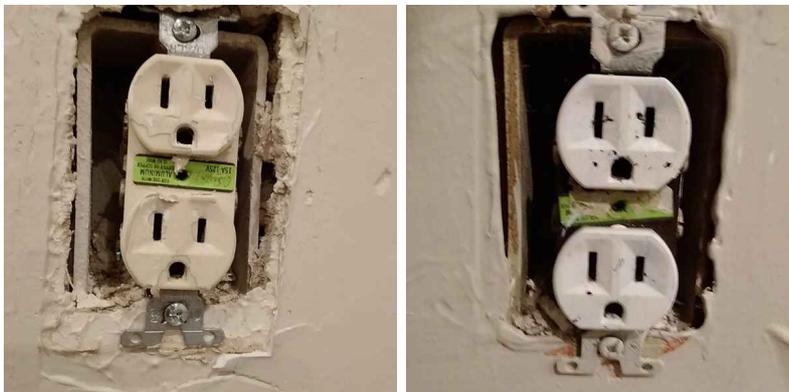
Random sampling of outlets showed some correct receptacles for aluminum wiring

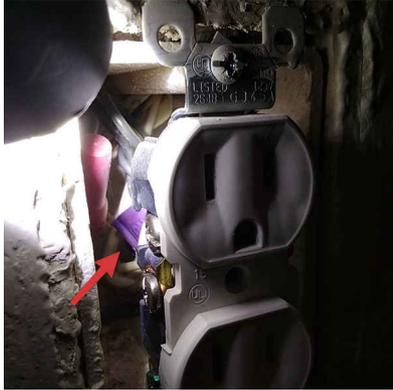
Purple wire nuts observed.

Recommendation: Contact a qualified professional.

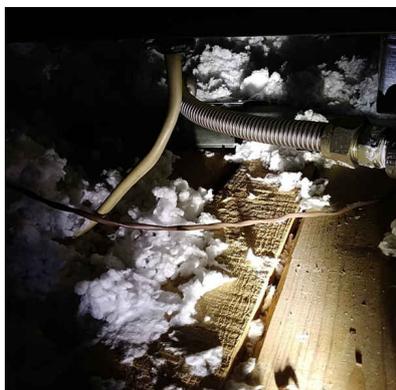
The gas shut off valve present at furnace(s) is not readily accessible, and is not located in a position that can be easily reached. Current standards call for gas shut off valve to be at accessible location within 6' of unit.

Gas shut off at back side of unit, not accessible

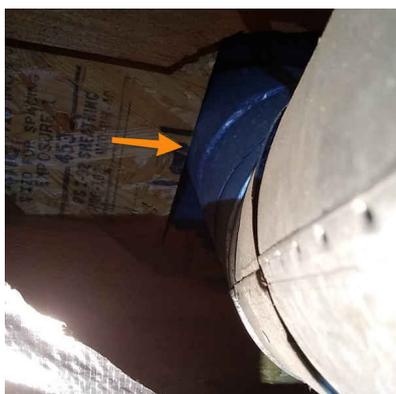
The heater(s) exhaust flue does not have the proper clearances from materials at property. A minimum 1" clearance from material is current standard at ceiling, wall, and roof penetrations.

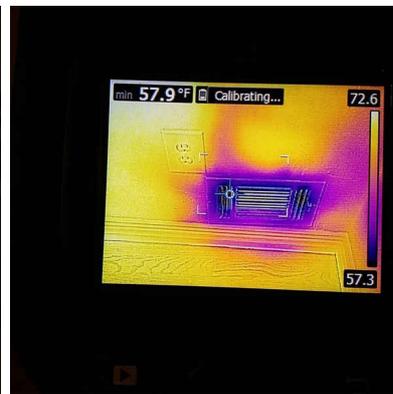
Supply

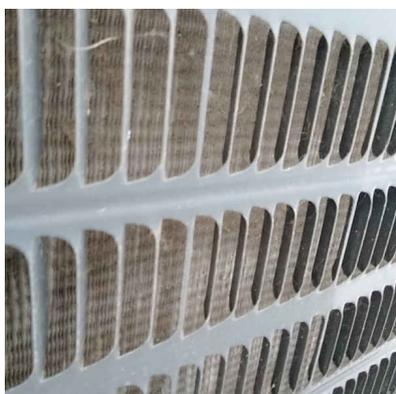
The condensing unit fins have dirt/debris. Condenser unit(s) should be cleaned periodically for proper performance.

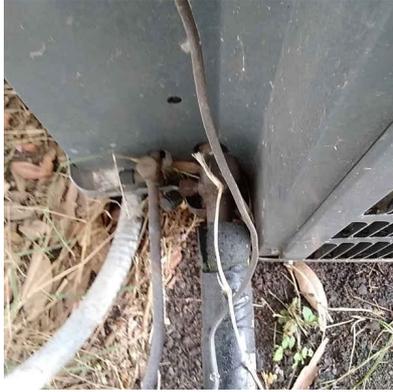
Did not observed locking freon caps in place at condenser freon lines as would now commonly be installed since 2009 per IRC M1411.6. These are recommended to be installed. Residential and multi-family properties may be subject to fines if absent. Only a licensed HVAC company may install or remove these caps.

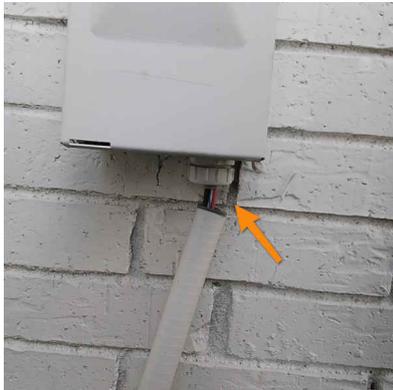
Observed loose conduit/exposed wiring at condenser unit(s).

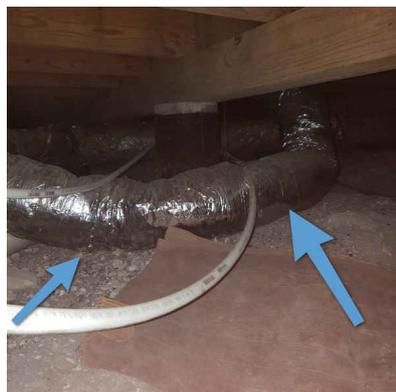
Ductwork in the crawlspace is laying on the ground at various locations. This can lead to deterioration of the duct work, and possibility of crawlspace air being drawn into residence. Common current installation practices would support ductwork at 4' intervals, to suspend duct material 4+" off ground.

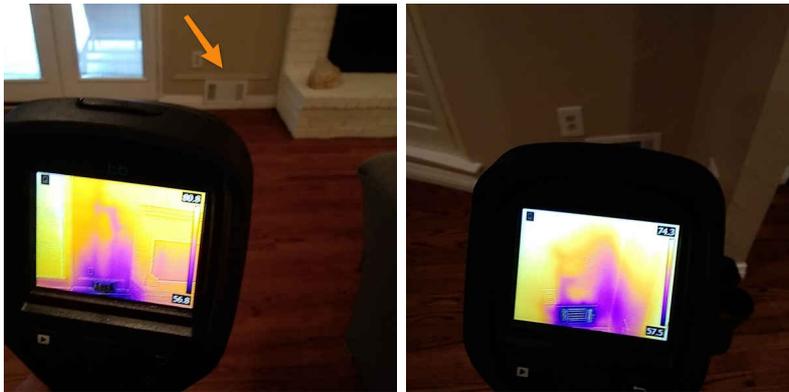
5: Infrared - Ducts - Air leakage behind wall.

Infrared inspection of property showed evidence of duct work leakage. Unusual "wash" of temperature present at location indicates possible leakage. This is commonly a result of ducts not being fully/properly sealed at register.

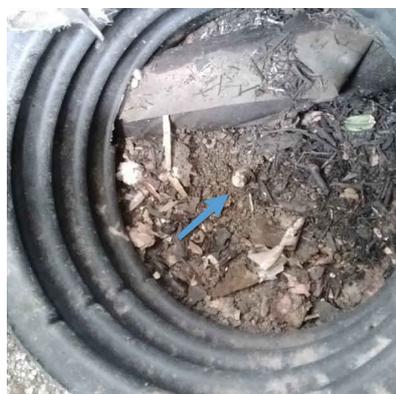
The main water supply shut off valve location appears to be buried or damaged, and shut off valve is not readily accessible. Recommend digging out to expose shut off valve.

Front left planter bed

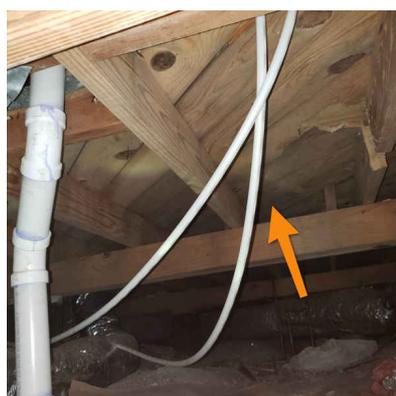
Observed pex water lines at property in attic or crawlspace areas without proper insulation. This may allow for freezing of water lines in winter conditions.

Crawlspace

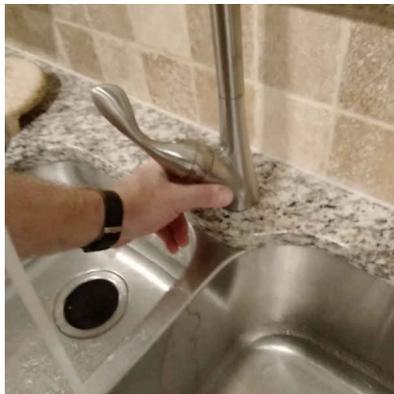
The sink faucet is loose and needs to be secured.

Kitchen

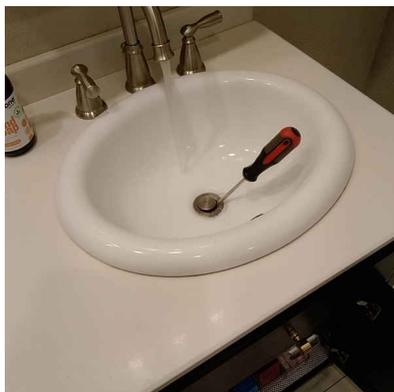
The stopper is missing or not functional at the sink. Stopper may not be properly attached, stay in the closed position, or may not be holding water when closed.

Master Bathroom

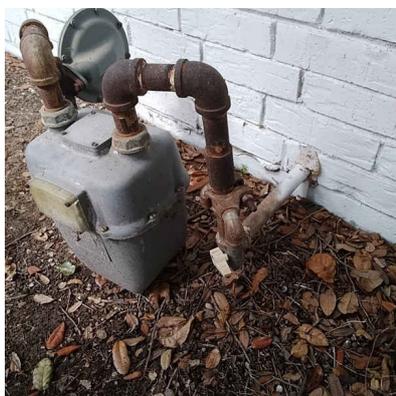
The gas riser/entry pipe at the structure is rusted, and may need some protective paint.

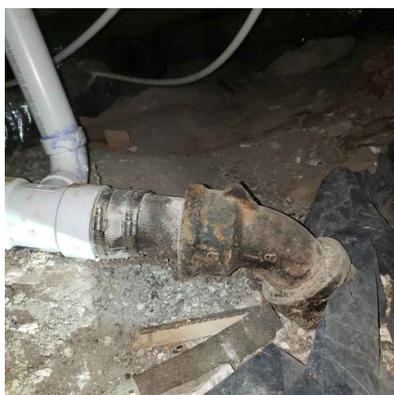
NOTE - Observed some older type cast iron plumbing in place at the property. Cast iron plumbing has the potential to crack or separate, and leakage may not be visible. Due to age and nature of this material, it is advisable to have a drain line system inspection completed by a licensed and qualified plumbing company. Please note, hydrostatic testing requires seller approval per current TREC, one to four family property contract guidelines. Recommend regular observations of the visible plumbing for potential deterioration.

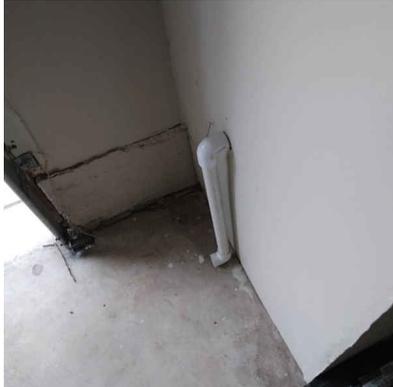
*The safety pan drain is terminated improperly at exterior of property. Current requirements call for safety pan drain line to go to the exterior, and terminate between 6 and 24 inches above grade.

Pan drains to garage

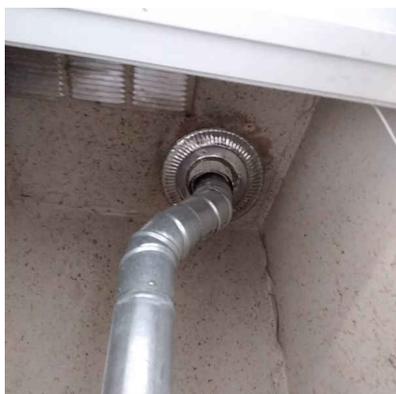
4: Exhaust Fire collar loose/missing.

The water heater(s) exhaust vent fire-stop collar is missing at the ceiling penetration, or is not properly installed in place.

Not flush to ceiling

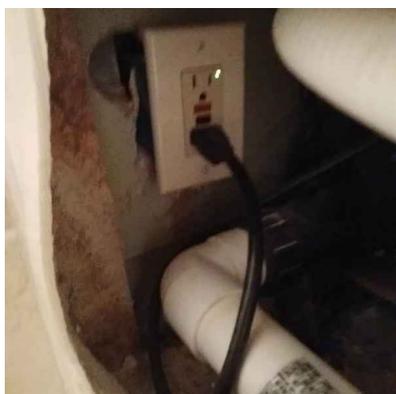
GFCI under tub.

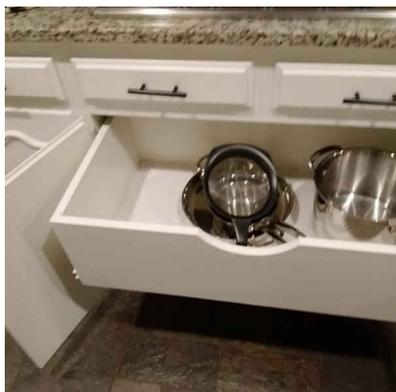
1: Cooking Gas system - Gas shut-off inaccessible.

The gas shut off valve for the cooking equipment is not readily accessible (i.e. - behind range, hidden under cabinet, etc). This appears to be by original design of the property.

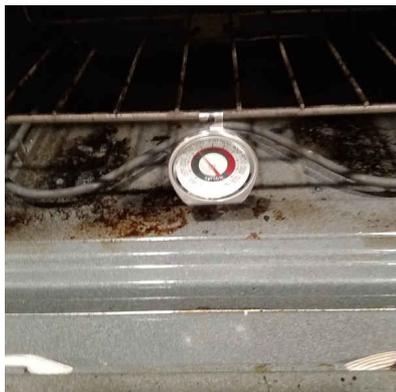
Unit may need calibration by qualified technician.

Upper oven

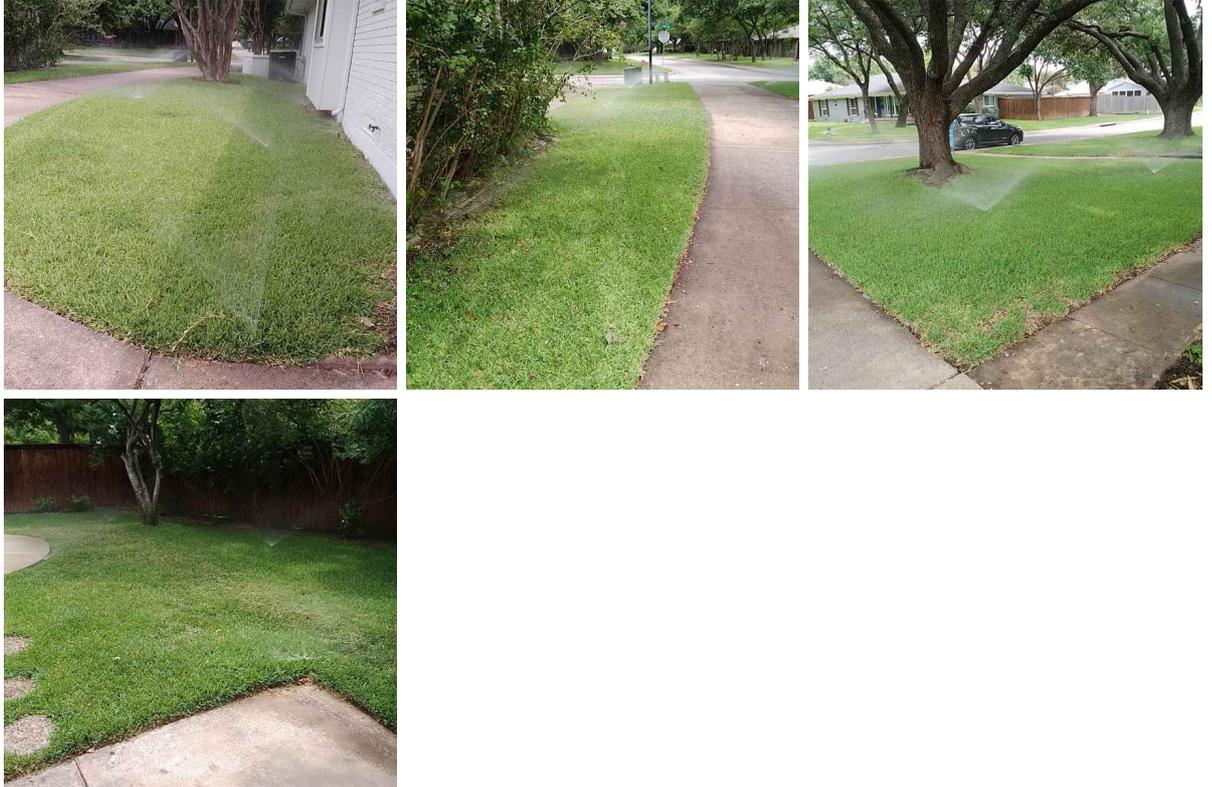
Stations responded to manual control and all visible watering areas of the lawn/landscape appear to be getting adequate coverage at time of inspection.

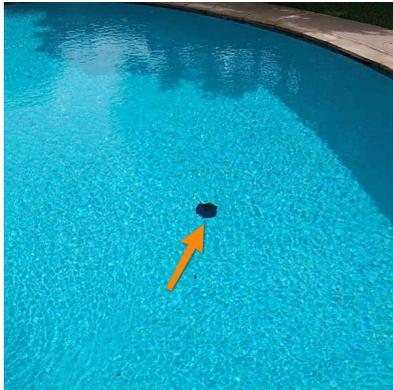
NOTE - Unable to determine or confirm that this device is adequate for water flow/suction of pool/spa equipment, and wether or not device is cracked or damaged. In addition, a large recall of such devices by the Consumer Product Safety Commission was issued in May 2011 (Release #11-230). This recall affects products sold/installed between December 2008 and April 2011. If this drain cover was purchased/installed between these date ranges, it is highly recommended to contact the manufacturer directly for resolution. A list of manufactures and contact information can be found on the CPSC website (www.cpsc.gov). Inspection and/or confirmation of device manufacturer, model #, or date of

Recommendation: Contact a qualified professional.

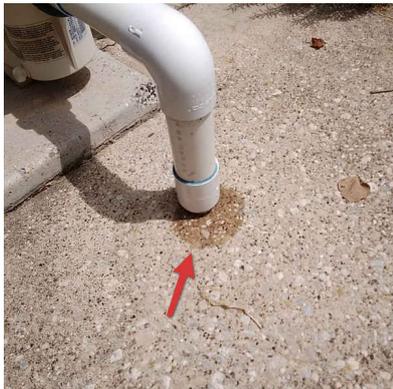
3: Pool/spa - Pumps - Leaks.

▲Significant Deficient Item

Leakage was observed at pump motor(s), water distribution piping, or filter cannister at time of inspection. **Recommend evaluation by qualified pool service company.**

Evidence of leakage at equipment

Recommendation: Contact a qualified professional.

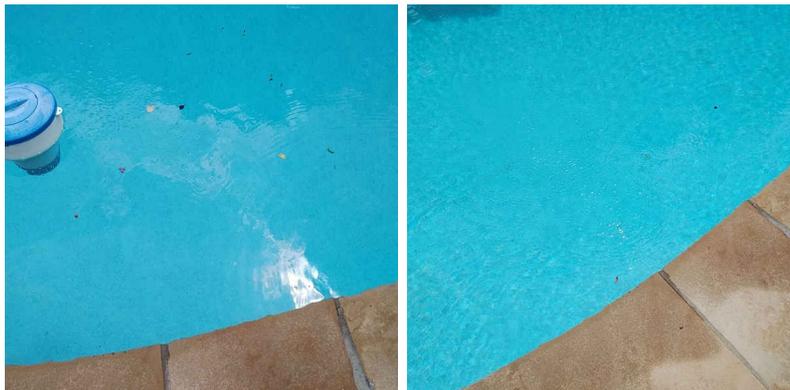
Air bubbles seen at Jets

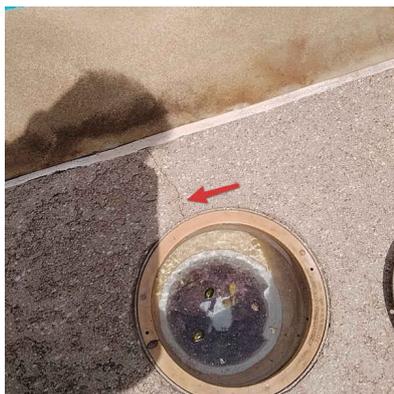
5: Pool/spa - Deck - Raised/cracking at skimmer.

▲Significant Deficient Item

The decking area at skimmer(s) has evidence of lifting and/or cracking. This is indicative of possible leakage at skimmer area.

Recommendation: Contact a qualified professional.

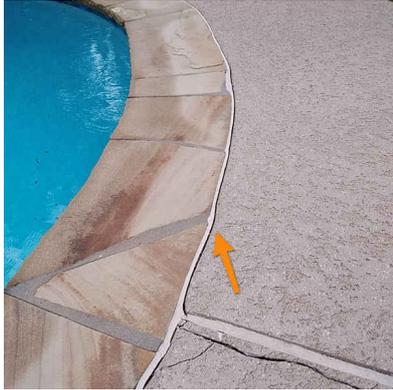
6: Pool/spa - Deck - Coping/deck sealant needed.

●Moderate Deficient Item

The flexible sealant between the coping stone and pool deck area has some minor separation/deterioration. Recommend this joint to be sealed/repared to prevent water penetration.

Recommendation: Contact a qualified professional.

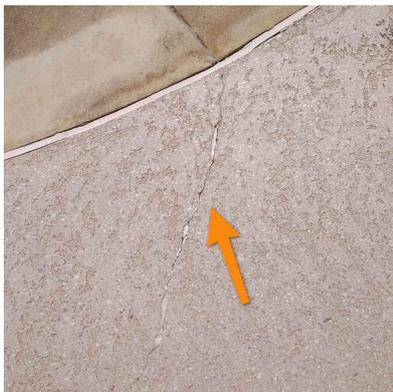
7: Pool/spa - Deck - Minor separation, cracking.

⊖ Moderate Deficient Item

The pool decking is cracking and/or shifting away from the edge of the pool coping. This is an indicator of soil movement and shifting. Separations at coping and decking edges may allow for weather/water intrusion at pool exterior. Water has been known to cause further expansion/movement of soils around pool areas. Recommend repair/sealing of separation(s) and monitoring of pool deck area over time for evidence of further movement.

Recommendation: Contact a qualified professional.

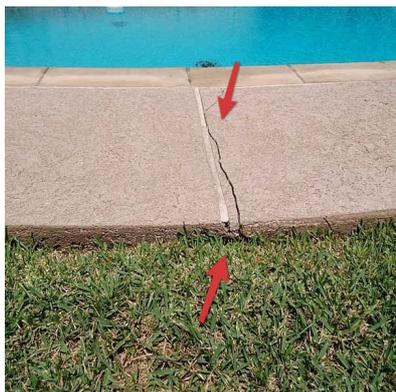
8: Pool/spa - Deck - Major separation/cracking.

▲ Significant Deficient Item

Observed evidence of significant cracking/shifting/movement of pool decking area. Decking area(s) around pool have noticeable signs of lateral and/or vertical elevation changes. This is an indicator of excessive soil movement and or shifting around or under pool and deck areas.

Recommendation: Contact a qualified professional.

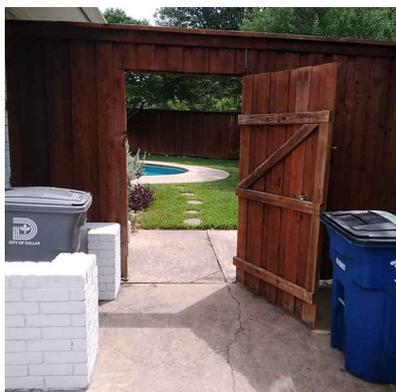
Date not self closing

Recommendation: Contact a qualified professional.

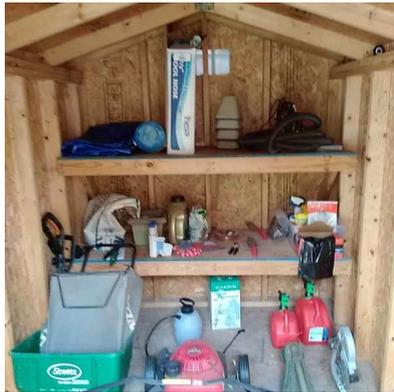
Storage Shed - Reasonable condition.:

Outbuilding/Storage shed at property appeared to be in reasonable condition, with no unusual wear & tear or damage.
