BELZONA: FORGING SOLUTIONS FOR THE STEEL INDUSTRY

The following examples are successful applications in the steel industry that resolve some of the common problems that a steel mill might confront.

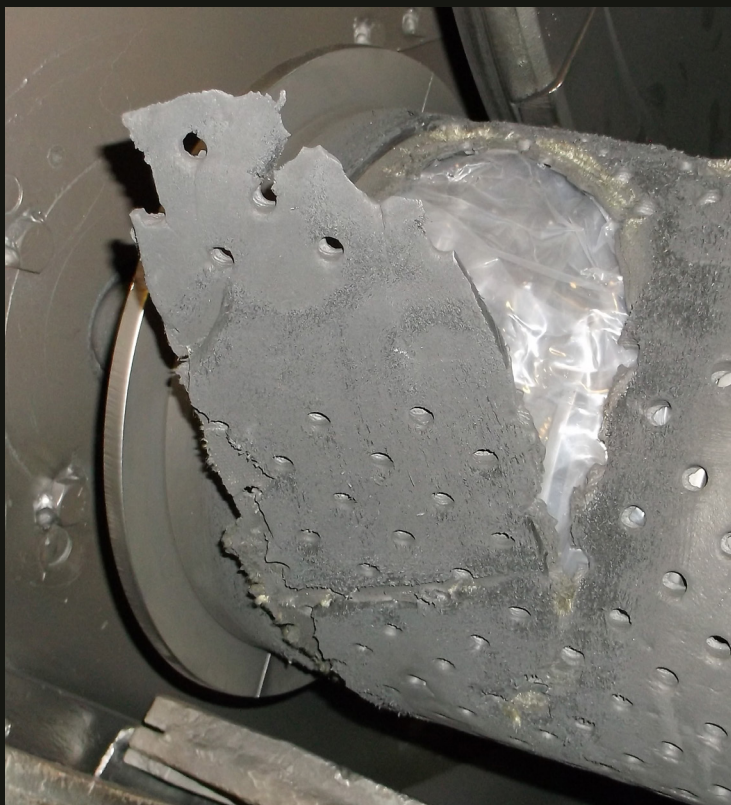
Damaged belt

At a metal foundry in Spokane, Washington, a piece of equipment got damaged: a metal part caught the rubber belt tumbler inside the shot blast machine during operation and severely ripped the belt. It was estimated that a replacement belt could cost over \$4,000 and would take three days to replace. The company was in the middle of a major order and could not shut down for that length of time which would have been required to replace the part. To avoid a lengthy downtime, Belzona was chosen and as a result the repair cost a fraction of the replacement cost and only took a day to complete.

The repair began by removing the guard plate to allow for more access to the interior of the machine. The loose material was cut away and the substrate was prepared with a roughening brush. A sheet of plastic was slipped underneath the belt to prevent the belt from attaching to the metal drive rollers and to ensure mobility after the repair. First, Belzona 2911 conditioner was applied to the rubber belt. Then two coats of Belzona 2211 elastomer and Belzona 9341 reinforcement sheet were applied to the seams. Finally, heat lamps were used to maintain an optimum curing temperature.

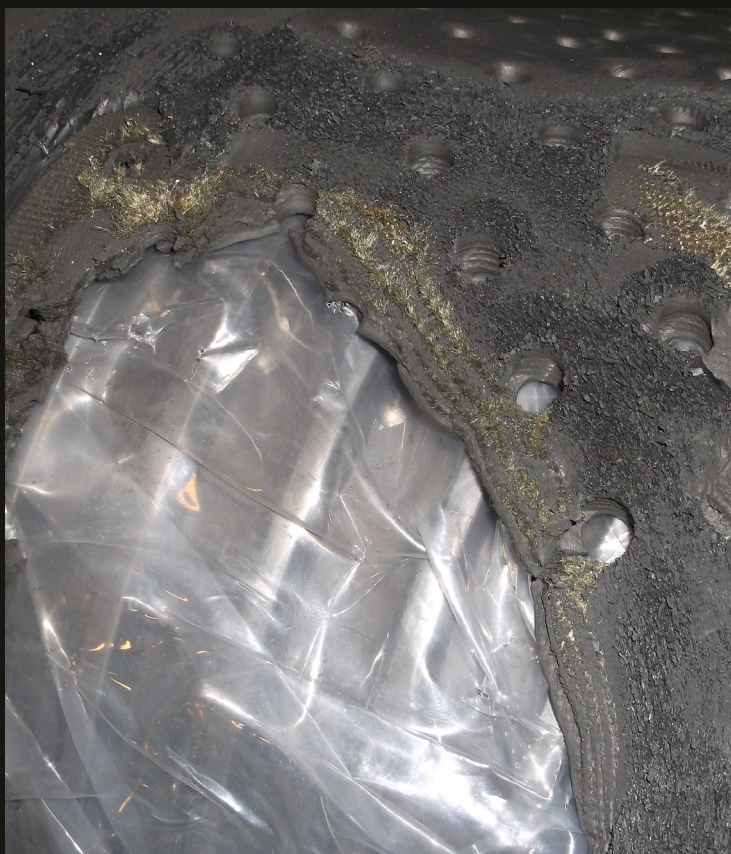
Roughened up area ready for application

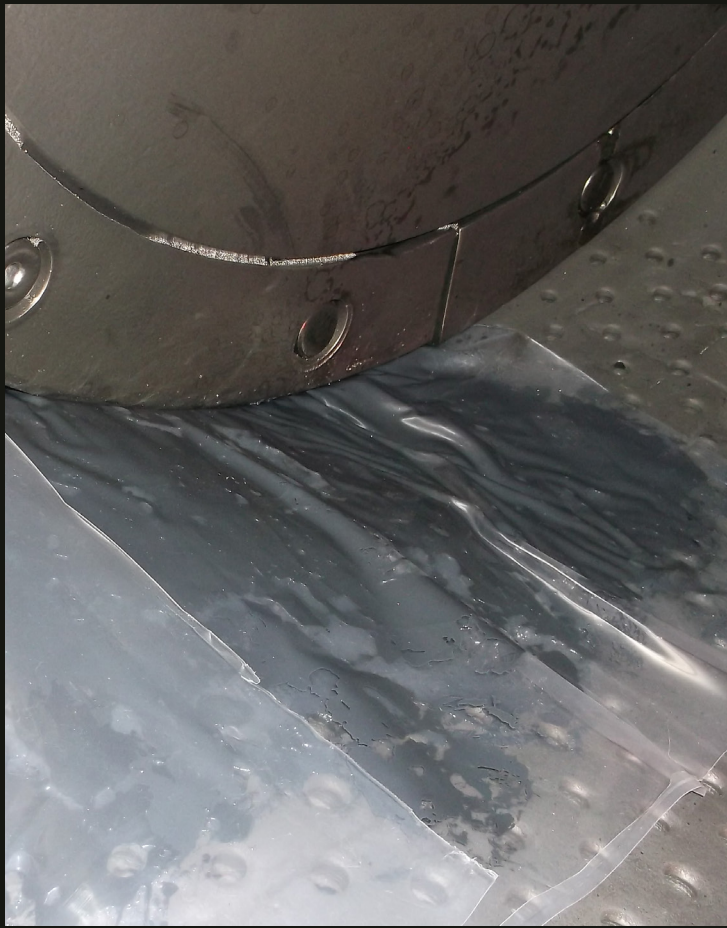
*Application completed and covered
with plastic*

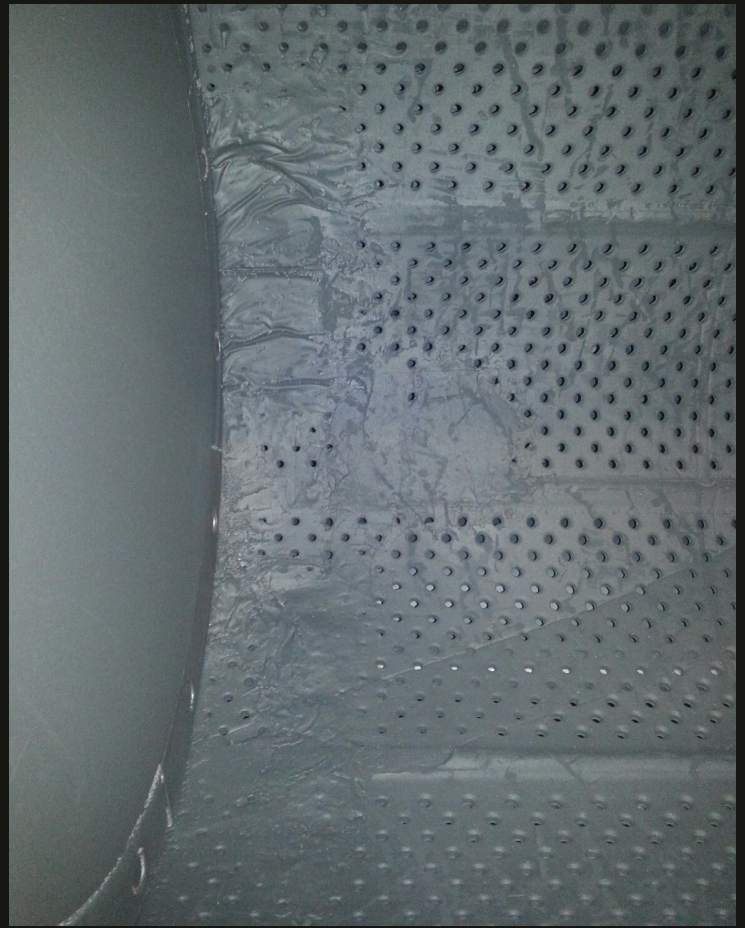
2 weeks later after use

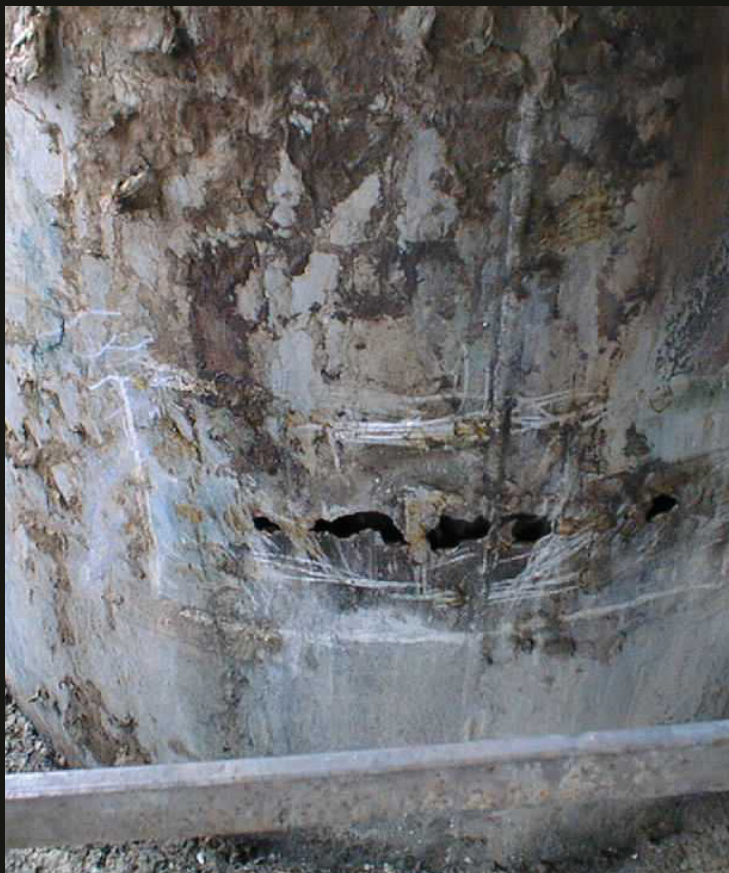
At a steel mill in Germany, storage tanks were experiencing corrosion on their walls and connection points. These tanks stored a corrosive medium, coke gas in water and local steam. The temperatures of the tank ranged from 122°F to 219°F (50°C to 104°C).

The corroded tank

A metal square was cut to a large enough size to cover the corroded area and curved to fit the contours of the tank. Belzona 1111 metal rebuild composite was applied to the surface of the metal square and the corroded substrate. Metal strapping was placed over the application to hold the square against the tank wall as the product cured. The excess material was used as a filler around the plate. After the completion of the cure, the straps were removed.

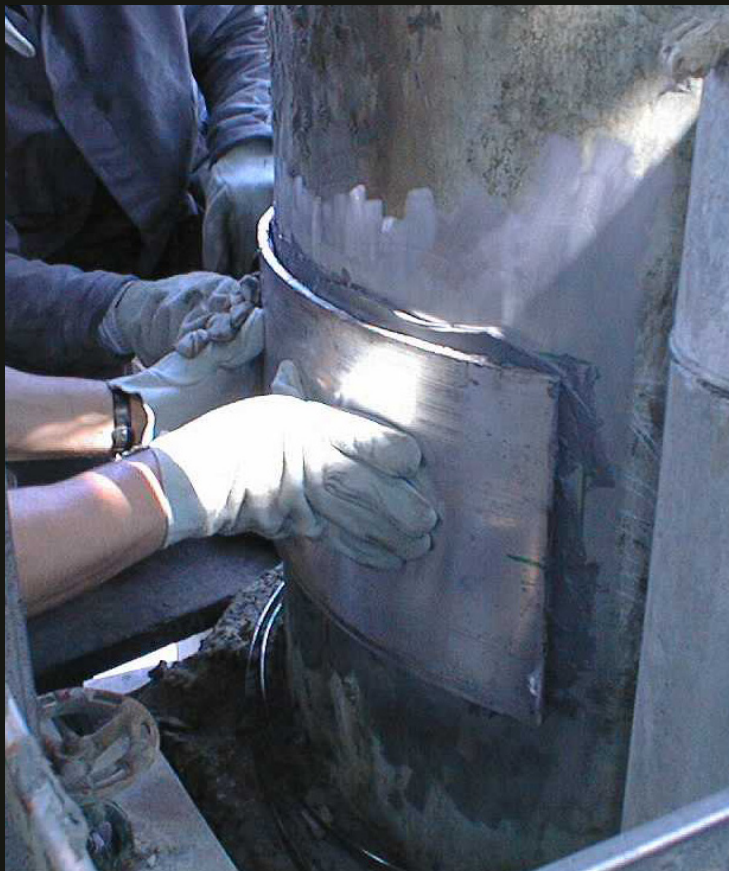
Fitting the plate

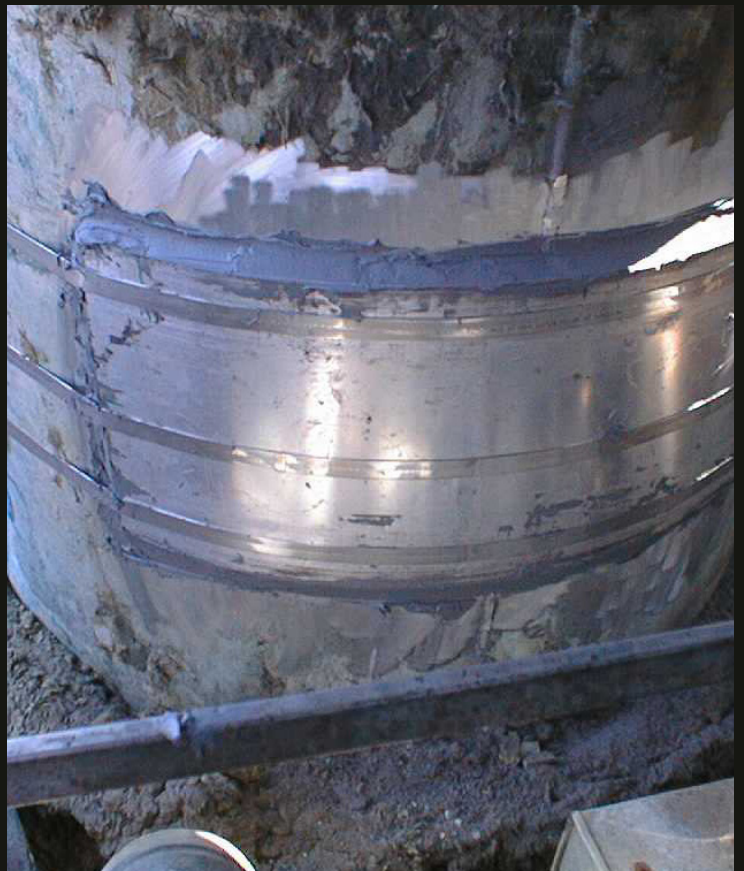
Finished application

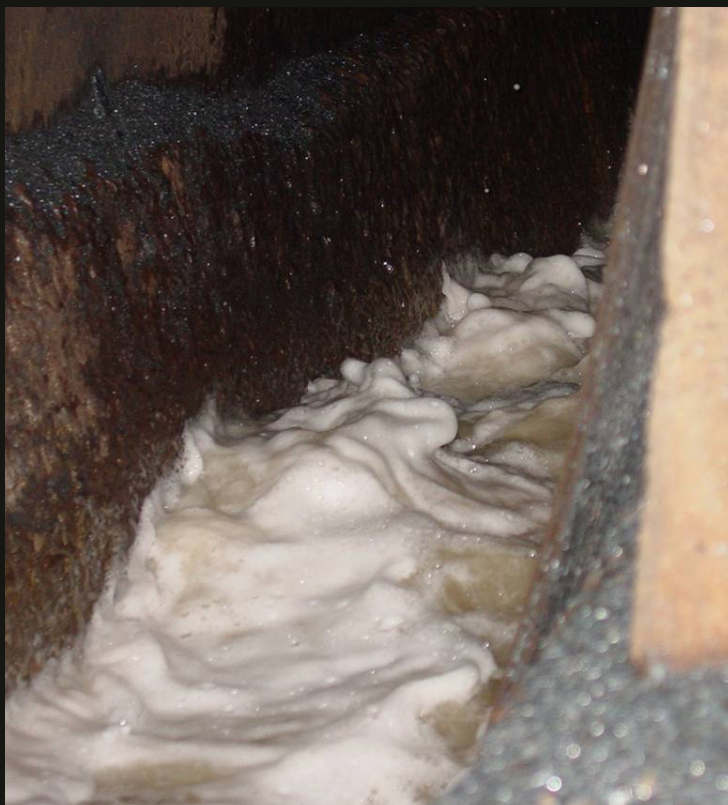
Trough prior to surface preparation

A steel mill was looking for a repair system for their eroded trough or a new trough entirely. They considered Polyurea coatings but decided against it due to their intolerance of damp concrete. They had also considered a new stainless-steel trough. However, Belzona was \$65,000 less expensive and offered the longevity and requirements set by the situation. Their problem was a badly eroded trough that conveyed highly abrasive waste material. It was rapidly deteriorating the asset by carving out a larger cross-sectional area than what was originally designed. The flow velocity dropped signifying the trough was not working as intended. Lastly, waste was building up within the trough.

After deciding to use Belzona to repair the problem, the substrate was abraded to create a good quality profile so the product could adhere better. Then, the surface was cleaned. Belzona 4124 was used to fill in the eroded areas of the trough. Then, the areas were resurfaced with Belzona 4111, which was applied at a thickness of a quarter of an inch. Finally, Belzona 1812 was applied to provide abrasion resistant barrier to the trough.

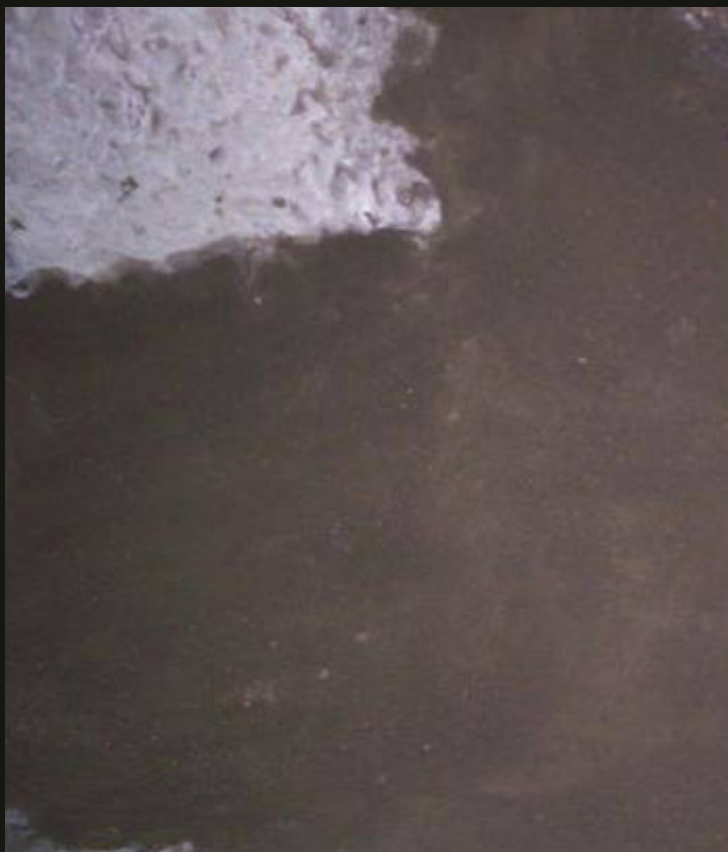
Trough profile reformed with Belzona

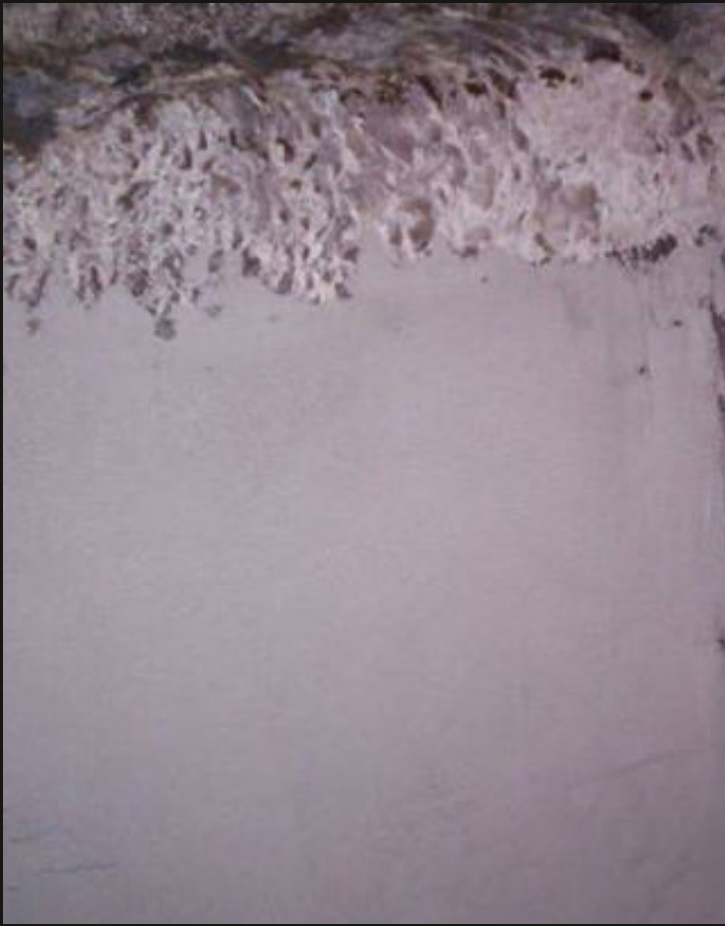
A further quarter inch of Belzona 4111 applied

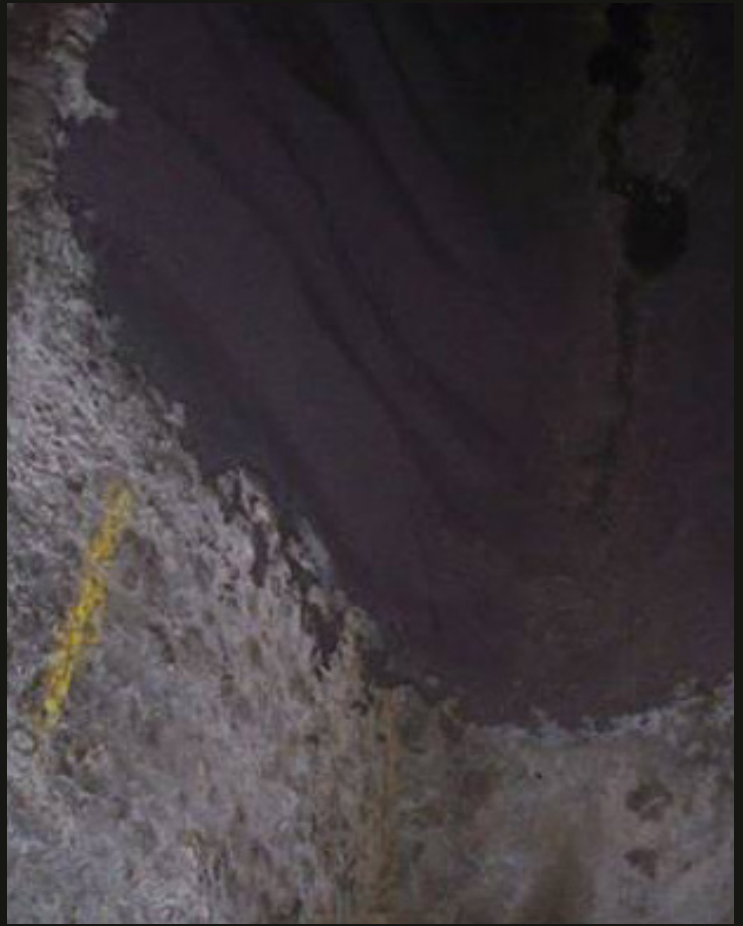
Trough fully coated with Belzona 1812

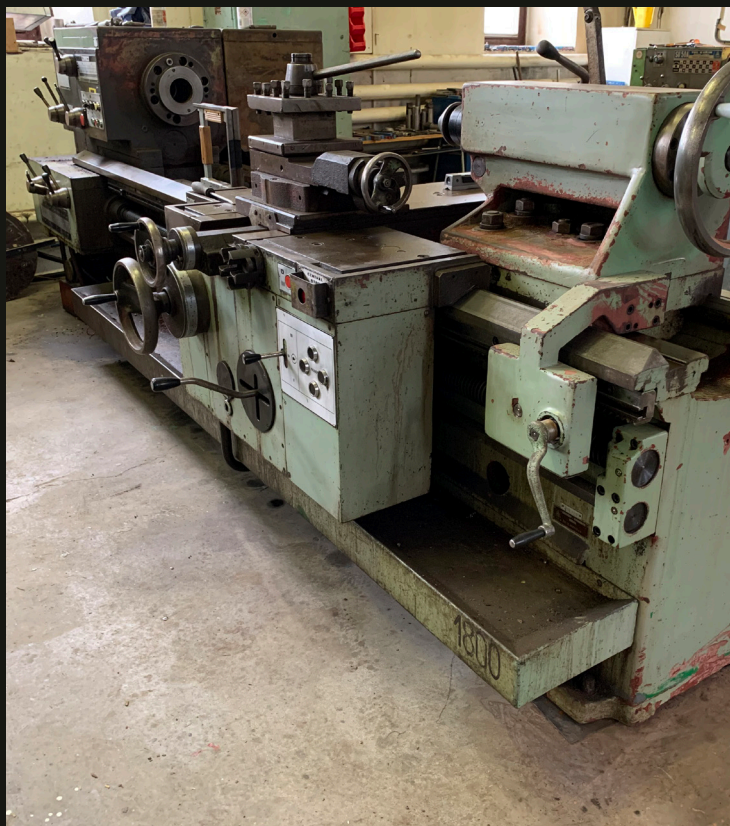
At a facility in Slovakia, a lathe was installed but it required a solid foundation. The situation required a solution that could withstand the compressive load of machinery and reduce vibrations. Normally the lathe would be bolted to the floor, but this does not prevent corrosion or damage to the baseplate due to vibration. After consideration Belzona 7111 was chosen as the appropriate product for the application.

Installed lathe required a solid foundation

To start, the surface was prepared by degreasing it with Belzona 9111. Belzona 9411 (Release Agent) was applied to any surfaces which would be in contact with Belzona 7111 to allow for future removal of the equipment. Then, a wooden dam was built around the perimeter of the lathe about half an inch away from the baseplate. Belzona 7111 was slowly and carefully poured within the dam and allowed to freely flow across

and underneath the machinery. Once the product was cured the dam was removed. This provided the long-term solution the company needed.

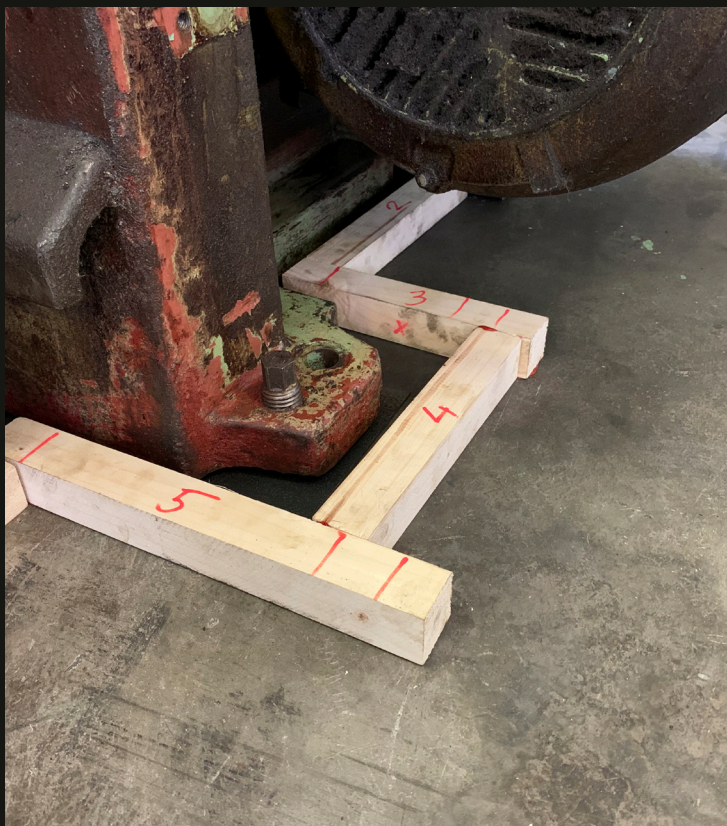
Temporary wood dam prepared

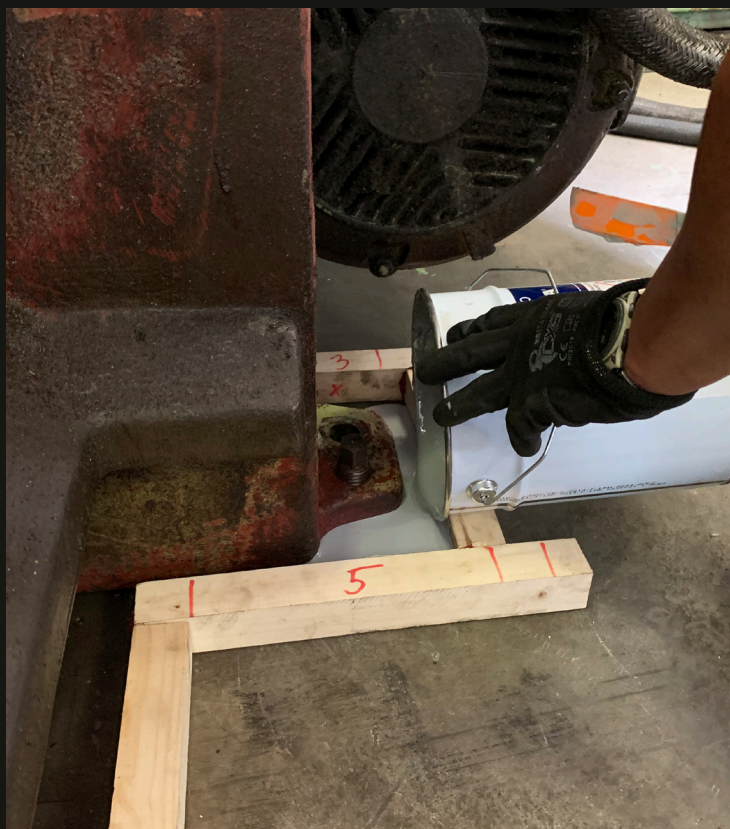
Pouring Belzona 7111

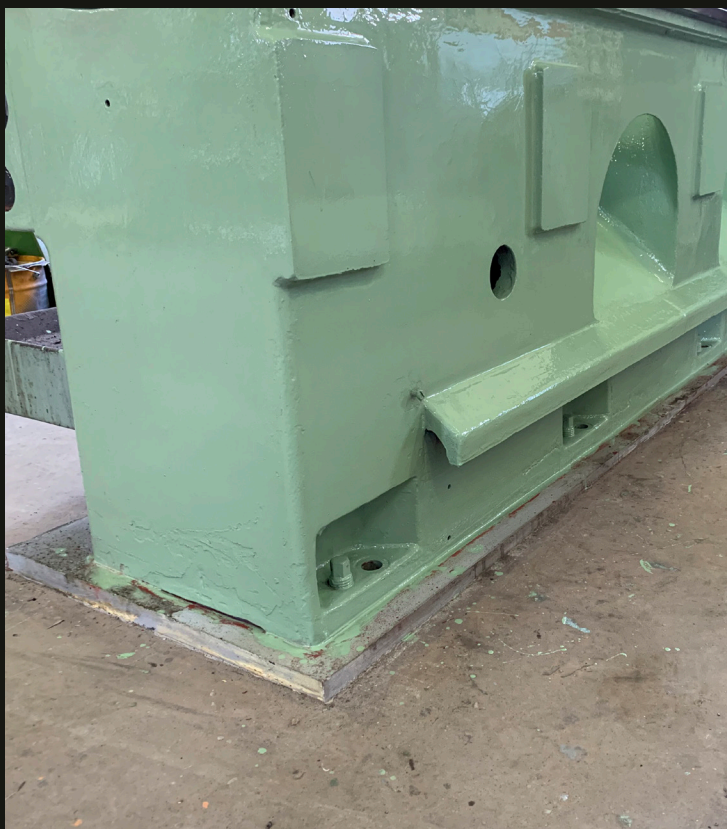
Final Application

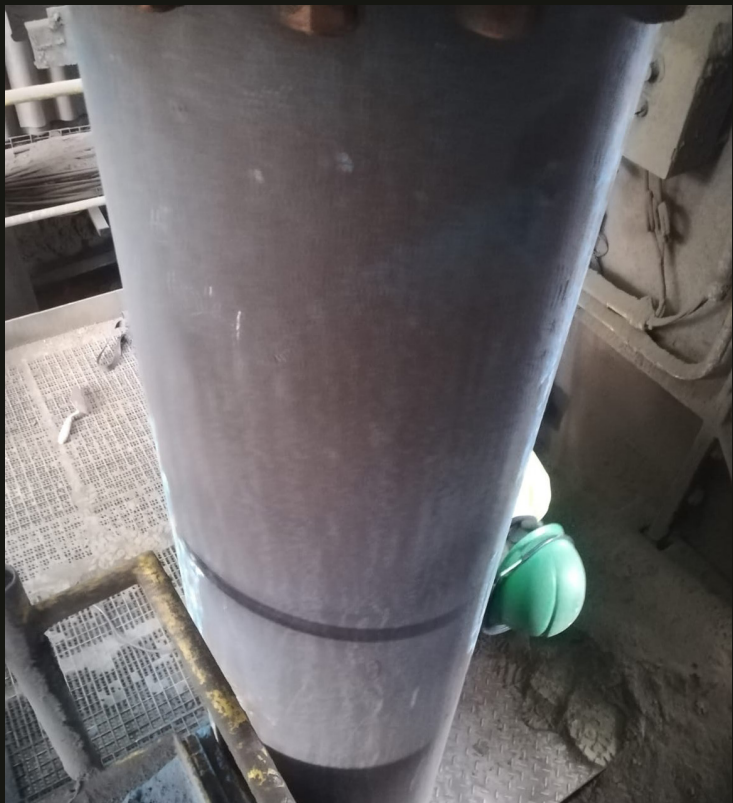
Pipe prior to application

A facility in Spain had a problem with an exposed hot pipeline causing a hazard to the personnel working there. The pipeline was operating in a contaminated area. Due to this, the original insulation material degraded over time causing the temperature of the pipeline to spike to an unfit range of 80°C to 100°C. The surface must be below 60°C to be considered safe. The facility believed Belzona 5871 was a good safety measure for the problem.

Manual preparation tools were used to remove corroded material and create a rough surface on the profile to aid in adhesion. Belzona 5871 was applied at a 1.5mm wet film thickness to achieve a dry film thickness of 4.5mm. Alternative solutions included reinstatement of traditional insulation, which would have taken much longer to install, therefore increasing the downtime. Due to the single-layer application of the Belzona 5871, a sufficient curing time was achieved within a preferable 6-hour downtime window. Most importantly, the temperature of the pipeline was able to be brought down below the required 60°C to under 55°C.

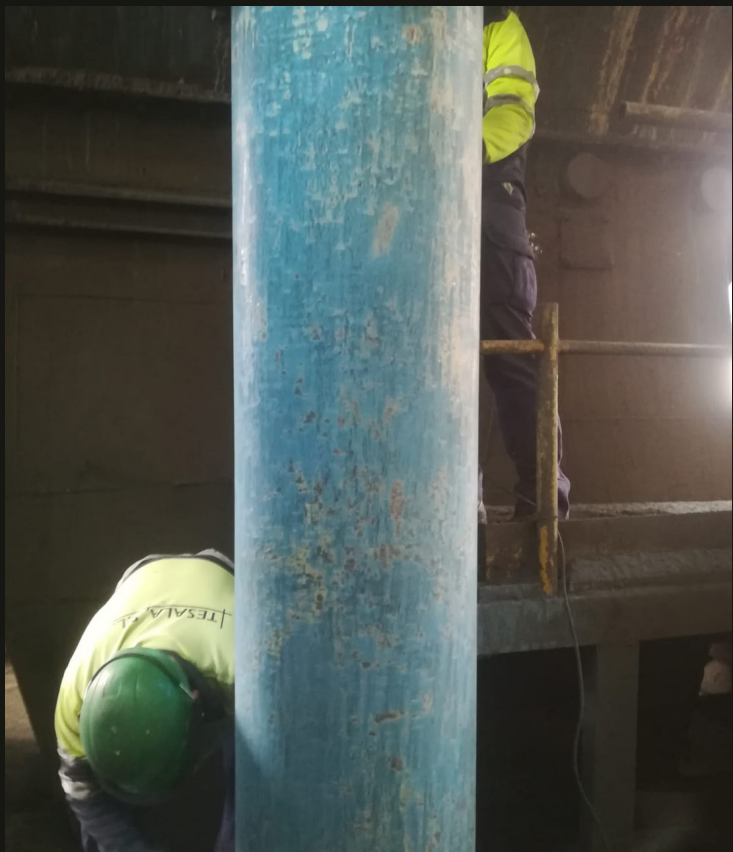
Surface preparation completed

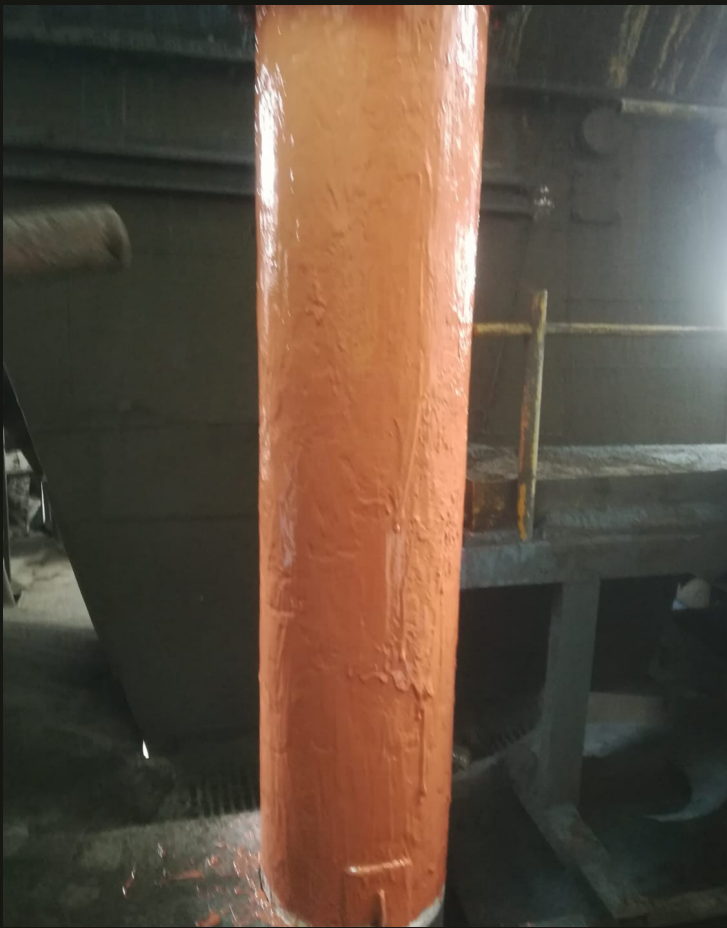
Application completed

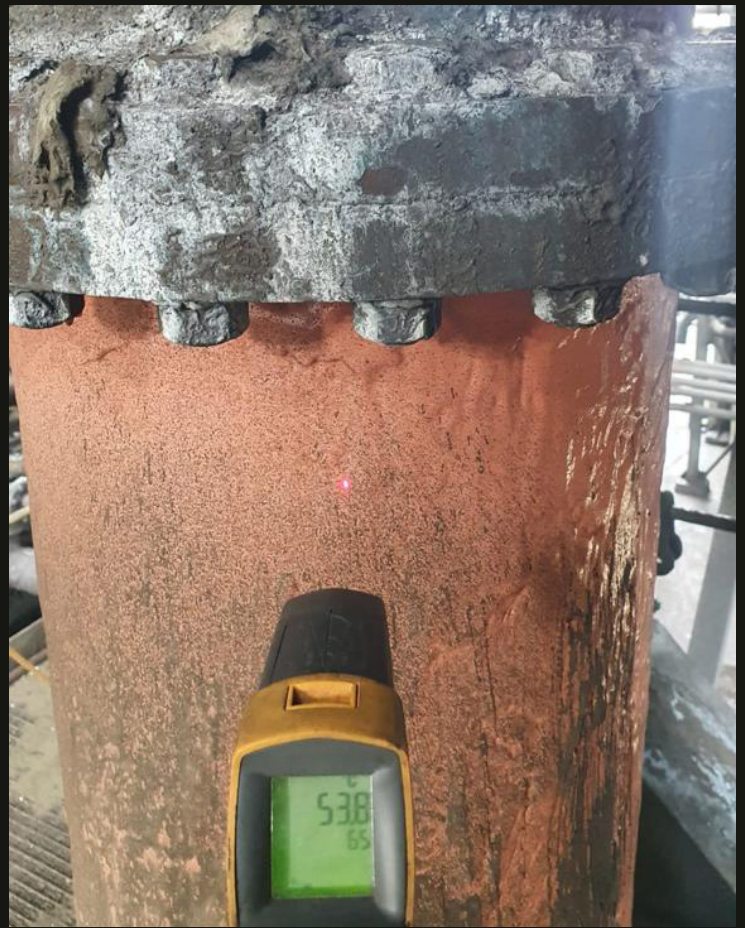
Surface temperature after curing

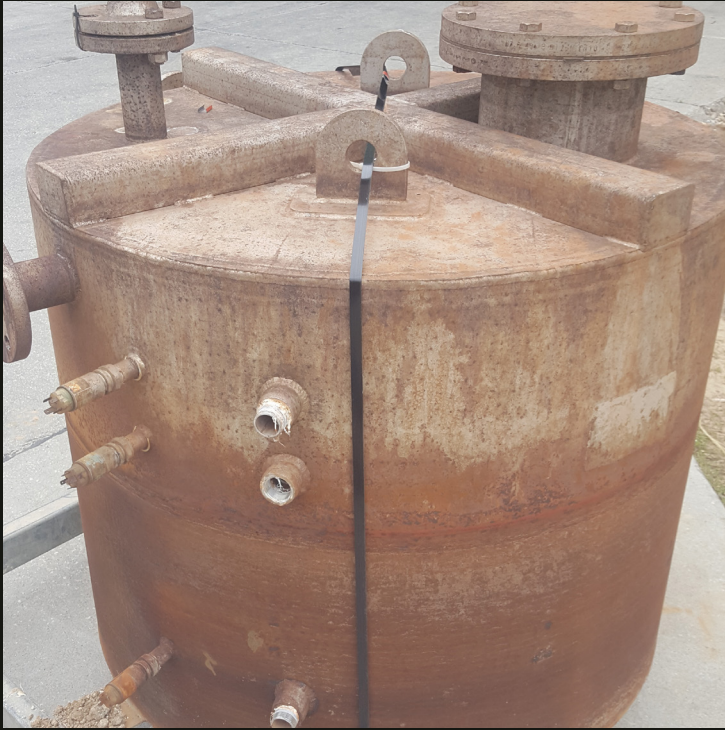
Before: A corroded condensate tank

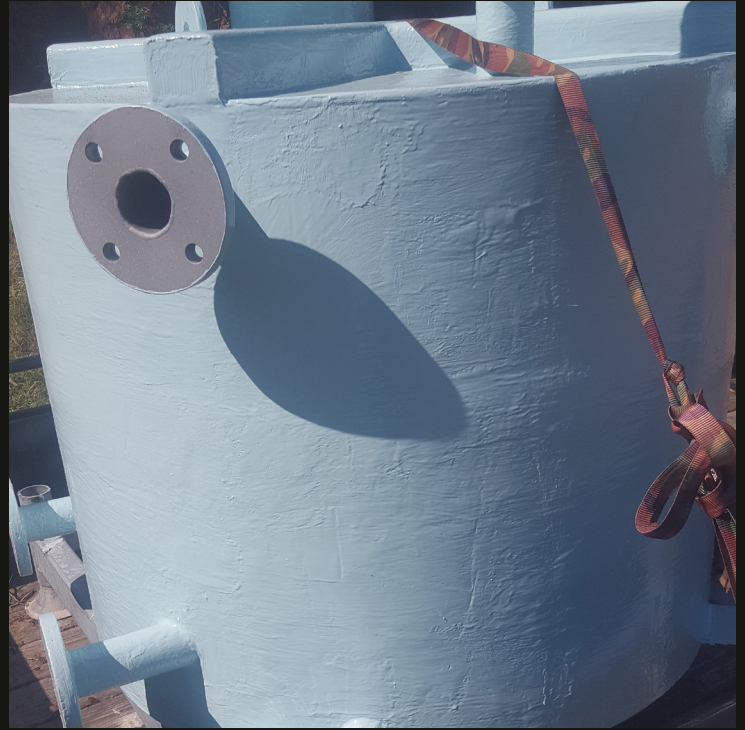
After: A condensate tank reprofiled with Belzona 1111 and coated with Belzona 1593

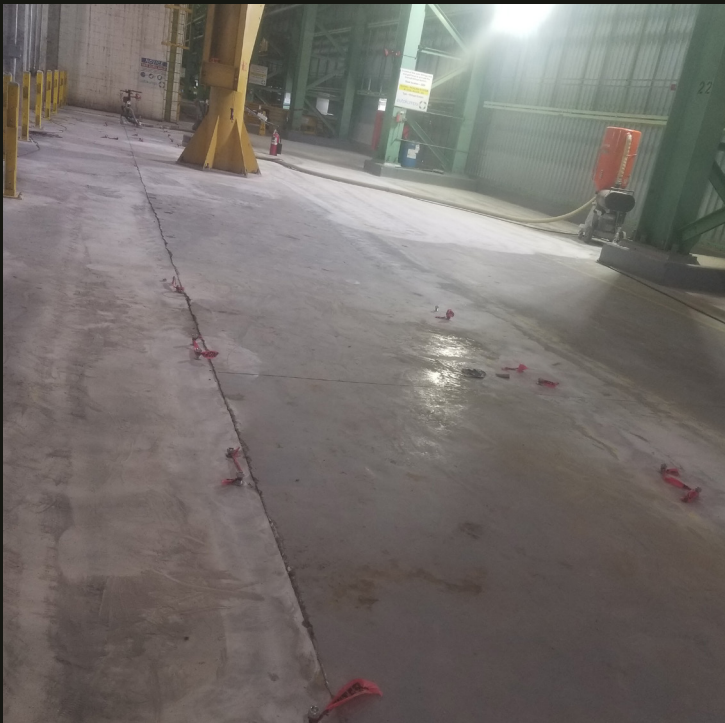
Before: A facility floor without slip-resistance

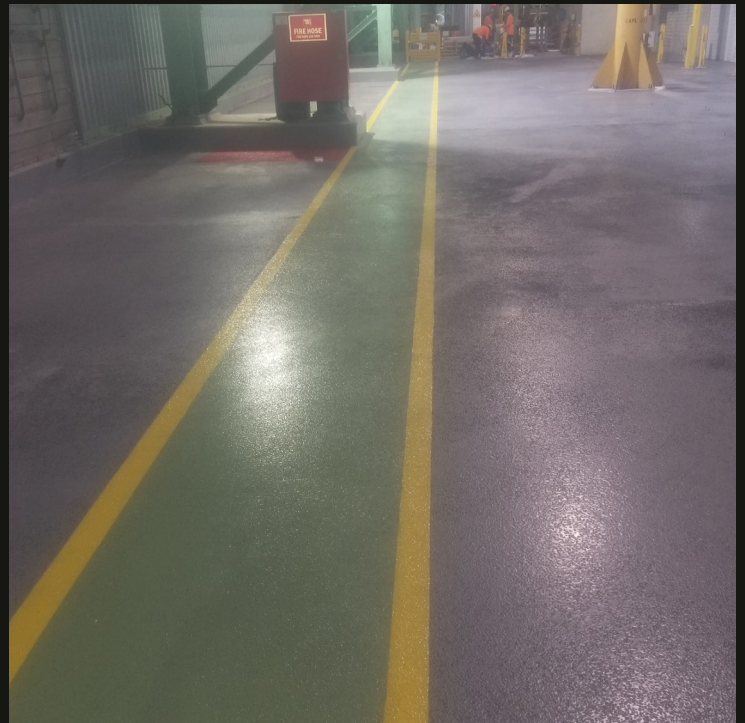
After: Belzona slip-resistant floor system (Belzona 5811 with Belzona 9211 aggregate) installed.

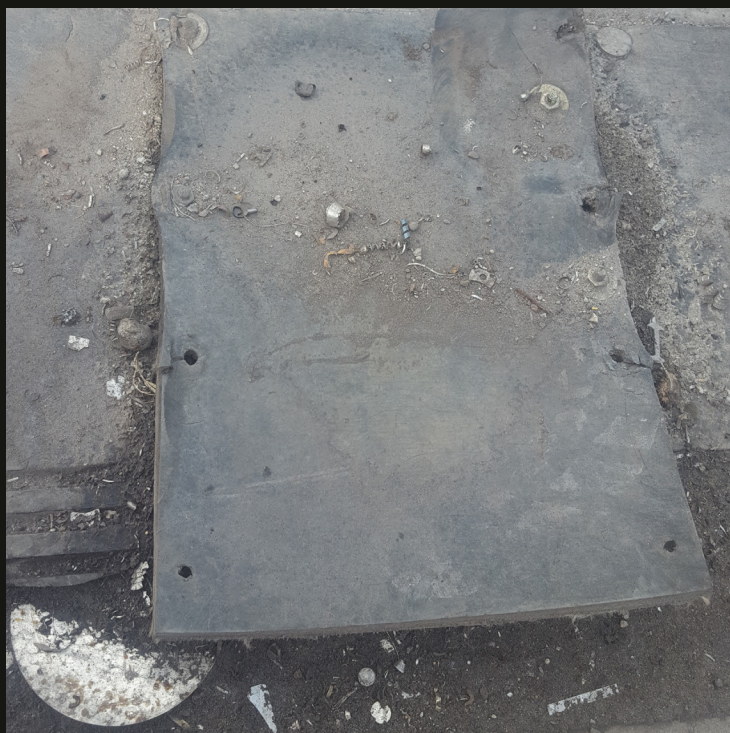
Before: Damaged panzer belt due to abrasion

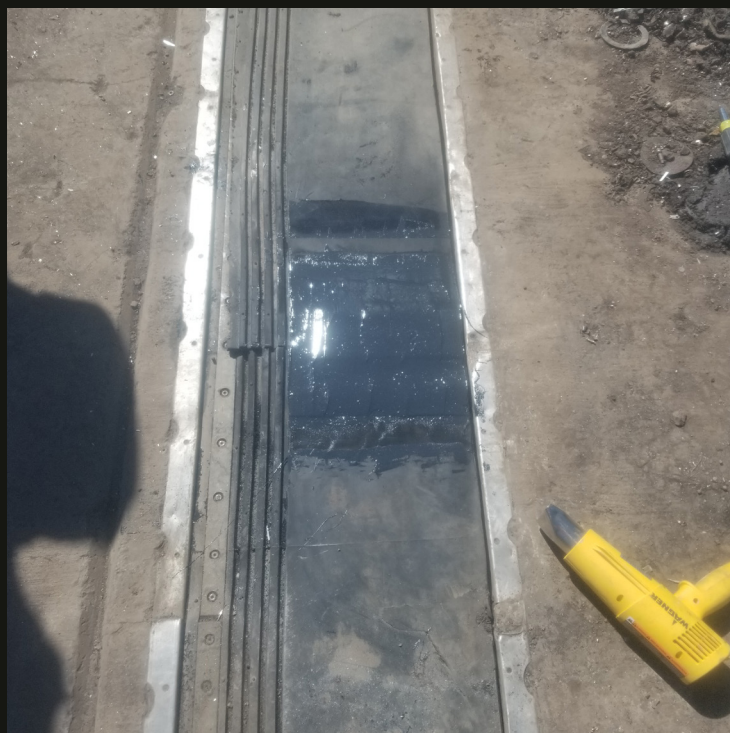
After: Panzer belt repaired with Belzona 2211 & Belzona 2911

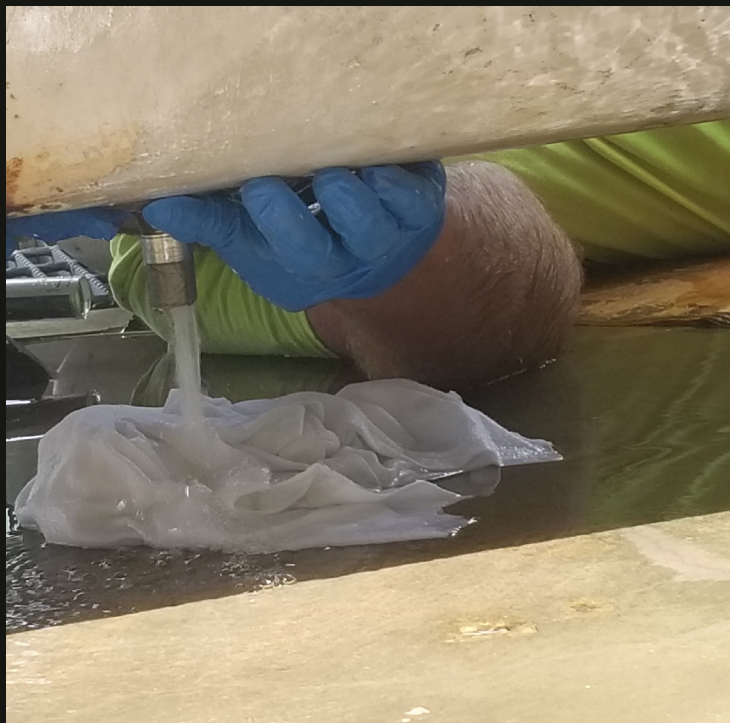
Before: An active leak

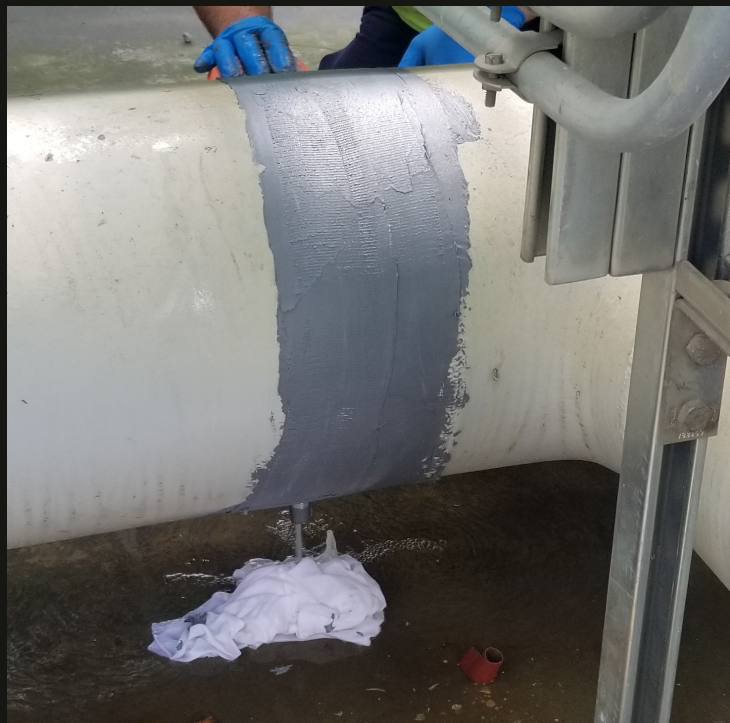
After: Live pipe leak repaired using Belzona 9611, Belzona 1212, & Belzona 9411 reinforcement sheet
