MAINTAINING ASSET INTEGRITY IN THE MARINE INDUSTRY

Belzona Protective Coatings and Engineering Composites

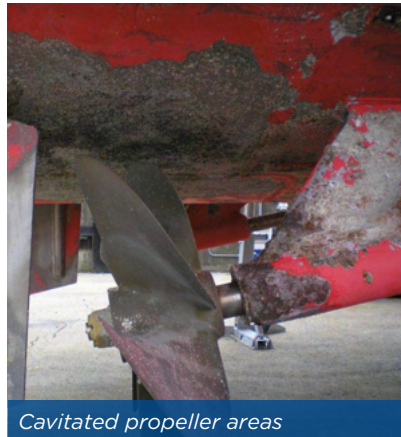
Cavitated propeller areas

In the Marine industry, cavitation usually occurs on foils in rudders, vanes in pumps and also on propulsion systems. Cavitation damage can lead to severe erosion-corrosion problems and render equipment useless if left untreated.

Cavitation damage can be repaired without the need for hot work with a Belzona paste grade material. Belzona offers a combination of ceramic epoxy coatings and resilient polyurethane coatings that provides outstanding corrosion and cavitation protection. Our ceramic coatings have a proven track record of increasing efficiency in fluid flow situations, as well as stopping corrosion and significantly slowing down erosion, while the polyurethane coatings are designed to absorb and disperse the cavitation energy, resisting its effects.

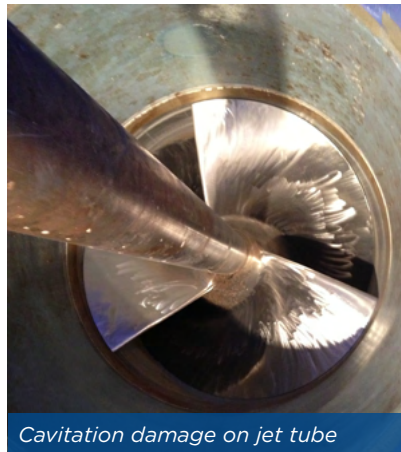
Cavitation damage on jet tube

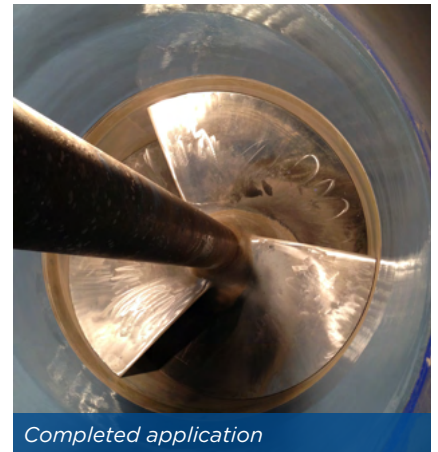
Completed application

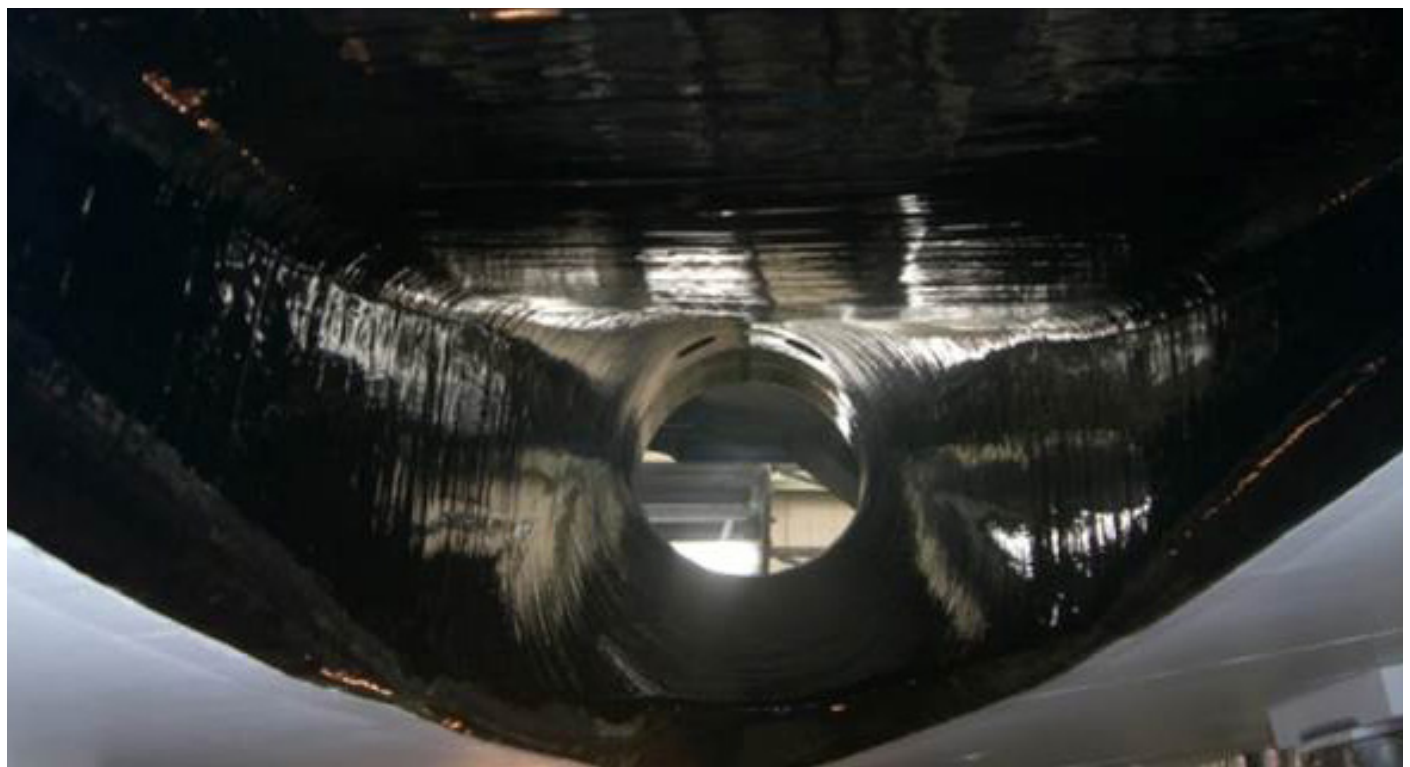
Cavitation protection coating applied to jet tube area on super yacht

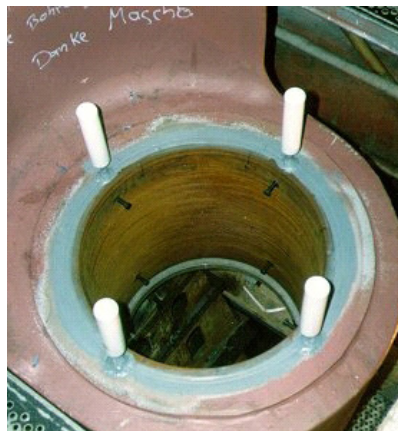
Rudder bearing bonding - top view

The critical requirement with rudder bearings relates to the bush retention in the housing. Corrosion and impact wear can result in the development of annular gaps between the housing and the bearing bush, resulting in a malfunctioning rudder and, consequently, costly repairs and loss of sea time.

The use of Belzona materials for installation of rudder bearings began in 1977 as a collaboration between Belzona and Germanischer Lloyd. The project investigated the use of Belzona materials to eliminate the problem of galvanic corrosion between steel housings and rudder bushes, pintle cones and liners. Nowadays, our polymeric composites and coatings are widely used in the Marine industry for the reseating or installation of new rudder bearings and pintle liners. Our materials allow thickness from 0.1mm to 25mm and demonstrate high adhesion and compressive strength, providing a long-term solution.

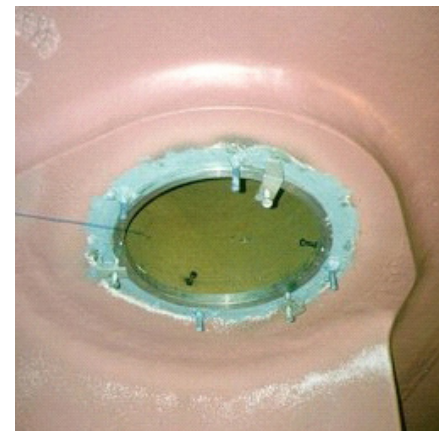
Rudder bearing bonding - bottom view

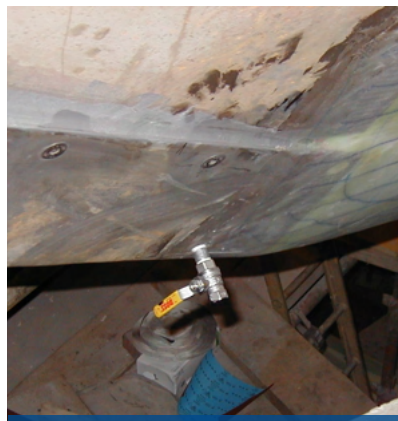
Anchor pocket bonding in progress

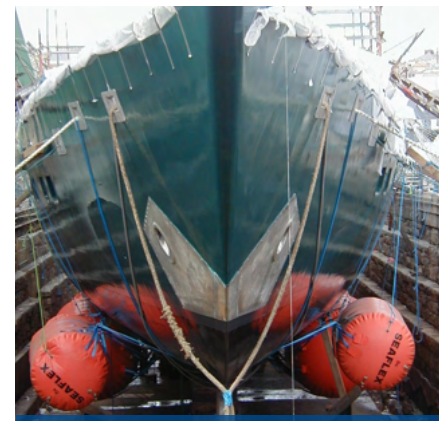
Anchor pocket bonding completed

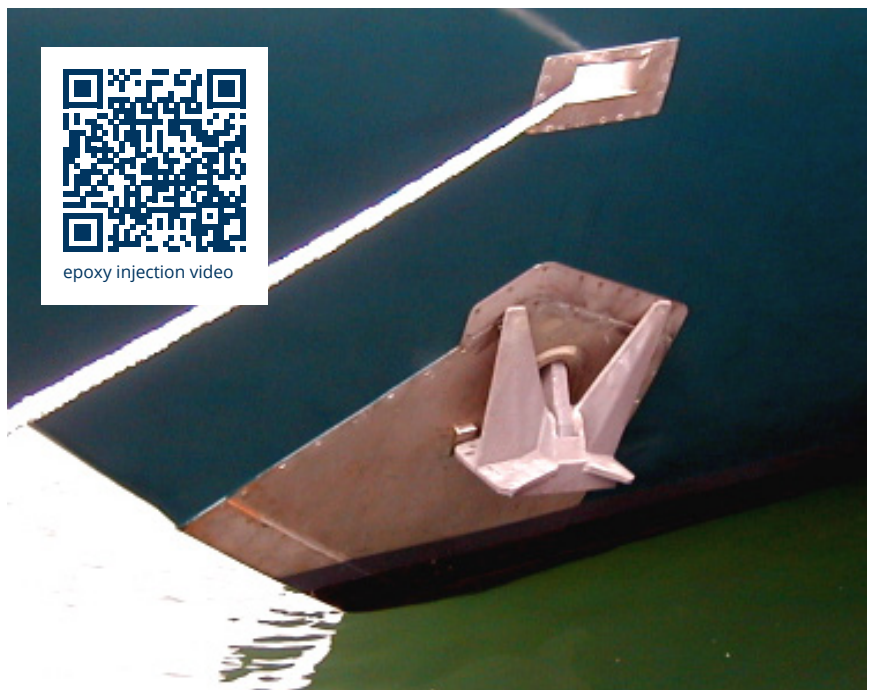
Completed application

Corroded equipment and structures can be repaired with Belzona's pioneering injection bonding technology, helping to restore their structural integrity. This technique has been successfully utilised for deck and hull renovation as well as equipment repairs such as cracked engine casings. Our deck strengthening technology has been extensively tested for bend, impact, flexural strength, drag and shear adhesion, which provides a durable solution.

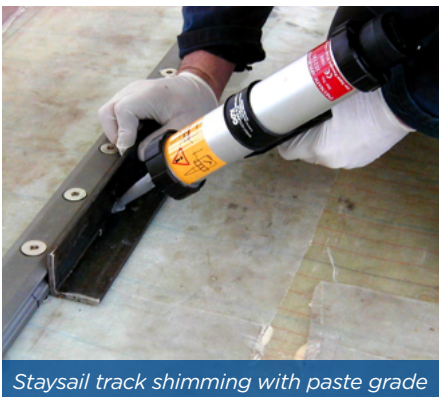
Staysail track shimming with paste grade

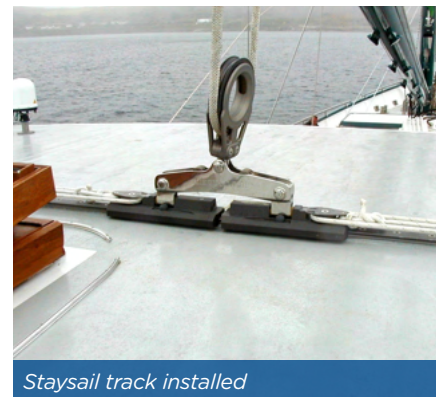
Staysail track installed

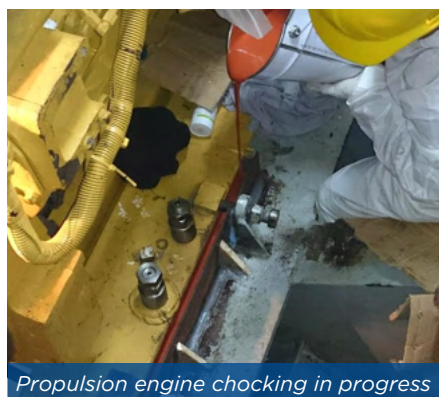
Propulsion engine chocking in progress

Cast compound chocks offer an alternative to conventional metal chocks. Belzona's 100% solids Marine chocking compound has been designed for the installation of Marine engines and other equipment, providing precise equipment alignment due to non-shrinking properties whilst its high impact and compressive strength provides high load bearing capabilities. This self-levelling material is easy to use, shortening installation time and offering a durable non-corroding solution for installation of ship propulsion systems and other heavy equipment where alignment and anchorage is essential.

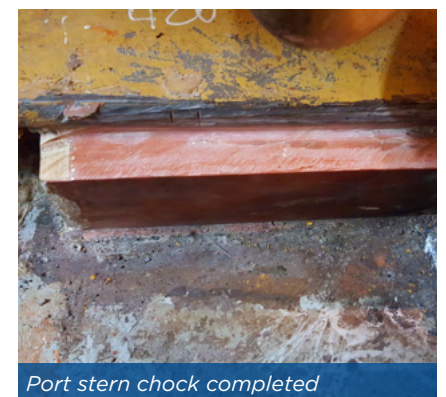
Port stern chock completed

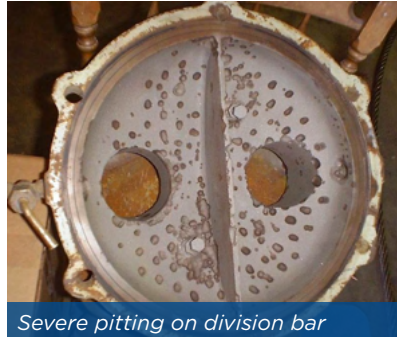
Severe pitting on division bar

When exposed to an electrolytic solution, galvanic corrosion occurs at the interface of the tube and the tube sheet. Belzona composites and coatings have been used for heat exchanger repair and protection since the 1970s, with known applications in service for over three decades. The Belzona solution eliminates the need for part replacement, therefore significantly reducing maintenance expenses, and offers excellent adhesion as well as erosion and chemical resistance. In order to prevent galvanic corrosion, new heat exchangers can be designed and coated with Belzona.

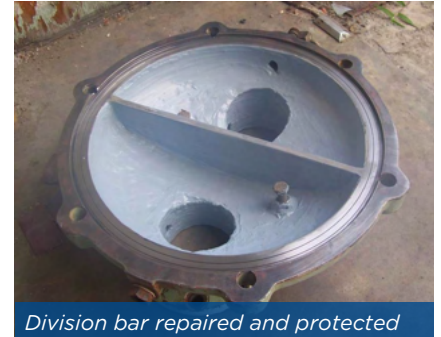
Division bar repaired and protected

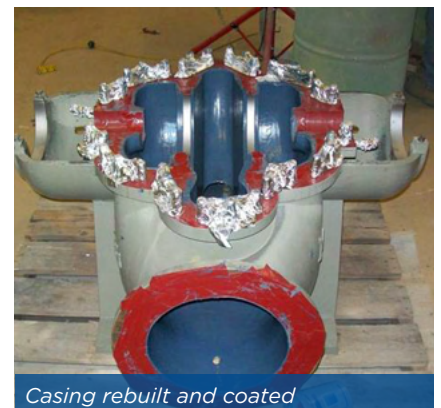
Casing rebuilt and coated

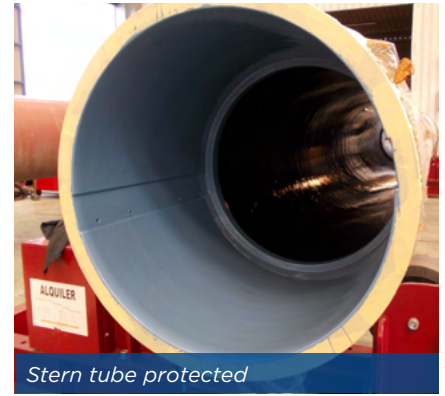
Stern tube protected

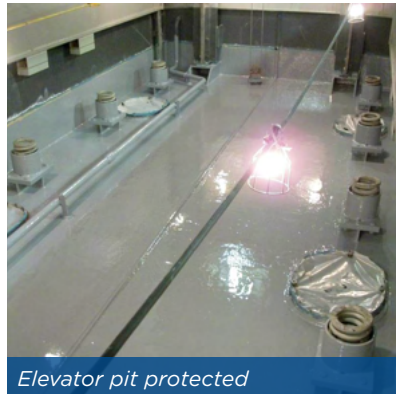
Elevator pit protected

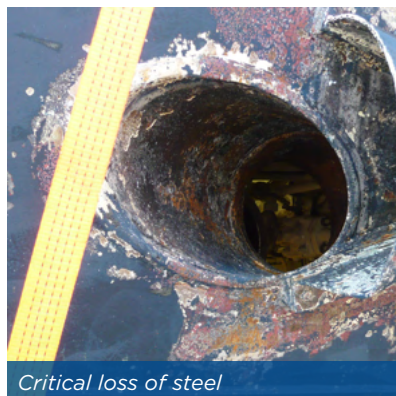
Critical loss of steel

Leisure boats with inboard engines often suffer from corrosion problems on the wet exhausts. The hot exhaust gas together with the salt water causes severe corrosion that can lead to critical loss of steel. High temperature resistant composite repair materials are used to recover the metal loss and rebuild the original surface profile of the water inlet and exhaust outlet. A high temperature lining can then be applied to provide long-term protection and eliminate future corrosion issues in the exhaust system.

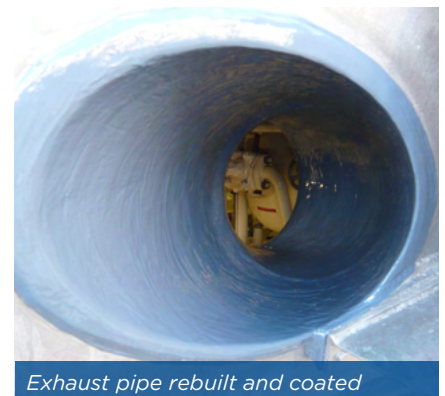
Exhaust pipe rebuilt and coated

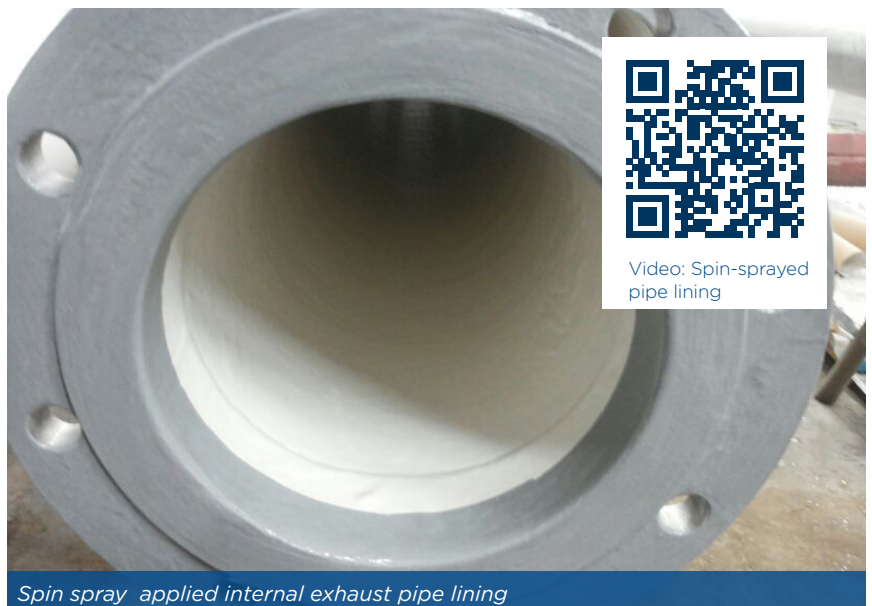
Spin spray applied internal exhaust pipe lining

Belzona pioneered a spray-friendly pipe lining system that offers erosion-corrosion protection from sea water and entrained solid particles such as sand. The substitution of hard ceramic fillers for a thermoplastic filler blend ensures there is very little wear to the spray equipment. The material can be spin spray or brush applied in situ at wet film thickness up to 1250 microns without sagging, effectively covering girth welds and joints in a single coat. The thermoplastic filler blend is formulated to achieve excellent impact and sliding abrasion resistance, a high degree of toughness and chemical resistance.

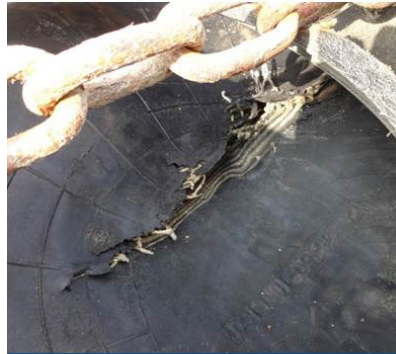
Torn Yokohama fender

By the very nature of their job, mooring equipment such as fenders are subjected to impact, abrasion and wear. As a result, punctures are common and cannot easily be repaired by conventional means such as hot vulcanising, which is time consuming, expensive and not always successful. Belzona Elastomers provide reliable repairs to these common problems. Tears and rips can be repaired using a Belzona Elastomer paste grade material, while surface deterioration is easily resolved with a coating grade.

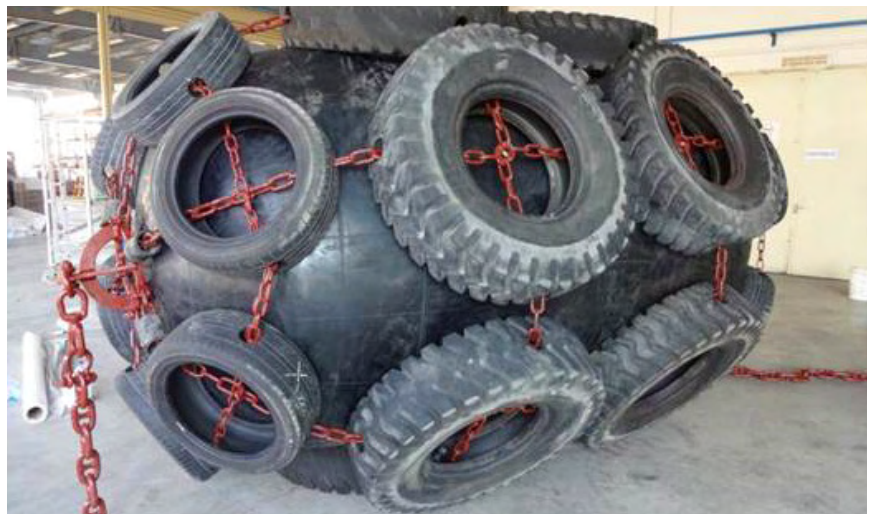
Yokohama fender repaired with Belzona

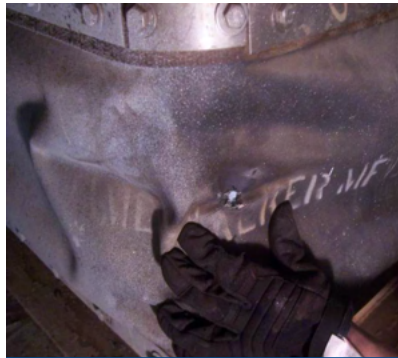
Ripped bellows

Tears or holes on bellows should be immediately repaired to prevent serious mechanical damage; however, ordering and fitting replacements is time consuming and expensive. Belzona Elastomers can provide a fast and reliable repair alternative as these materials bond strongly to rubber and metal. The repair can be performed in-situ with an emergency repair Elastomer, a rubber repair material that cures in minutes.

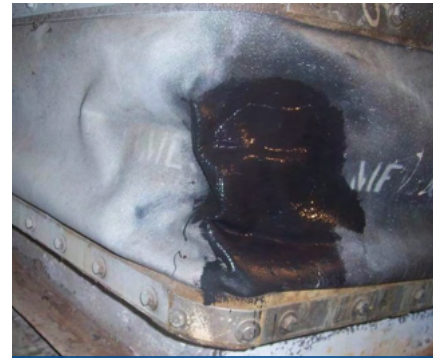
Localised repair

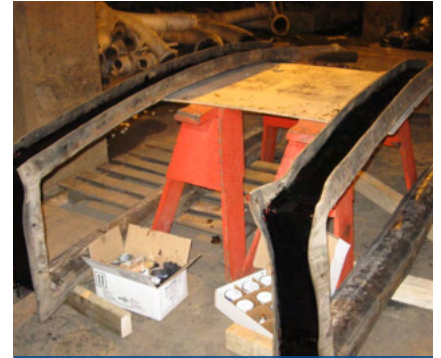
Repair completed

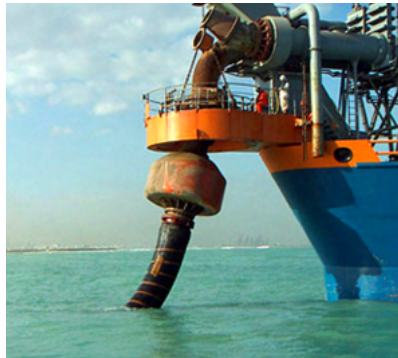
Floating hose buoyancy device

Floating hoses and buoyancy devices can represent a significant expense, as the rubber, internal surfaces and flange faces can often be damaged due to in service or in transit deterioration. If the damage is not addressed at an early stage, it can lead to loss of buoyancy and ultimately catastrophic fuel or oil spillage with potentially costly implications.

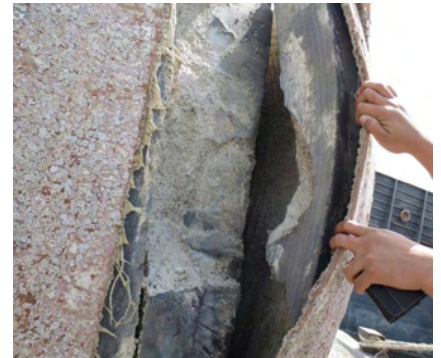
Major damage

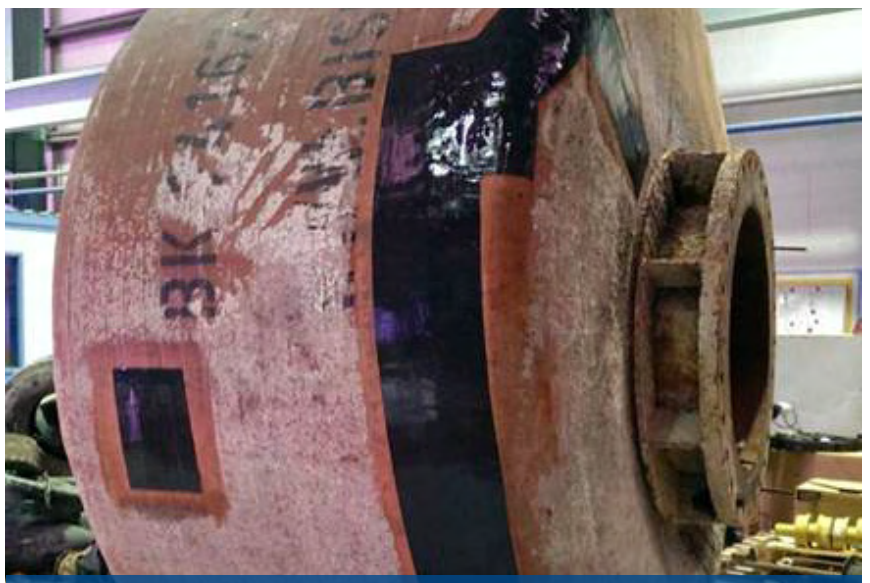
Damaged areas repaired

Belzona Elastomers provide a rapid and resistant repair solution to damaged floating hoses and buoyancy devices. Our rubber repair materials adhere strongly to any type of hose and provide outstanding abrasion and impact resistance once the hose is put back in service. Due to Belzona's range of multi-purpose Elastomers, we are able to repair both localised and large defects, as well as ensure high quality repairs onto vertical surfaces.

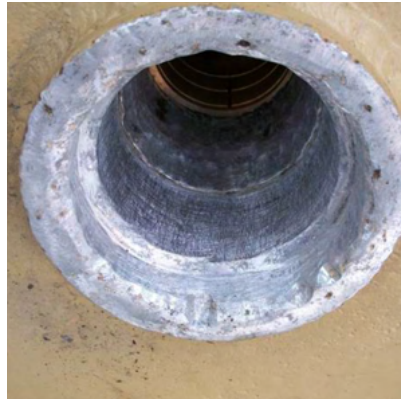
Damaged bearing bushing

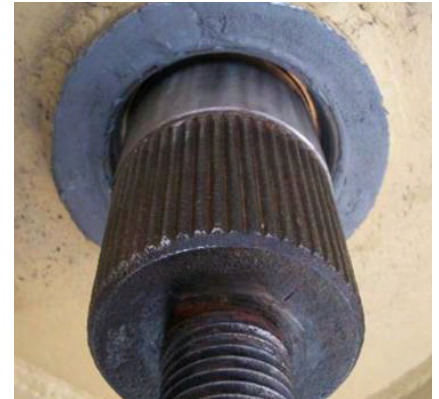
Bearing bushing rebuilt in situ

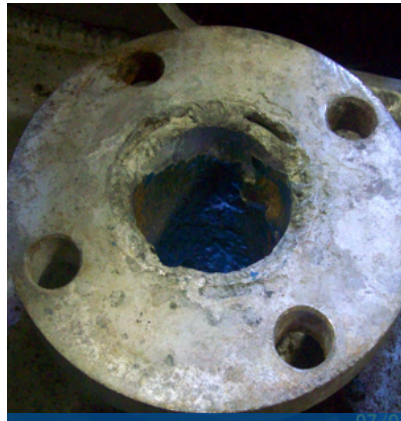
Corroded sea chest flange

Crevice and galvanic corrosion can be repaired with a unique Belzona composite forming technology. Prefabricated formers are used to shape the specified Belzona material, which bonds strongly to the flange face. The sealing face is then effectively isolated from corrosive media whilst maintaining its shape and profile. This simple repair can be carried out in situ without disassembling the equipment and eliminating the need for welding.

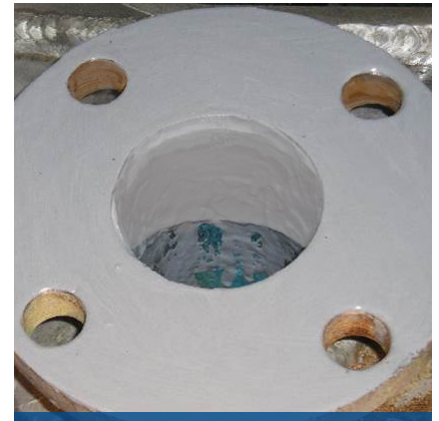
Rebuilding application completed
