MAINTAINING ASSET INTEGRITY IN THE WATER AND WASTEWATER INDUSTRY

Belzona Protective Coatings and Engineering Composites

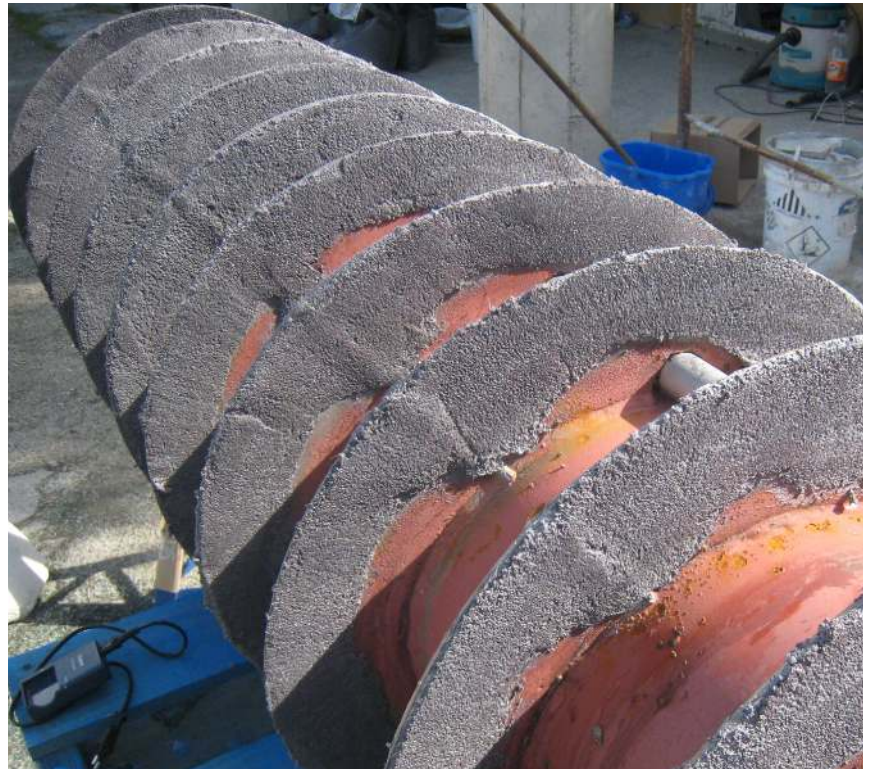
Belzona abrasion resistant coating extends the life of screw conveyor

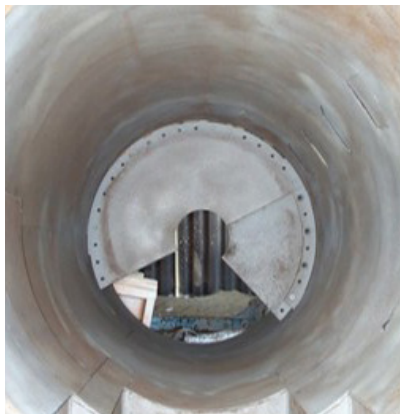
Thin-wall defects on mixer

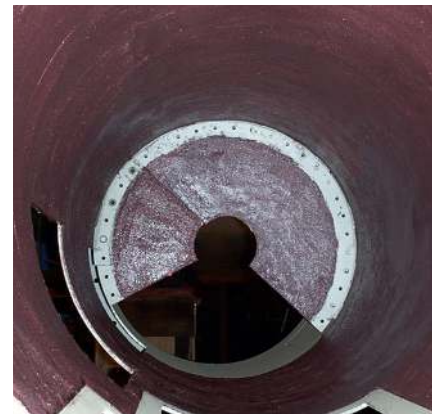
Rebuilt and protected against abrasion

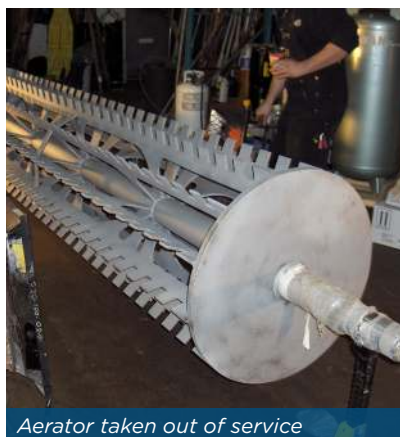
Aerator taken out of service

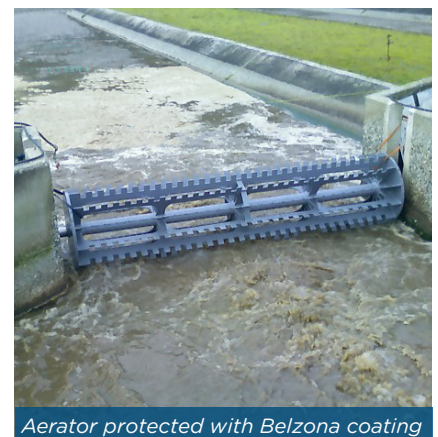
Aerator protected with Belzona coating

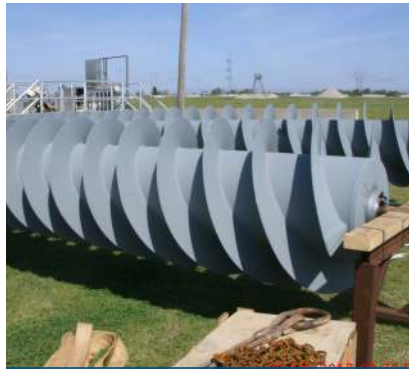
Screw conveyors prior to coating

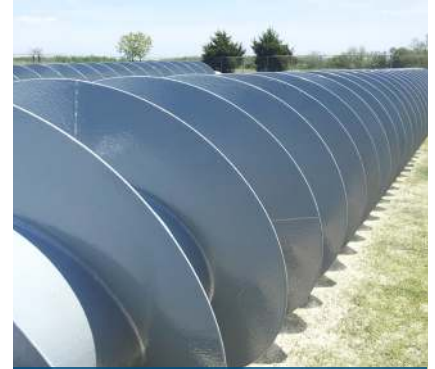
Erosion resistant coating applied

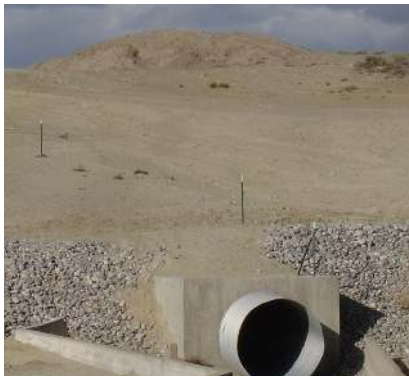
Pipe used to carry irrigation water

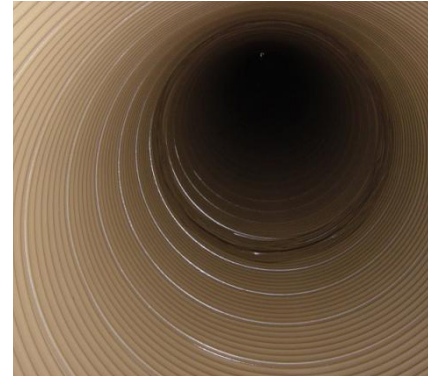
Spray applied internal coating applied

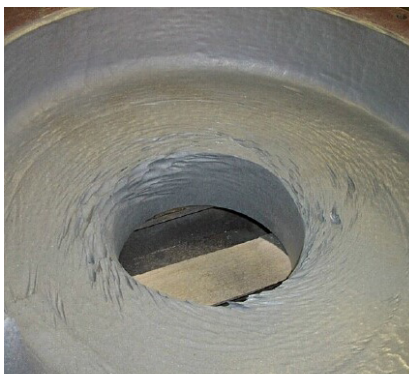
Entrainment damage on slurry pump

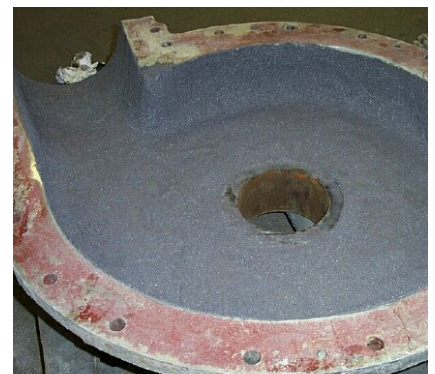
Abrasion resistant coating applied

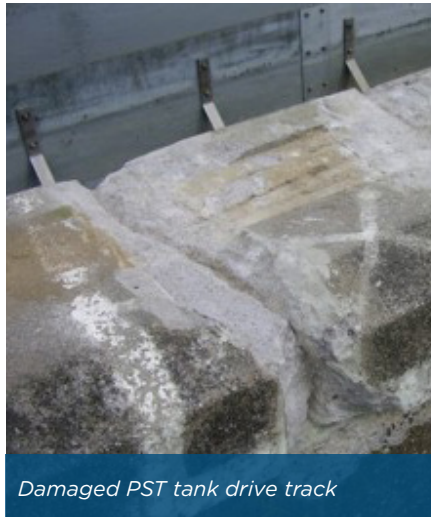
Damaged PST tank drive track

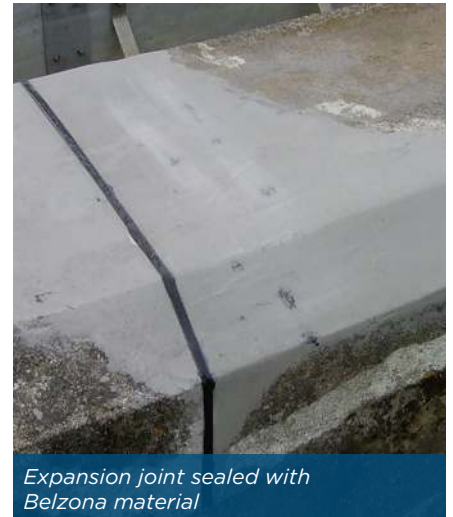
Expansion joint sealed with Belzona material

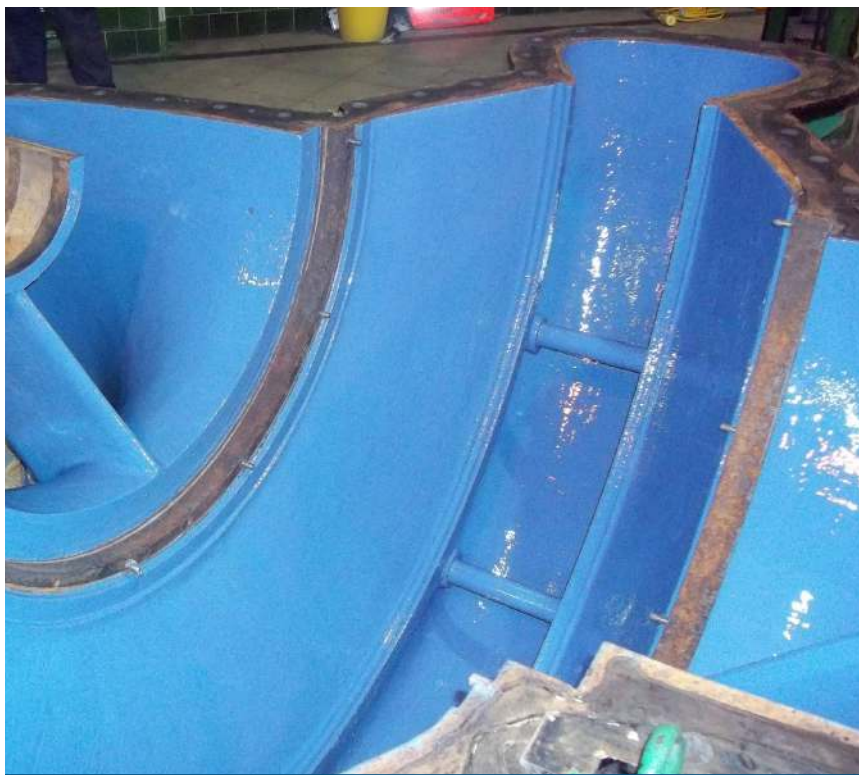
Pump internals coated with Belzona materials for long-term corrosion protection

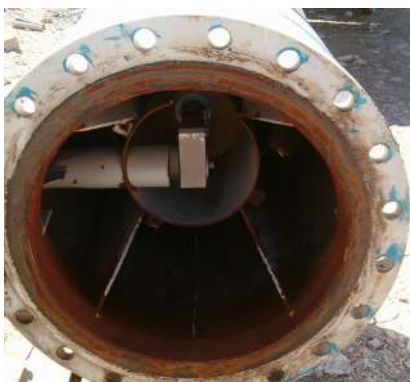
Corrosion and erosion on internal surfaces caused by sewage water

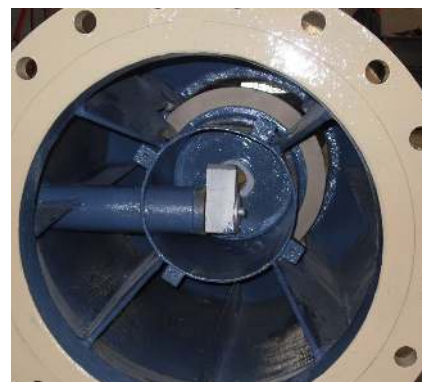
Internal surfaces rebuilt and protected with Belzona coating

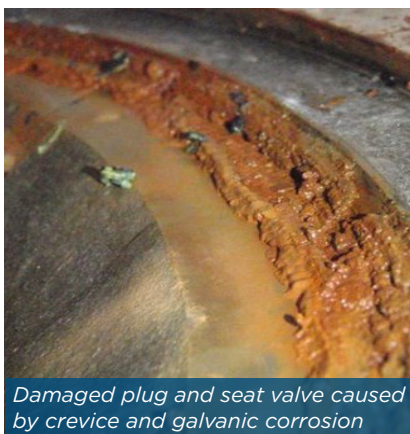
Damaged plug and seat valve caused by crevice and galvanic corrosion

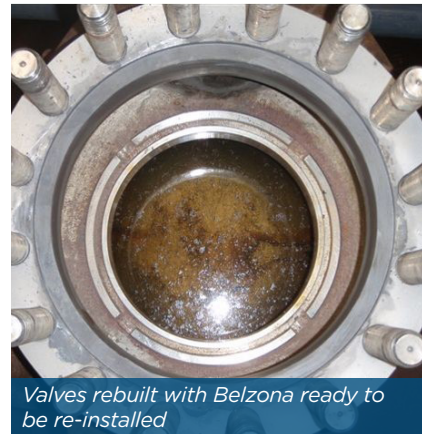
Valves rebuilt with Belzona ready to be re-installed

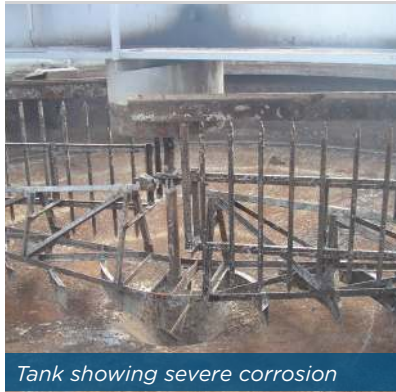
Tank showing severe corrosion

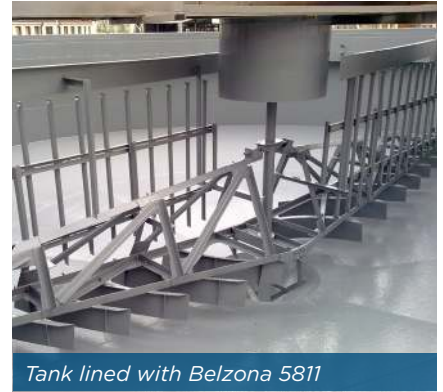
Tank lined with Belzona 5811

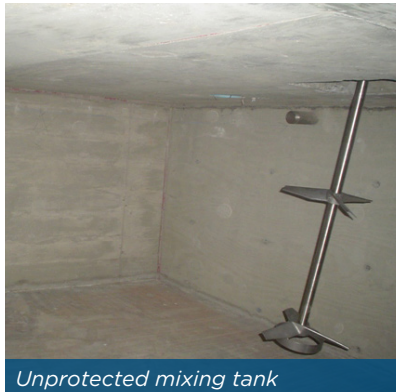
Unprotected mixing tank

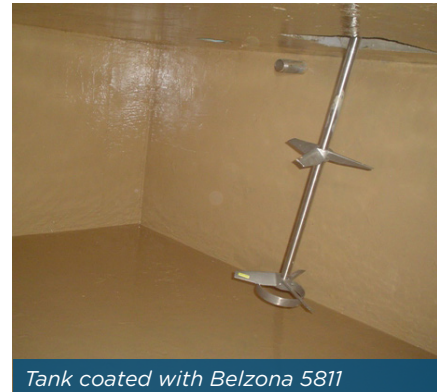
Tank coated with Belzona 5811

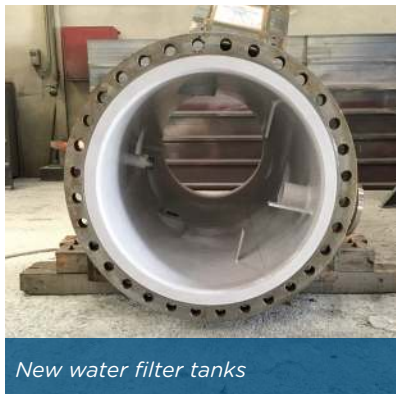
New water filter tanks

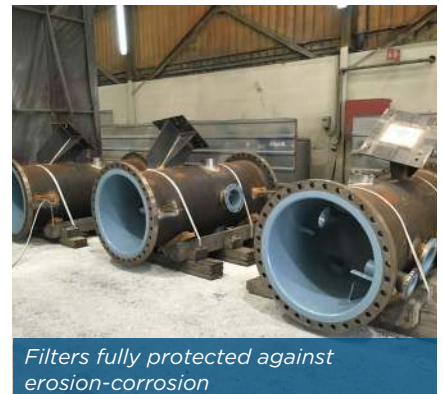
Filters fully protected against erosion-corrosion

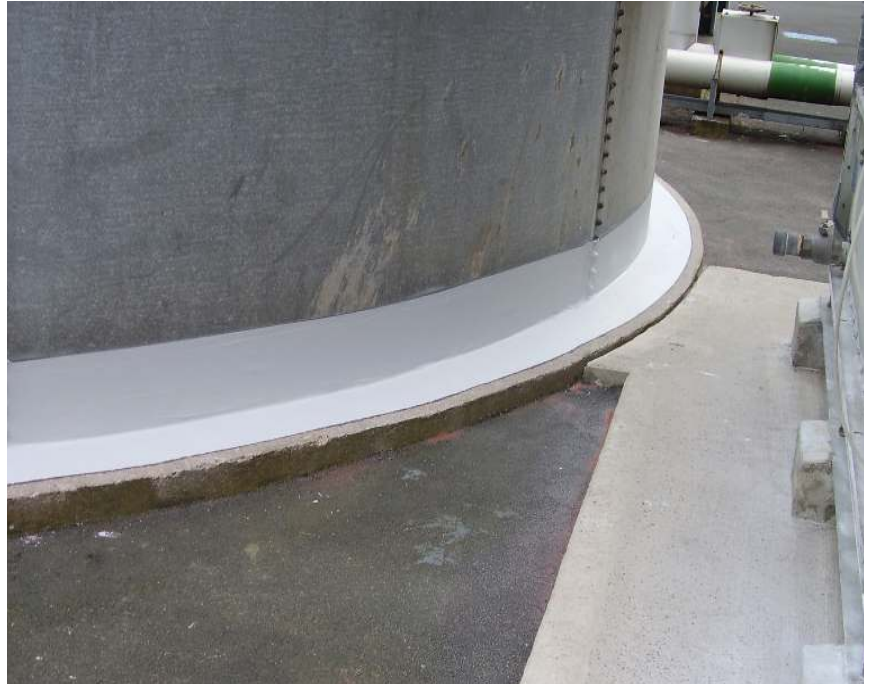
Belzona lining applied to a newly fabricated process vessel

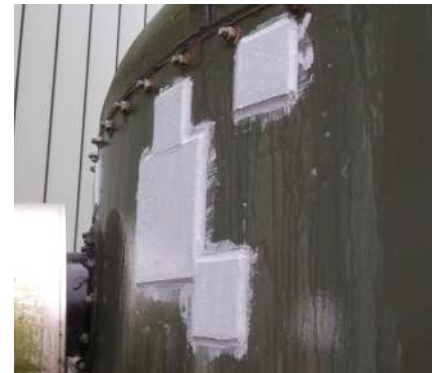
Tank repaired by cold bonding

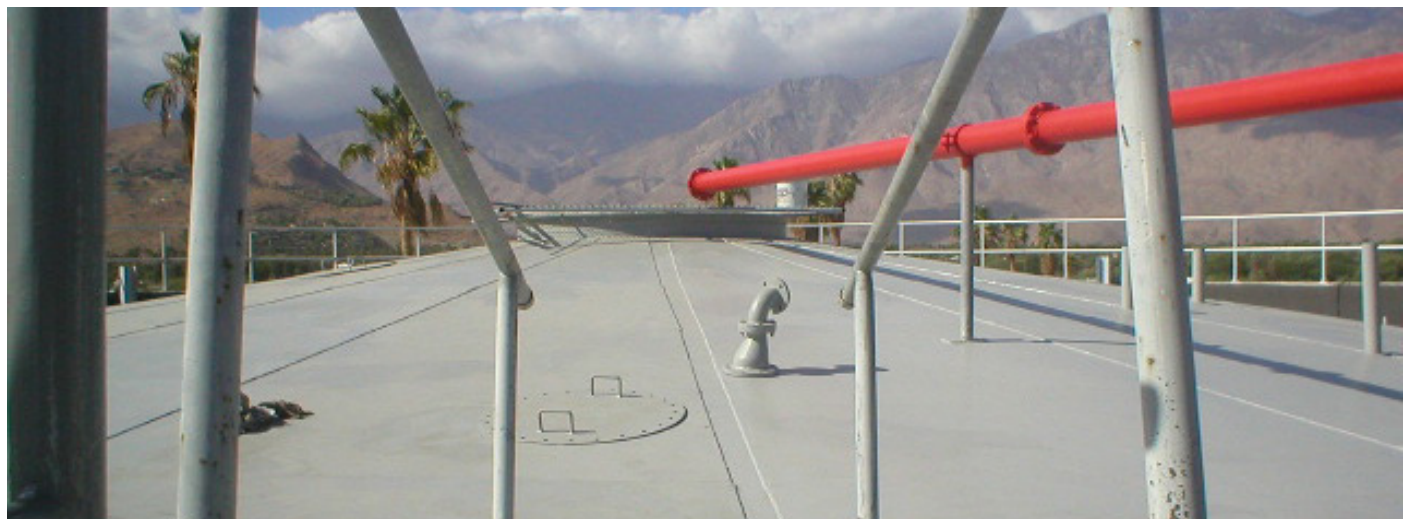
Tank roof restored with a Belzona protective coating

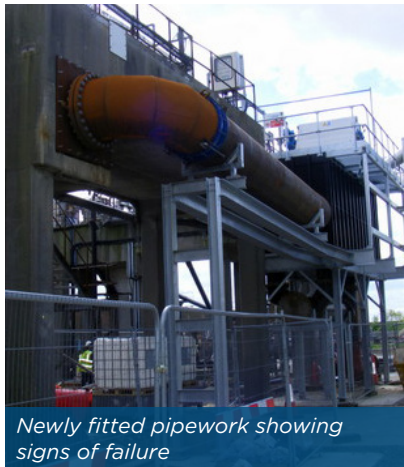
Newly fitted pipework showing signs of failure

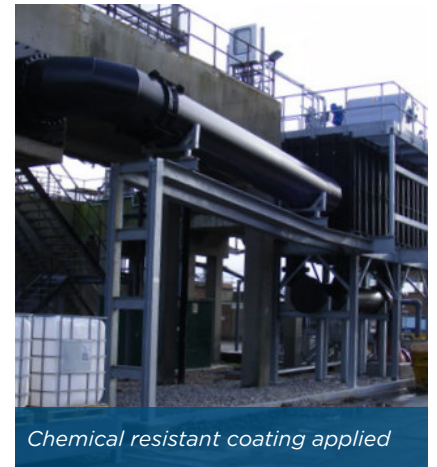
Chemical resistant coating applied

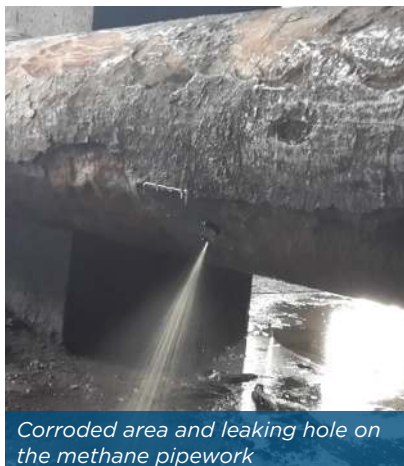
Corroded area and leaking hole on the methane pipework

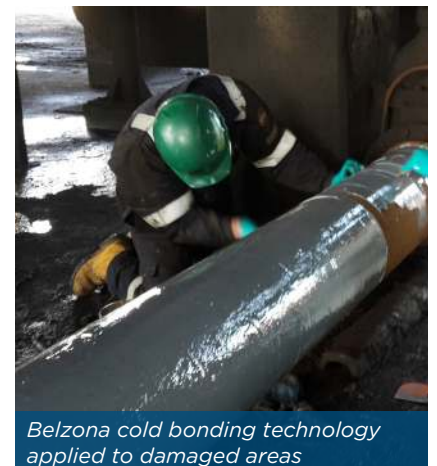
Belzona cold bonding technology applied to damaged areas

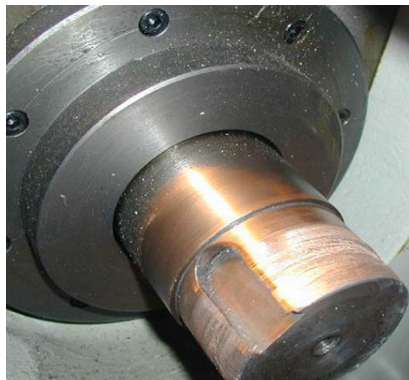
Damaged keyway housing and scored shaft

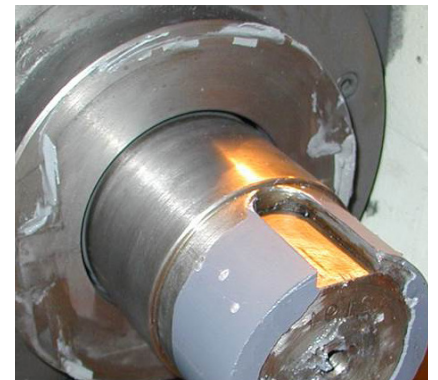
Keyway housing and shaft repaired with Belzona material

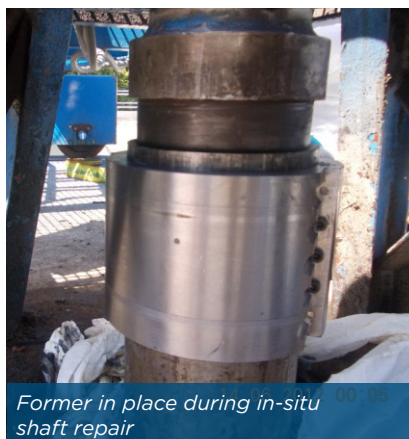
Former in place during in-situ shaft repair

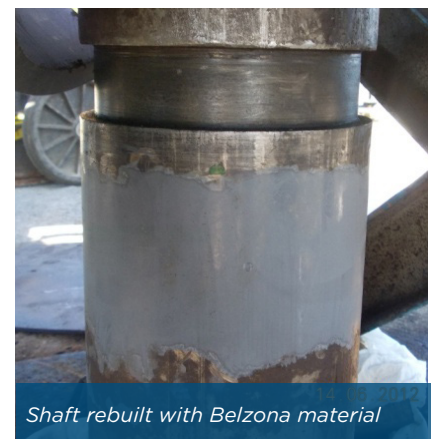
Shaft rebuilt with Belzona material

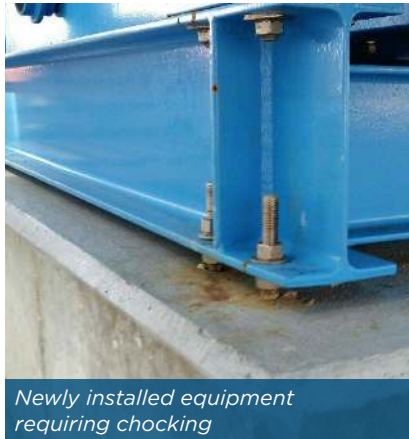
Newly installed equipment requiring chocking

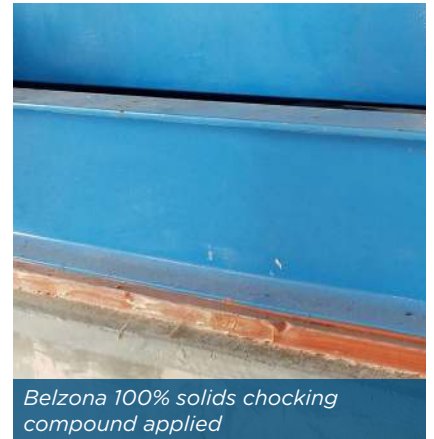
Belzona 100% solids chocking compound applied

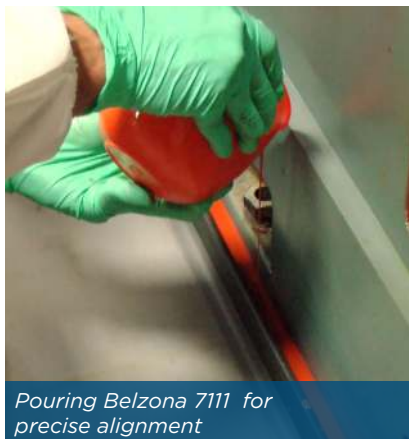
Pouring Belzona 7111 for precise alignment

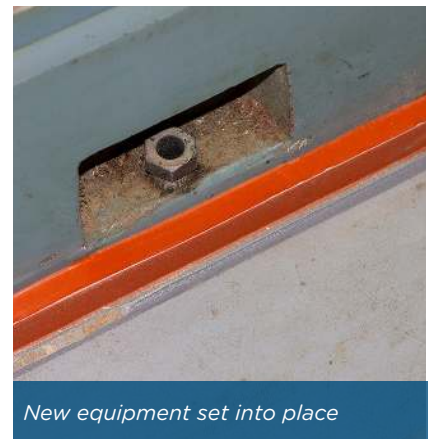
New equipment set into place
