# MAINTAINING ASSET INTEGRITY IN THE OIL AND GAS INDUSTRY – DOWNSTREAM

Belzona Protective Coatings and Engineering Composites

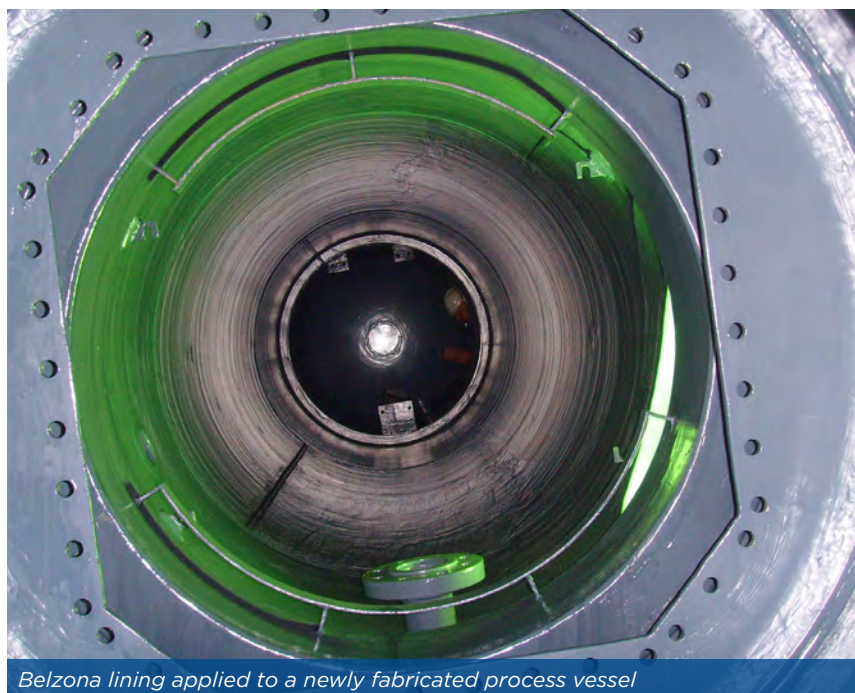
*Belzona lining applied to a newly fabricated process vessel*

Our linings can be spray or hand applied and, once cured in service, form a barrier between the substrate and corrosive media, enabling the operator to implement a corrosion management plan. As well as resisting erosion-corrosion, Belzona linings are designed to withstand vast pressure and temperature fluctuations, including steam-out and explosive decompression.

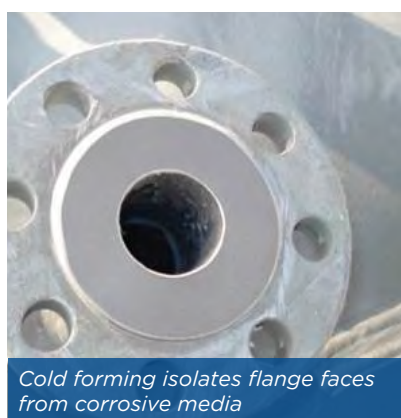
*Cold forming isolates flange faces from corrosive media*

Crevice and galvanic corrosion can be prevented or repaired with a unique Belzona composite forming technology. Prefabricated formers are used to shape the specified Belzona material that bonds strongly to the flange face. The sealing face is then effectively isolated from corrosive media whilst maintaining its shape and profile.

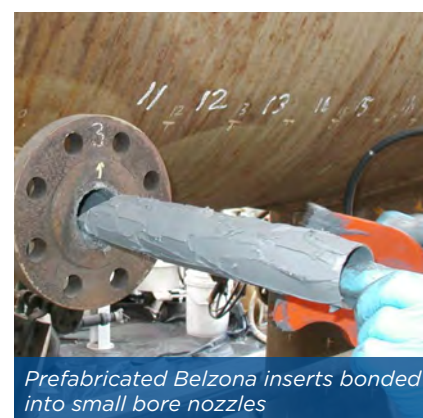
*Prefabricated Belzona inserts bonded into small bore nozzles*

Narrow nozzles no longer need to be considered "the Achilles' heel" of process vessels. Tailor made Belzona inserts are bonded into the nozzle using a fluid grade material, eliminating the risk of pinholes or holidays. Excellent chemical and erosion resistance ensures long-term protection of the nozzle, thus extending maintenance-free periods.

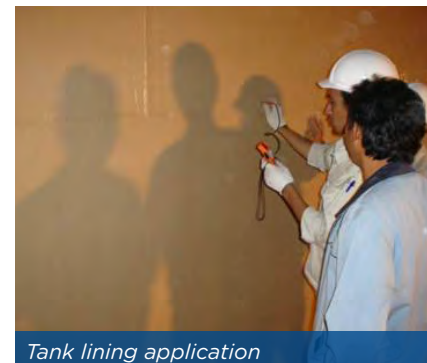
Tank lining application

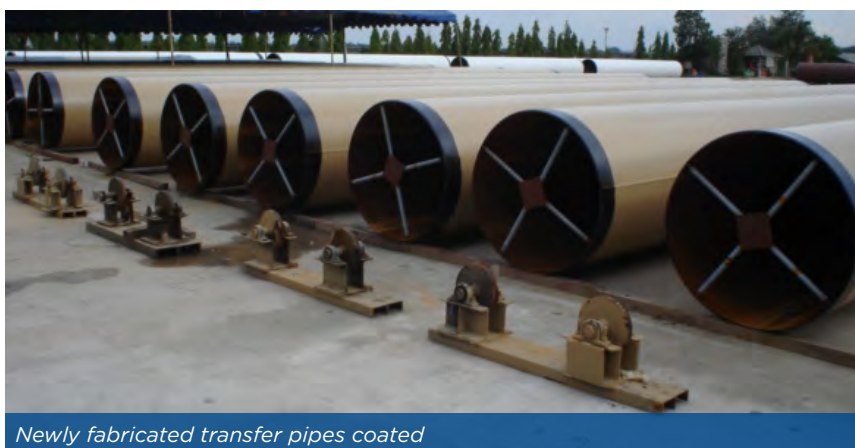
Newly fabricated transfer pipes coated

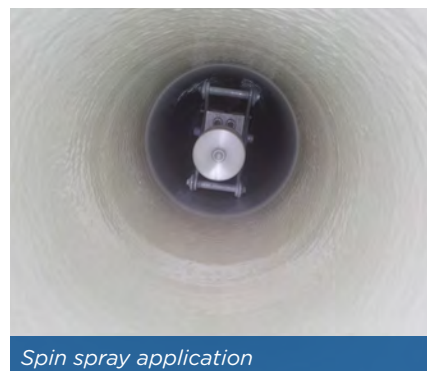
Spin spray application

The material is spin spray applied in situ at wet film thickness up to 2000 microns without sagging, effectively covering girth welds and joints in a single coat. The thermoplastic filler blend is formulated to achieve excellent impact and sliding abrasion resistance, a high degree of toughness and chemical resistance. Belzona also offers barrier coatings for the external protection of buried pipework.

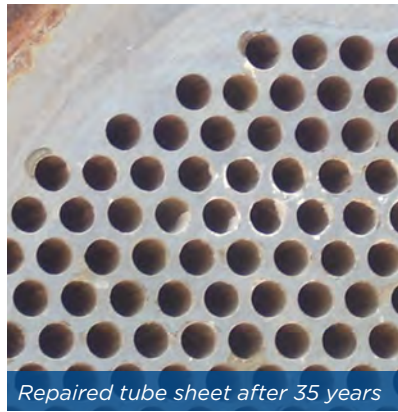
Repaired tube sheet after 35 years

When exposed to an electrolytic solution, galvanic corrosion occurs at the interface of the tube and the tube sheet. Belzona composites and coatings have been used for heat exchanger repair and protection since the 1970s, with known applications in service for over three decades. The Belzona solution eliminates the need for part replacement, therefore significantly reducing maintenance expenses, and offers excellent adhesion as well as erosion and chemical resistance.

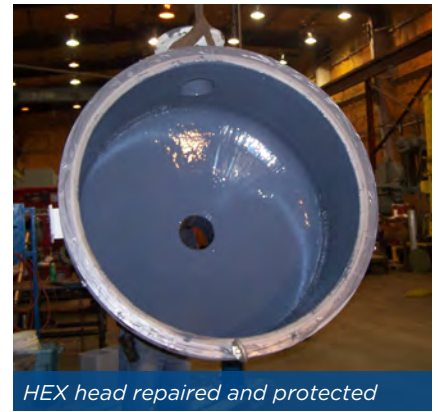
HEX head repaired and protected

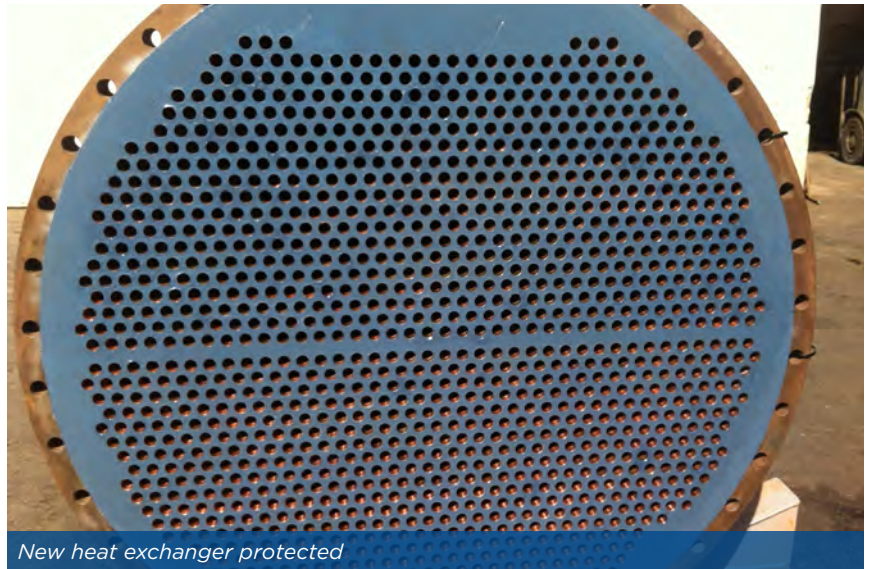
New heat exchanger protected

In order to prevent galvanic corrosion, new heat exchangers can be designed and coated with Belzona, thus reducing expenses associated with repairs or replacement.

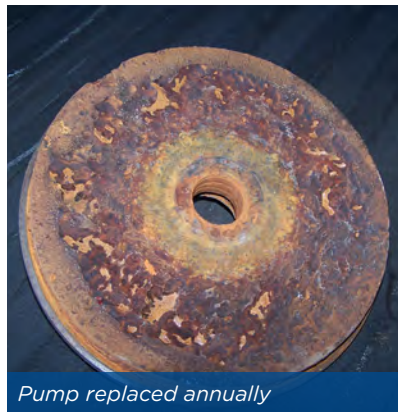
Pump replaced annually

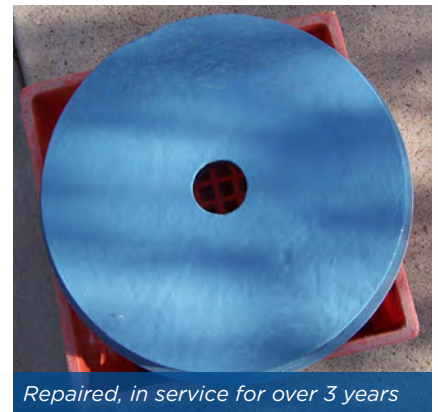
Repaired, in service for over 3 years

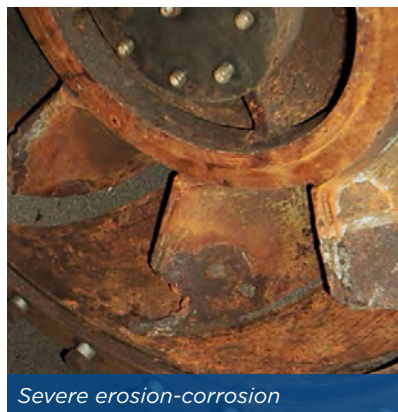
Severe erosion-corrosion

Pump deterioration leads to decreased pumping efficiency and eventually costly part replacement. Pitting, worn wear ring clearances as well as casing thin and through wall defects can be rebuilt using composites specifically designed for erosion-corrosion resistance under immersion. Pumping efficiency is restored and enhanced with the use of a hydrophobic smooth lining, which also protects from erosion and corrosion. Once the pump has been protected with Belzona, it can remain maintenance-free for many years with applications still in service after several decades.

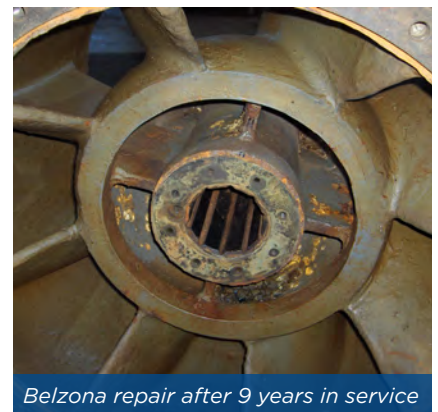
Belzona repair after 9 years in service

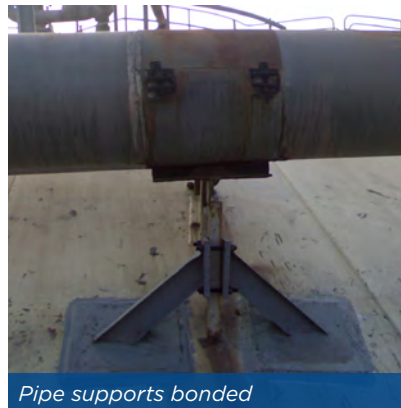
Pipe supports bonded

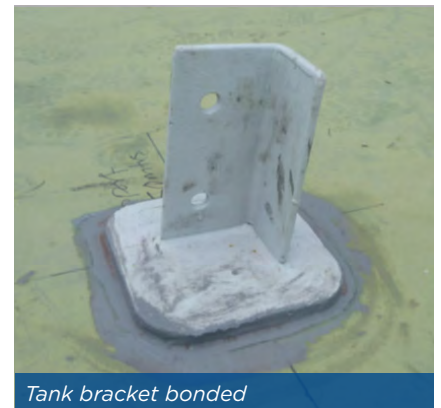
Tank bracket bonded

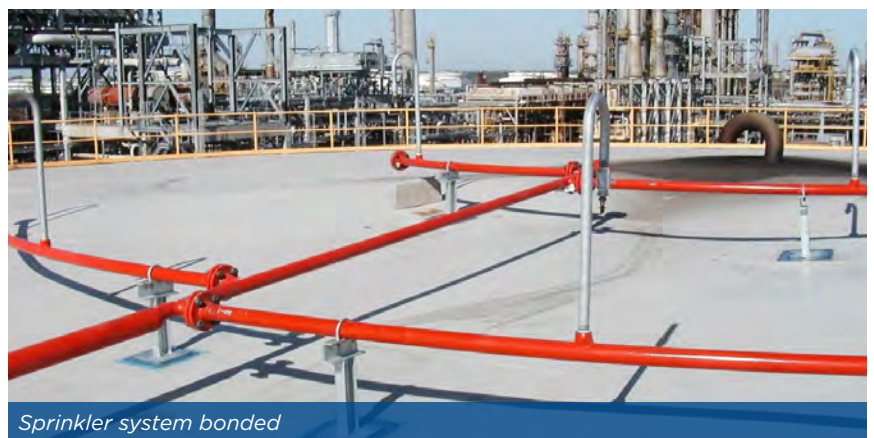
Sprinkler system bonded

Cold bonding of fittings eliminates the need for hot work and facilitates rapid installation. With tensile shear adhesion of up to 2,960psi (20.4MPa), pull off adhesion of up to 3,240psi (22.3MPa) and flexural strength of up to 14,300psi (98.6MPa), fittings, framework, handrails and supports can be bonded permanently and safely.

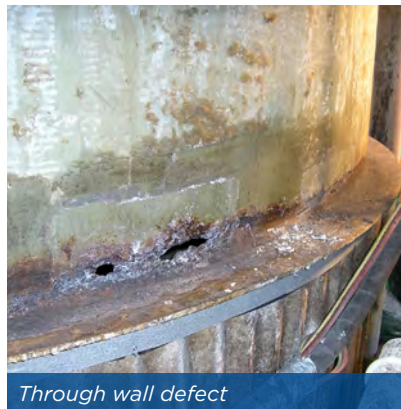
Through wall defect

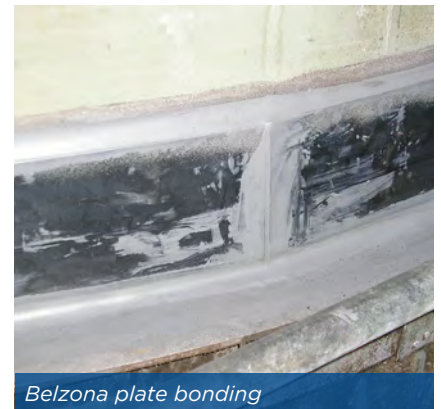
Belzona plate bonding

In order to facilitate in-situ repairs of severely corroded equipment and structures, Belzona pioneered cold plate bonding technology. This technique has been successfully utilised for structural integrity restoration whilst maintaining site safety. Over a decade of successful applications which are still in service today attest to this method's effectiveness.

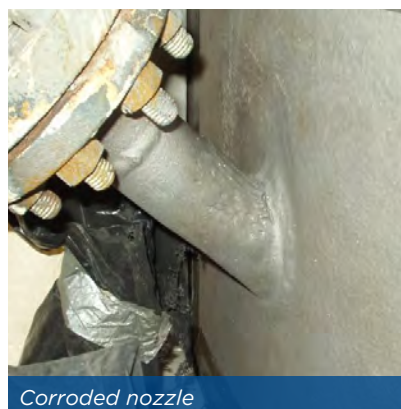
Corroded nozzle

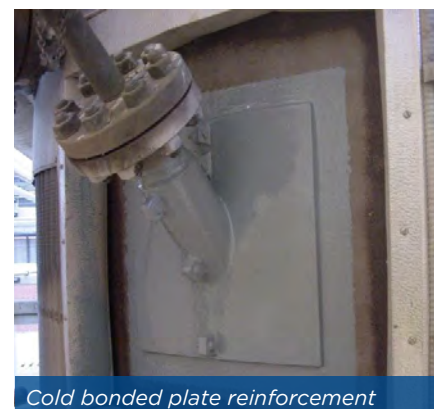
Cold bonded plate reinforcement

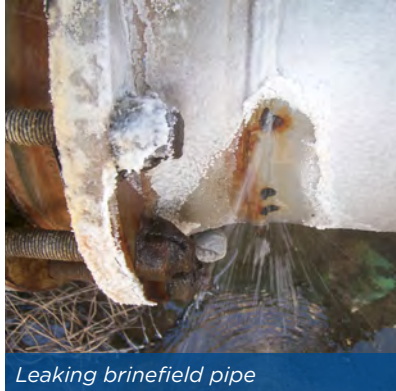
Leaking brinefield pipe

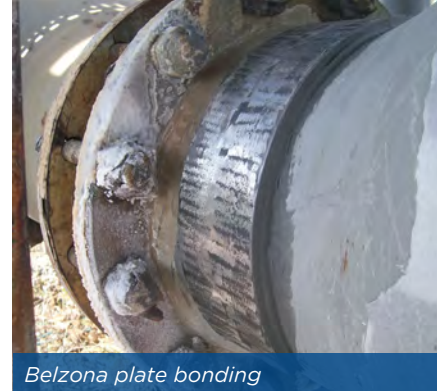
Belzona plate bonding

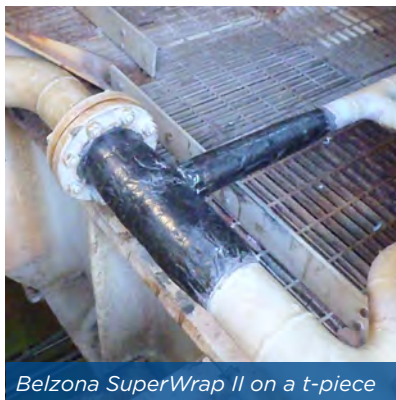
Belzona SuperWrap II on a t-piece

Following almost five decades of pipe wrap installations, in 2007 we added Belzona SuperWrap to the range, which is compliant with ASME PCC2 Article 4.1 and ISO/TS 24817. Every Belzona SuperWrap system is individually designed and applied by validated specialists. Repairs can be carried out to a variety of defects to restore pressurised pipeline and pipework integrity. In 2014, Belzona SuperWrap II was released, which exhibits greater strength and allows for a much more efficient application procedure, therefore reducing overall costs and downtime.

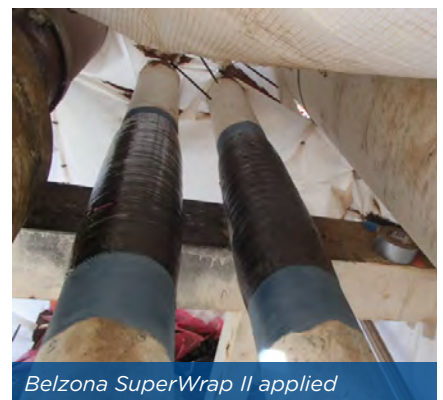
Belzona SuperWrap II applied

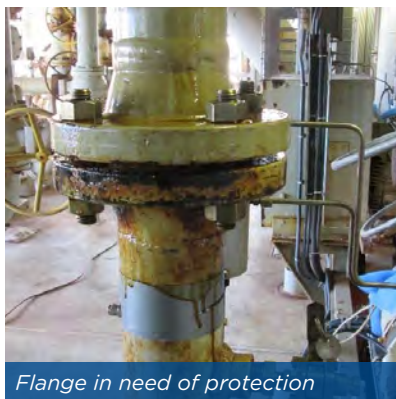
Flange in need of protection

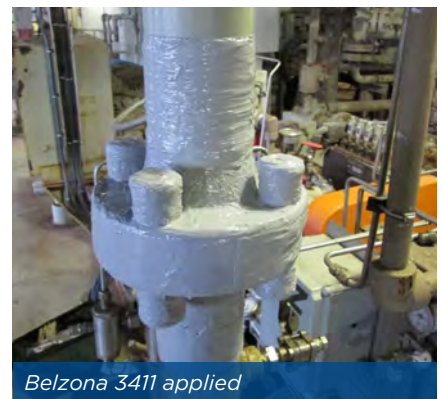
Belzona 3411 applied

Repairing flange crevice corrosion can be a very costly exercise, whereas common preventative measures in most cases are not 'inspection friendly'. Belzona encapsulating membrane system seals bolted flange connections preventing corrosion. The liquid applied system includes a corrosion inhibitor and was designed to allow for periodic inspection, where the flexible protection can be cut, peeled back and then easily resealed. To maintain Health and Safety standards, the system is hand applied and cures at ambient temperatures and can resist common corrosive media.

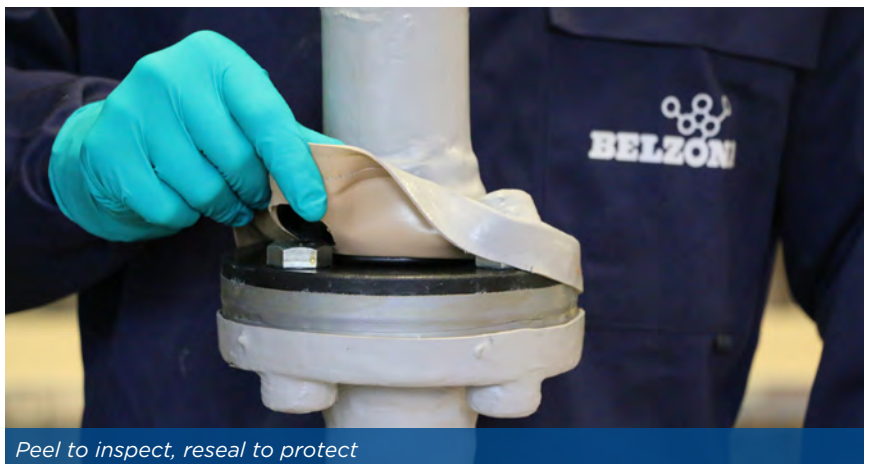
Peel to inspect, reseal to protect

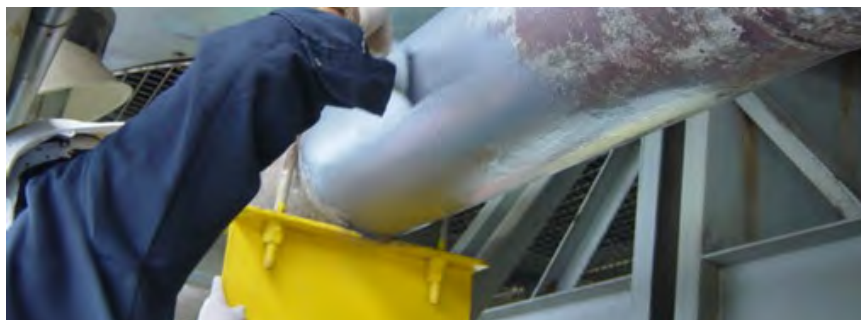
CUI solution applied on-line onto hot contaminated surfaces

Corrosion under insulation occurs at an accelerated rate and can remain undetected for some time. Taking affected parts of the pipework out of service for repairs or replacement can in turn lead to high costs and lengthy downtime. To address this problem, in the late 1990s, Belzona formulated heat activated composites and coatings that facilitate on-line repairs. These materials adhere exceptionally well to hot contaminated surfaces and penetrate deep into the substrate eliminating the need for an angular profile prior to application.

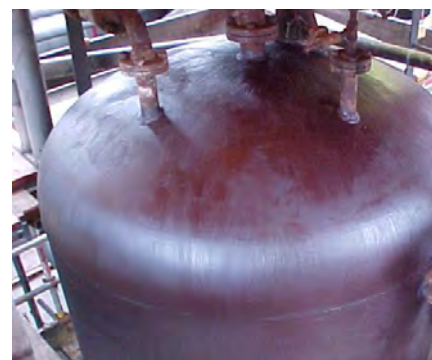
Completed application

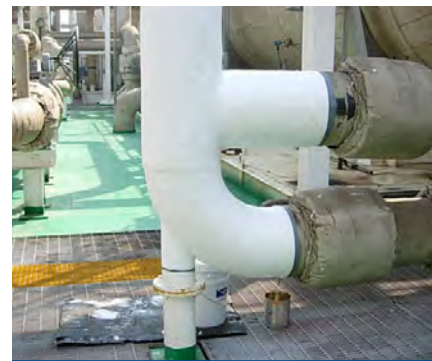
Pipe lagging sealed

In order to prevent CUI, Belzona designed a liquid applied breathable insulation encapsulation system in the 1980s. This membrane system can be applied to protect the lagging of pipework, towers and LNG spheres. The system keeps the underlying substrate dry by allowing for the vapour to escape and facilitates localised inspections. This system is durable and fire retardant and remains flexible in service.

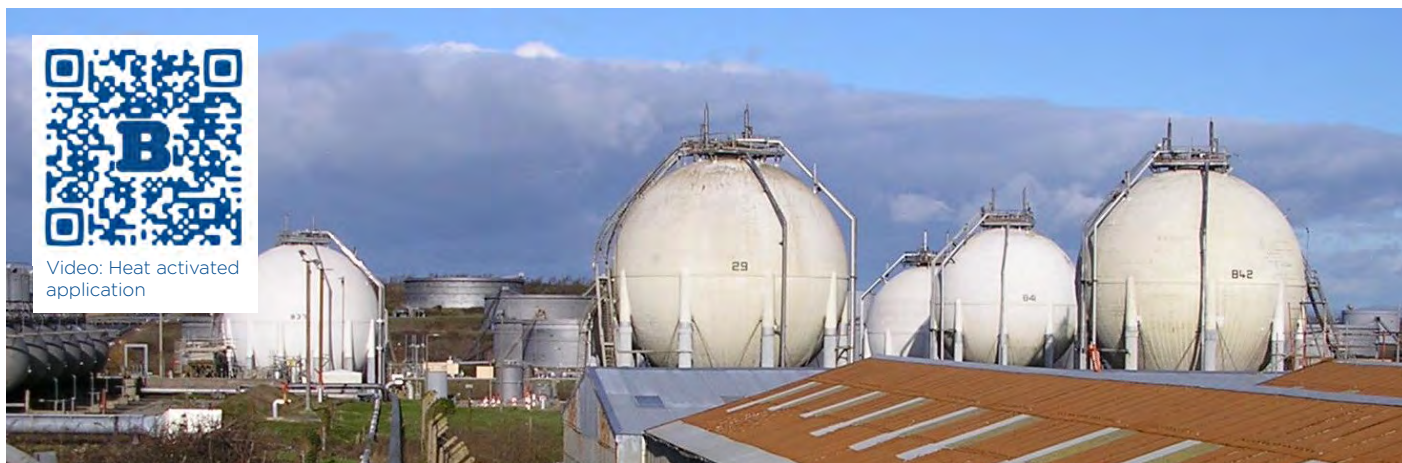
LNG spheres protected with Belzona, inspected 11 years later

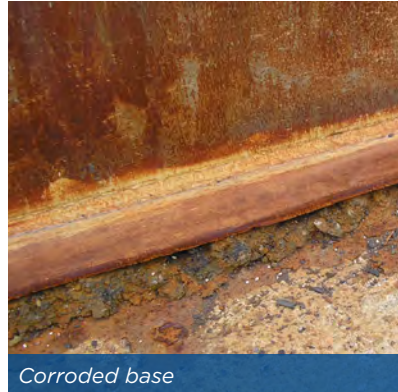
*Corroded base*

Sealant failure, adverse weather conditions or condensation can lead to corrosion of the tank base, leakage and ultimately tank failure. To combat these problems, Belzona formulated a tank base sealing system in the mid 1960s, which is liquid applied in conjunction with a reinforcement sheet. As a membrane, the system possesses a unique breathable feature. Liquid cannot permeate the membrane while the vapour escapes freely, allowing for the base seal to stay dry. The system remains flexible in service and adapts to thermal expansion loading, while at the same time offering excellent UV resistance. NDT can be used through the system to measure the thickness of the annular ring. Following three decades of tank base repairs, Belzona membrane is now being specified as the sealant choice for new tanks.

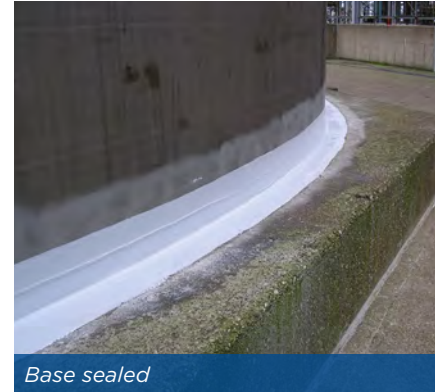
*Base sealed*

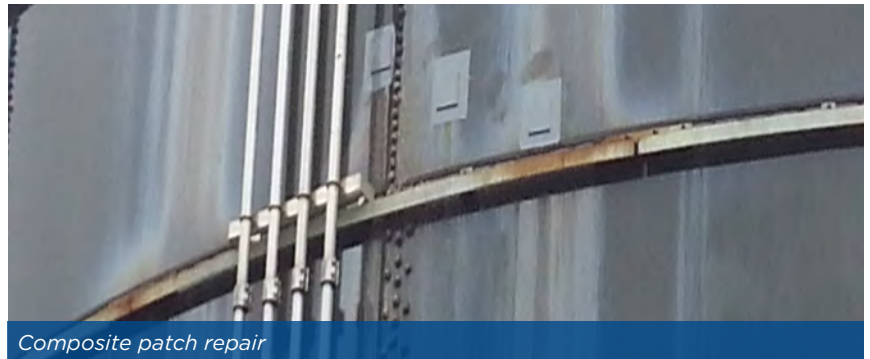
*Composite patch repair*

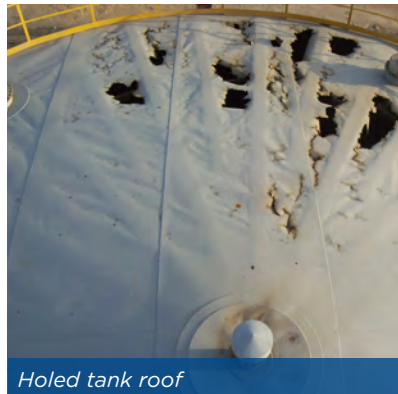
*Holed tank roof*

Roofs are susceptible to rapid deterioration caused by the corrosive vapour of the storage media and exacerbated by external forces, in particular when tanks are located near the sea. Roof damage can be safely repaired in situ and on-line eliminating the need to degas and drain the tank.

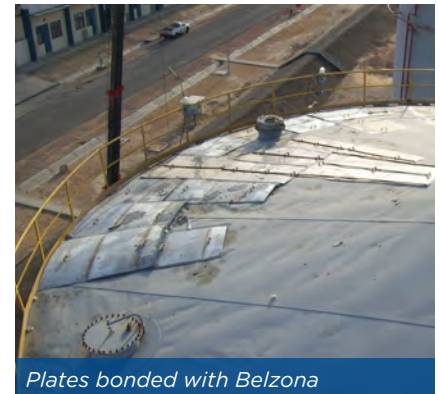
*Plates bonded with Belzona*

Tank walls can also suffer from leaking welds and corrosion. Belzona repairs can be carried out on-line with the use of cold bonded doubler plates or a reinforced composite system. Cold bonding technique can be utilised not only for repairs, but also for bonding rails, pipe supports and other fittings.

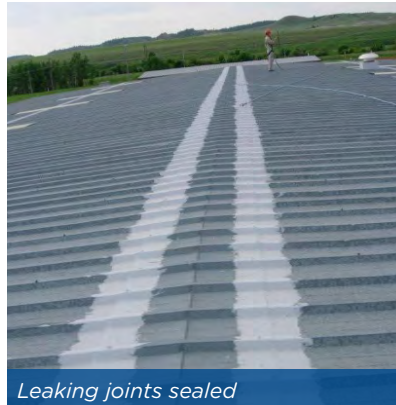
*Leaking joints sealed*

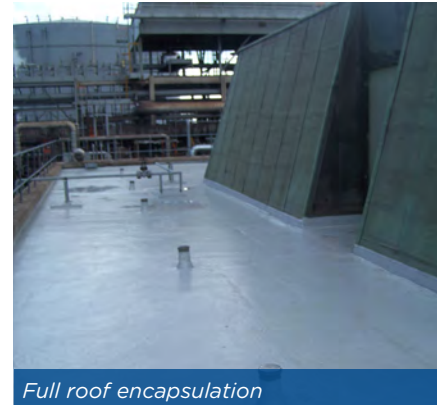
*Full roof encapsulation*

Movement, loading and freeze-thaw cycles can lead to the deterioration of roofing protection. Belzona liquid applied membranes can seal localised leaking areas or the whole roof and adhere to various substrates and geometries. Protection is seamless and moves in sympathy with the substrate, allowing for expansion and contraction. Emergency solutions are also available, applied directly onto wet roofs.

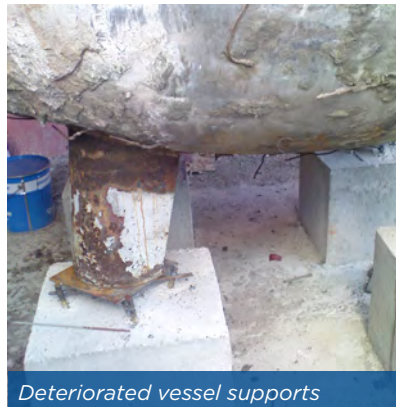
*Deteriorated vessel supports*

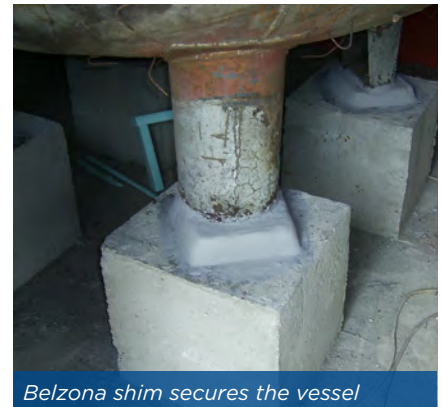
*Belzona shim secures the vessel*

Load bearing floor areas, plinths and supports can suffer damage caused by impact or chemical attack. Belzona materials adhere exceptionally well to dissimilar substrates and provide excellent chemical resistance and compressive strength. Full cure can be achieved within a few days, and the shim can be formed to achieve the required dimensions.

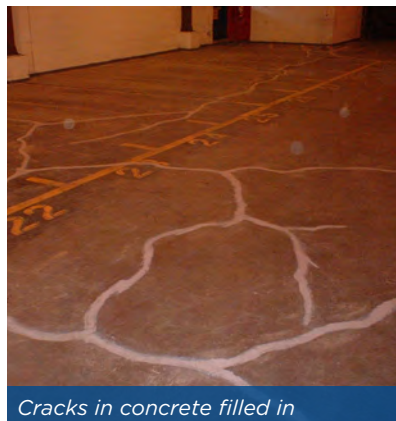
*Cracks in concrete filled in*

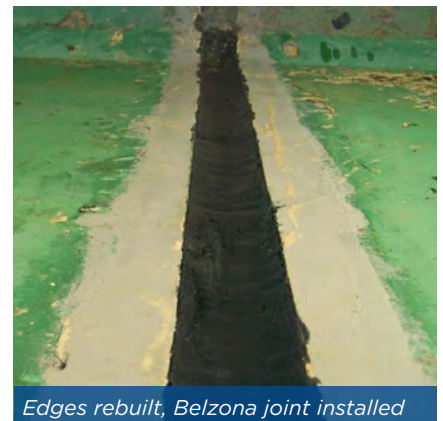
*Edges rebuilt, Belzona joint installed*

Joints and concrete nosings are susceptible to deterioration caused by impact, thermal cycling, UV and chemical attack. Belzona Elastomers are used to recreate the expansion joint and allow for greater movement due to their up to 1000% elongation. Concrete or metal nosings can be rebuilt using fast curing Magma Polymers, which also provide excellent abrasion, impact and chemical resistance.

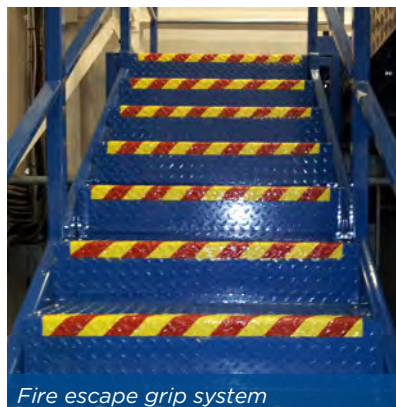
*Fire escape grip system*

Unsafe slippery surfaces make for a hazardous working environment. Belzona offers safety grip systems available in various safety colours and applicable to numerous substrates, including metals, concrete and tiles. Coatings are blinded with aggregate and hand-applied to create a durable grip system. Belzona grip systems remain maintenance-free for longer as the aggregate does not wear off easily through movement and impact.

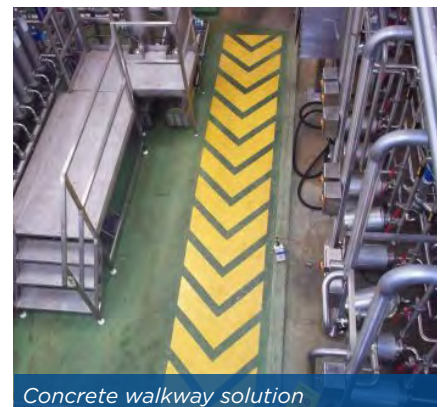
*Concrete walkway solution*
