# MAINTAINING ASSET INTEGRITY IN THE POWER INDUSTRY

Belzona Protective Coatings and Engineering Composites

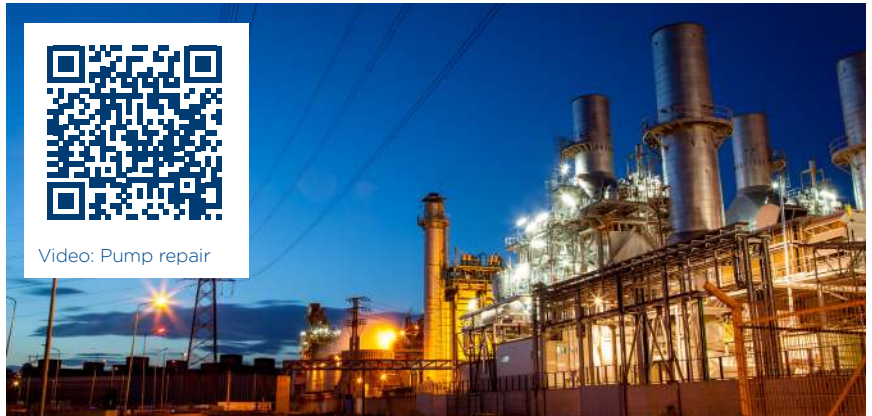
Video: Pump repair

Pump deterioration can lead to decreased pumping efficiency, higher energy consumption and eventual costly part replacement. Pitting, worn wear ring clearances as well as thin-wall and through-wall casing defects can be rebuilt using cold-applied paste grade composites which provide long-term corrosion and erosion resistance.

After the surface profile has been rebuilt, the pump internal areas can be protected for the long term against the effects of erosion-corrosion with a Belzona 1300 Series coating. Pumping efficiency can be restored and enhanced with the use of a hydrophobic smooth lining. Belzona 1341 (Supermetalglide) has demonstrated efficiency increases of up to 7% on new equipment and up to 20% on refurbished assets.

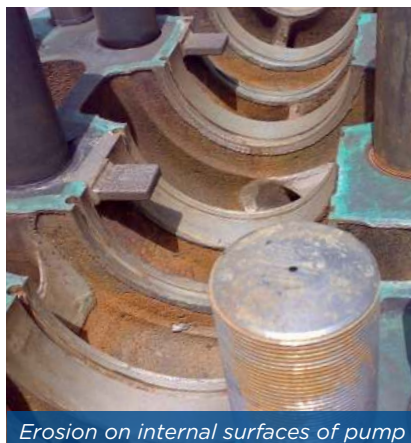
Erosion on internal surfaces of pump

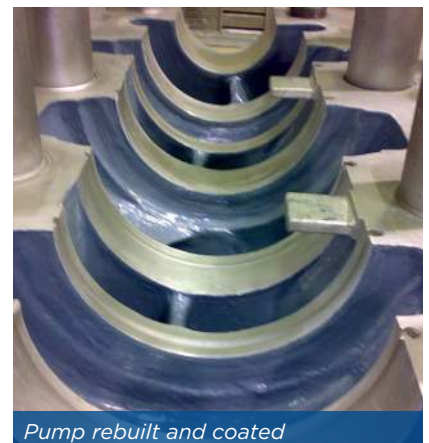
Pump rebuilt and coated

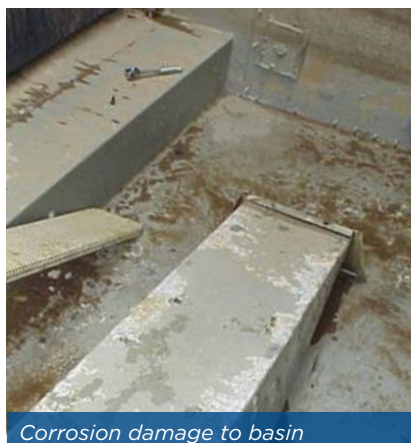
Corrosion damage to basin

Commonly, cooling tower basins are constructed from steel or concrete and, over time, suffer from general corrosion. The water treatment chemicals used to prevent scale and fouling further accelerate corrosion rates. Corrosion of the hot well and sump at the base of the tower is a common problem which can be prevented with Belzona.

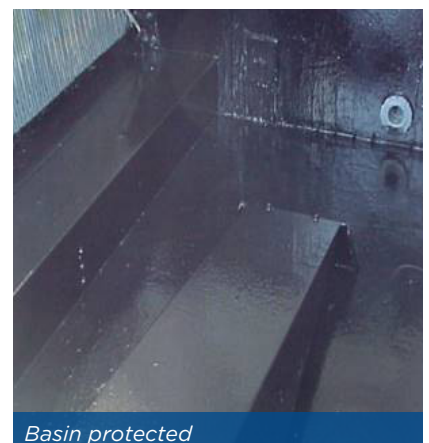
Basin protected

Belzona 5800 Series coatings are specifically designed to be suitable for continuous immersion in aqueous solutions such as cooling water. These materials will also continue to provide protection even if the water chemistry is seriously compromised.

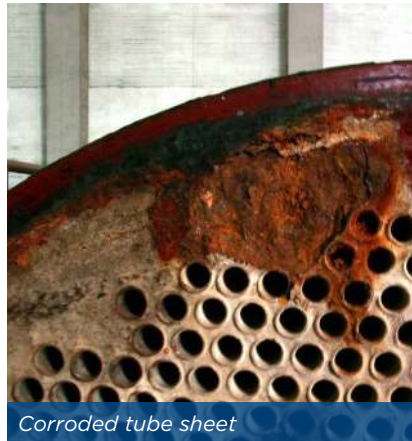
*Corroded tube sheet*

When exposed to an electrolytic solution, galvanic corrosion can occur at the interface of the tube and the tube sheet. Belzona materials halt galvanic corrosion, preventing continuing metal loss, and offer excellent erosion and chemical resistance. This eliminates the need for part replacement and significantly reduces maintenance expenses. A Belzona 1100 Series rebuilding metal can be used to rapidly repair and rebuild damaged tube sheets in situ, prior to the application of a long-lasting protective coating.

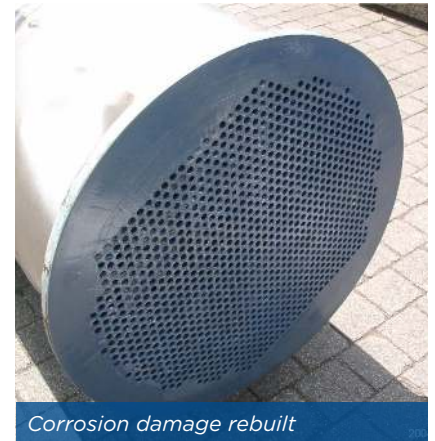
*Corrosion damage rebuilt*

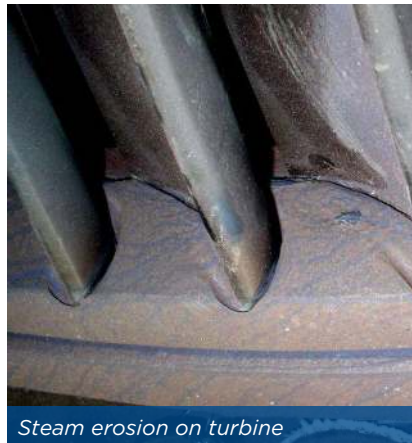
*Steam erosion on turbine*

Despite their importance, steam turbines are often condemned due to operating inefficiency or rising vibration levels. In cases where evidence of steam erosion-corrosion is visible, a Belzona solution can be utilised to provide a long-term repair. Turbine diaphragms, flanged joints and rotors can be repaired and protected using Belzona 1100 Series rebuilding composites and Belzona 1300 Series coatings. Our solutions offer exceptional continual wear resistance whilst demonstrating excellent erosion-corrosion protection. By utilising a Belzona solution, steam turbine operators can expect significant cost savings when compared to equipment replacement.

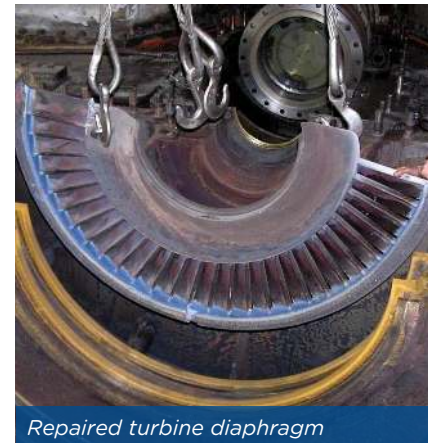
*Repaired turbine diaphragm*

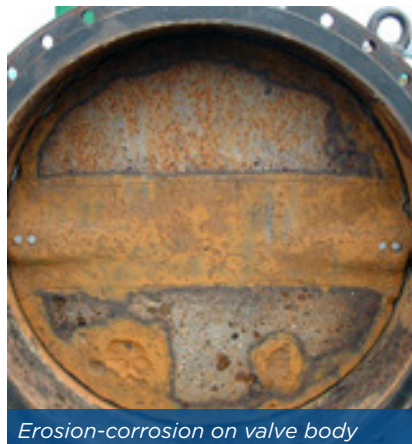
*Erosion-corrosion on valve body*

Common causes of damage and deterioration to pipes, valves and fittings can include impact and frost damage, corrosion, erosion and chemical attack. Belzona provides a wide range of cold-curing repair composites and epoxy-based immersion coatings specifically designed to offer outstanding erosion and corrosion protection coupled with excellent chemical resistance.

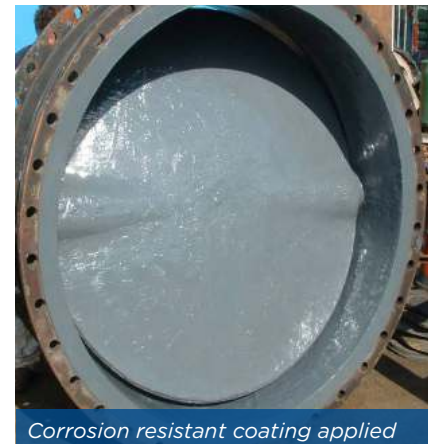
*Corrosion resistant coating applied*

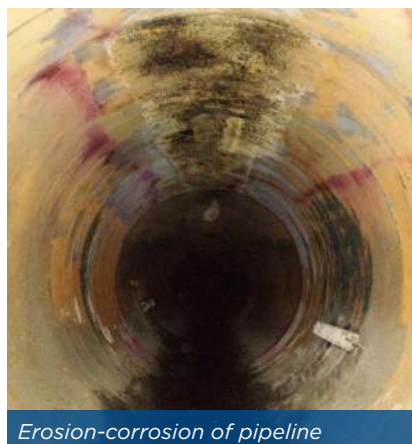
*Erosion-corrosion of pipeline*

Belzona pioneered a spray-friendly pipe lining system that offers outstanding erosion-corrosion protection. The substitution of hard ceramic fillers for a thermoplastic filler blend ensures there is very little wear spray equipment. These linings allow for in-situ spin spray applications at wet film thickness over 1,200 microns without sagging, effectively covering girth welds and joints in a single coat.

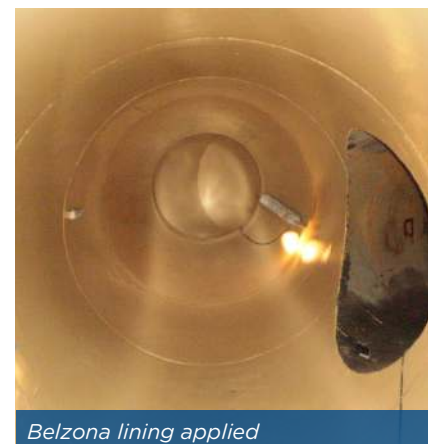
*Belzona lining applied*

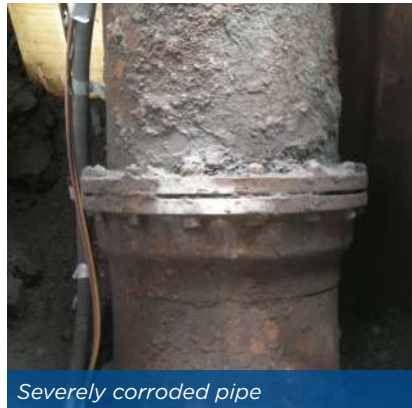
Severely corroded pipe

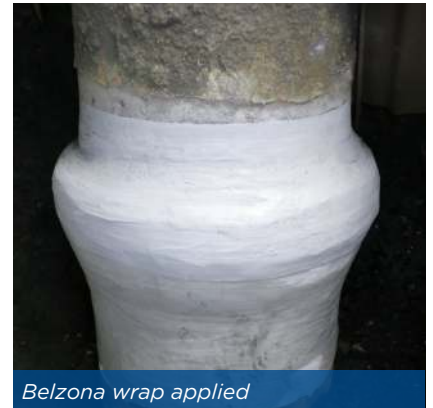
Belzona wrap applied

A wrap system is composed of a reinforcement sheet and a Belzona composite material, tailored to the asset's performance criteria, such as presence of contaminants, operating temperature and pressure levels amongst others. Following almost five decades of pipe wrap applications, Belzona SuperWrap II was introduced to repair corroded, weakened and holed pipe and tank walls. This system is compliant to ASME PCC2 Article 4.1 and ISO/TS 24817.

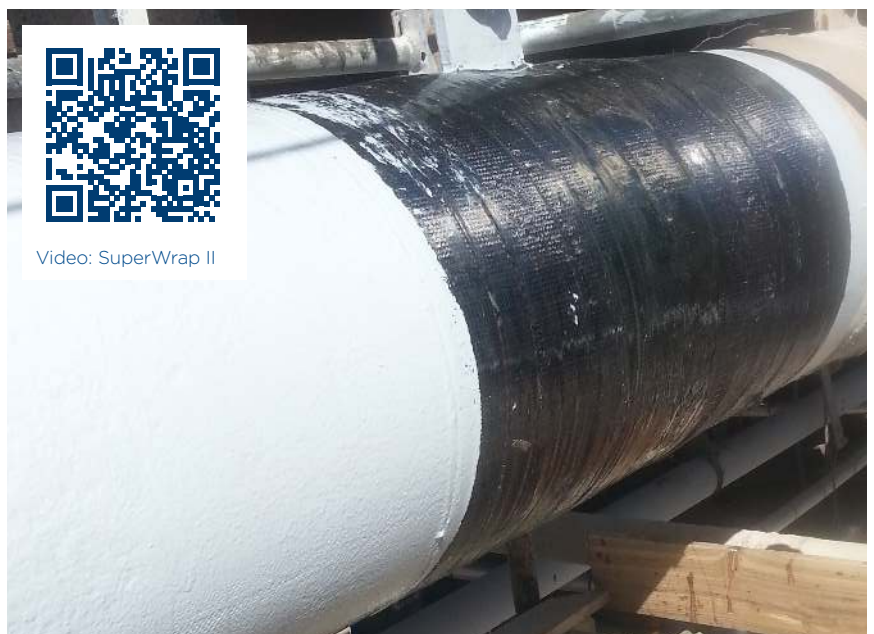
Video: SuperWrap II

Belzona SuperWrap II compliant to ASME PCC2 Article 4.1 and ISO/TS 24817

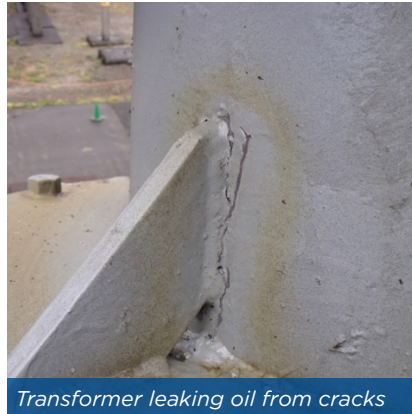
Transformer leaking oil from cracks

Transformer leaks are commonly caused by degrading gaskets or holing as a result of corrosion and impact in the radiator fins or steel tanks. Often these leaks present as slow drips but, over time, large volumes of oil can be lost, spilling hundreds of gallons of mineral oil into the environment. If a failure like this occurs it can cause the transformer to short circuit and result in health and safety concerns. These dangers, coupled with the transformers' isolated locations, make inspection, repair and maintenance a major challenge.

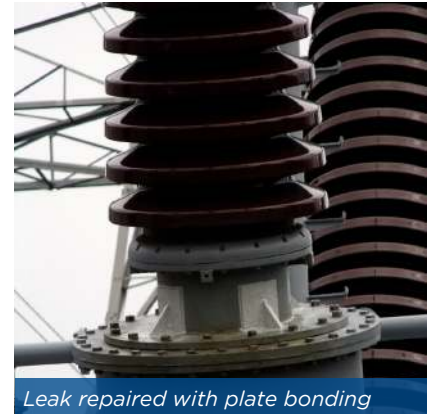
Leak repaired with plate bonding

By utilising a Belzona 1200 Series emergency rebuilding paste grade material, repairs can be undertaken quickly and in situ without the need to drain the transformer oil.

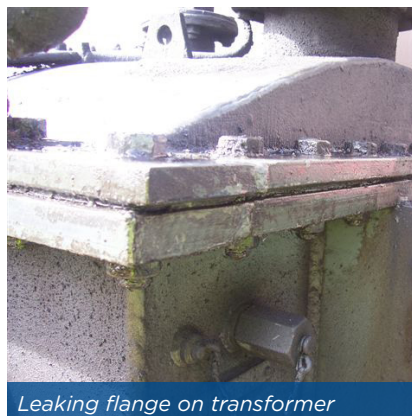
Leaking flange on transformer

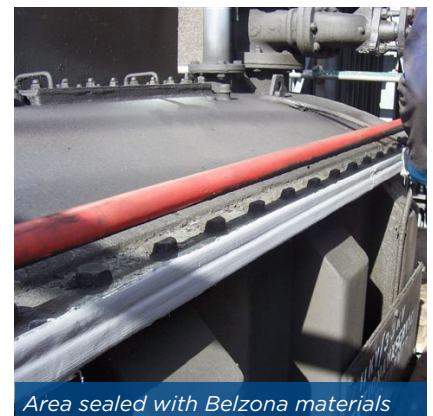
Area sealed with Belzona materials

Surface-tolerant, fast-curing materials such as Belzona 1212 will bond strongly to oily and wet metal surfaces. These cold-applied materials eliminate the need for hot work and have been designed to be easy and safe to use.

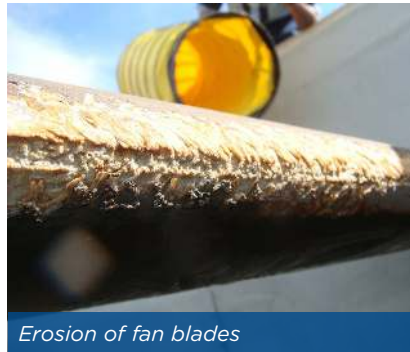
Erosion of fan blades

Cooling tower fan blades commonly suffer from erosion, corrosion, impingement and UV degradation. On leading edges this can reduce the overall efficiency and operation of the cooling system, raising concerns over blade replacement.

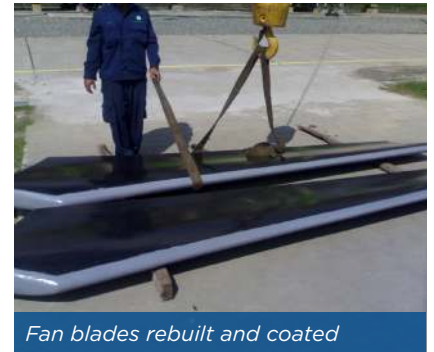
Fan blades rebuilt and coated

Belzona erosion and corrosion resistant paste grade materials and coatings are extensively used by power plant engineers to repair, protect and even increase the efficiency of damaged fan blades. After rebuilding the leading edge profile with a paste grade material for pit filling or by cold bonding a steel plate where the damage is more extended, a Belzona 1300 Series erosion resistant coating is applied to provide long-term protection. A Belzona 5000 Series coating can be used on the blade body to protect it against corrosion and environmental degradation.

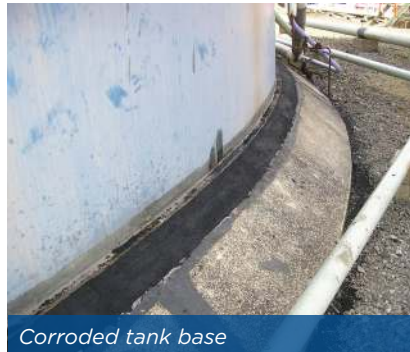
Corroded tank base

Sealant failure, adverse weather conditions or condensation can lead to corrosion of the tank base, leakage and ultimately tank failure. To combat these problems, Belzona formulated a tank base sealing system in the mid 1960s, which is liquid applied in conjunction with a reinforcement sheet. As a membrane, the system possesses a unique breathable feature; liquid cannot permeate the membrane. However, the vapour escapes freely, allowing for the base seal to stay dry. The system remains flexible in service and adapts to thermal expansion loading, while at the same time offering excellent UV resistance.

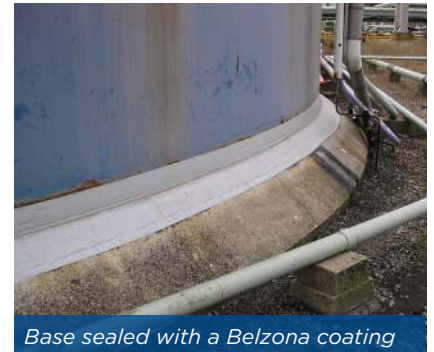
Base sealed with a Belzona coating

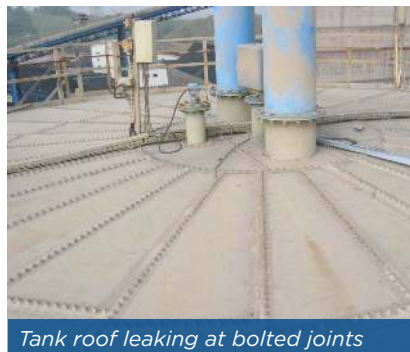
Tank roof leaking at bolted joints

Tank roofs are susceptible to rapid deterioration caused by the corrosive vapour of the storage media and is exacerbated by external forces. Roof damage can be safely repaired in situ and on-line, eliminating the need to degas and drain the tank.

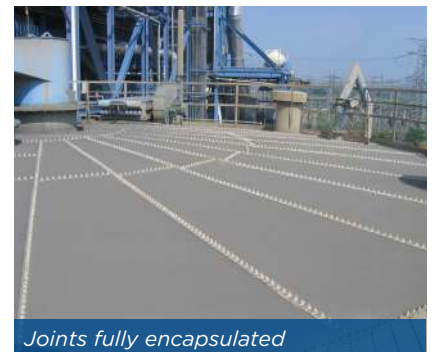
Joints fully encapsulated

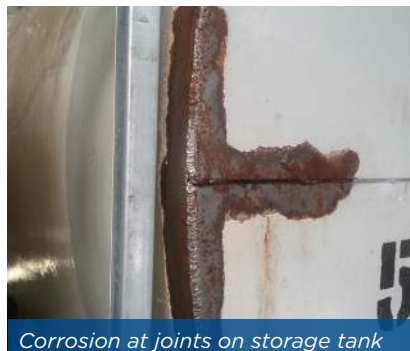
Corrosion at joints on storage tank

Tank walls can also suffer from corrosion and leaking welds. Belzona repairs can be carried out on-line with the use of cold bonded doubler plates or a reinforced composite system. The cold bonding technique can be utilised, not only for repairs, but also for bonding rails, pipe supports and other fittings.

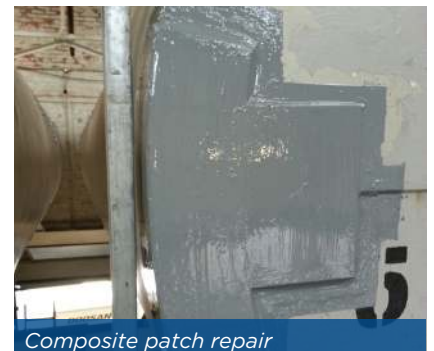
Composite patch repair

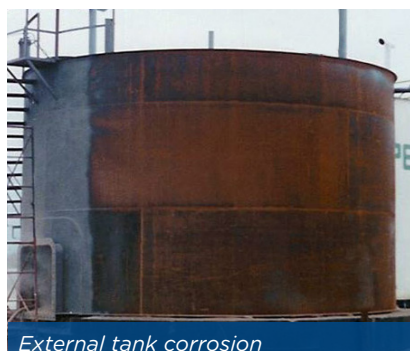
External tank corrosion

Spray applied, corrosion resistant epoxy coatings provide easy to clean surfaces and long-term corrosion protection for tank external surfaces.

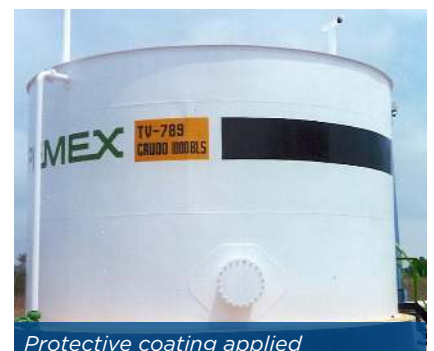
Protective coating applied

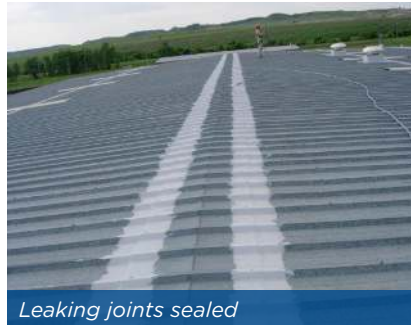
Leaking joints sealed

Movement, loading and weathering can lead to the deterioration of roofing protection. Belzona liquid applied 3000 Series membranes can seal the entire roof or localised leaking areas and adhere to various substrates and geometries. Protection is seamless and moves in sympathy with the substrate, allowing for expansion and contraction. Emergency solutions are also available, which can be applied directly onto wet surfaces.

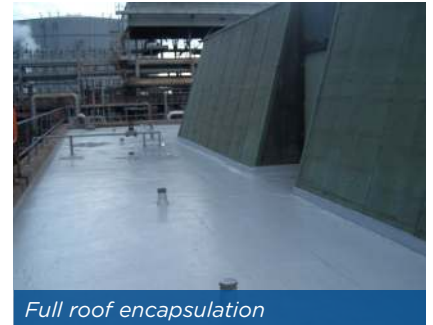
Full roof encapsulation

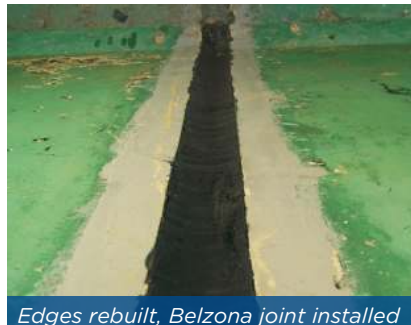
Edges rebuilt, Belzona joint installed

Joints and concrete nosings are susceptible to deterioration caused by impact, thermal cycling, mechanical and chemical attack. Belzona 2000 Series Elastomers are used to recreate expansion joints but allow for even greater movement due to their excellent elongation.

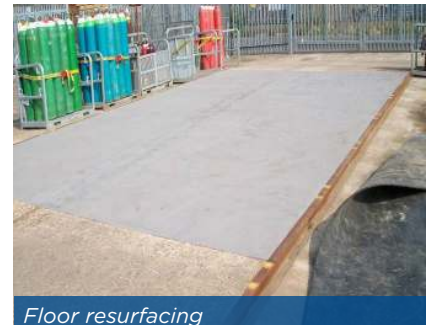
Floor resurfacing

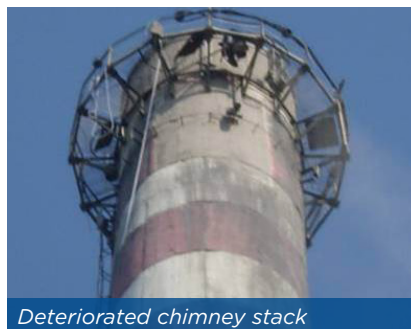
Deteriorated chimney stack

Walls and chimneys suffering from physical, bacterial and chemical attack, as well as water ingress, can be protected with Belzona 5000 Series coatings. Our range of wall coatings provides excellent UV protection and their smooth surface does not attract dirt and will 'self-clean' during rain fall.

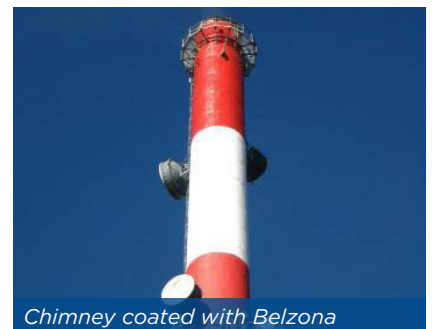
Chimney coated with Belzona

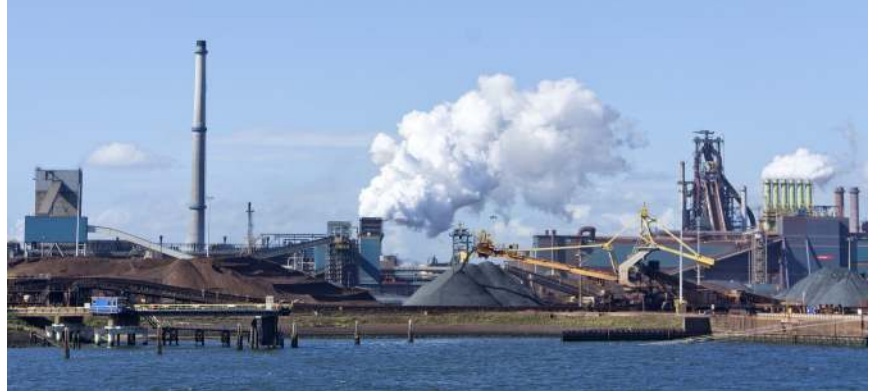
Damage to pipework

Flue Gas Desulphurisation (FGD) systems and associated equipment are exposed to highly severe environments. These include high abrasion, high temperature and temperature fluctuations, aggressive acid atmospheres and wet-dry cycles, or a combination of these. Construction materials can be easily damaged when exposed to these conditions and require repair and protection solutions able to withstand this environment.

Belzona paste grade composites for metal repair can be used to rebuild deteriorated FGD equipment. Withstanding different damage mechanisms, such as high erosion or elevated temperatures, these materials help to significantly slow down the erosive process even in areas such as piping, ductwork and absorbers, where chemicals are present. A Belzona coating can then be specified to protect the equipment from further deterioration.

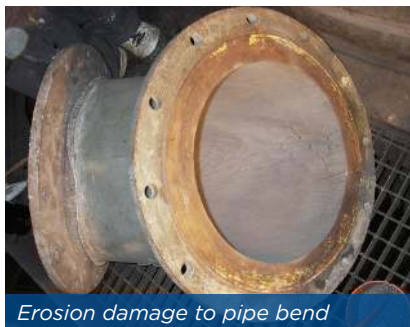
Erosion damage to pipe bend

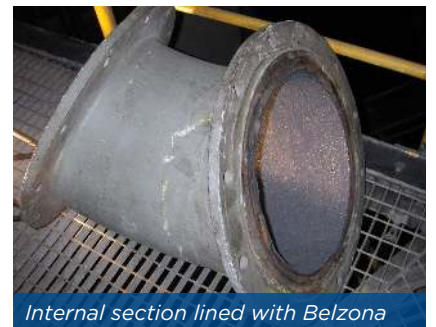
Internal section lined with Belzona

Belzona 1800 Series of abrasion resistant linings combine hard wearing ceramic aggregates in a polymeric binder to rebuild the lost metal and provide a tough sacrificial lining. New equipment can also be lined with these materials to significantly slow down wear rates. These linings are applied and cure at room temperature, eliminating the need for hot work. Their solvent-free formulation allows the materials to be safely applied in confined areas.

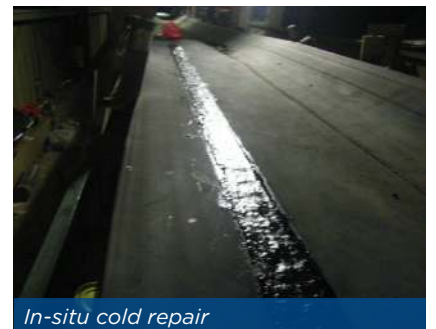
In-situ cold repair

Due to general wear, tear and heavy abrasion, conveyor belts regularly become worn, ripped or torn. Belzona Elastomers are ideal for the in-situ repair of conveyor belts without the need to disassemble the equipment. These flexible materials can be applied without the need for specialist tools, vulcanisation or heat and will adhere to almost any surface. They provide excellent resistance to wear, abrasion and atmospheric degradation and, in addition, offer high elasticity and exceptional mechanical strength.
