All Around Home Inspection

PROPERTY INSPECTION REPORT

Concerning: 102 Any Street, Your Town , TX
(Address or Other Identification of Inspected Property)

By: Darron Bunch, Lic #TREC # 22645 05/09/2018
(Name and License Number of Inspector) (Date)

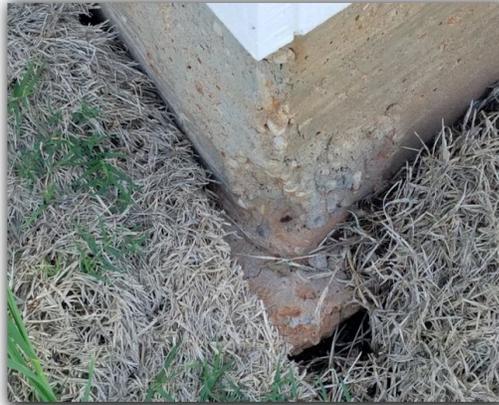
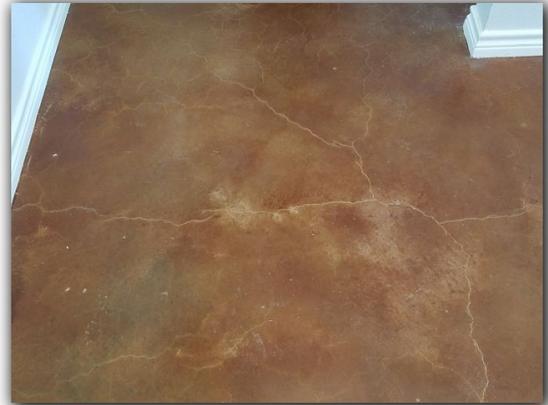
Corner spalling/popping or cracking observed.

Evidence of air pockets during the form and pour process observed in multiple locations.

Finished floor is the foundation surface. Surface cracking observed. Commonly found when concrete dry's and sets.

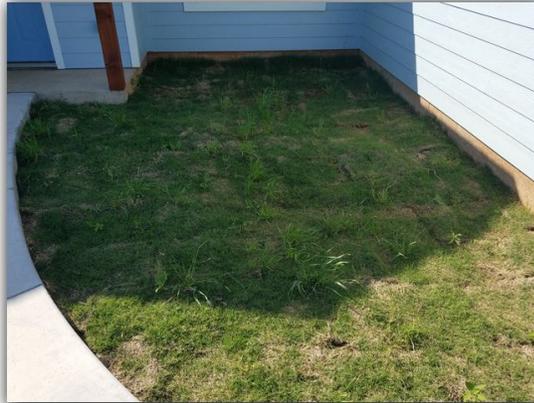
Drainage needs to be corrected.

Grade slopes towards foundation

Side walk may trap water runoff

Recommend further evaluation to improve drainage.

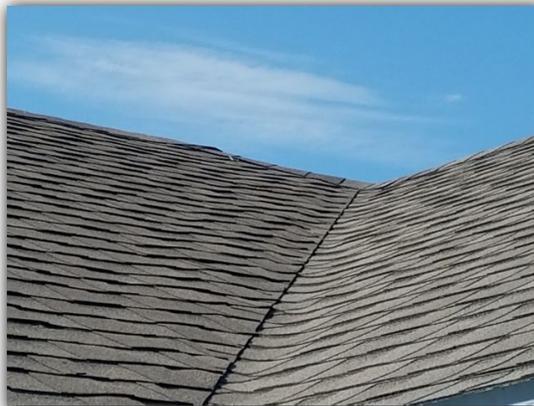
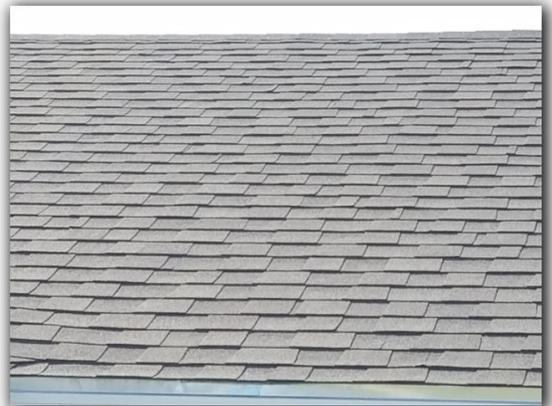
Roof cover appears to be in first stages of life.

Appears to be as intended at the time of inspection.

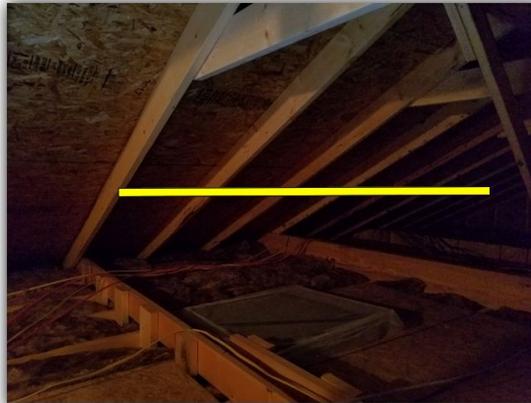
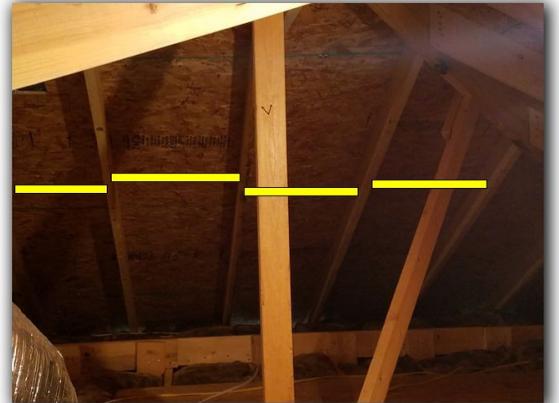
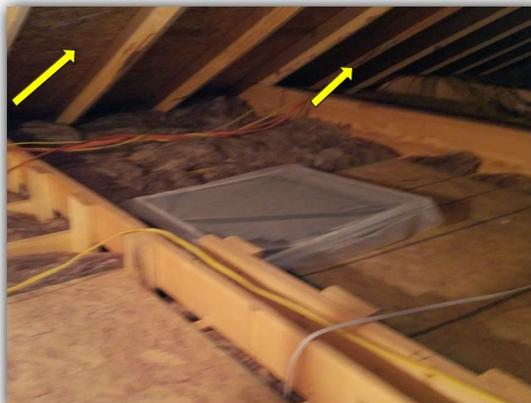
Rafter ties of minimum 2 x 4 between every rafter pair is recommended.

Under periling minimum 2 x 4 to are also recommended to prevent rafter movement and bowing.

Recommend further evaluation by structural engineer.

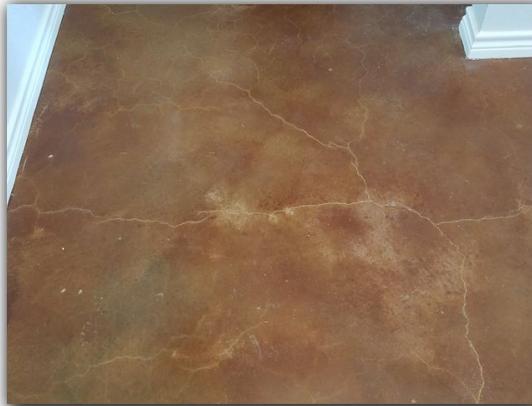
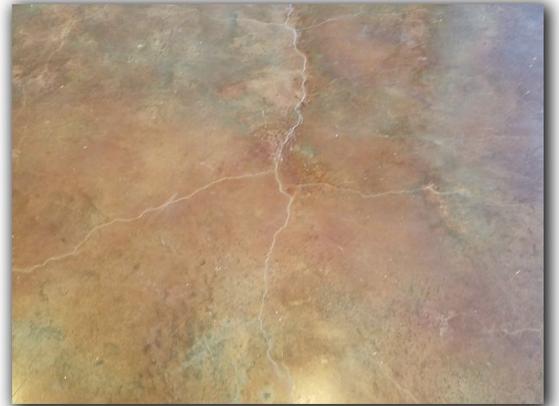
Slab cracking observed in finish floor. Commonly found issue.

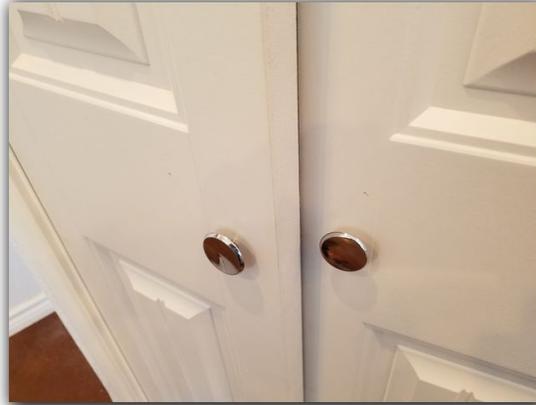
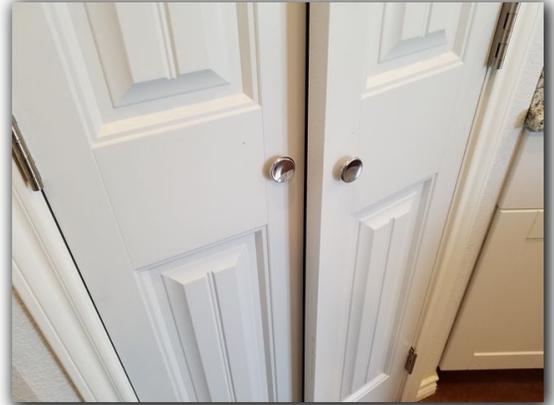
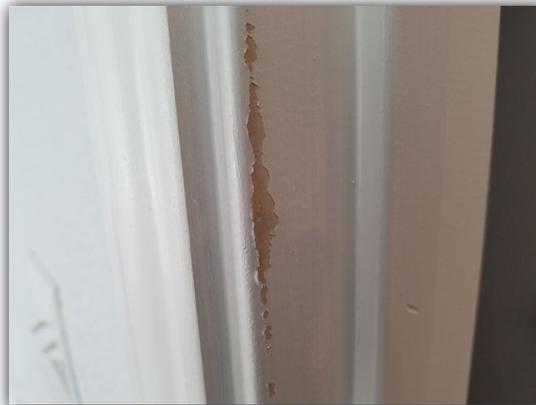
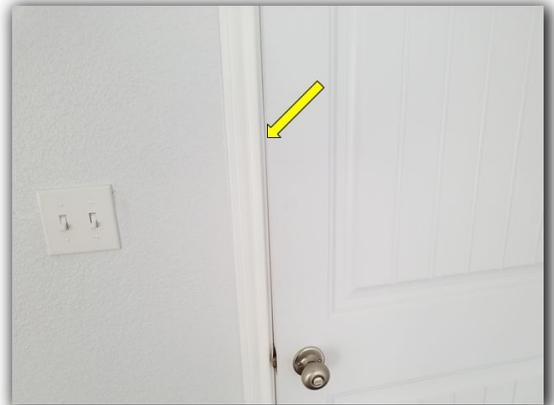
Conflict of pantry doors. Both should closed beside the other and not forced.
Master bedroom door frame and door touch. Damage observed.

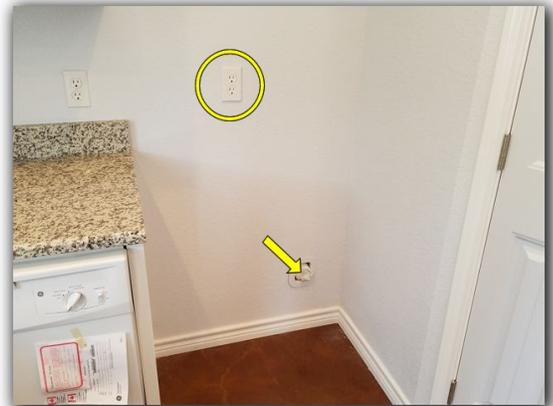
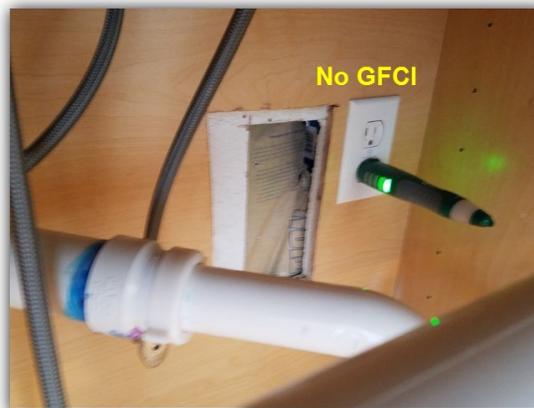
GFCI is not used as recommended by today's standards.

GFCI protection is not used in all locations within 6 feet of a water source.

Damage under counter observed.

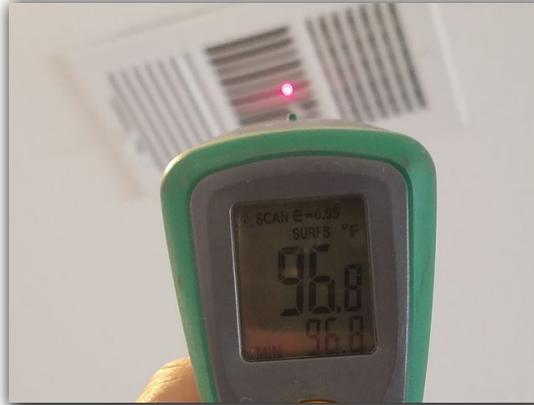
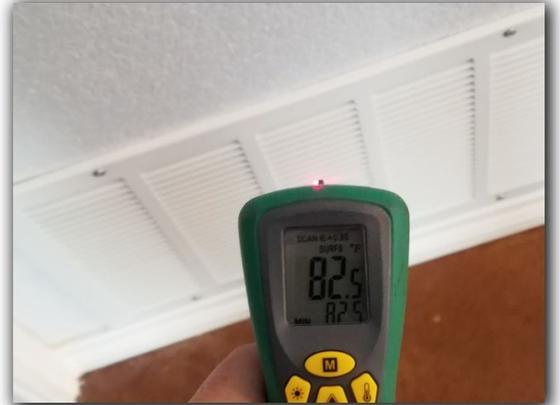
Primary drain is to have a trap and uncapped vent.

Door stop is no recommended. Access should not be blocked 30 x 30 min.

Recommend further evaluation buy licensed professional in HVAC.

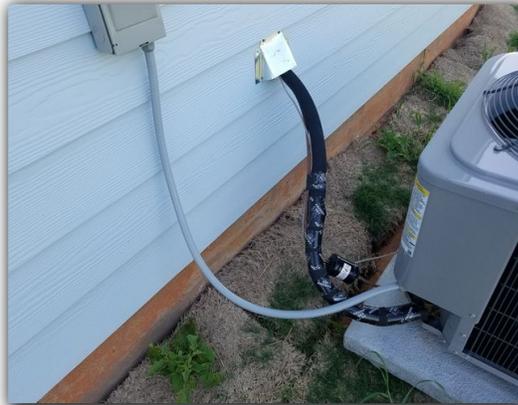
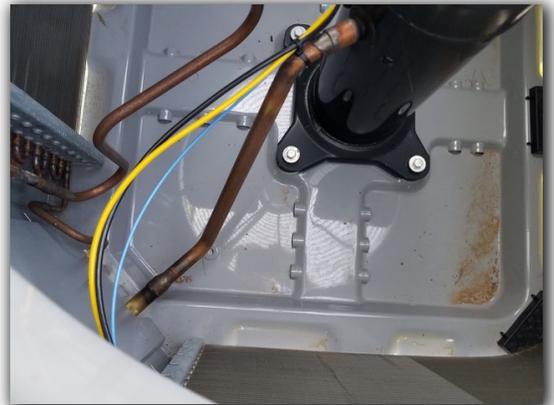
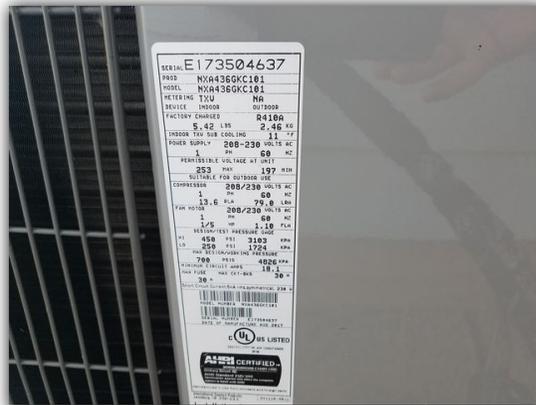
A/C Size: 3.0 ton

Appear to be as intended at the time of inspection

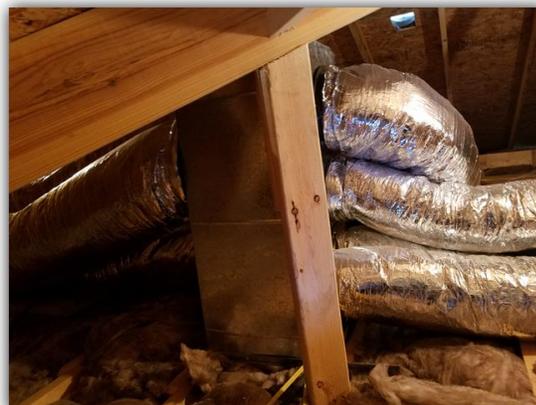
Type of Duct: Flex Duct

Appear to be as intended at the time of inspection

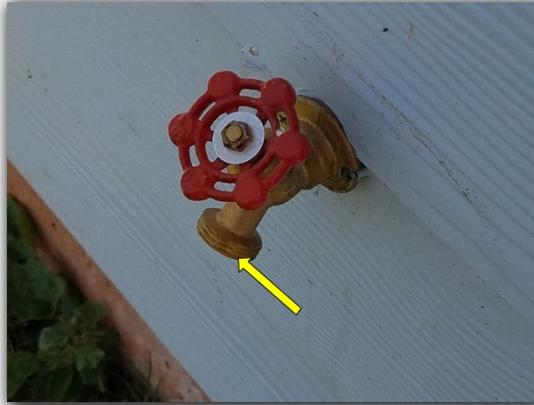
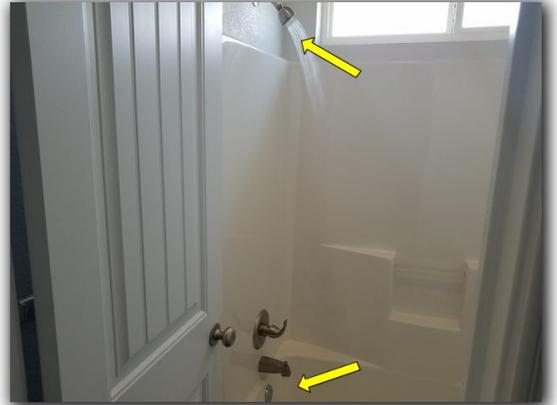
Shower Diverter. Did not properly control water flow to the shower head.

Mixing valve control improperly installed.

Anti syphon, back flow devices are recommended by today's standards.

Recommend further examination by licensed professional plumber.

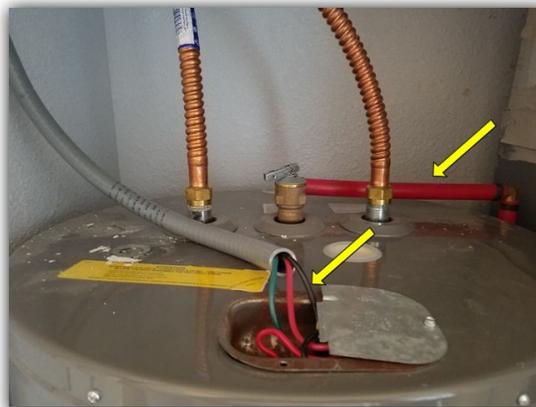
Note: Water heating equipment in a location that a leak in the tank may cause damage, A secondary drain pain should be installed by today's standards.

PEX piping is to be increased one nominal pipe size when used as a drain line.

Drain pains are recommended to piped be outside or approved drain.

Improper wiring observed.

Recommend further evaluation by licensed plumbing professional.

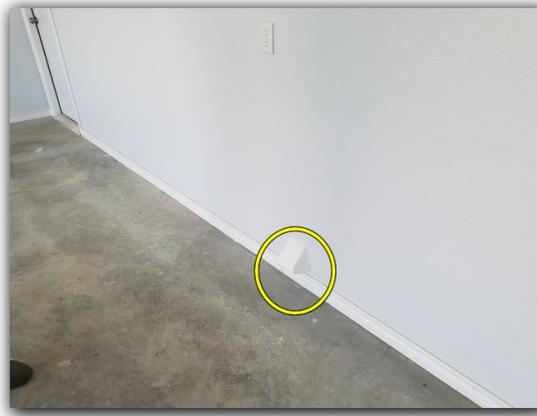
Lint collection or dryer exhaust system is to be vented to the exterior.

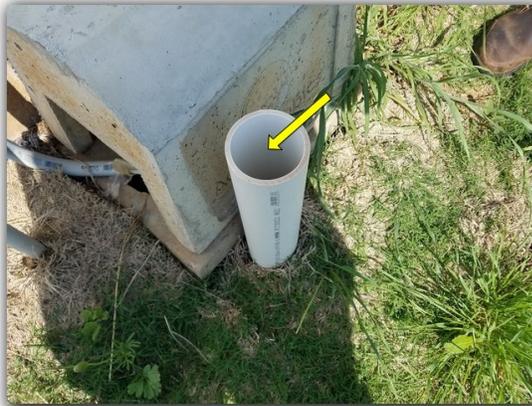
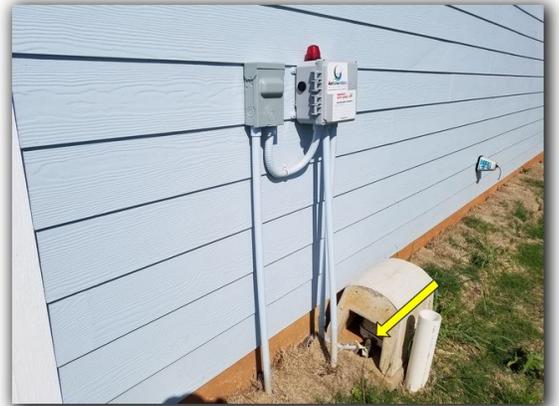
Breaker was off stopping the proper function.
System in alarm at the time of inspection.
Clean out uncapped. Recommend threaded clean out cap.
Tank level full
Septic aerator system is not setting level.
Functional flow tested.
Recommend farther evaluation by professional septic service provider.

Note: System seemed to run until proper water levels were reached and the alarm stopped by the end of the inspection.
