All Around Home Inspection

PROPERTY INSPECTION REPORT

Concerning: 007 Any Street, Your Town , TX 76007
(Address or Other Identification of Inspected Property)

By: Darron Bunch, Lic #TREC # 22645 08/01/2017
(Name and License Number of Inspector) (Date)

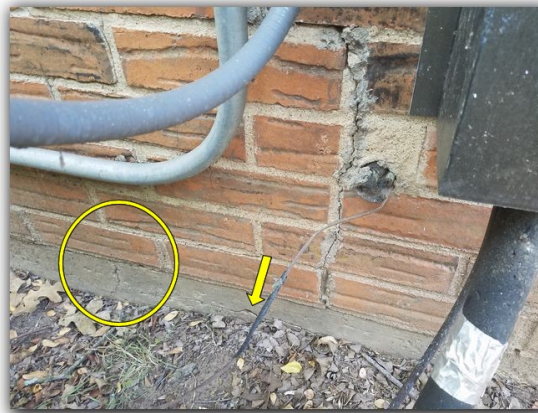
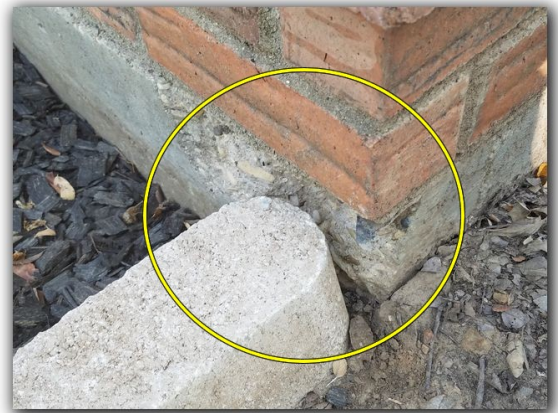
Foundation shows signs of movement primarily in the front and East side of the home.

Further evaluation by professional foundation engineer is recommended.

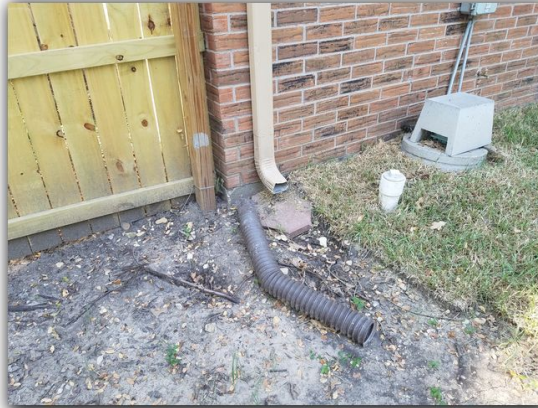
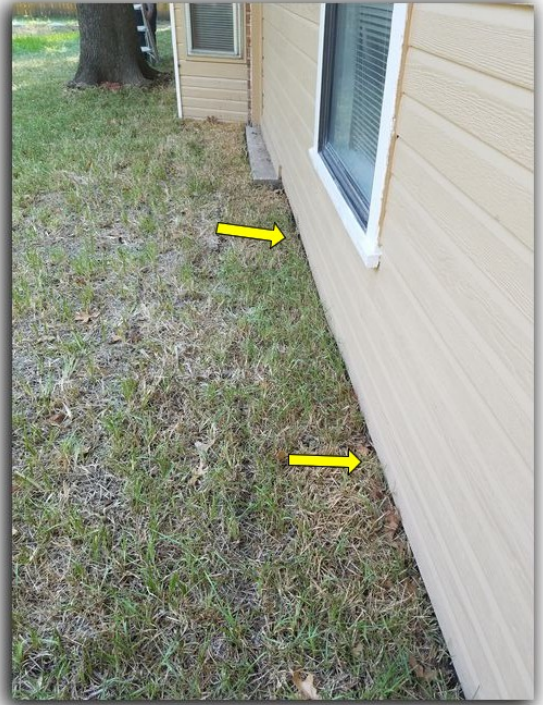
Debris observed in rain gutter.

Hight of the sod added around the home is recommended 4 to 6 lower than brick or siding.

Down spouts are recommended to waste 3 to 5 feet away from structures.

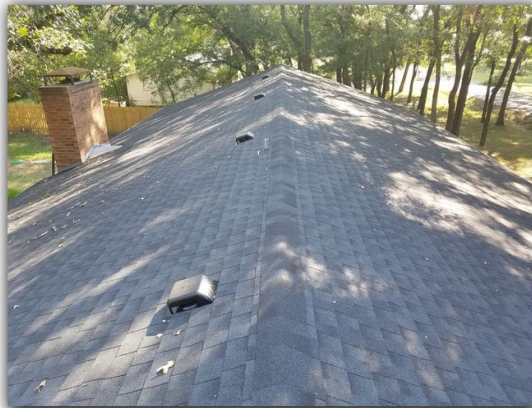
Shingles appear to be in early stage of there lifetime.

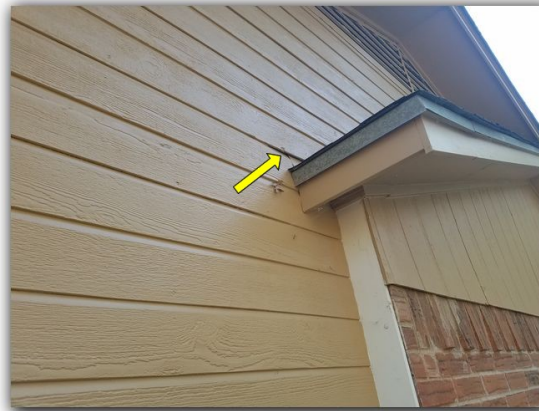
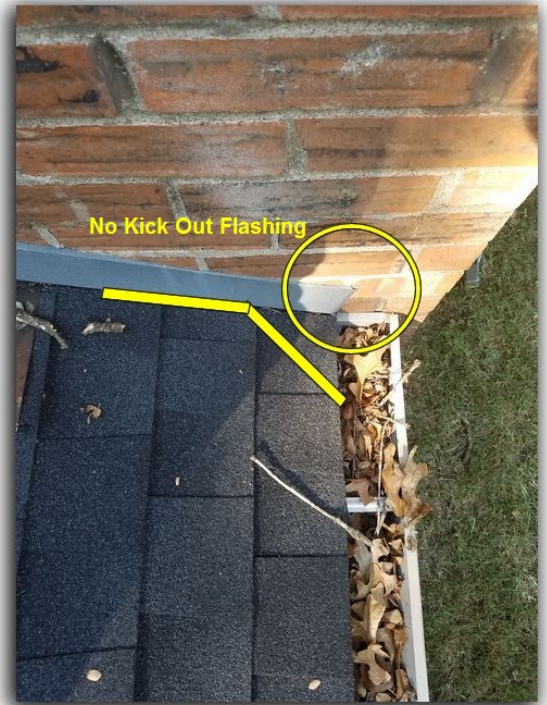
Flashing was cut short and not extended past the edge.

No kick out flashing was used for proper water run off.

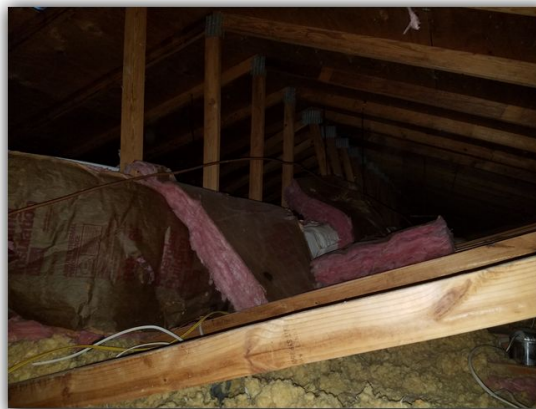
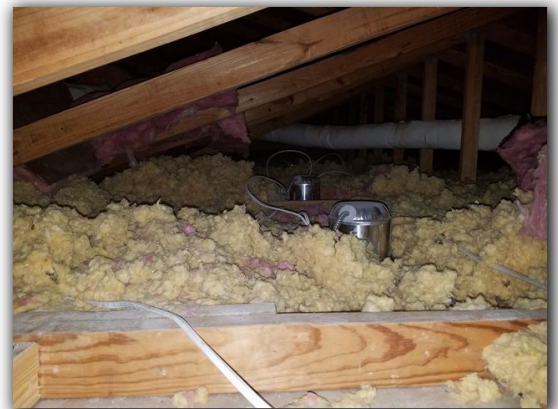
Insulation has been rolled out and laid over AC duct.

Attic structure appears to be as intended at the time of inspection.

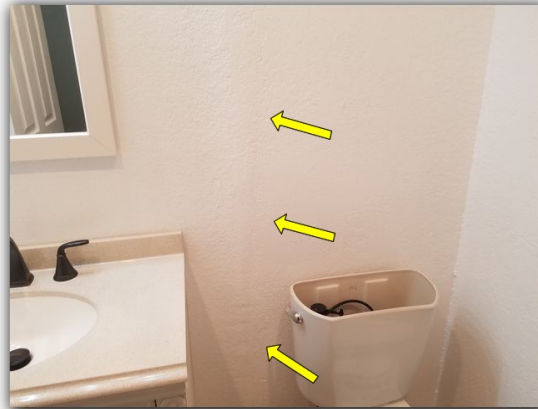
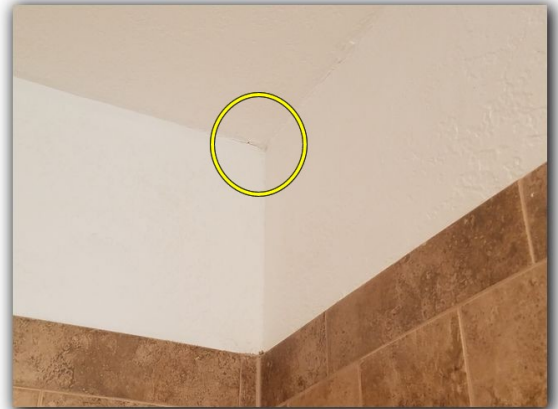
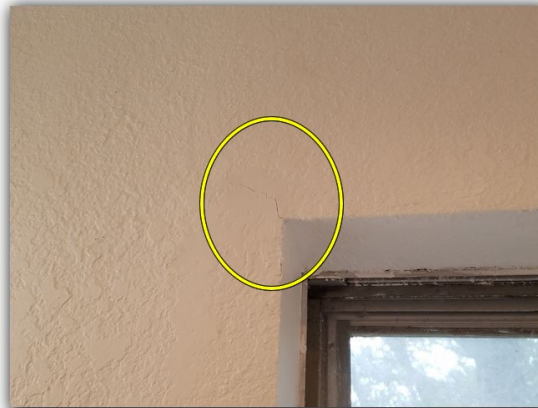
Signs of repair on walls in the East end of the home.

Separation observed in multiple locations, in corners and along joining angles.

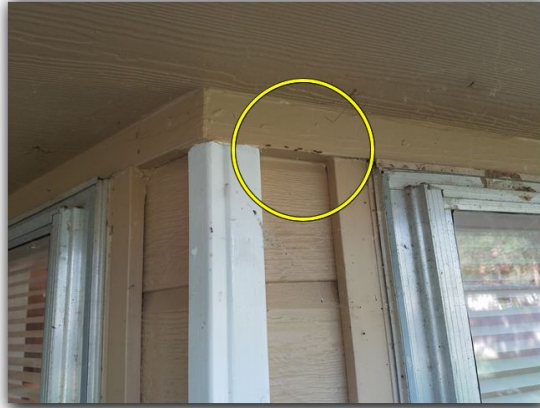
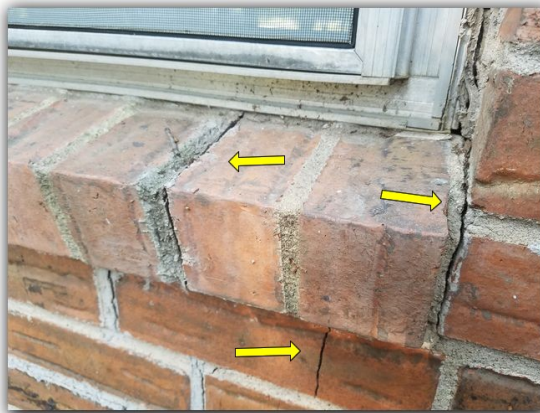
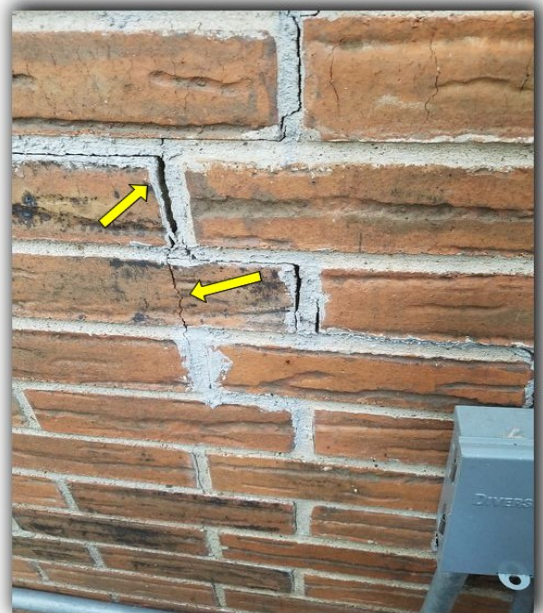
East end of the home has cracking of brick mortar away from the brick.

Bricks are cracked in multiple locations.

Separation of caulking joints between brick and wood at multiple locations.

Holes drilled into mortar. Appears to be from a flag holder that has been removed.

Ants were observed on the back of the house entering a widow frame.

Recommend further evaluation by professional exterminator for wood destroying insects.

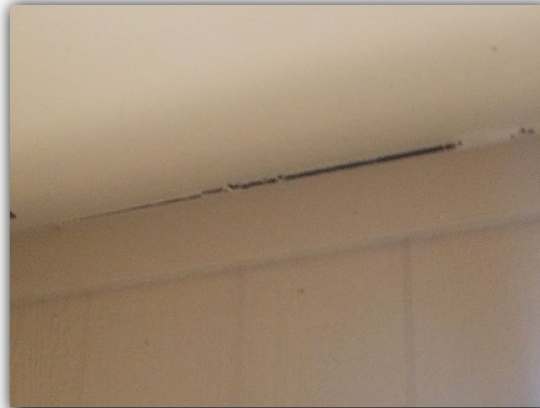
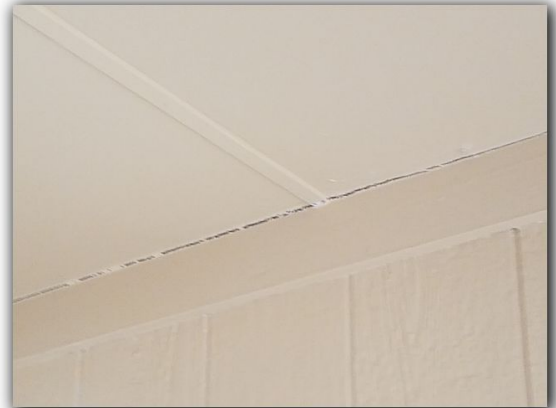
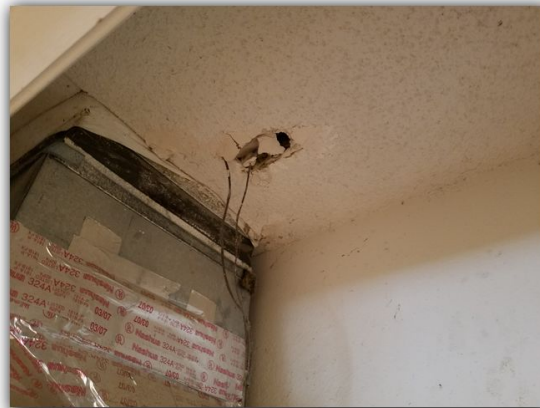
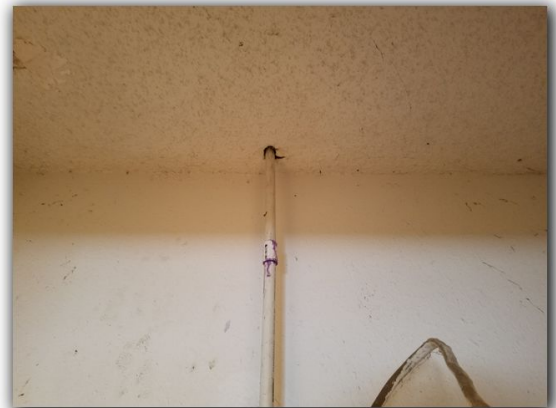
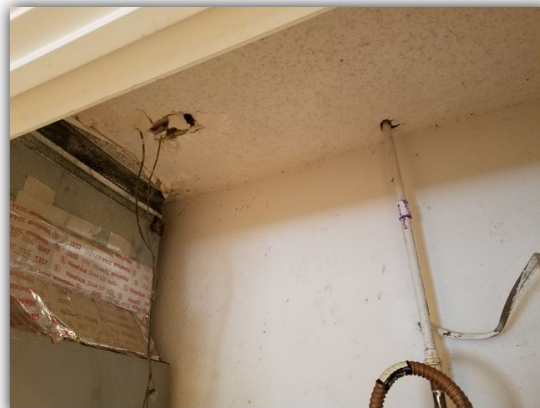
Separation observed between wood and brick ceiling at front door area.

Multiple locations of punched holes in interior closet spaces.

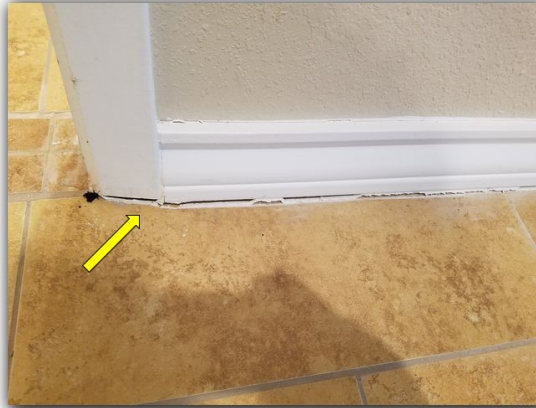
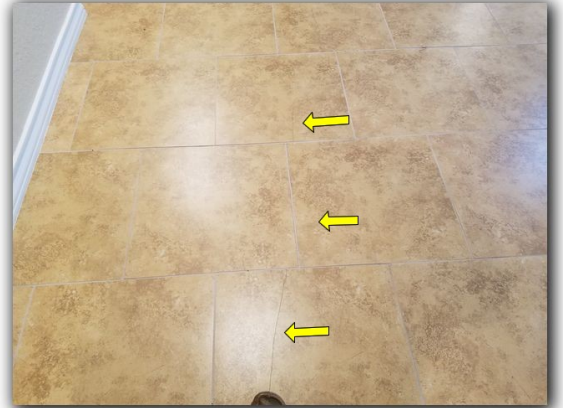
Separation of wall to floor near the entry way along kitchen wall

East and West crack in the tile of living area floor.

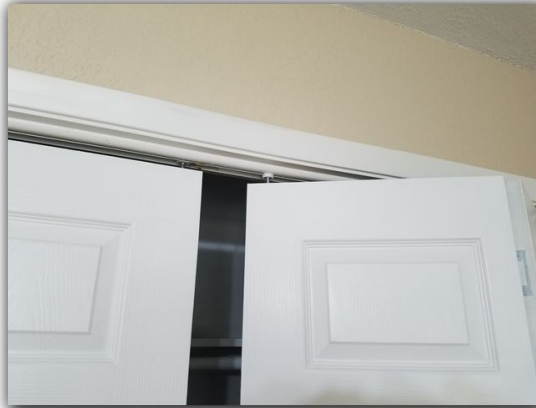
Closet door roller leaves the track when closing and re-enters when opening.

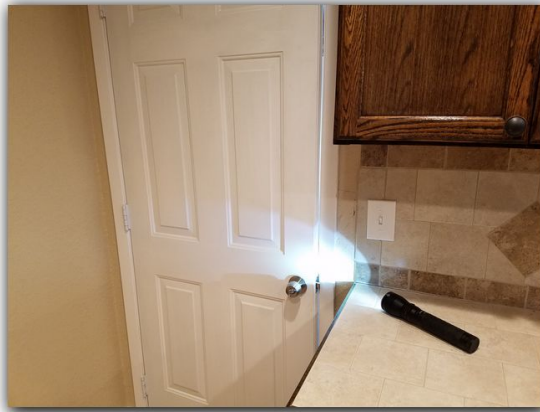
Garage to kitchen entry door is sticking and hard to open.

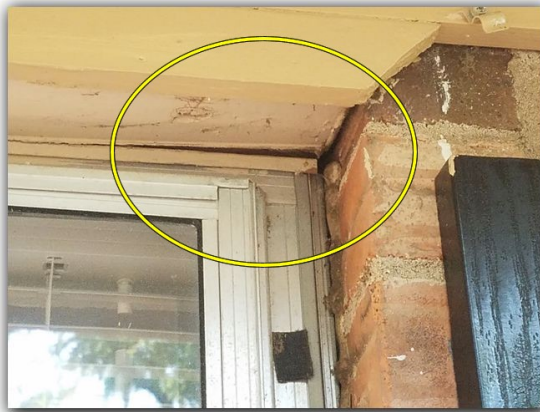
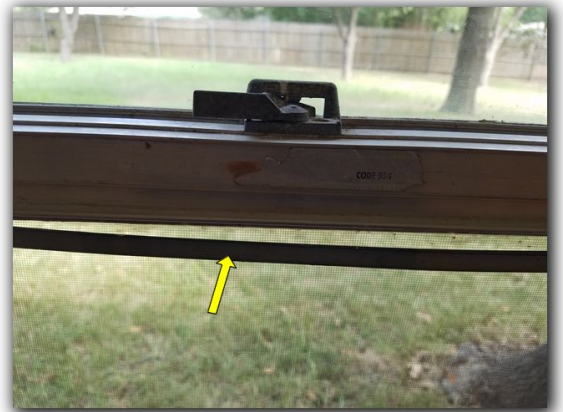
Separation of caulking and seals around multiple windows both inside and out side.

Widows are missing screens in master bed room.

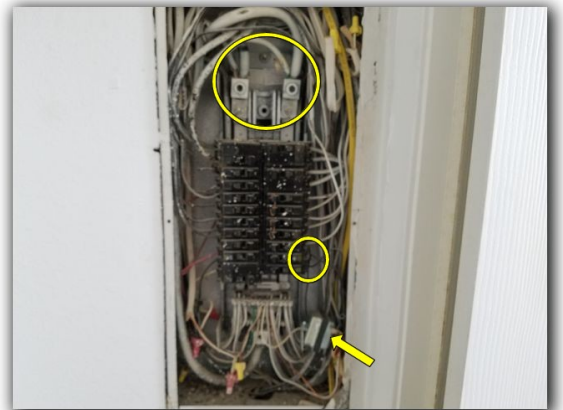
Main Panel is not recommended to be installed in a closet where clothing is hung.

Main serves lugs have been double tapped. Suspect the smaller lines are for the A/C unit that has breaker panel out side. Main panel is not designed for this by today's standards.

Some type of after market transformer is added to an already used breaker. This double tape is also not recommended. The transformer is believed to be for the thermostat control.

Recommend further evaluation by professional electrician.

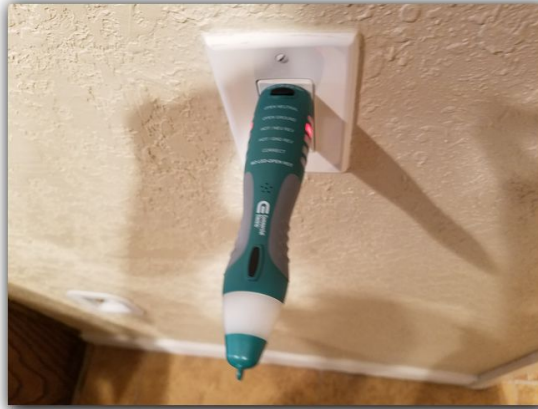
GCFI are installed in the proper locations however. The one located for the refrigerator shows an open ground. Also this reset button is for more than one receptacle along the cabinet. If it kicks you will have to move the refrigerator to reset.

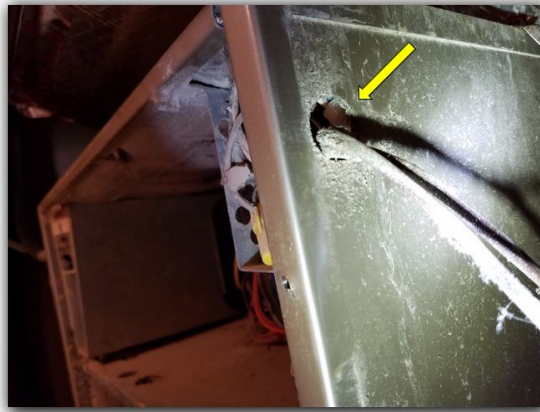
Power wiring should be isolated from the cabinet to prevent a short.

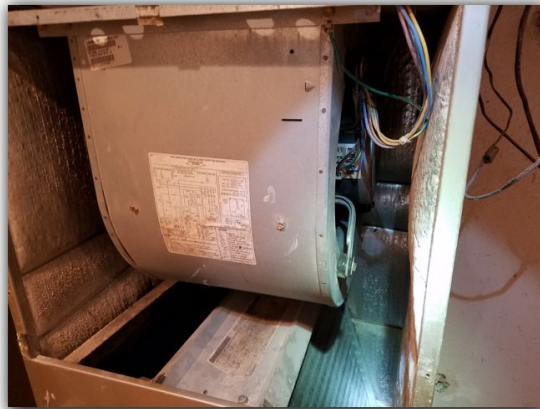
The unit is covered in dust. Recommend servicing.

Recommend further evaluation by professional.

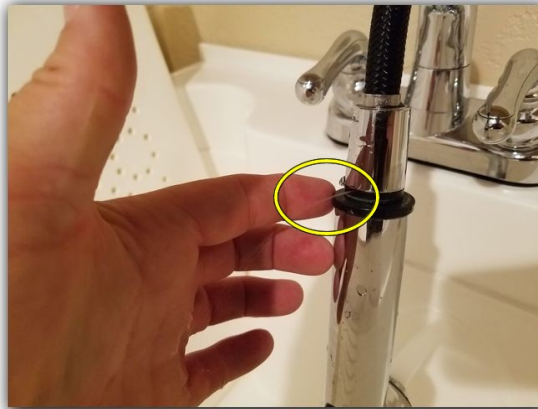
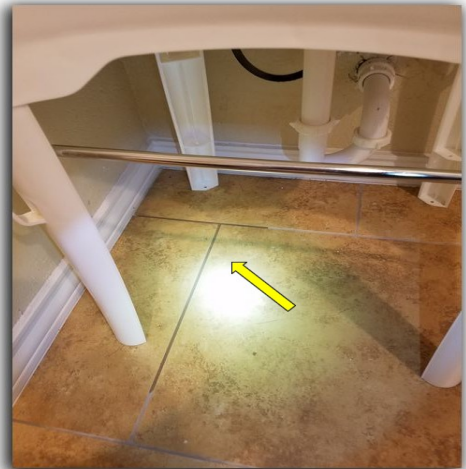
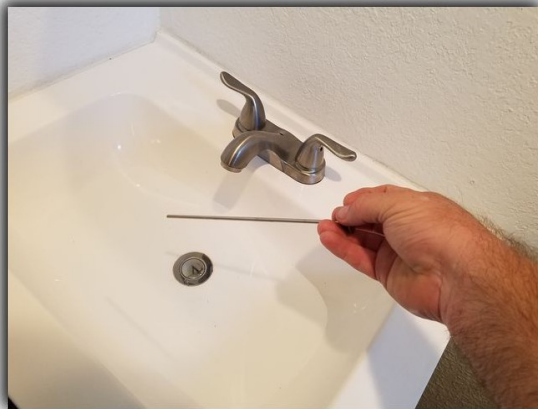
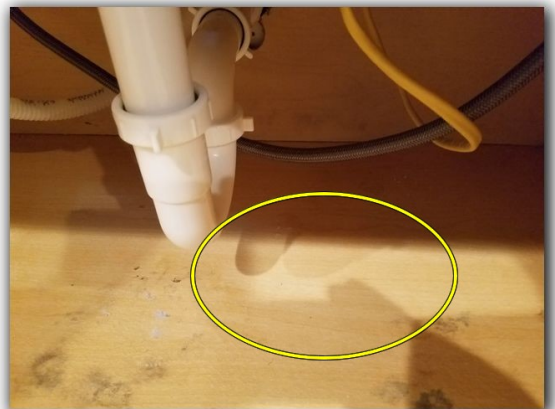
Mop sink leaking water at the spray head. water will run to the floor when in operation.

Addition bath sink stopper handle is not properly installed.

Under kitchen sink water was observed after the use of the dishwasher.

Recommend repair and further examination by licensed professional plumber.

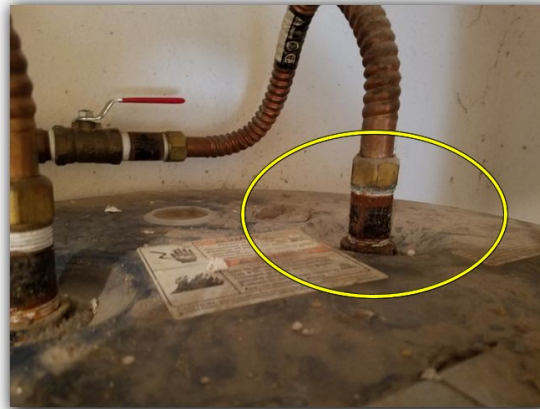
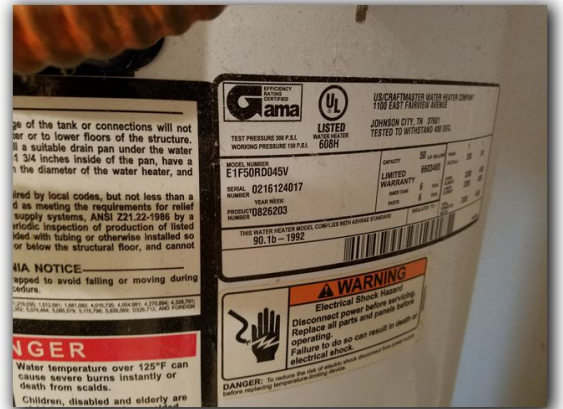
Rusting of carbon still has accorded. Galvanized pipe fittings are recommended,

Recommend further evaluation by licensed plumbing professional.

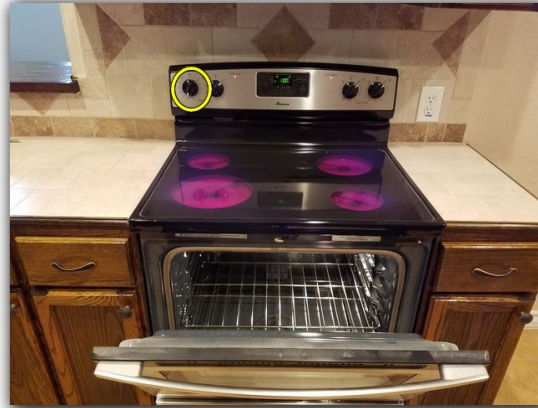
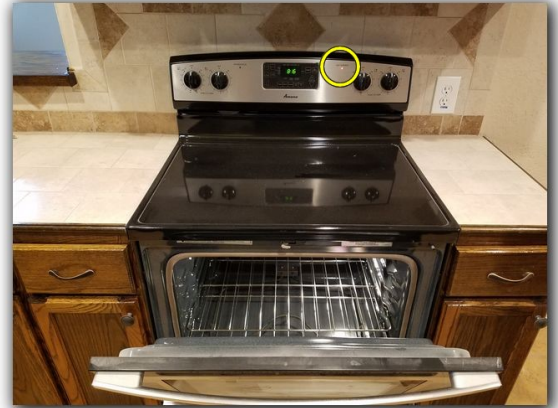
Left front has inner and outer burner controls. FYI

Hot surface light flickers.

Oven not anchored in cabinet
