SUMMARY INSPECTION REPORT

Client: Jenifer & Kevin Joyce
Inspection Address: 3004 NE 193rd St, Lake Forest Park, 98115
Inspection Date: 5/18/2022 Start: 11:00 am End: 1:00 pm
Inspected by: Don Hartman, Licensed Home Inspector #292

CONFIDENTIAL INSPECTION REPORT

3004 NE 193rd St, Lake Forest Park, 98115

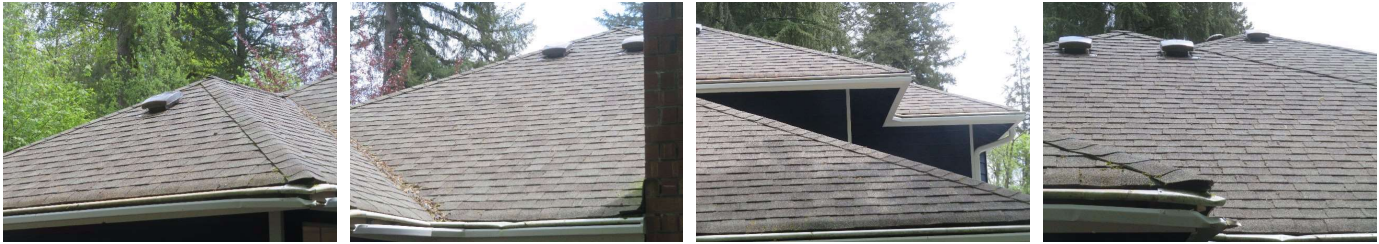
The roof is in serviceable condition, but this is not a guarantee against leaks. For a guarantee, you would need to have a roofing company perform a water-test and issue a roof certification.
