# SITE INTELLIGENCE REPORT

High-resolution drone mapping of a 20.42-acre site — orthomosaic, terrain model, and aerial intelligence captured in a single coordinated flight.

The aerial mapping project conducted by Aerial Atomics LLC aimed to document a church site in Escondido, utilizing advanced drone technology to capture high-resolution imagery and generate a comprehensive point cloud. The mission focused on assessing site conditions, infrastructure, and terrain characteristics, providing valuable insights for the client while ensuring adherence to strict confidentiality protocols.

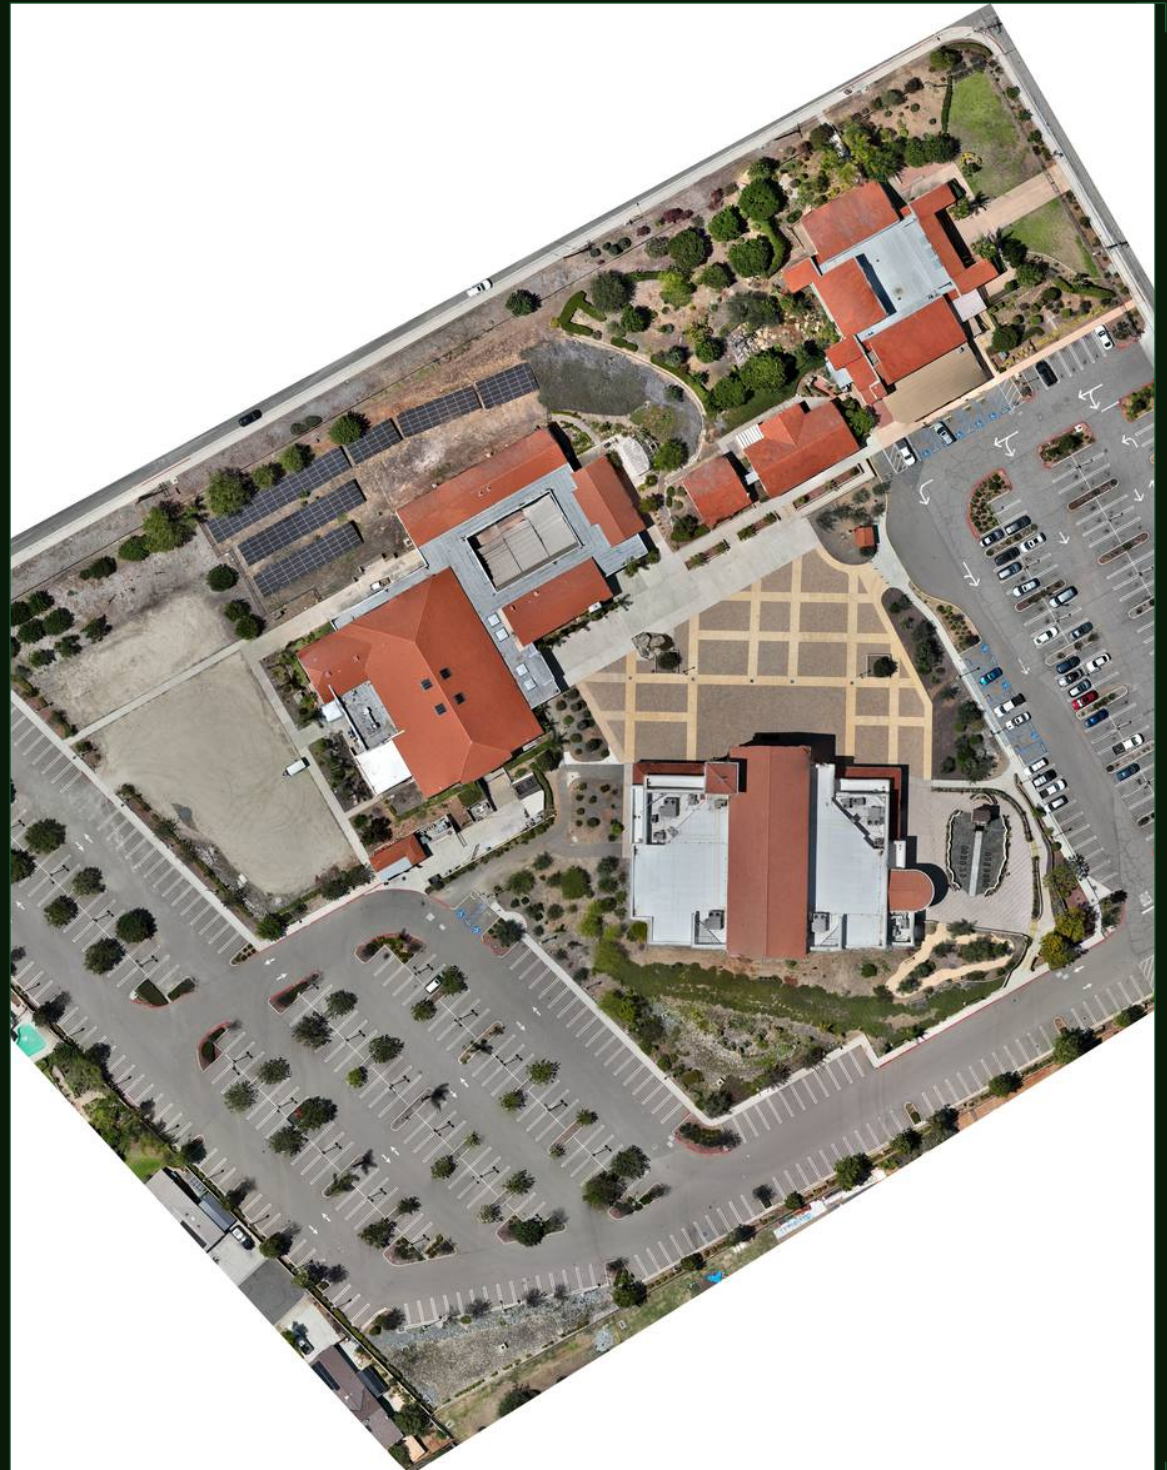
■ FIG. 01 · ORTHOMOSAIC

The full property was reconstructed from 822 images into a seamless 1.4 cm/pixel orthomosaic — one georeferenced base layer for every measurement and condition call.

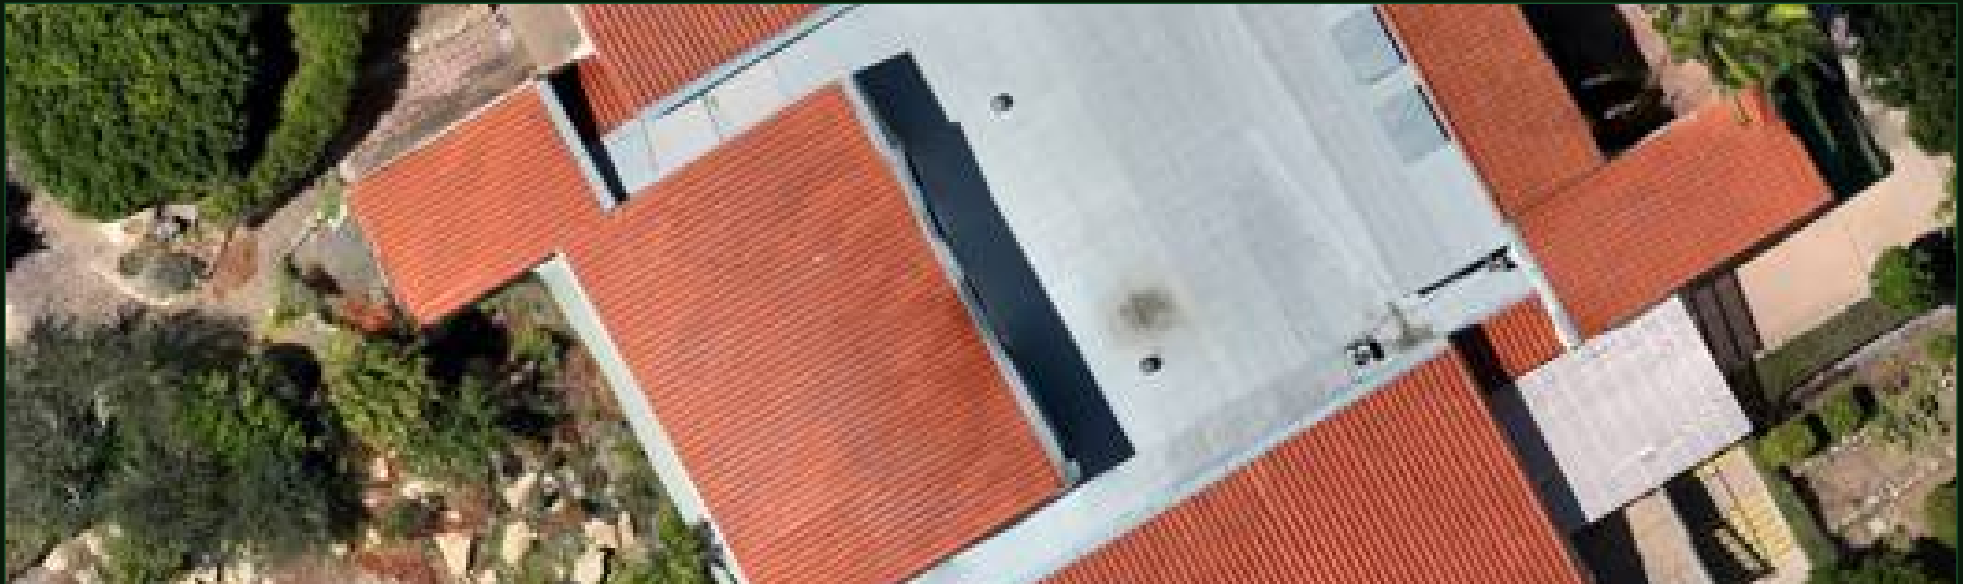
At 1.4 cm/pixel, surface conditions, wear patterns, and drainage indicators are clearly resolved across the entire site footprint.

WEATHERING & DEBRIS DISCOLORATION

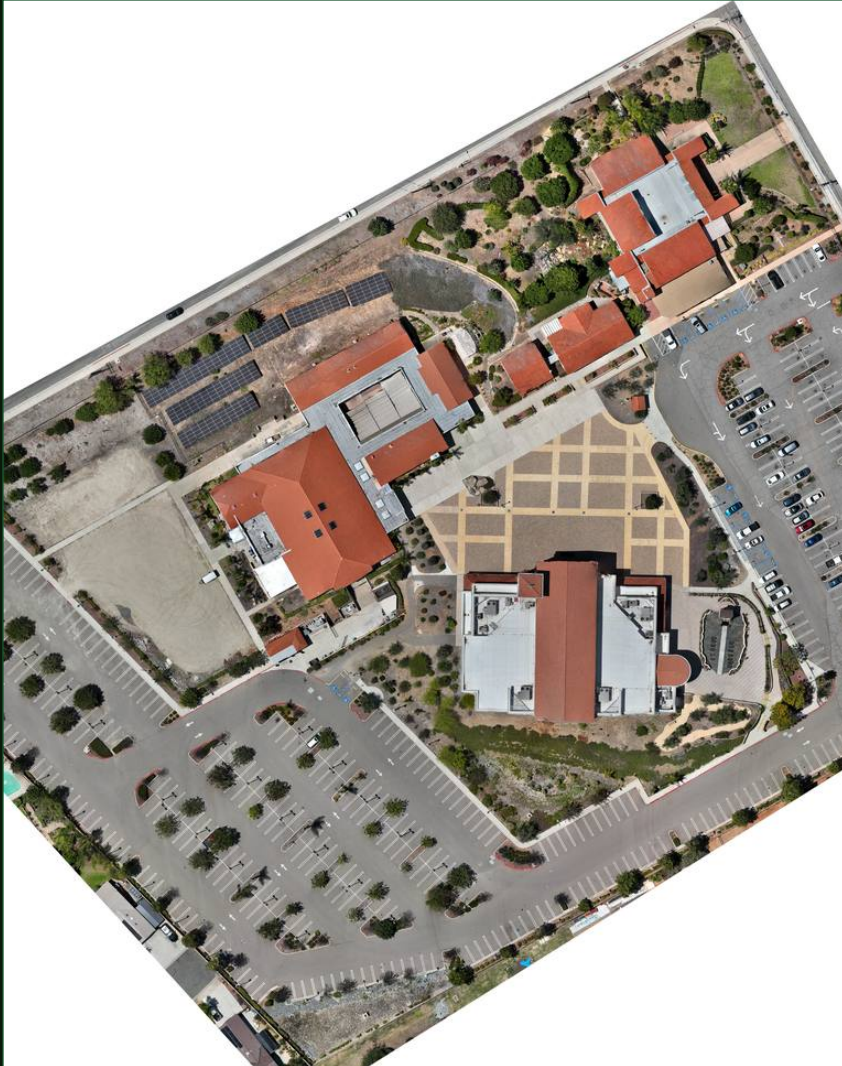
SITE SURFACE OVERVIEW

The DSM converts surface form into actionable drainage and condition analysis — pairing what the orthomosaic shows with where water actually moves.
