# Rasp Mine

## Annual Environmental Management Report

**1 January 2019 - 31 December 2019**

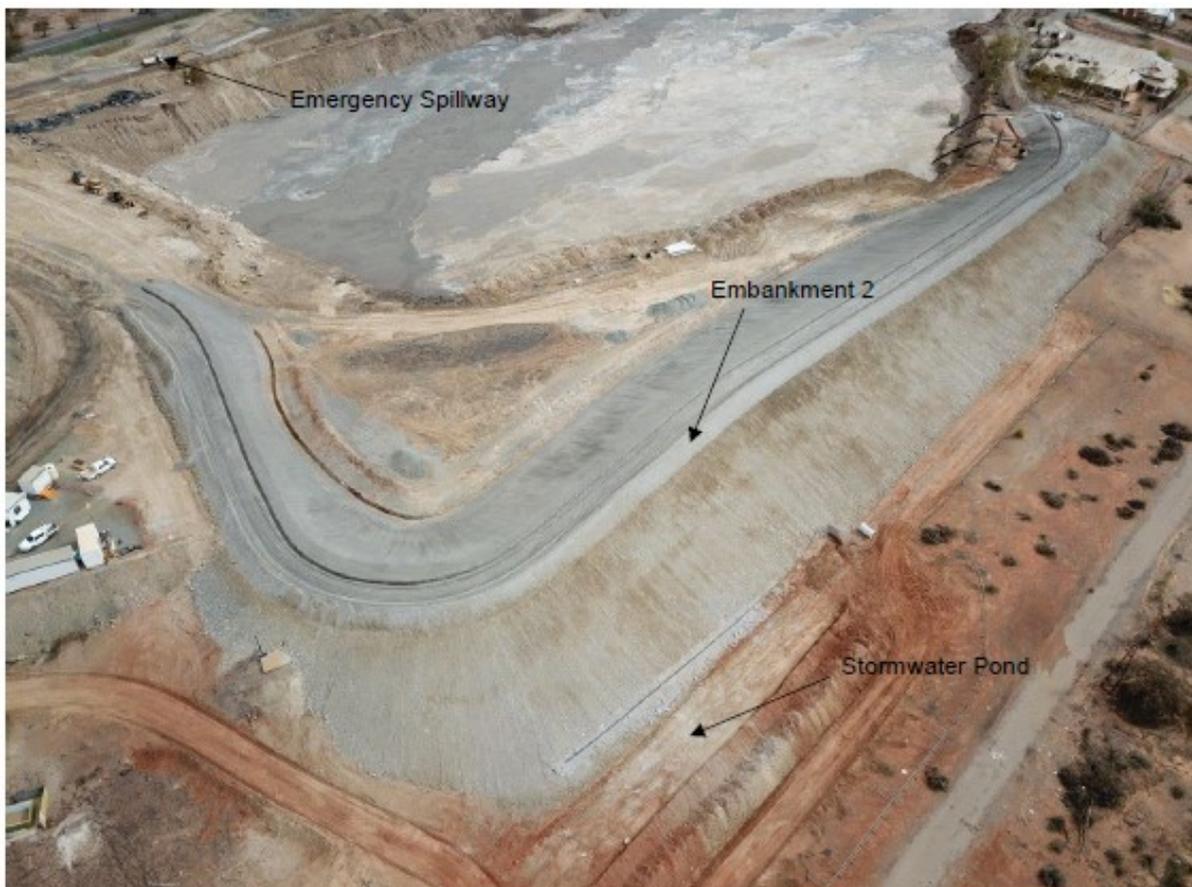
**Figure 2-1 Aerial view of Embankment 2, Stormwater Pond and Emergency Spillway**

Embankment 2 construction involved the excavation, conditioning and placement of the fill material from the Embankment 2 footprint. The embankment wall was constructed of rock fill, select rock fill and screened rock fill, as well as layer of filter sand with a seepage collection system and the installation of a HDPE liner on the upstream side of the embankment.

The Stormwater Management System for Embankment 2 consists of two drains feeding to a stormwater pond. A spillway was installed at the northern end of the stormwater pond.

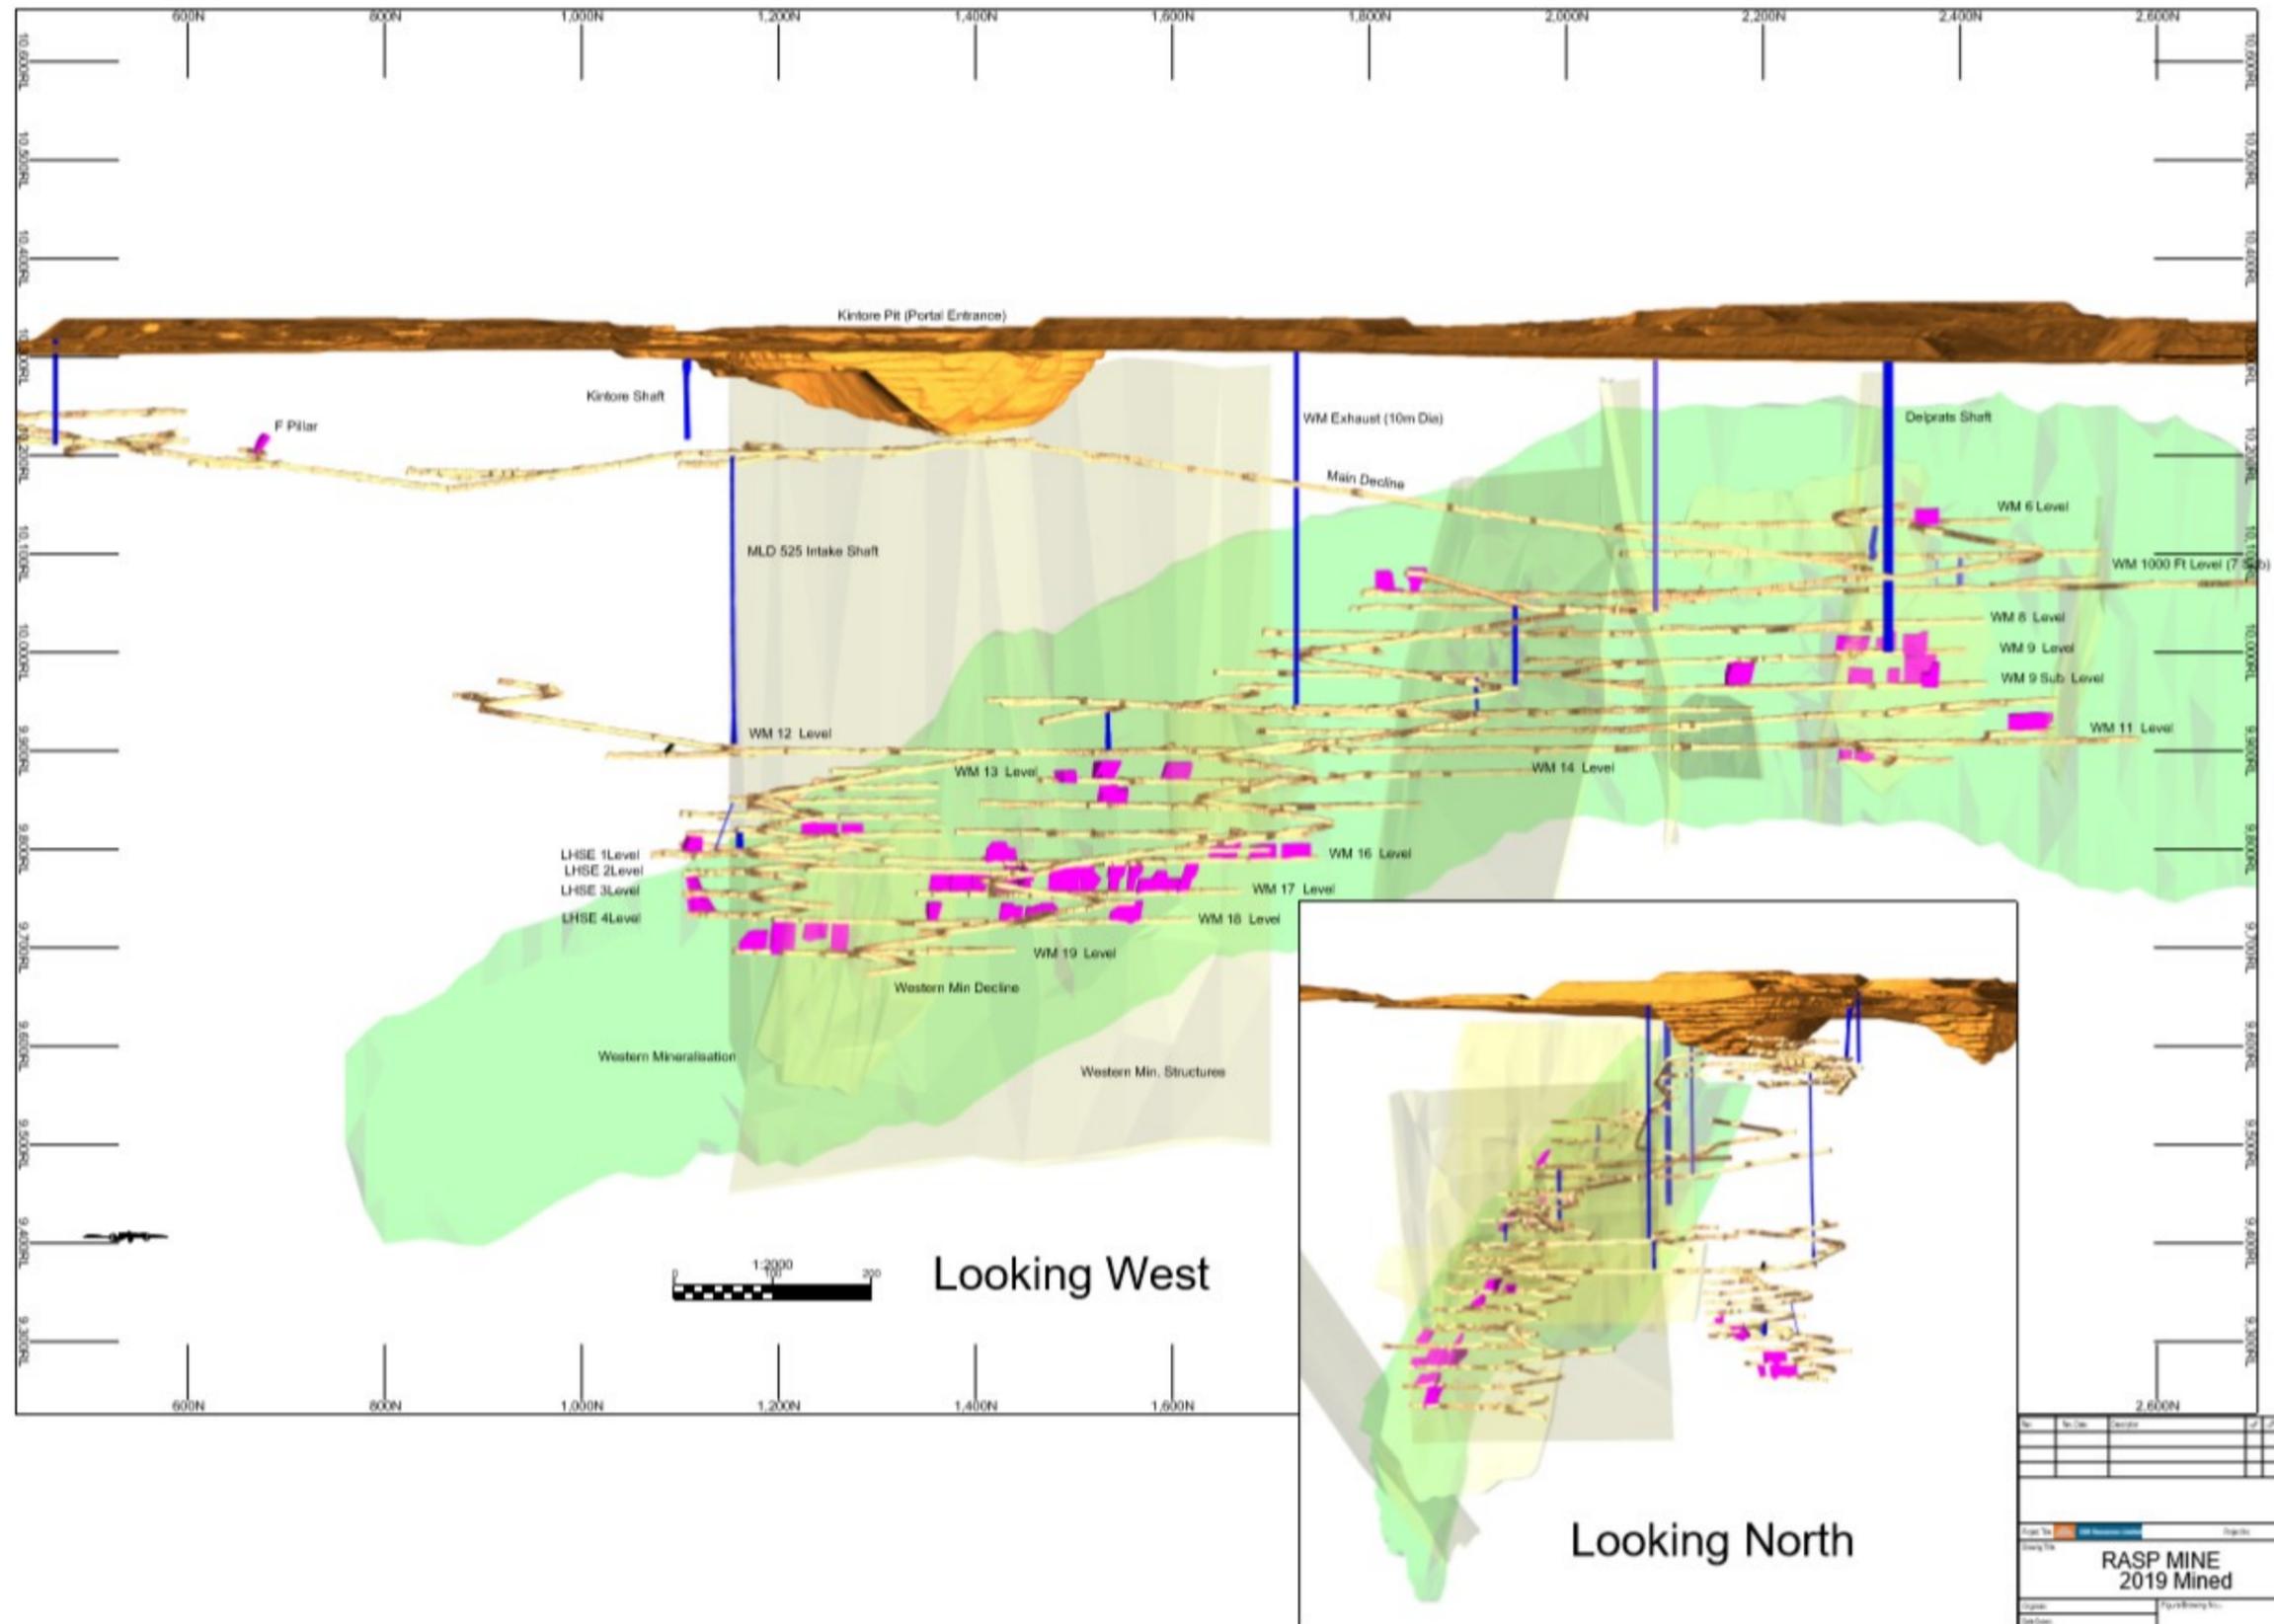
Figure 2-2 Plan 3 Mining Activities in the Reporting Period (2019)

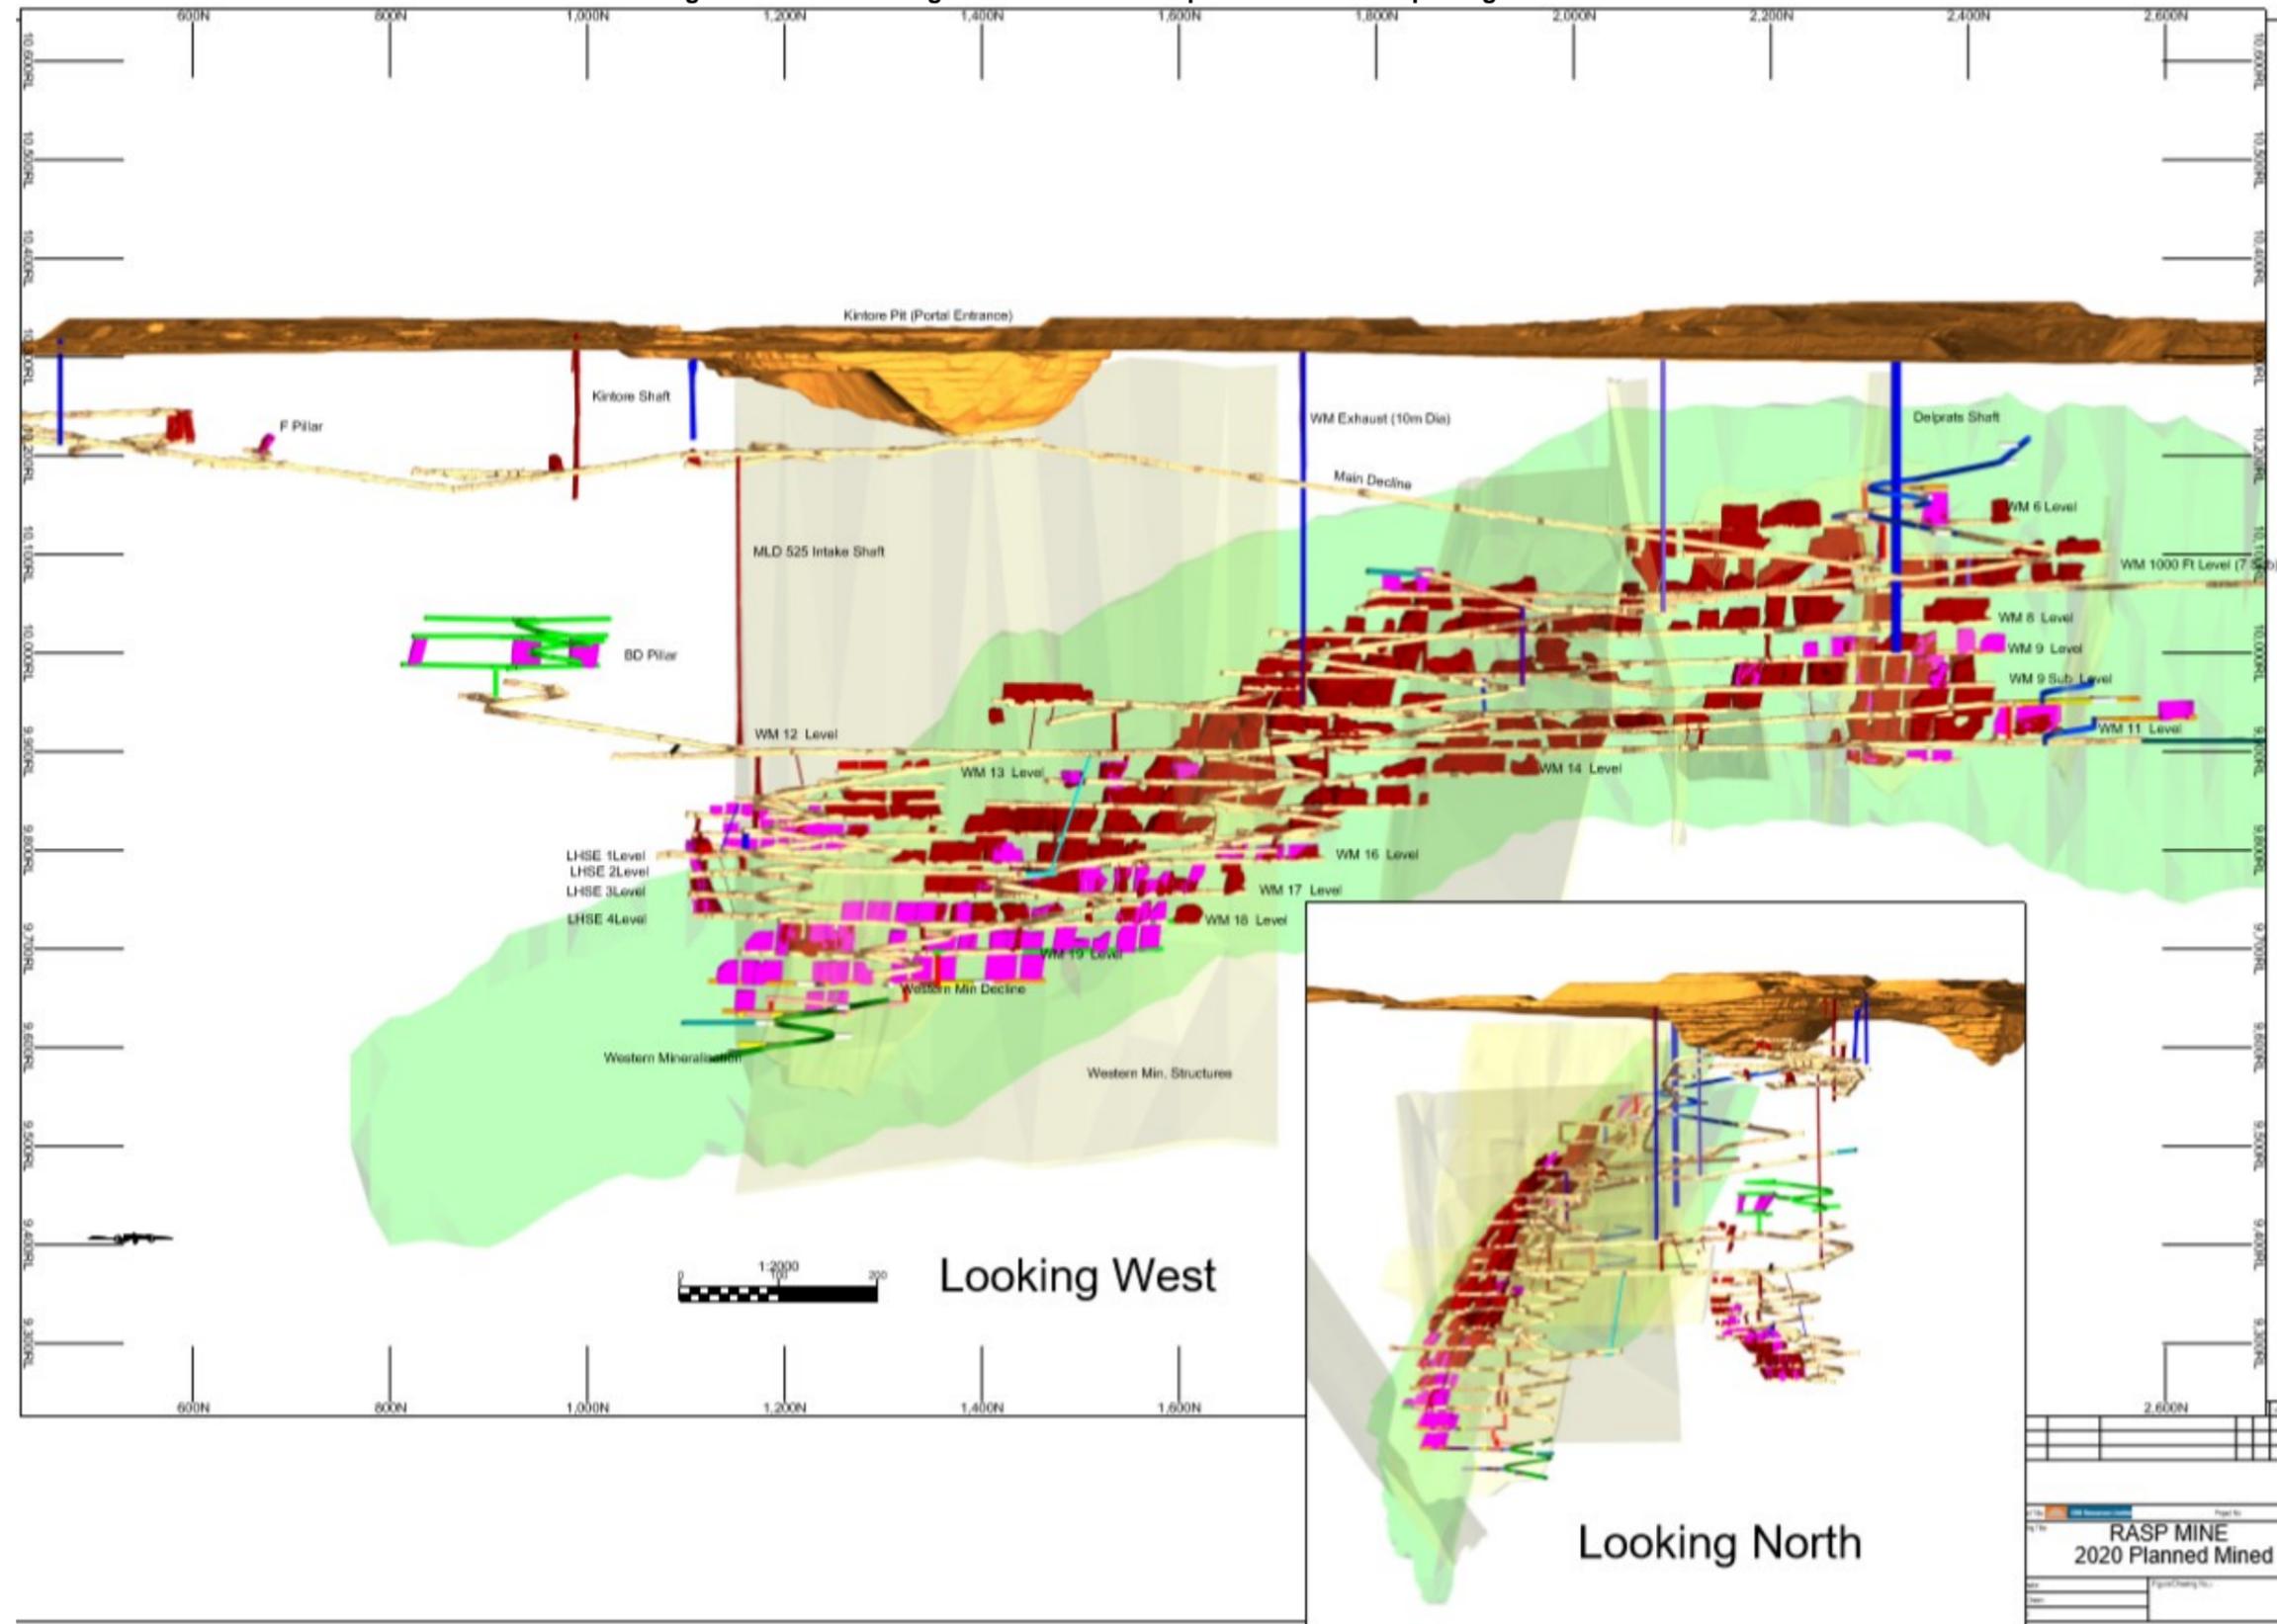
Figure 2-3 Plan 3 - Long Section Planned Stopes for the Next Reporting Period 2020

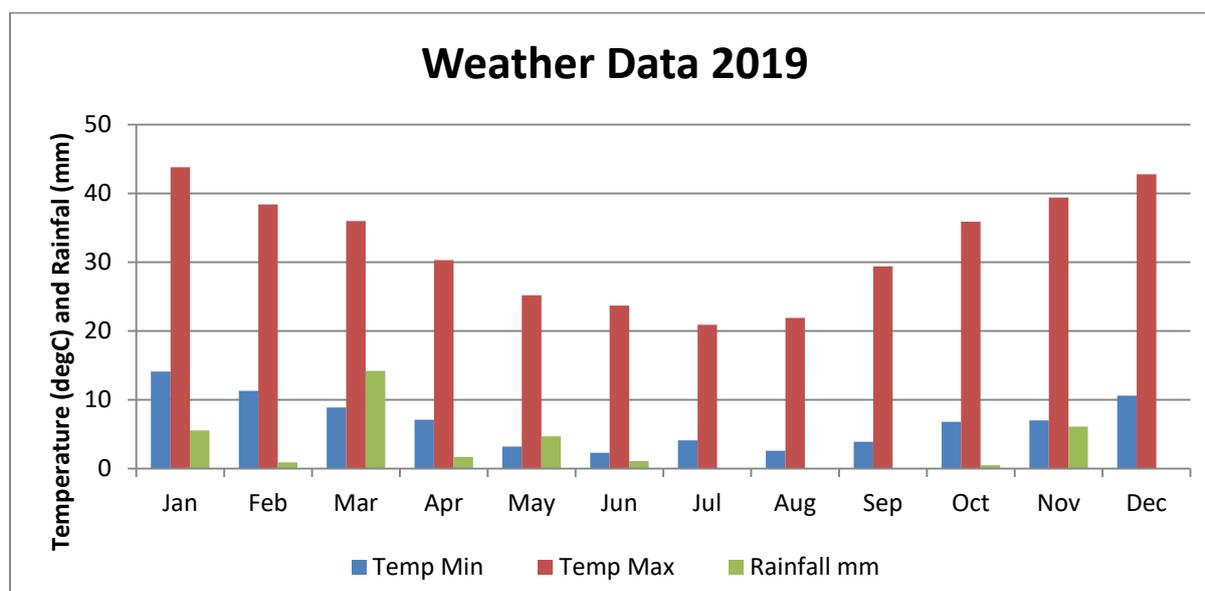
**Figure 3-1 Weather Data for the Reporting Period (2019)**

While temperatures in 2019 remained consistent with historical records, rainfall (34.76 mm) for the period was significantly lower than the BoM's long-term annual average of 259 mm. There were only 18 rain days for the period (35 in previous period) with most rain falling in Autumn (20.6 mm). Winds were predominantly from the south with high winds experienced during July to November.

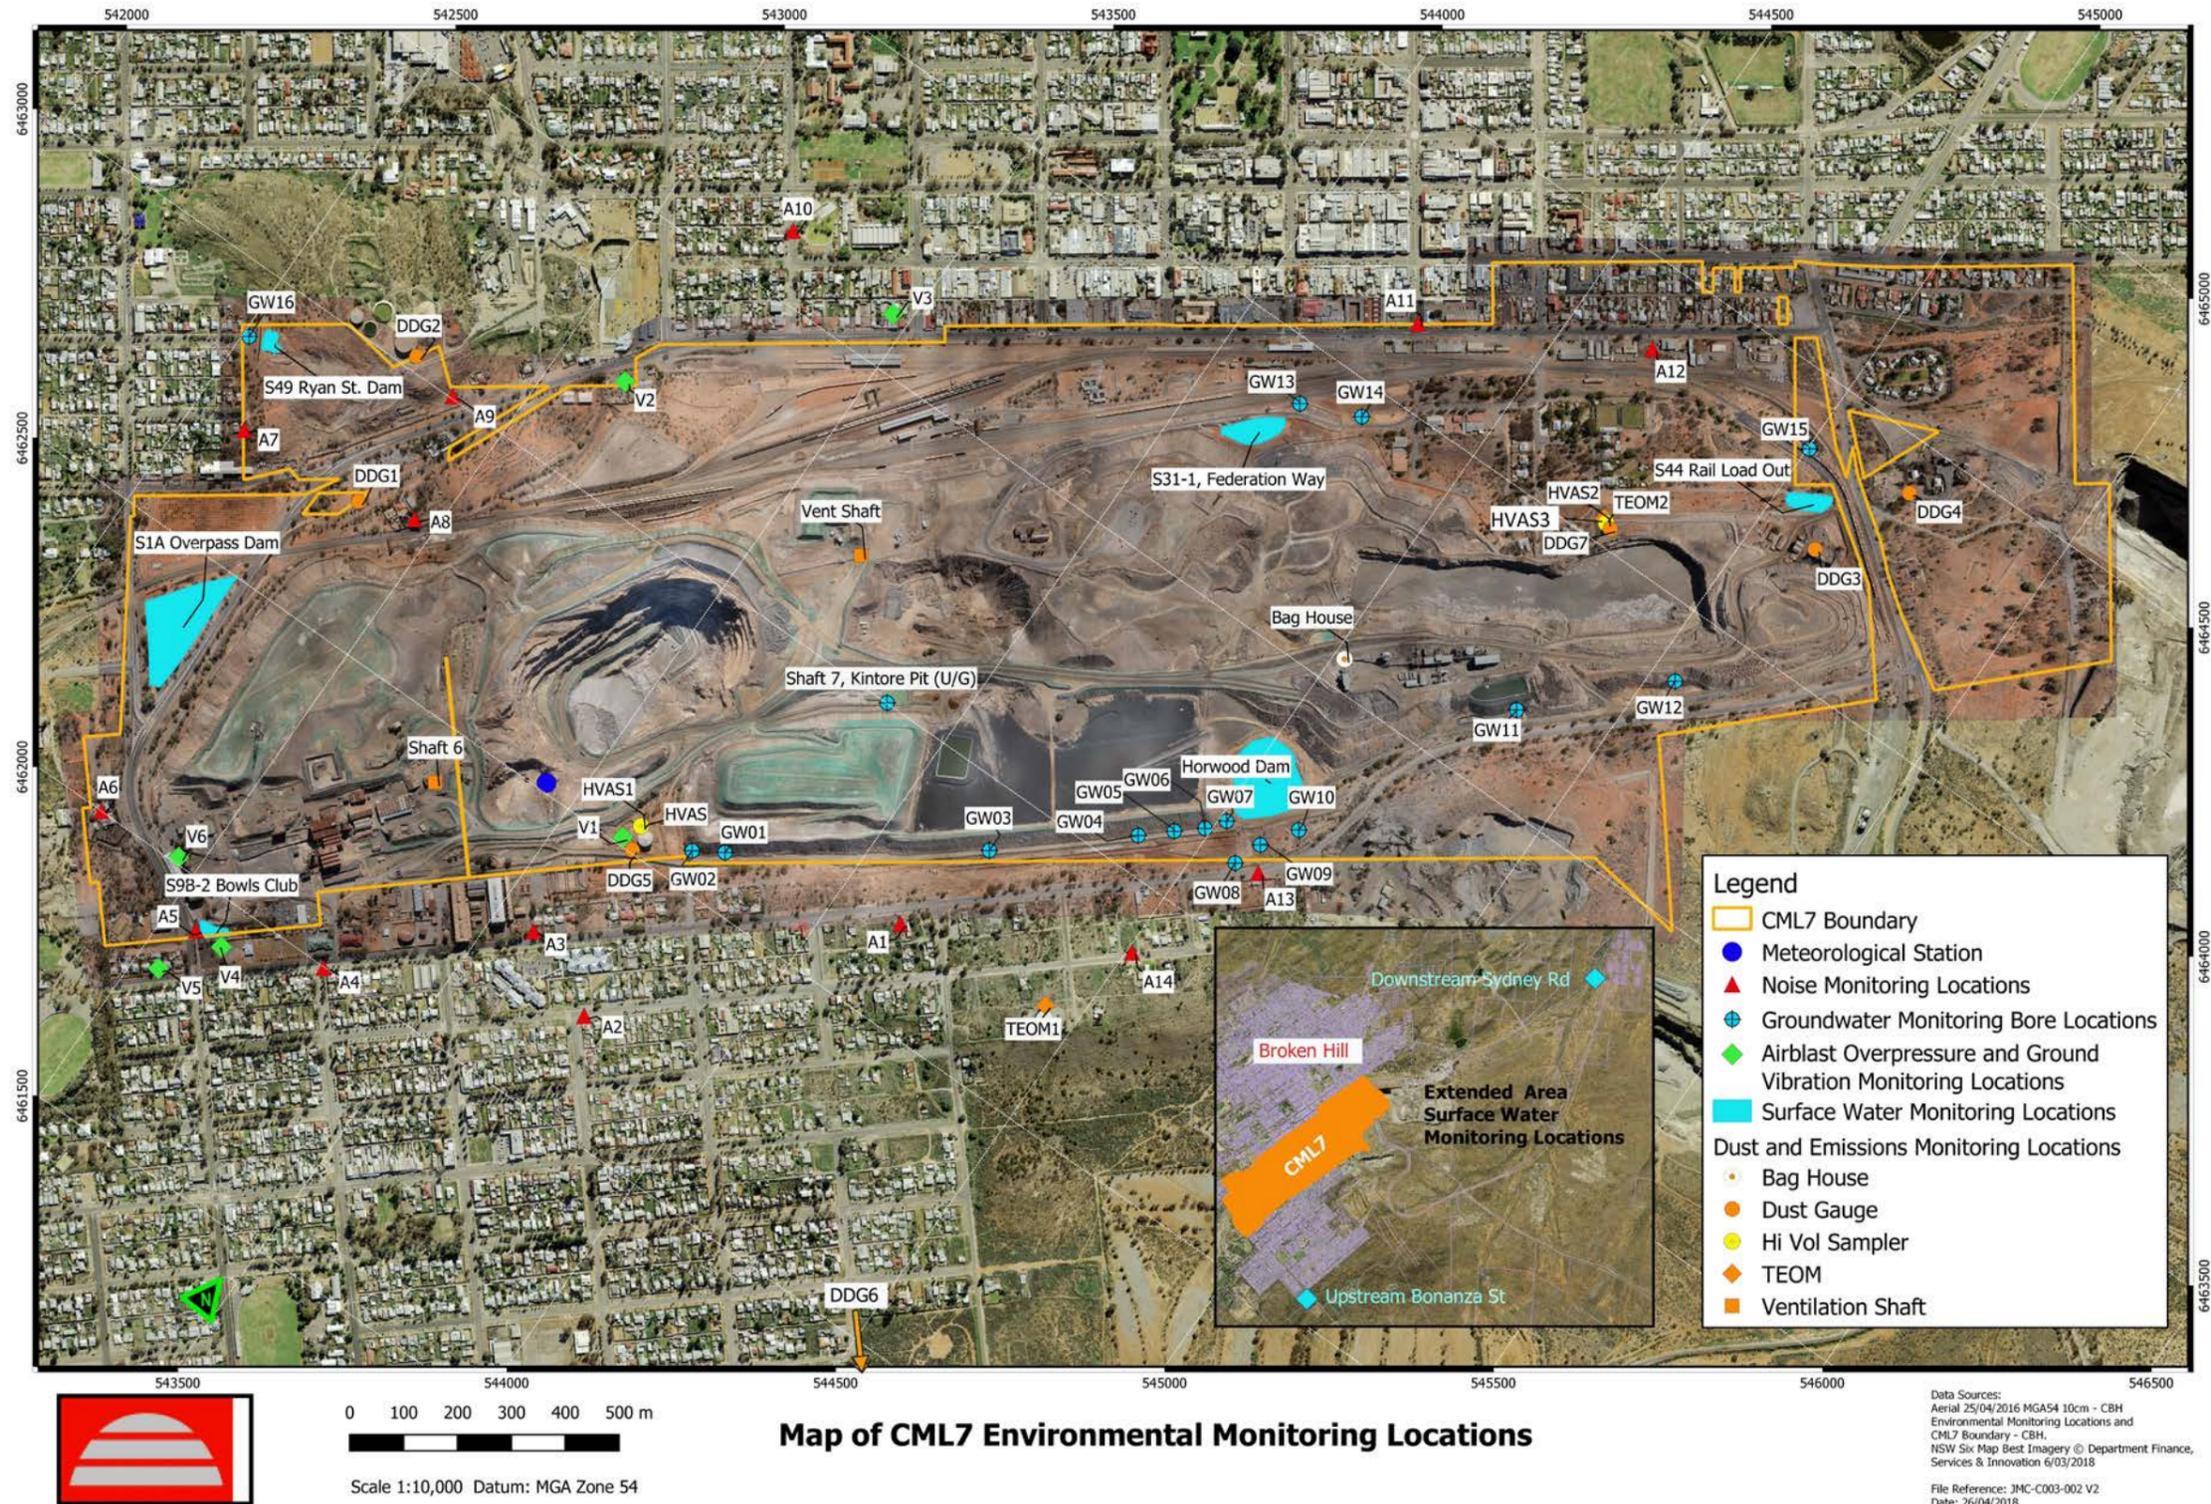
Figure 3-2 Location of Monitoring / Sampling Points

The BHOP site environmental monitoring program is summarised in **Table 3-2**, locations for sampling/monitoring points are shown in **Figure -3-2**. Shaft 6 was removed as an air quality monitoring location in MOD5, approved in November 2018, as Shaft 6 became an air intake point in April 2018. In April, blast monitor V4 at 123 Eyre St was removed at the residents request and placed at the Eyre St Bowls Club. The site weather station is due for replacement in early 2019 as the current weather station cannot calculate Sigma Theta, a requirement of EPL 12559.

Figure 3-2 shows the sampling locations for all air quality monitoring units.

The Rasp Mine has two Tapered Element Oscillating Microbalance (TEOM) air quality monitors, which record real time PM10 data. **Figure 3-2** shows the location of these monitors.

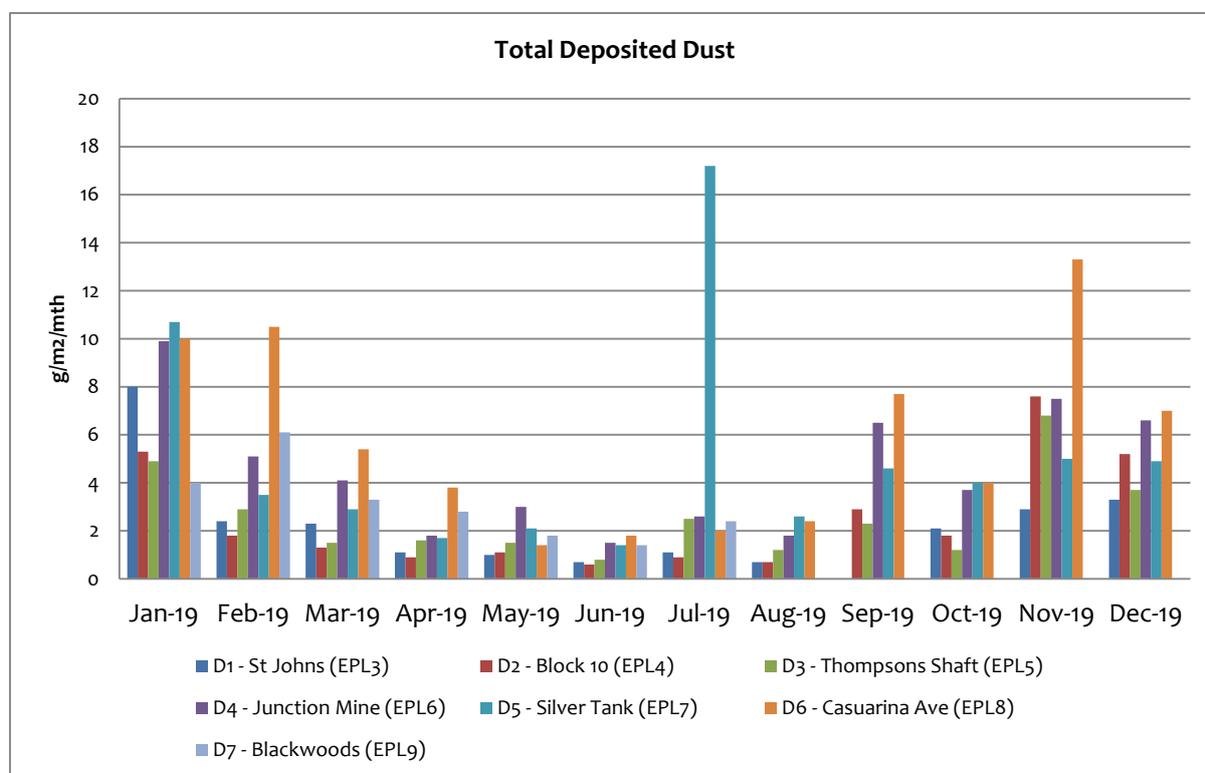
Figure 3-3 Monthly Total Deposited Dust for 2019

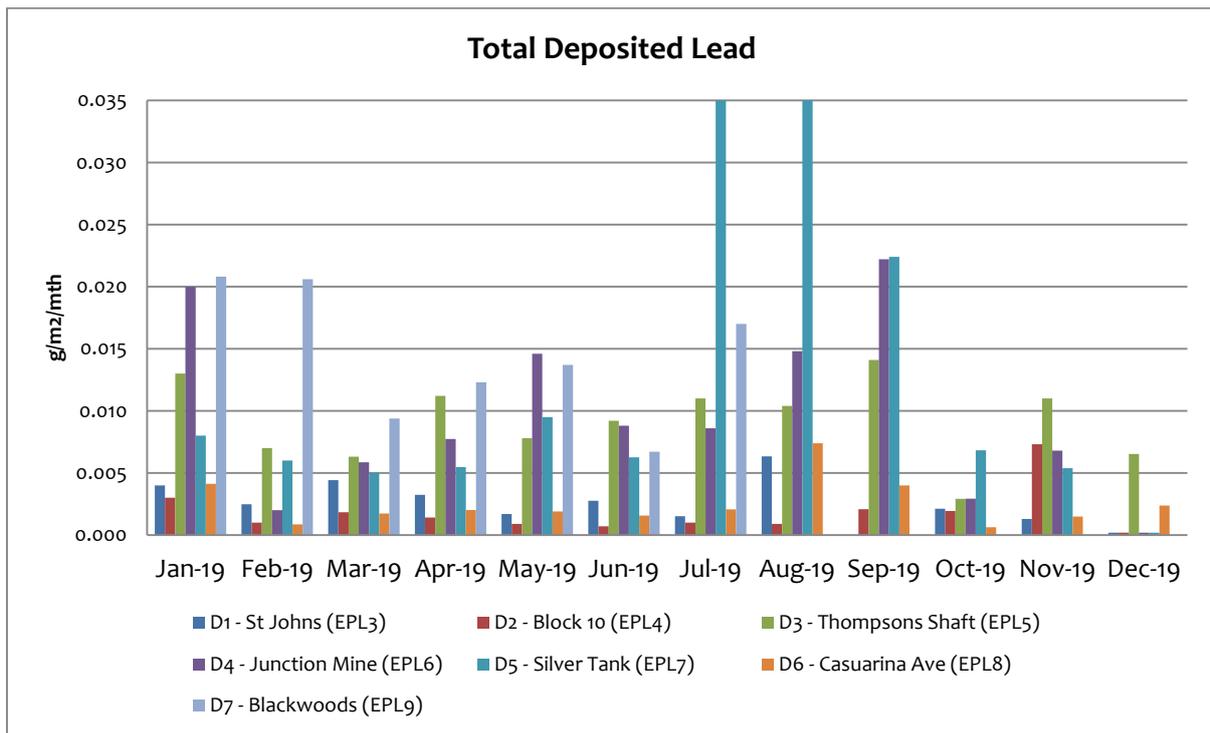
Figure 3-4 Monthly Lead Deposition for 2019

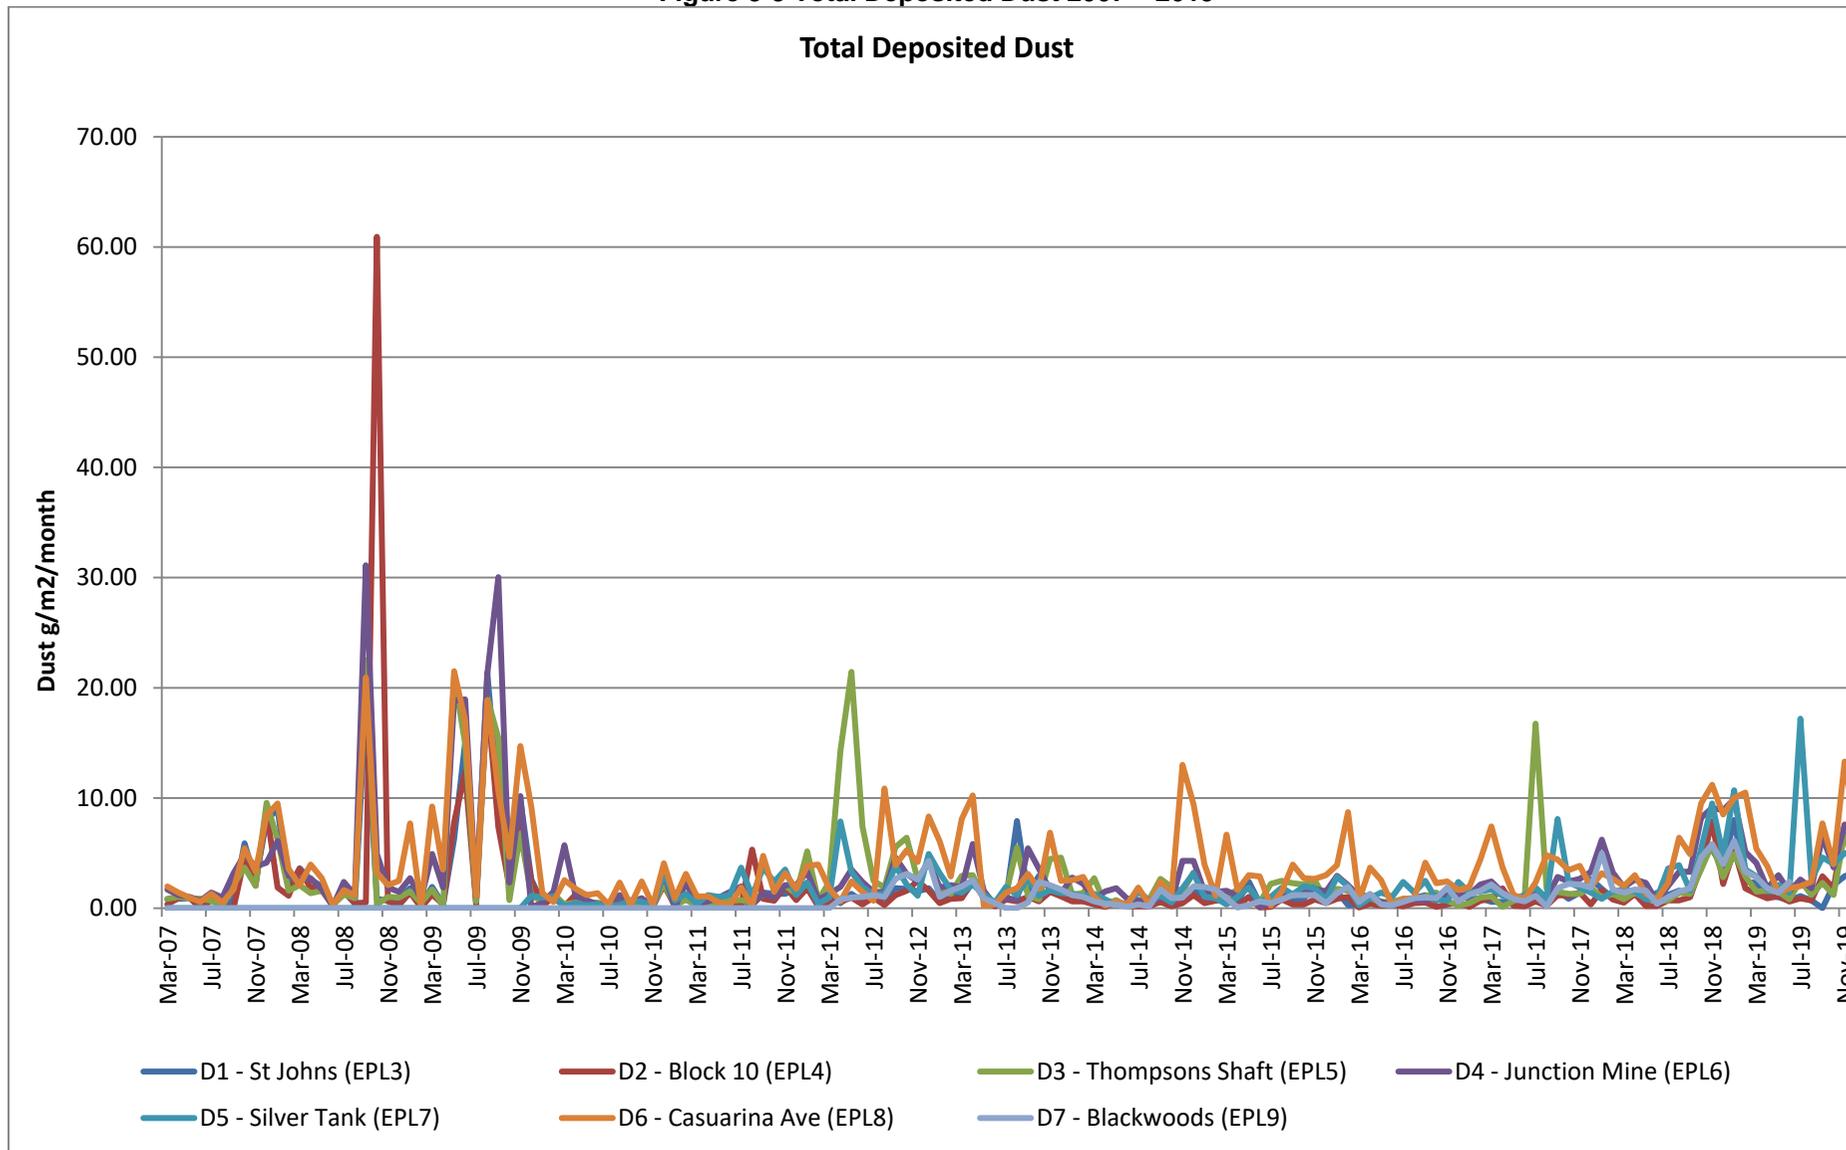
Figure 3-5 Total Deposited Dust 2007 – 2019

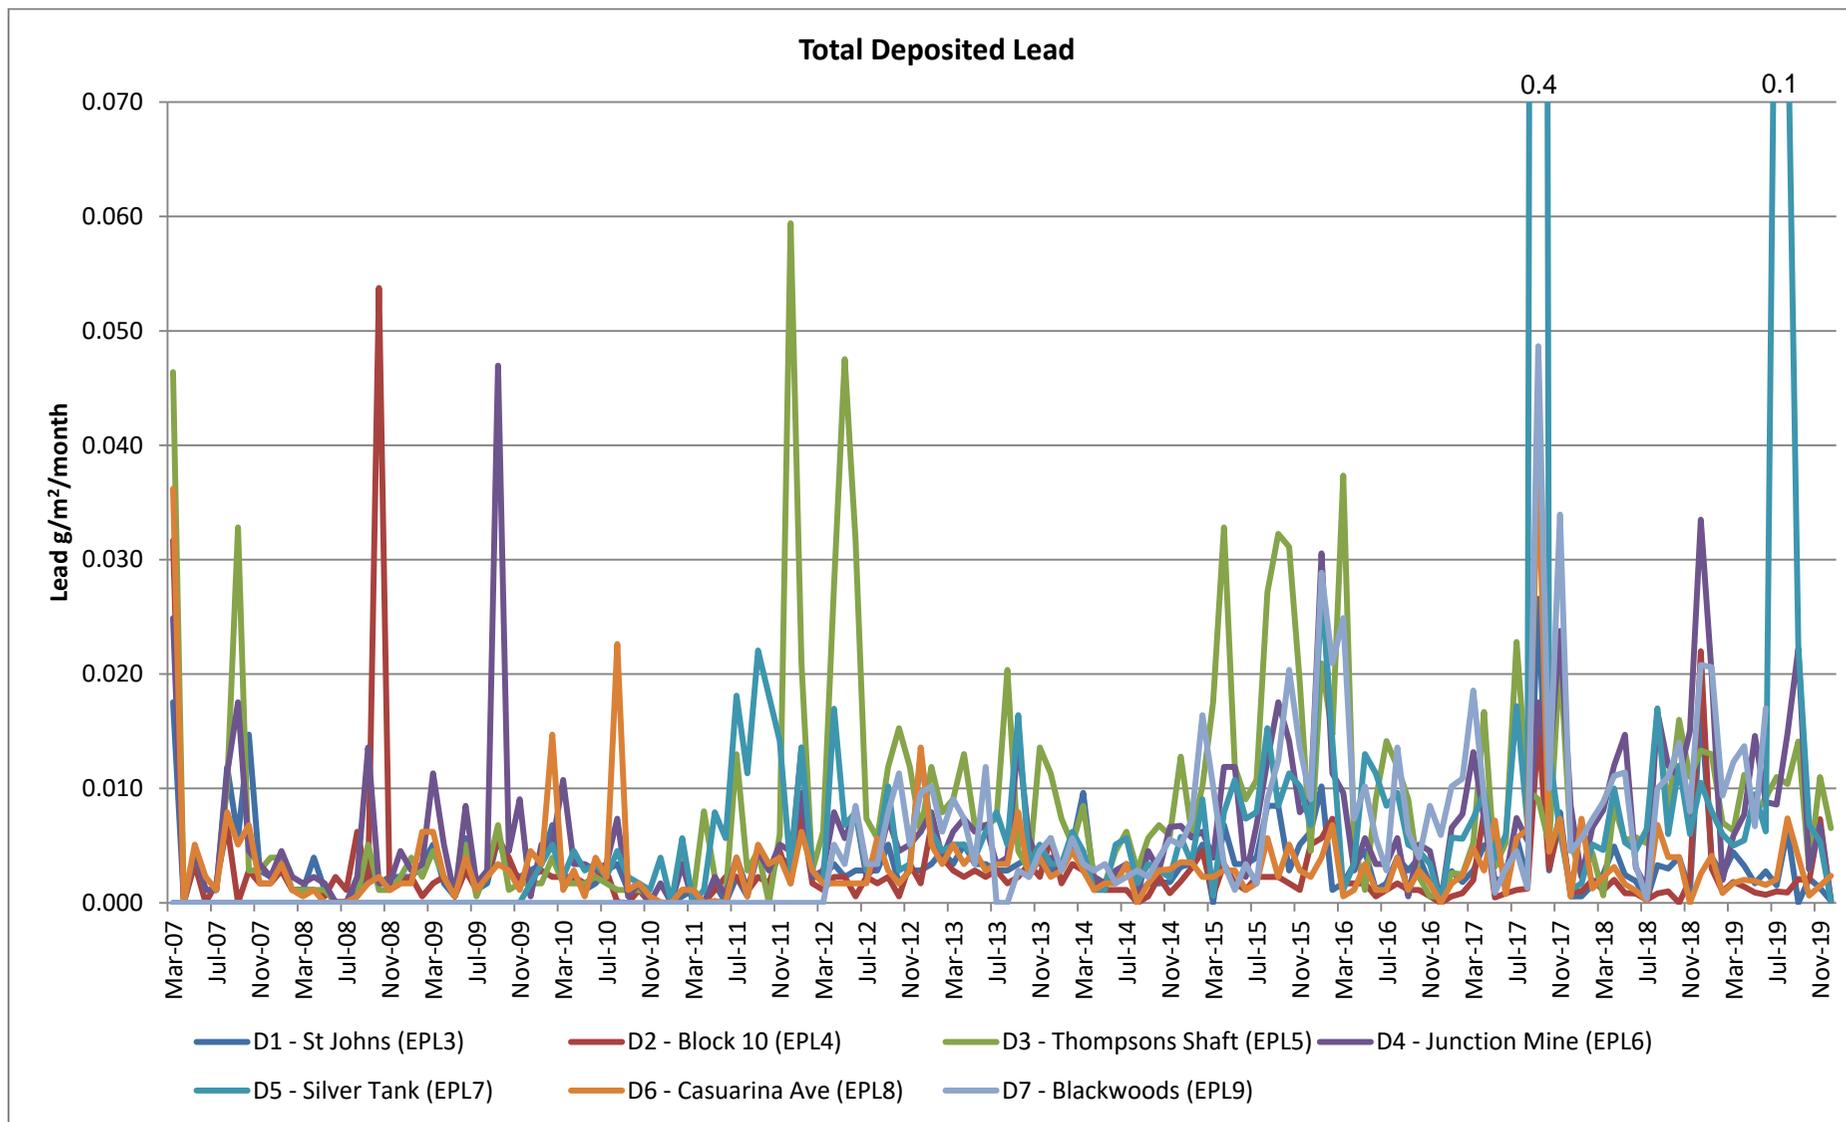
Figure 3-6 Total Deposited Lead 2007 to 2019

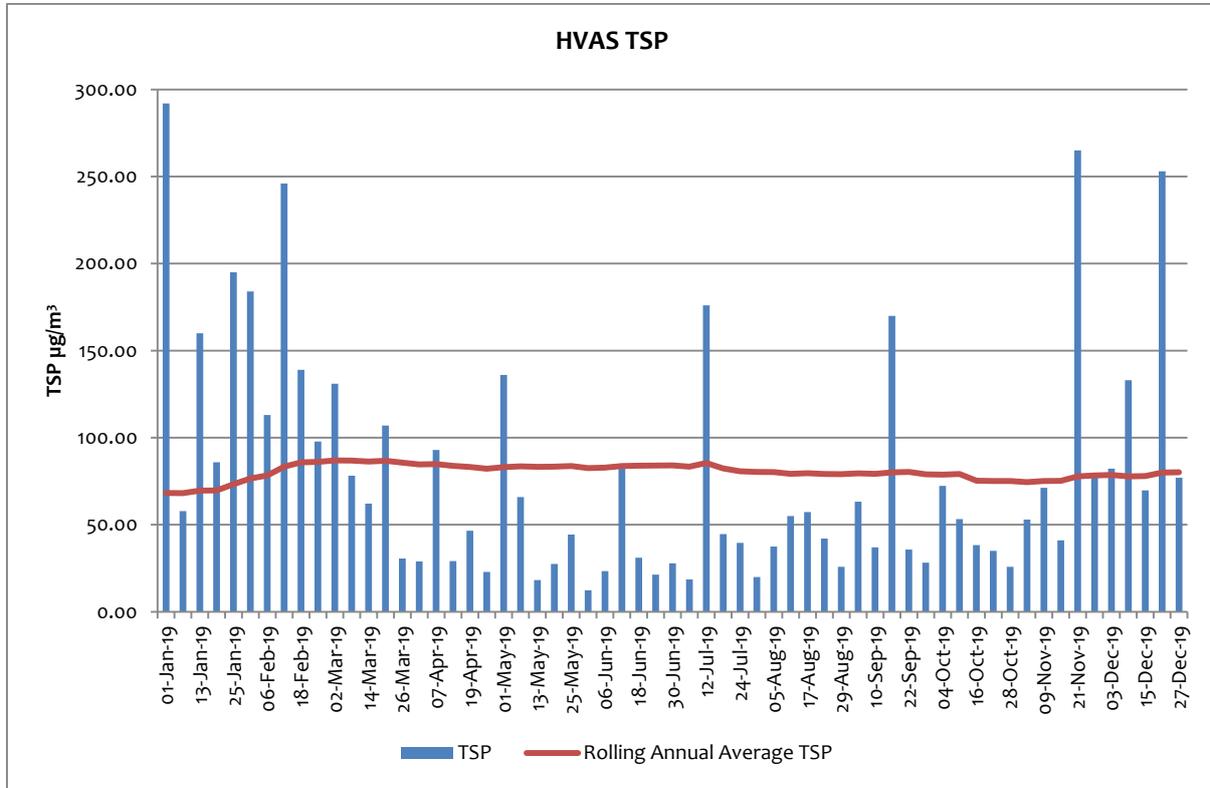
**Figure 3-7 HVAS TSP Results for the Reporting Period (2019)**

The rolling annual average TSP at the HVAS unit recorded 80.17 µg/m<sup>3</sup> for the reporting period was a significant increase over the previous period rolling annual average of 62.89 µg/m<sup>3</sup>. Drought conditions and frequent dust storms in Spring and Summer are responsible for the high dust levels.

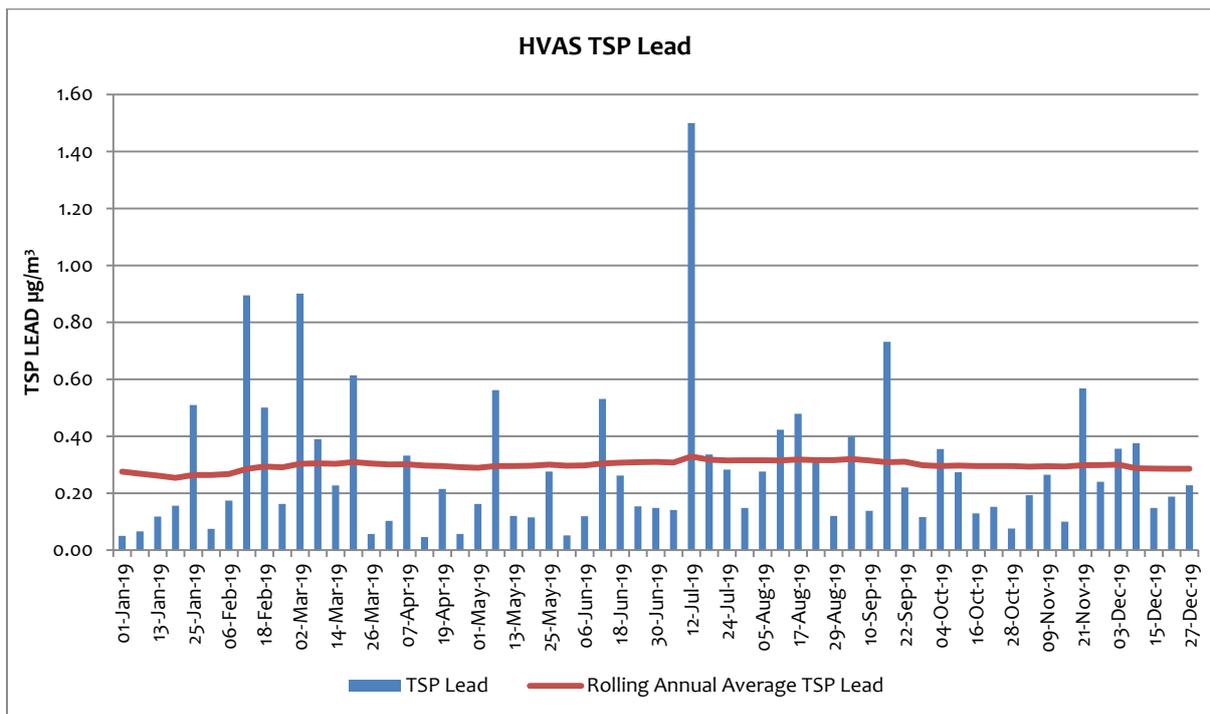
**Figure 3-8 HVAS TSP-Lead Results for the Reporting Period (2019)**

The highest TSP-Lead levels were on 12 February (0.9 µg/m<sup>3</sup>), 2 March (0.9 µg/m<sup>3</sup>), and 12 July (1.5 µg/m<sup>3</sup>). Winds were predominantly from the SSW (39.2 km/hr), ENE (30.4 km/hr) and NW (41.8 km/hr), respectively. The results of 12 February and 12 July may have been a result of site activities although no specific activities could be identified as the cause.
