# Rasp Mine

## Annual Environmental Management Report

**1 January 2019 - 31 December 2019**

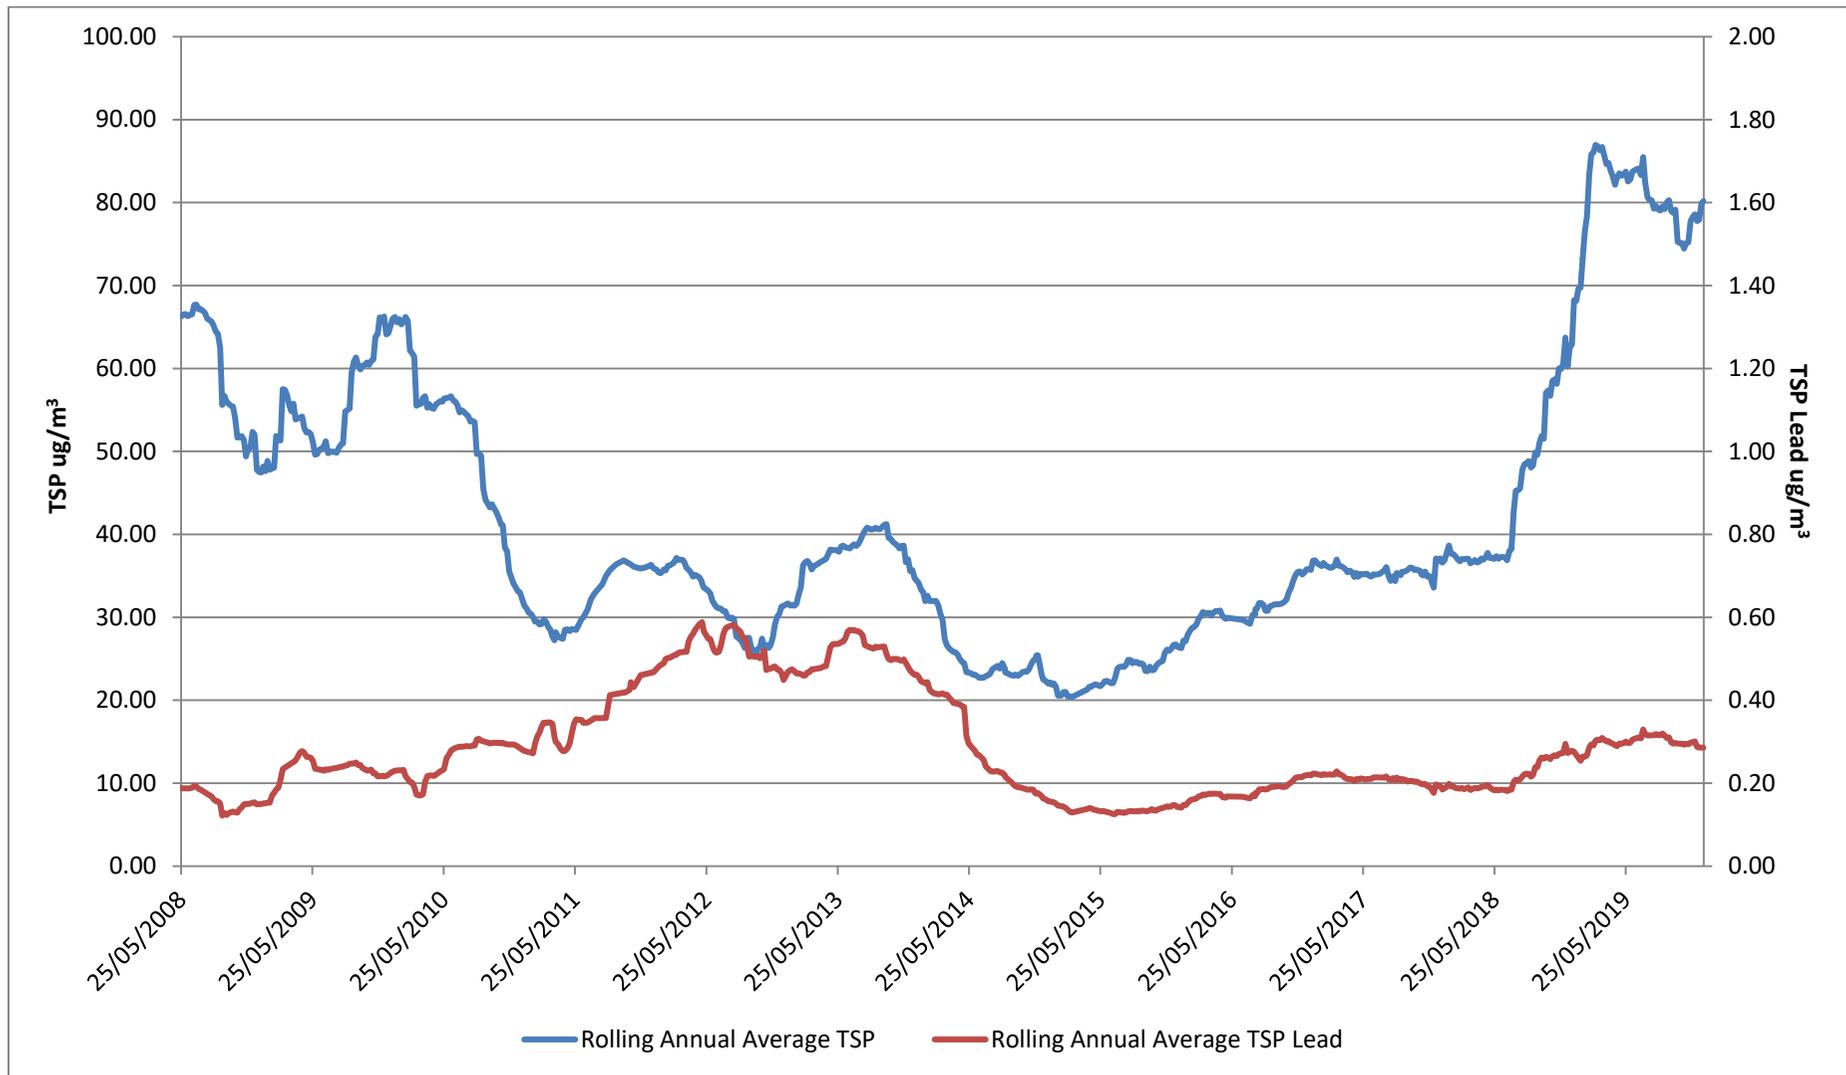
Figure 3-9 HVAS TSP and TSP-Lead Results for the Period 2008 to 2019

**Figure 3-9** provides a summary of TSP and TSP-lead results from 2008 to 2019. Results for TSP are well below the EPA threshold of  $90 \mu\text{g}/\text{m}^3$  and  $0.5 \mu\text{g}/\text{m}^3$  for TSP-lead.

As can be seen in **Figure 3-9** there is an increase in dust levels recorded in HVAS since 2016 while Lead levels have remained stable, which suggests that much of the dust contributed is not from site and likely the result of drought conditions.

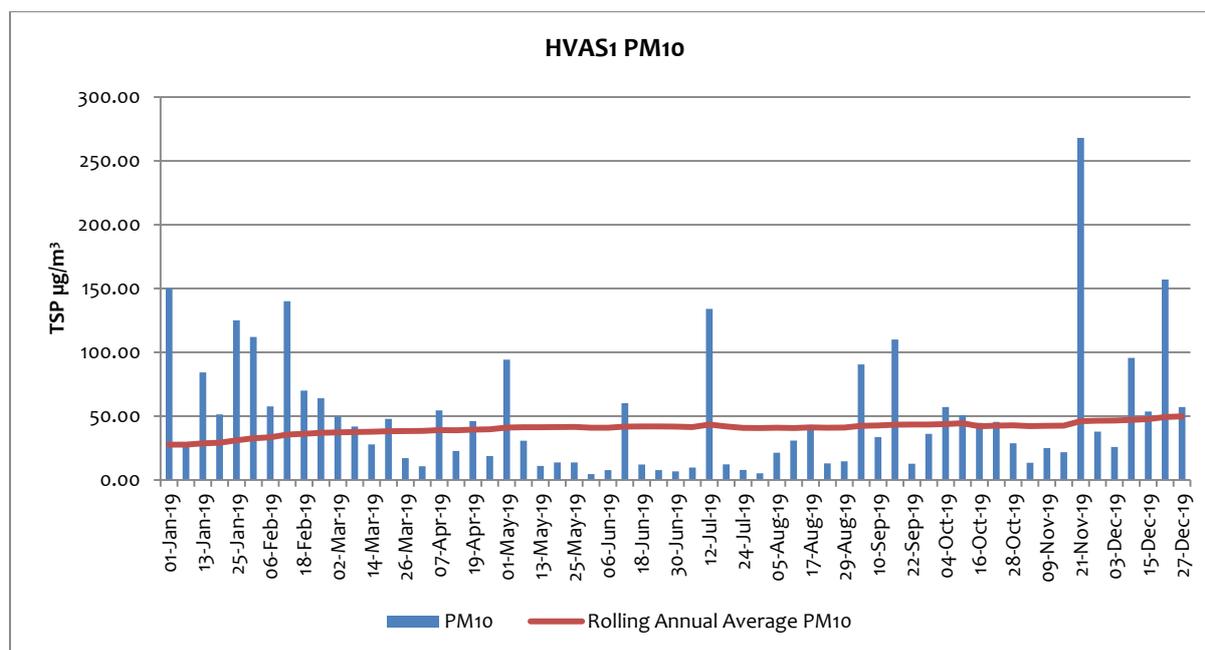
**Figure 3-10 HVAS1 PM<sub>10</sub> Results for the Reporting Period (2018)**

HVAS1 is used for sampling PM<sub>10</sub> and PM<sub>10</sub>-lead. The average annual PM<sub>10</sub> level recorded at this monitoring point at the end of the reporting period was 49.8 µg/m<sup>3</sup>, which has increased from the previous reporting period of 25.4 µg/m<sup>3</sup> and is above the background level reported in the EA of 29.1 µg/m<sup>3</sup>. Results for the reporting period are shown in **Figure 3-10** which indicates that the rolling annual average for PM<sub>10</sub> is above the criteria of 25 µg/m<sup>3</sup>. As expected there were elevated PM<sub>10</sub> levels recorded in the summer and spring months. The elevated result of 134 µg/m<sup>3</sup> recorded on 12 July was due to an unexplained event which was also recorded in the co-located HVAS TSP (EPL 10).

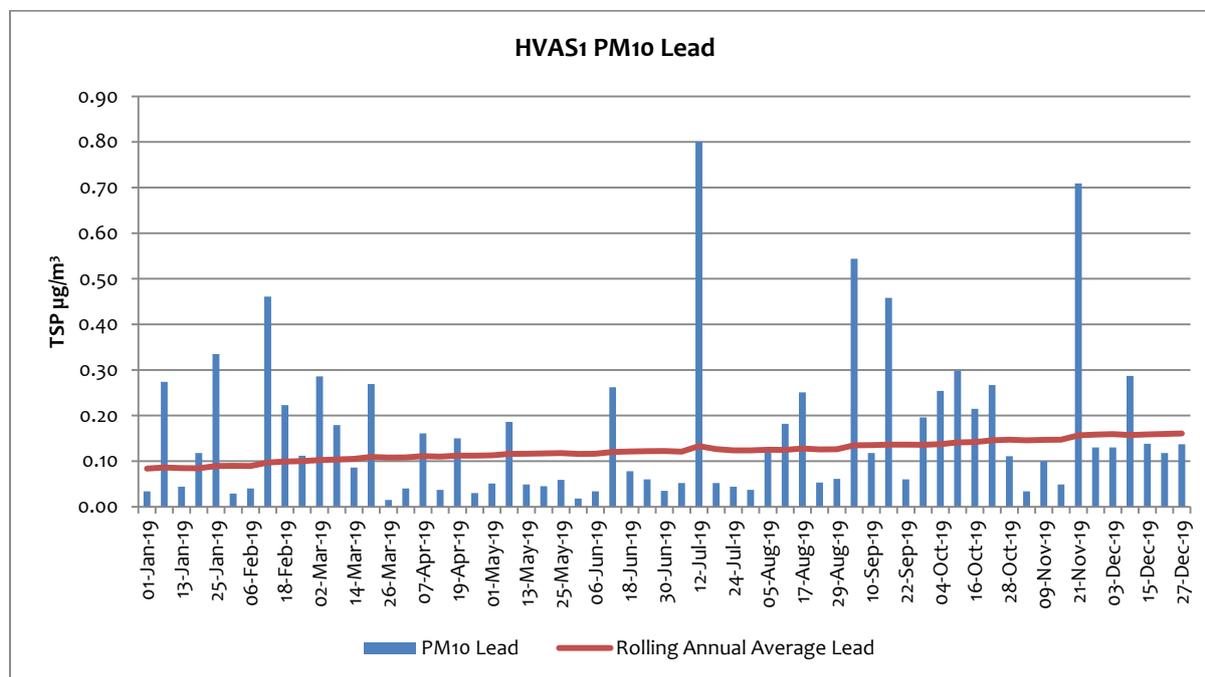
Figure 3-11 HVAS1 PM<sub>10</sub>-Lead Results for the Reporting period (2018)

The annual average PM<sub>10</sub>-lead concentration has increased slightly from 0.08 µg/m<sup>3</sup> in the previous reporting period to 0.16 µg/m<sup>3</sup>, **Figure 3-11**. The highest HVAS1-Lead levels were on 12 July (0.8 µg/m<sup>3</sup>) and 21 November (0.71 µg/m<sup>3</sup>). Winds were predominantly from the NW (41.8 km/hr) and the South (47.9 km/hr), respectively. Since May 2011 when HVAS1 started operating dust levels have fallen and then risen in the last year due to the drought and frequent dust storms.

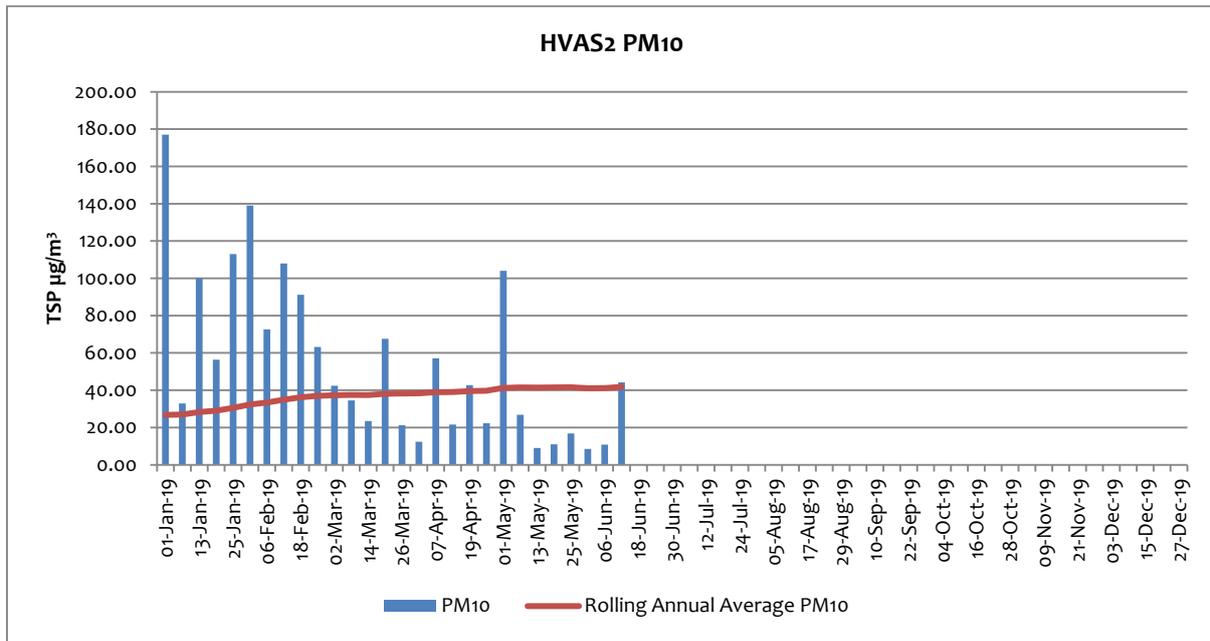
**Figure 3-12 HVAS2 PM<sub>10</sub> Annual Average Results for the Reporting Period (2019)**

HVAS2 was removed from Blackwoods Pit in June 2019 due to Embankment 2 construction works. To 12 June the average annual PM<sub>10</sub> level recorded at this monitoring point was 41.74 µg/m<sup>3</sup>, which has increased significantly from the previous reporting period (23.78 µg/m<sup>3</sup>), above the background level reported in the EA of 29.1 µg/m<sup>3</sup> and above the criteria of 25 µg/m<sup>3</sup> (for off-site receptors), **Figure 3-12**. Data presented includes that which may be result of external events, particularly dust storms which are expected in the spring and summer months.

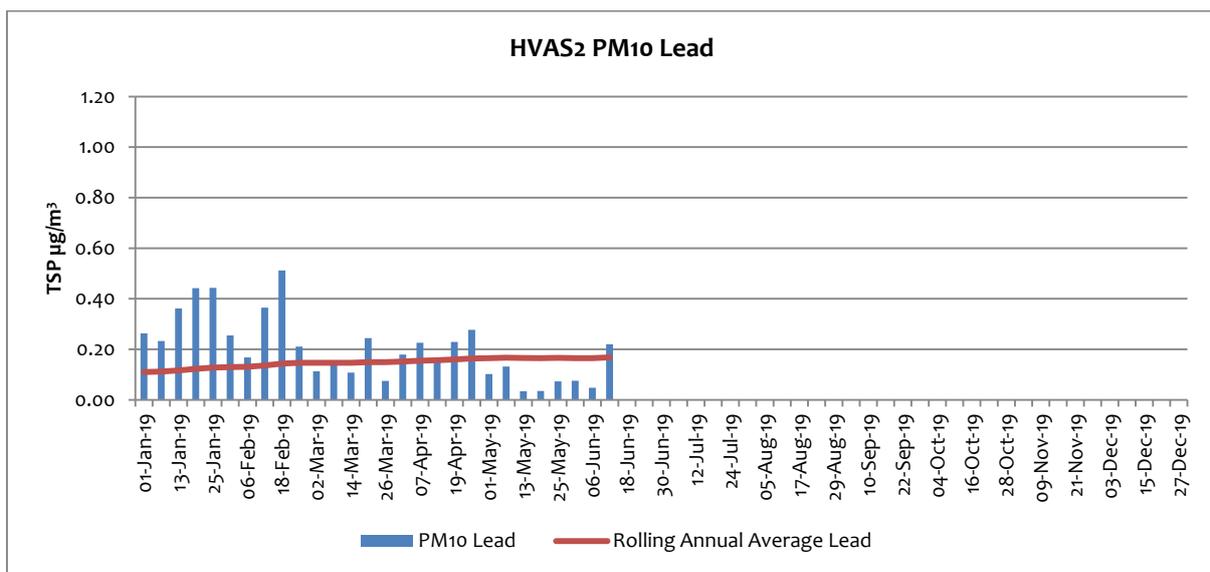
**Figure 3-13 HVAS2 PM<sub>10</sub>-Lead Results for the Reporting Period (2019)**

HVAS2 was removed from Blackwoods Pit in June 2019 due to Embankment 2 construction works. To 12 June the annual average PM<sub>10</sub>-lead concentration recorded an increase from 0.11 µg/m<sup>3</sup> at the end of the previous period to 0.17 µg/m<sup>3</sup>, **Figure 3-13**. The highest HVAS2-Lead levels were on 19 January (0.44 µg/m<sup>3</sup>), 25 January (0.44 µg/m<sup>3</sup>), and 18 February (0.51 µg/m<sup>3</sup>). Winds were predominantly from the SSE (38.4 km/hr), South (38 km/hr), and South (41.4 km/hr) respectively. There are no criteria for PM<sub>10</sub>-lead.

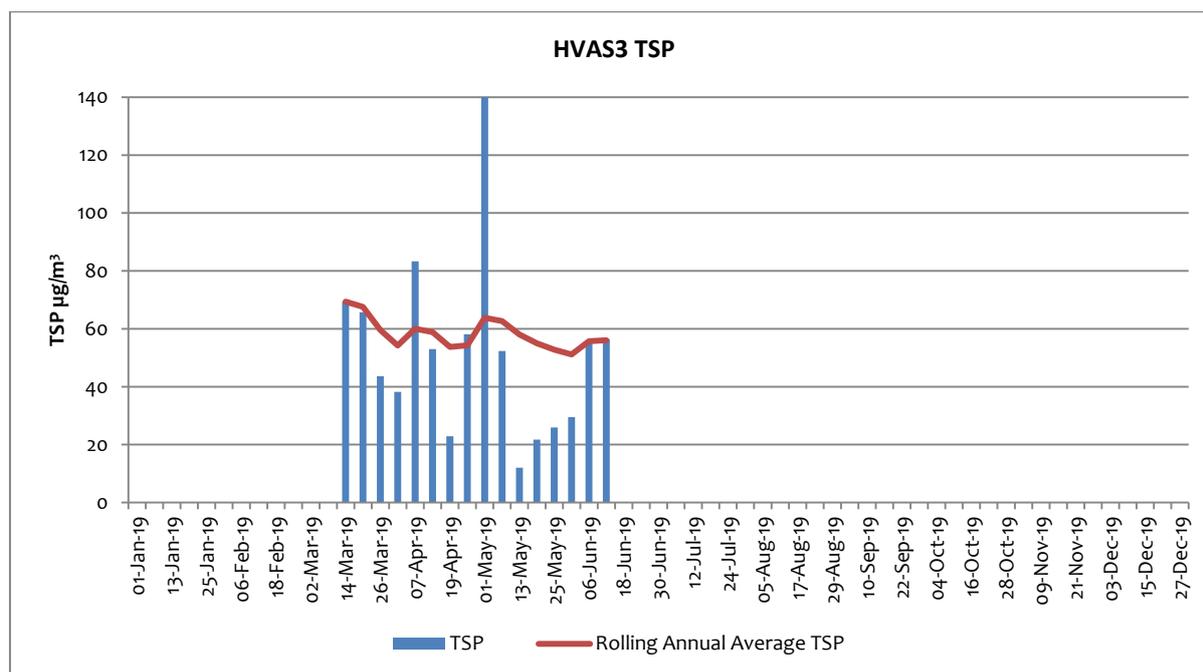
**Figure 3-14 HVAS3 TSP Results for the Reporting Period (2019)**

To 12 June the rolling average annual TSP level recorded at this monitoring point was 56.05  $\mu\text{g}/\text{m}^3$  and while it appears it may be falling it is based on three months of data only as shown in **Figure 3-14**. Data in June suggests the dust collected may have been a result of activity in preparation for the construction of Embankment 2 as there was a corresponding increase in Lead recorded at HVAS3.

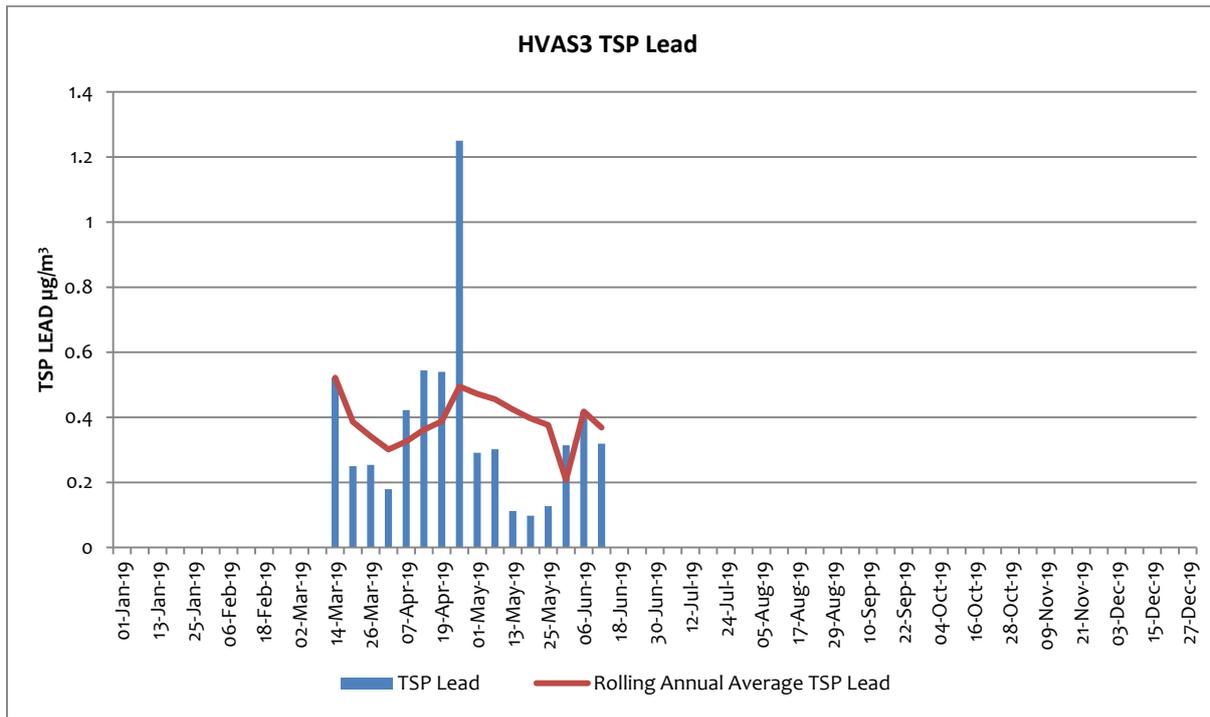
Figure 3-15 HVAS3 TSP-Lead Results for the Reporting Period (2019)

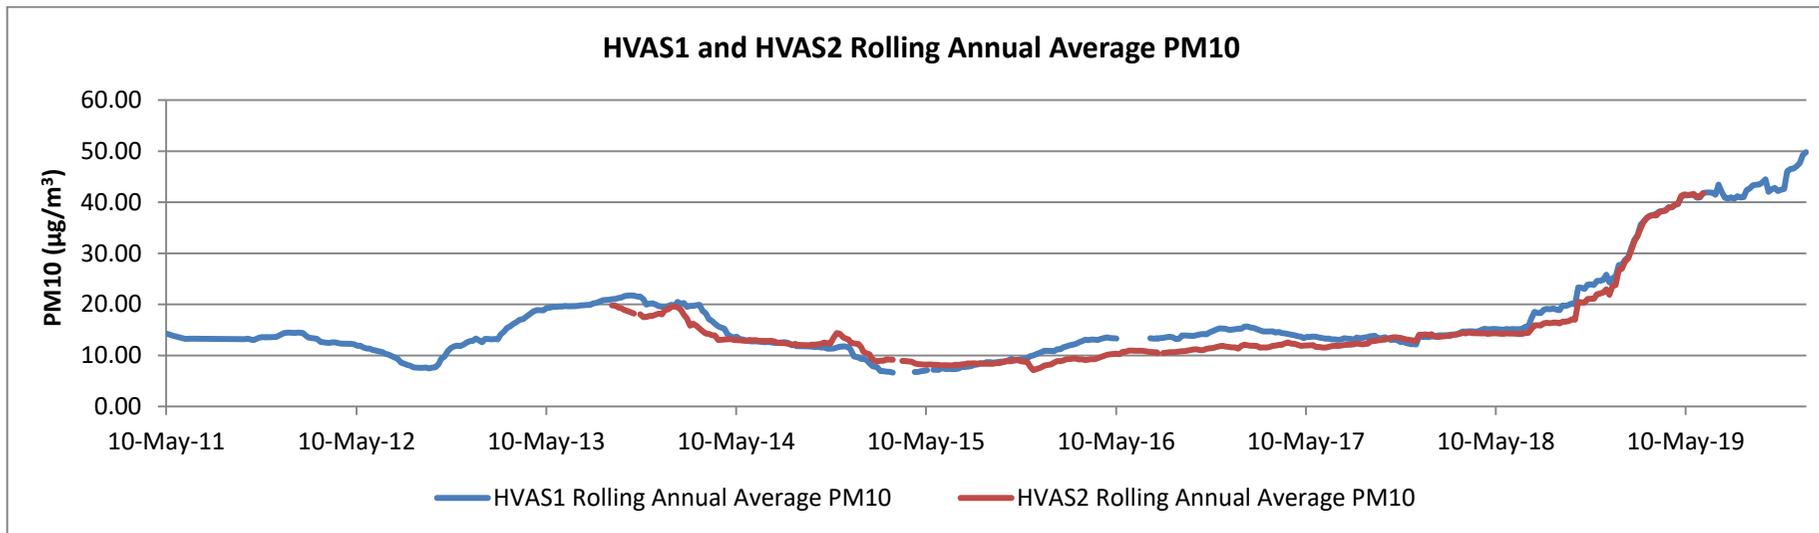
Figure 3-16 HVAS1 & HVAS2 PM10 Annual Average Results for the Period 2011 to 2019

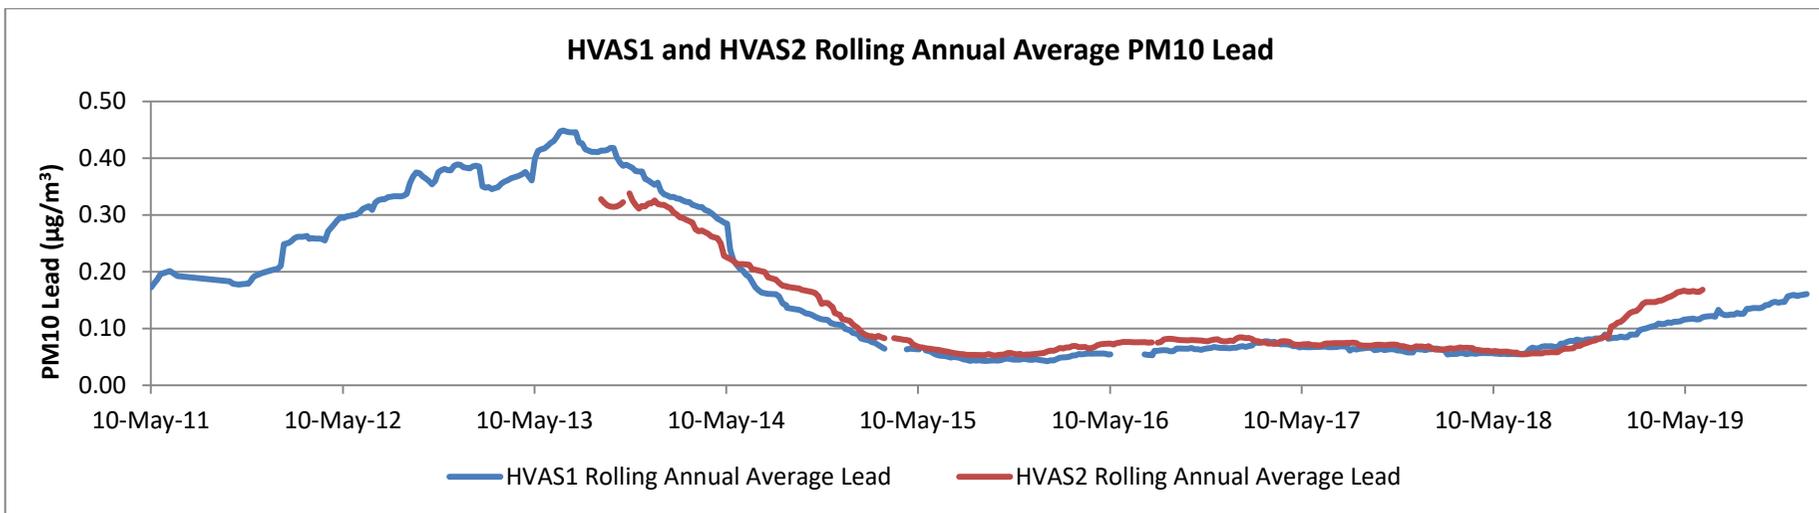
Figure 3-17 HVAS1 & HVAS2 PM10-Lead Annual Average Results for the Period 2011 to 2019

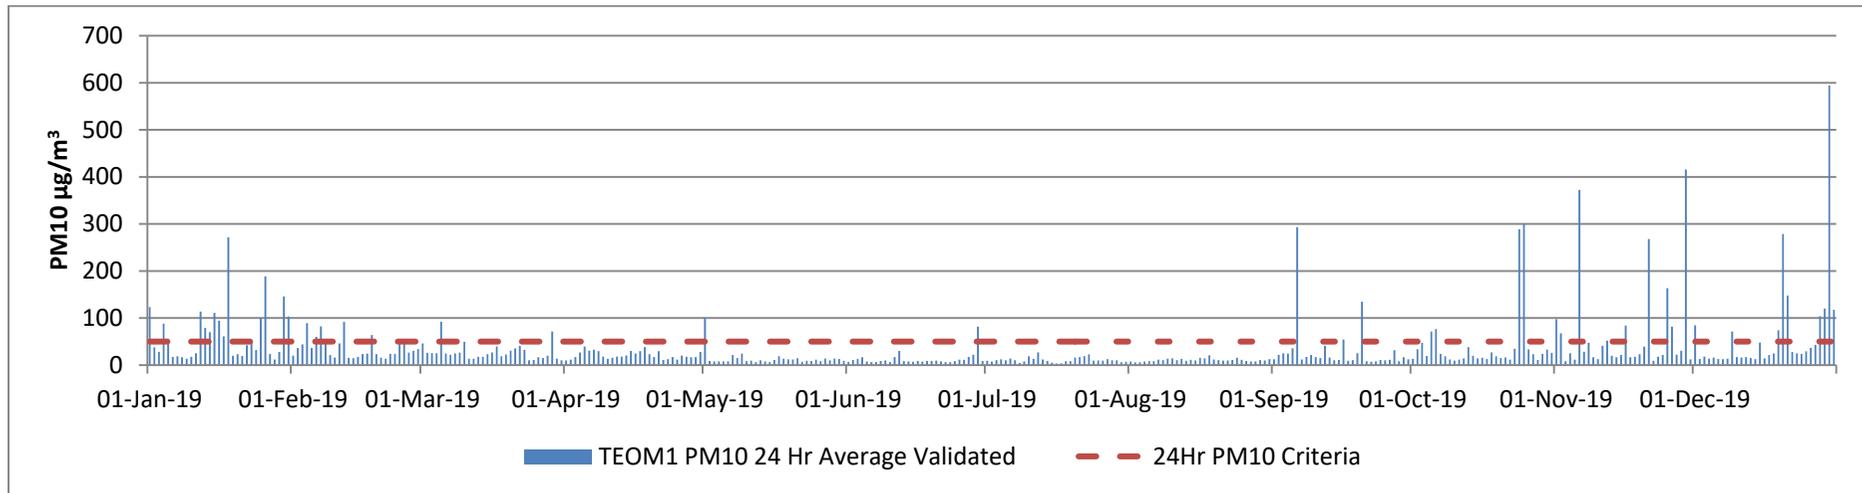
Figure 3-18 TEOM1 PM10 24-hour Average Results for the Reporting Period (2019)

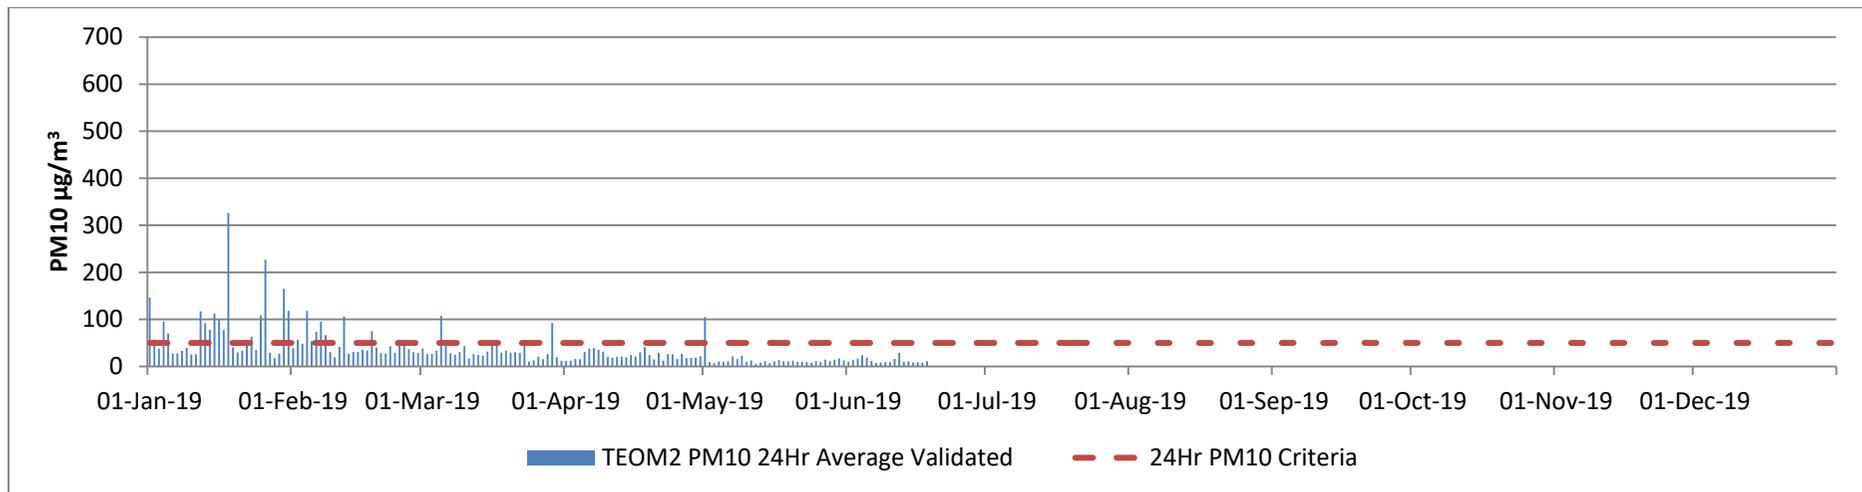
Figure3-19 TEOM2 PM10 24-Hour Average Results for the Reporting Period (2019)

The un-validated results for TEOM2 PM10 24-hour average for the reporting period are provided in **Figure 3-19**. There were a number of occasions during the reporting period when TEOM2 (located adjacent Blackwood Pit) recorded above the criteria for a 24-hour average. The highest record of these events was on 18 January (326 µg/m<sup>3</sup>). Again, this was the result of dust storms across Broken Hill. Storm events are excluded from the application for criteria.

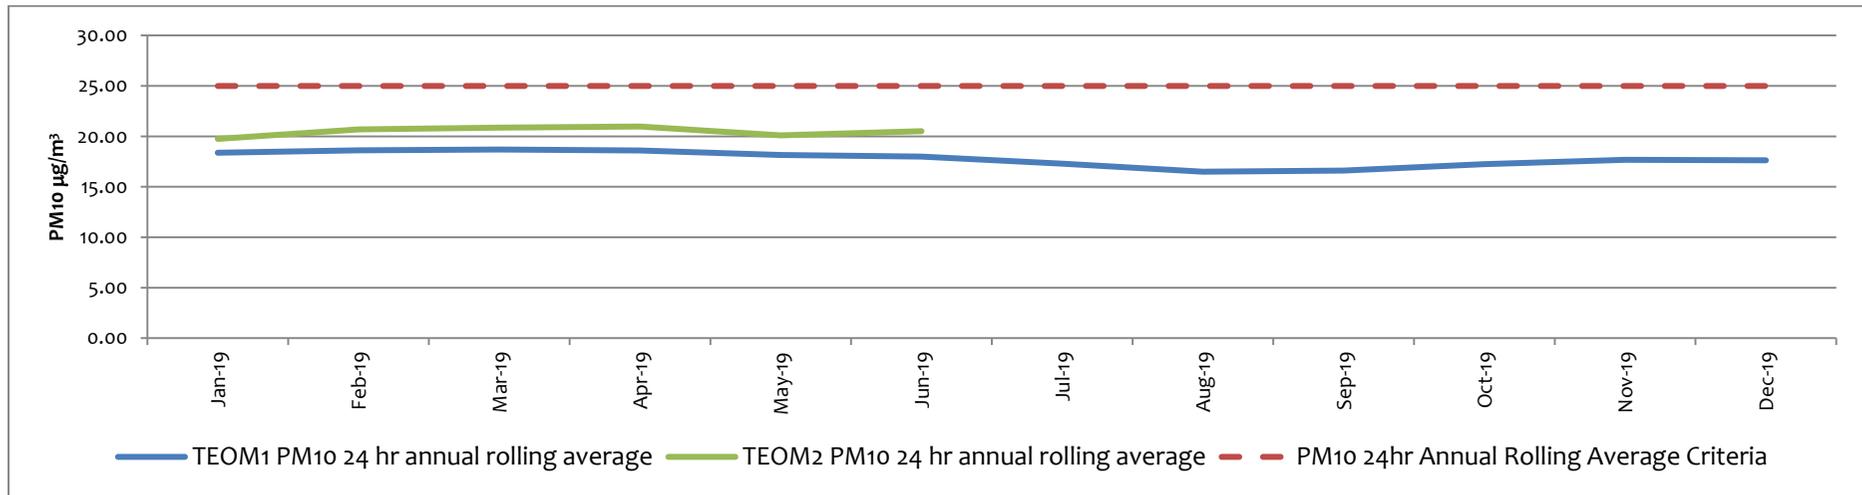
**Figure 3-20 TEOM1 & TEOM2 PM10 Annual Rolling Average for the Reporting Period (2019)**

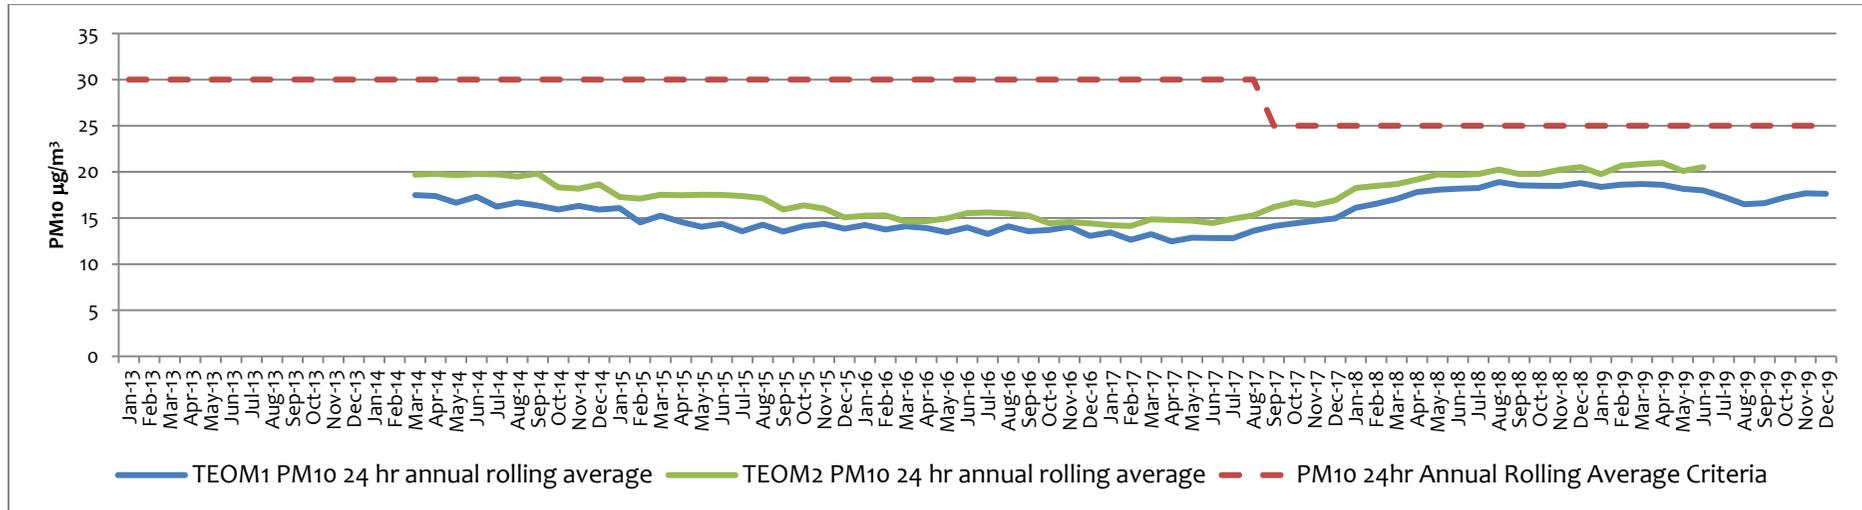
**Figure 3-21 TEOM1 & TEOM2 PM10 Annual Rolling Average Results for the Period 2013 to 2019**

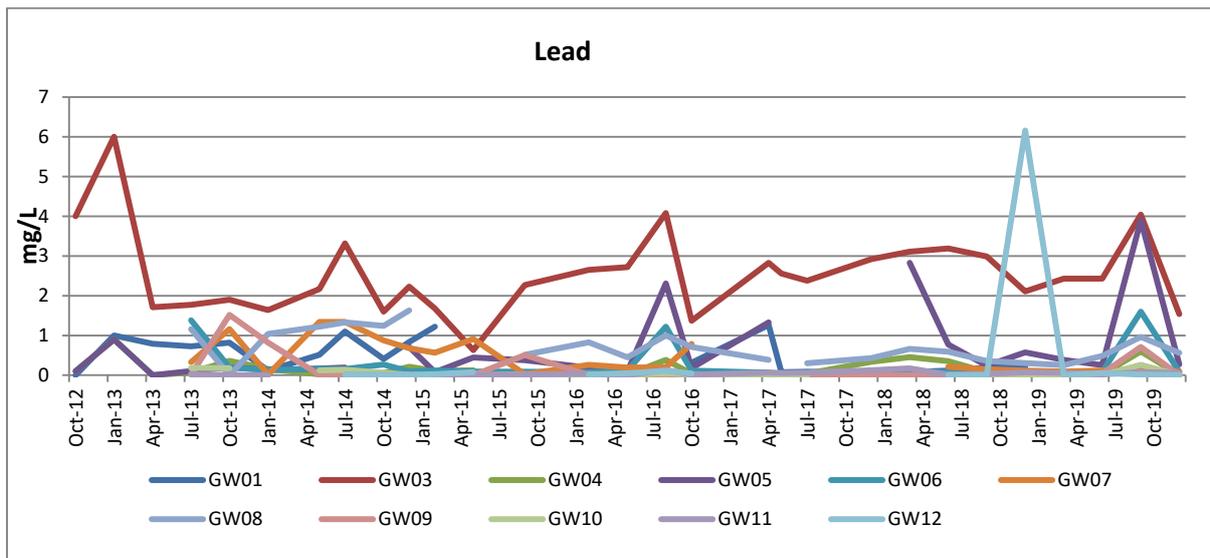
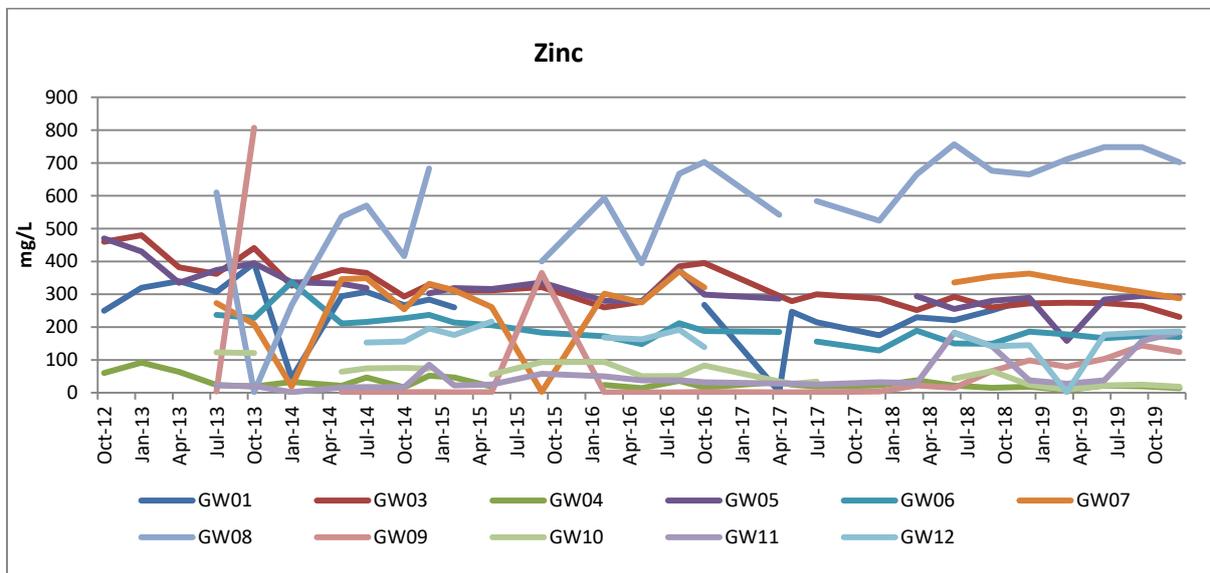
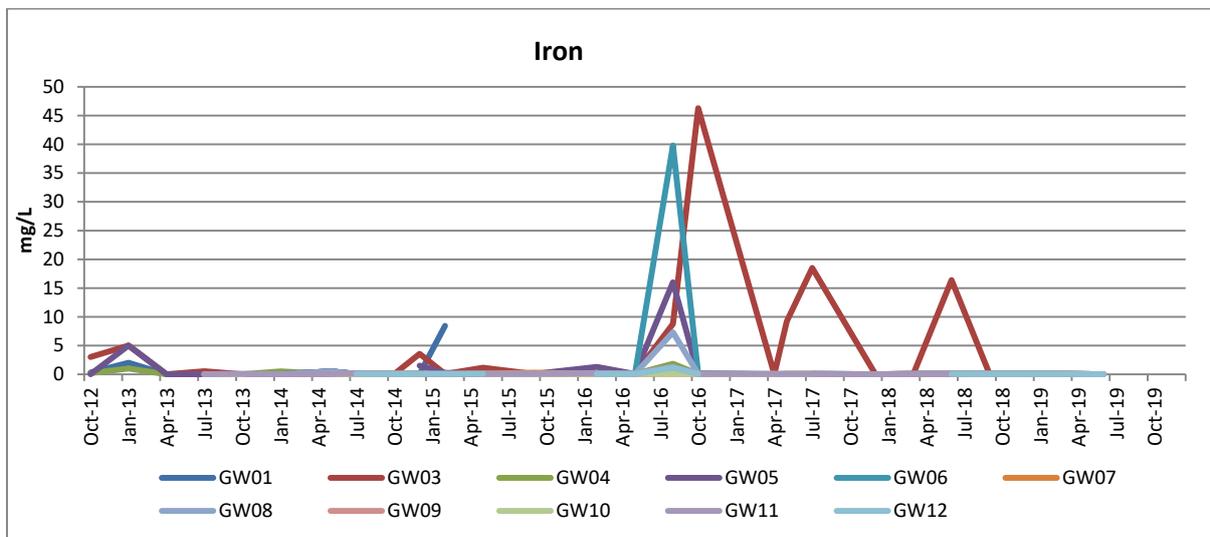
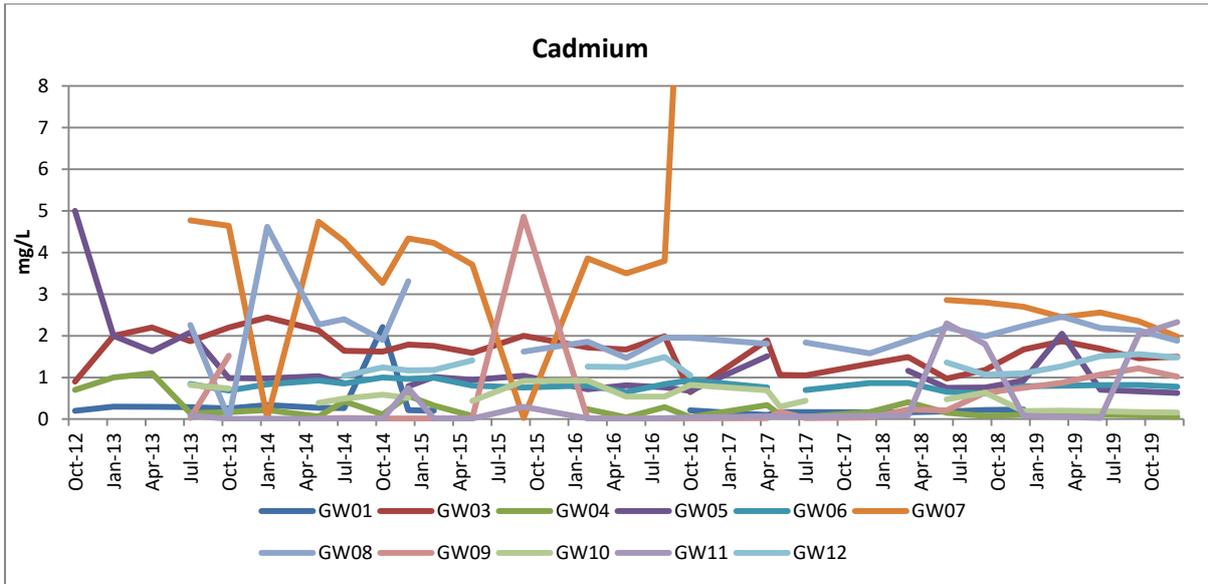
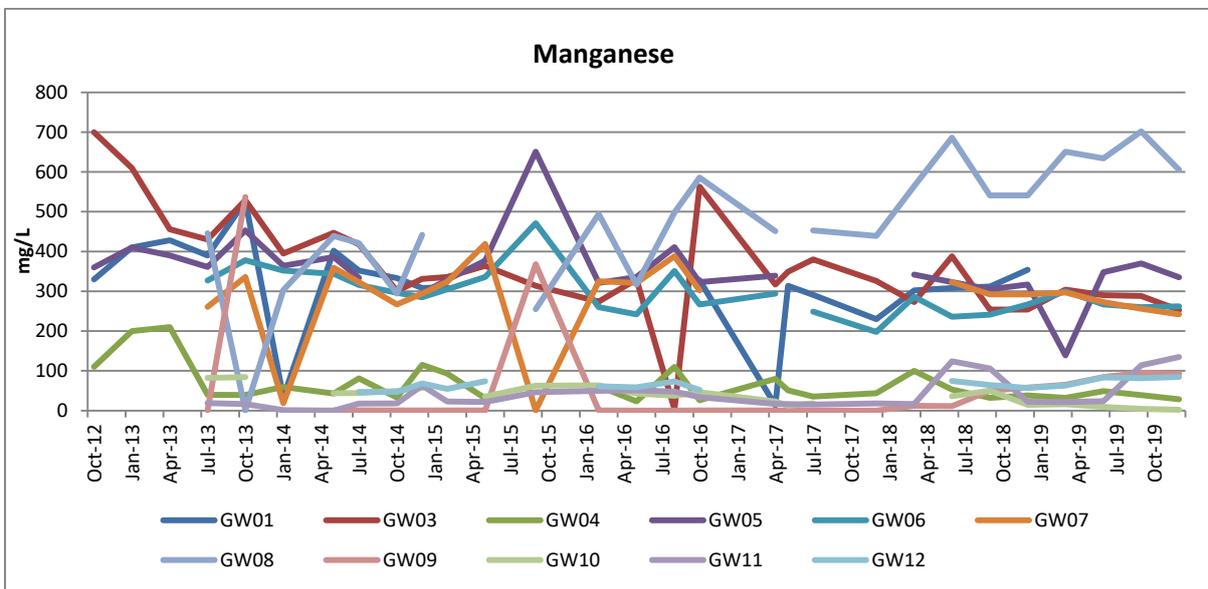
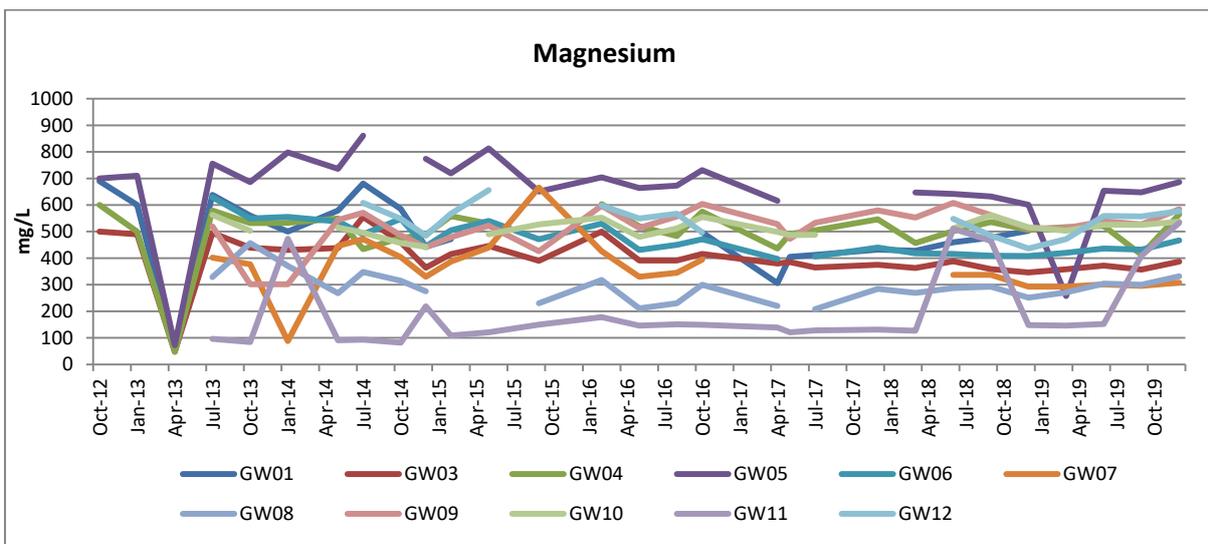
Figure 3-22 Groundwater Quality Results for Sampled Parameters for the Period 2012 to 2019

The ground water level in GW11 was slightly lower than previous periods and the level of GW12 decreased but is higher than in 2015 and 2016. GW11 recorded elevated Cadmium, Manganese, Magnesium, Calcium, Total Alkalinity, Sodium, Chloride, Sulphate, TDS and EC in September and December. The same pattern occurred in June and September 2018 and is likely due to the tailings level in TSF2 reaching a point where a fault or crack has allowed water to escape. Concentrations are being monitored and levels are expected to return to normal as the fault or crack is sealed by tailings. **Figure 3-22** indicates results remain within historic ranges.

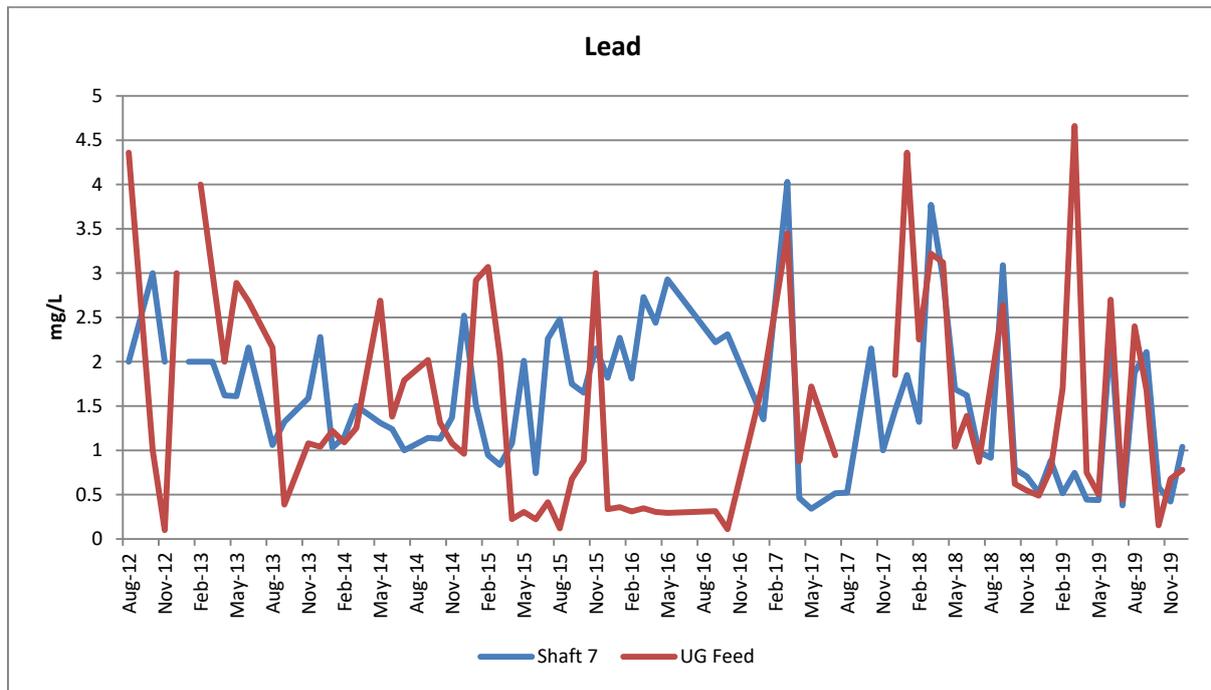
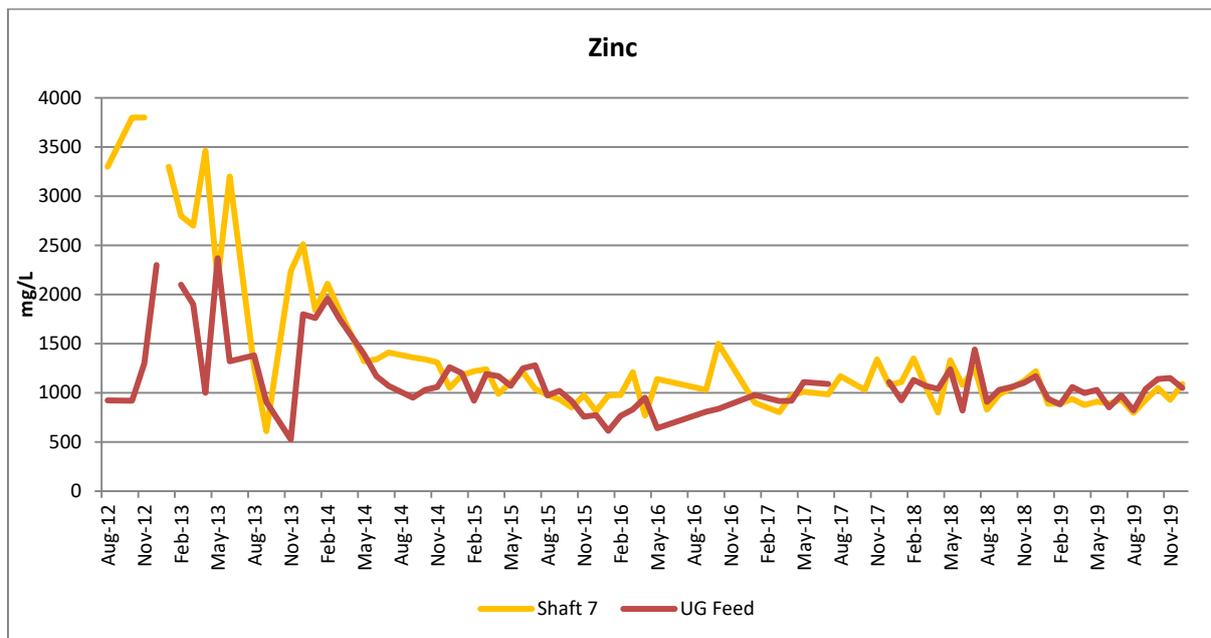
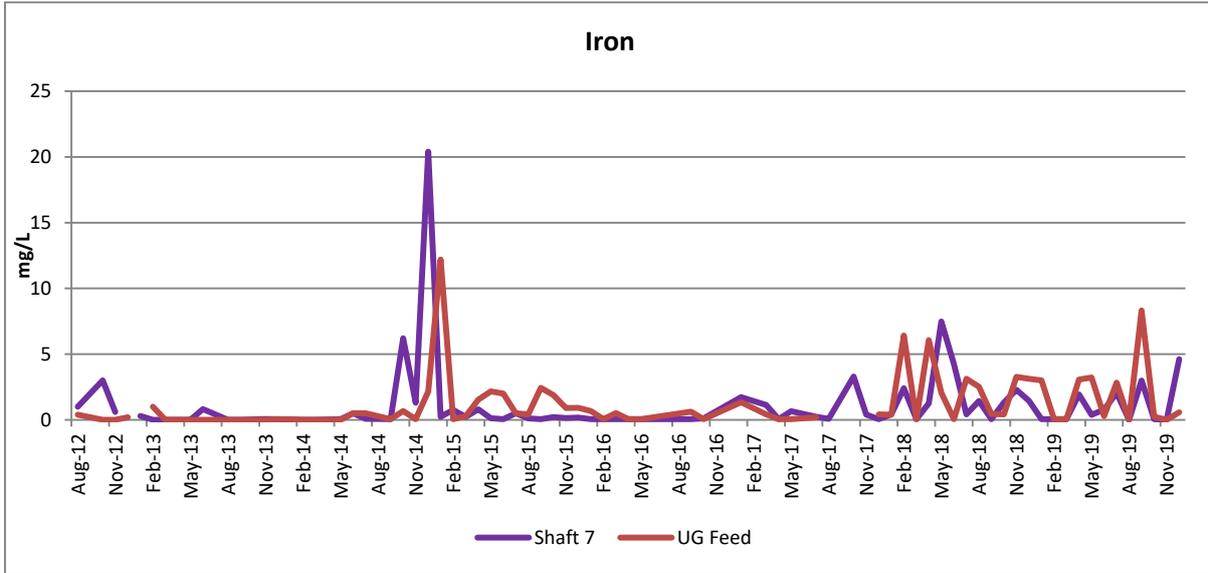
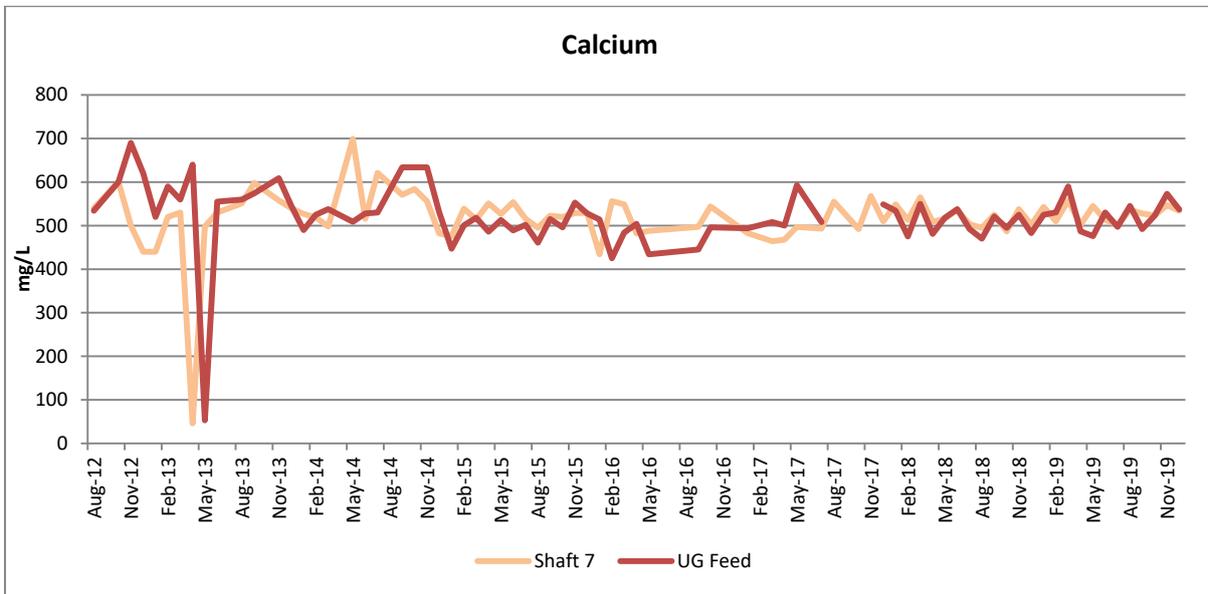
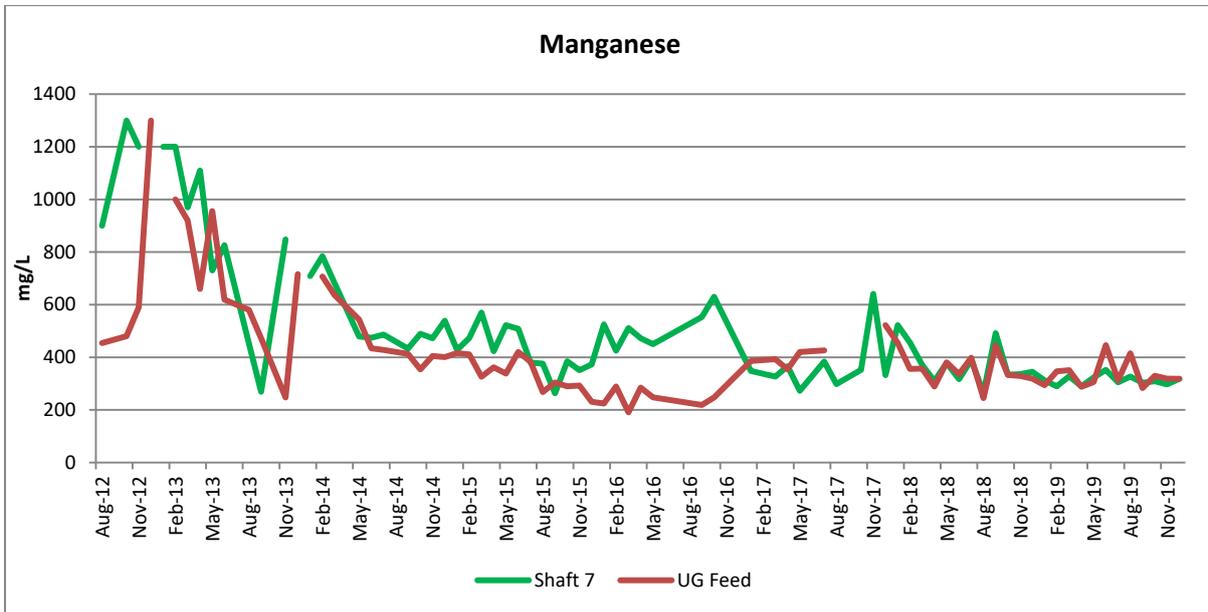
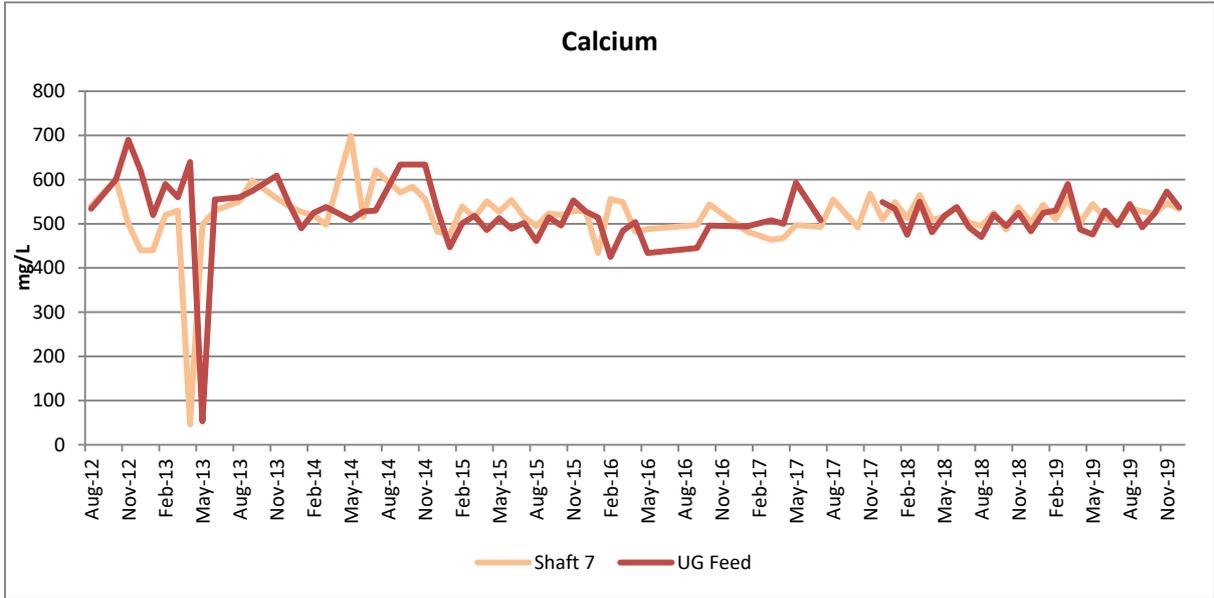
Figure 3-23 Shaft 7 & Mine Dewatering Results for Sampled Parameters - Period 2012 to 2019

Figure 3-23 provides a series of graphs indicating results for the period 2012, commencement of operations, to 2019. Results are within the historic range for all parameters, and in some cases such as with Zinc and Manganese, lower.
