# Rasp Mine

## Annual Environmental Management Report

**1 January 2019 - 31 December 2019**

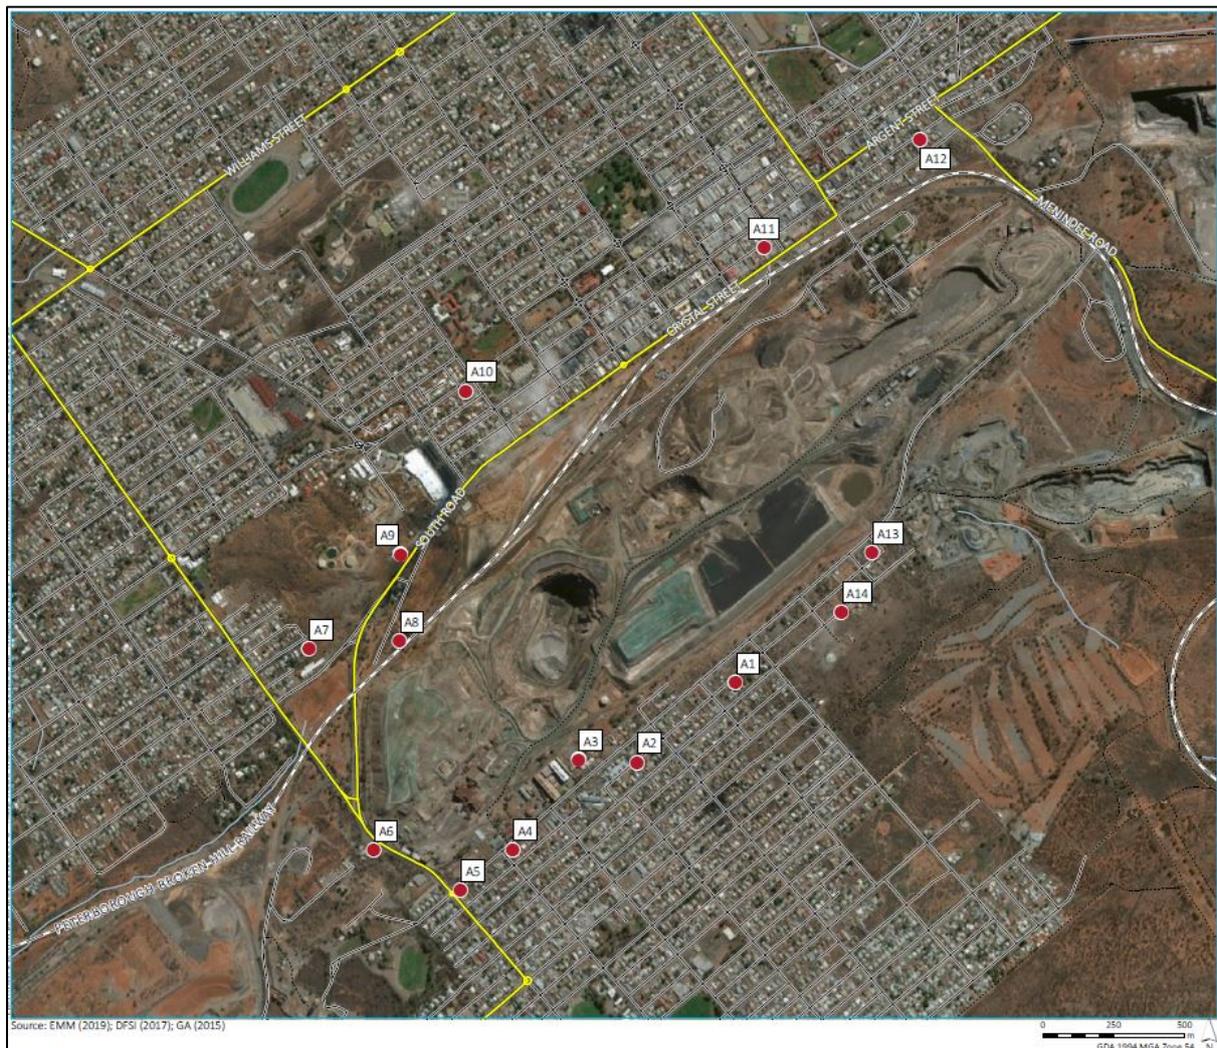
**Figure 3-24 Noise Receptors**

A total of 28 operator-attended noise measurements were completed, including two measurements at each of the 14 monitoring locations. For 11 out of the 28 samples (39%), the wind speed was below 3 m/s and therefore the noise limits did apply for these samples according to the site's EPL. Site noise was inaudible during one of two measurements at locations A5, A8, A10 and A11. Noise monitoring results are shown in **Table 3-24**.
