Broken Hill Operations Pty Ltd ABN 95 103 555 862

Annual Environmental Management Report

16 December 2014 to December 31 2015

Name of Mine:	Rasp Mine
Mining Titles / Leases:	Consolidated Mining Lease 7, Broken Hill
	MPLs 183, 184, 185, 186
MOP Commencement Date 16/12/14	MOP Completion date 31/10/15 (New MOP has been submitted, awaiting approval)
AEMR Commencement Date 16/12/14	AEMR End Date 31/12/15
Name of Leaseholder:	Broken Hill Operations Pty Ltd
Name of Mine Operator:	Broken Hill Operations Pty Ltd
Reporting Officer:	Leonard Sharp
Title	Environment Officer
Signature

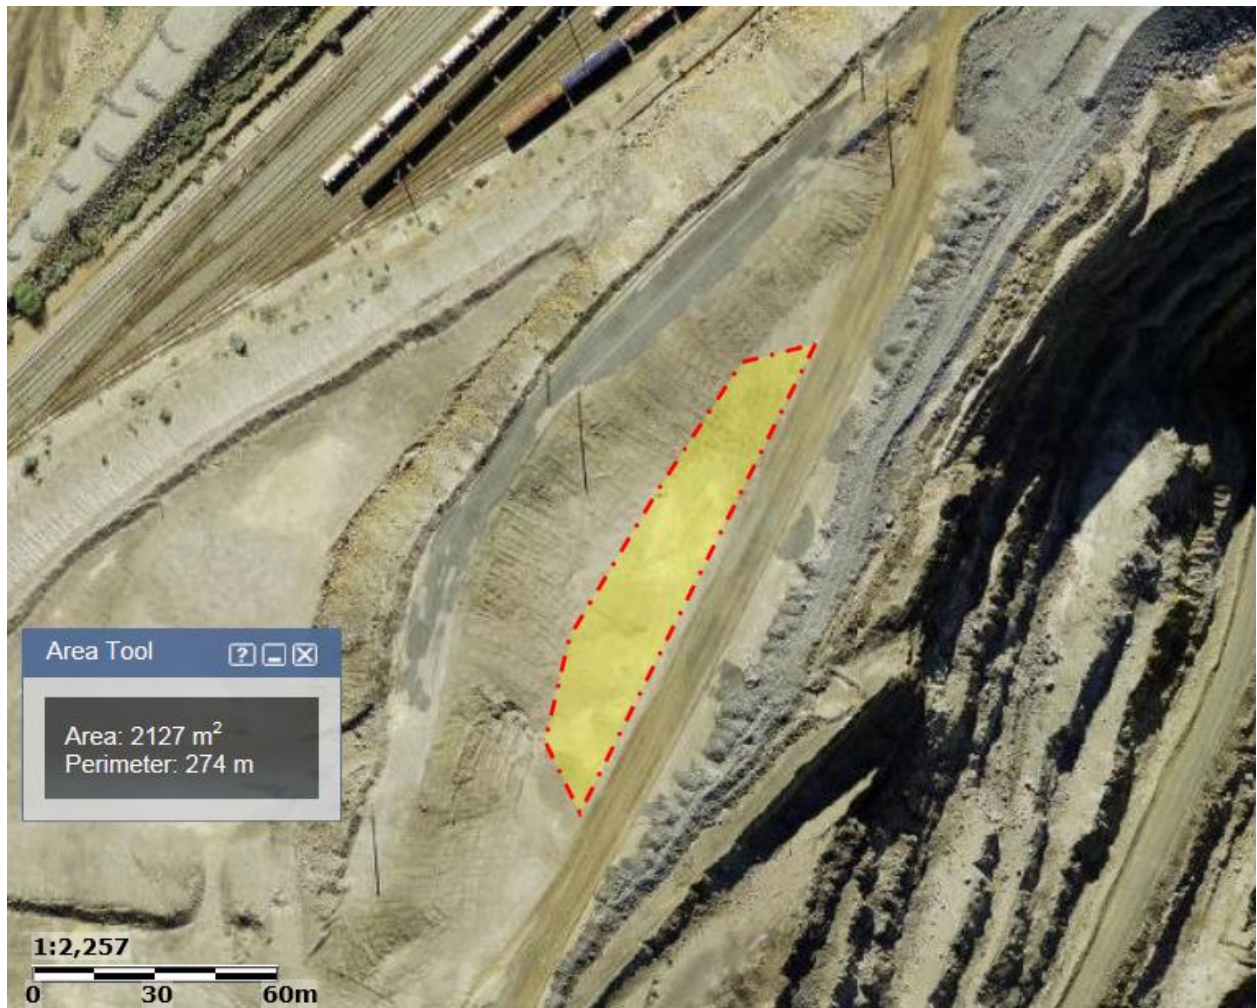
A waste rock trial was conducted during the reporting period on the northern side of Kintore Pit. The trial was conducted as per the waste schedule sent to DRE on 29/1/2015. Approximately 2200m² was covered with waste rock.

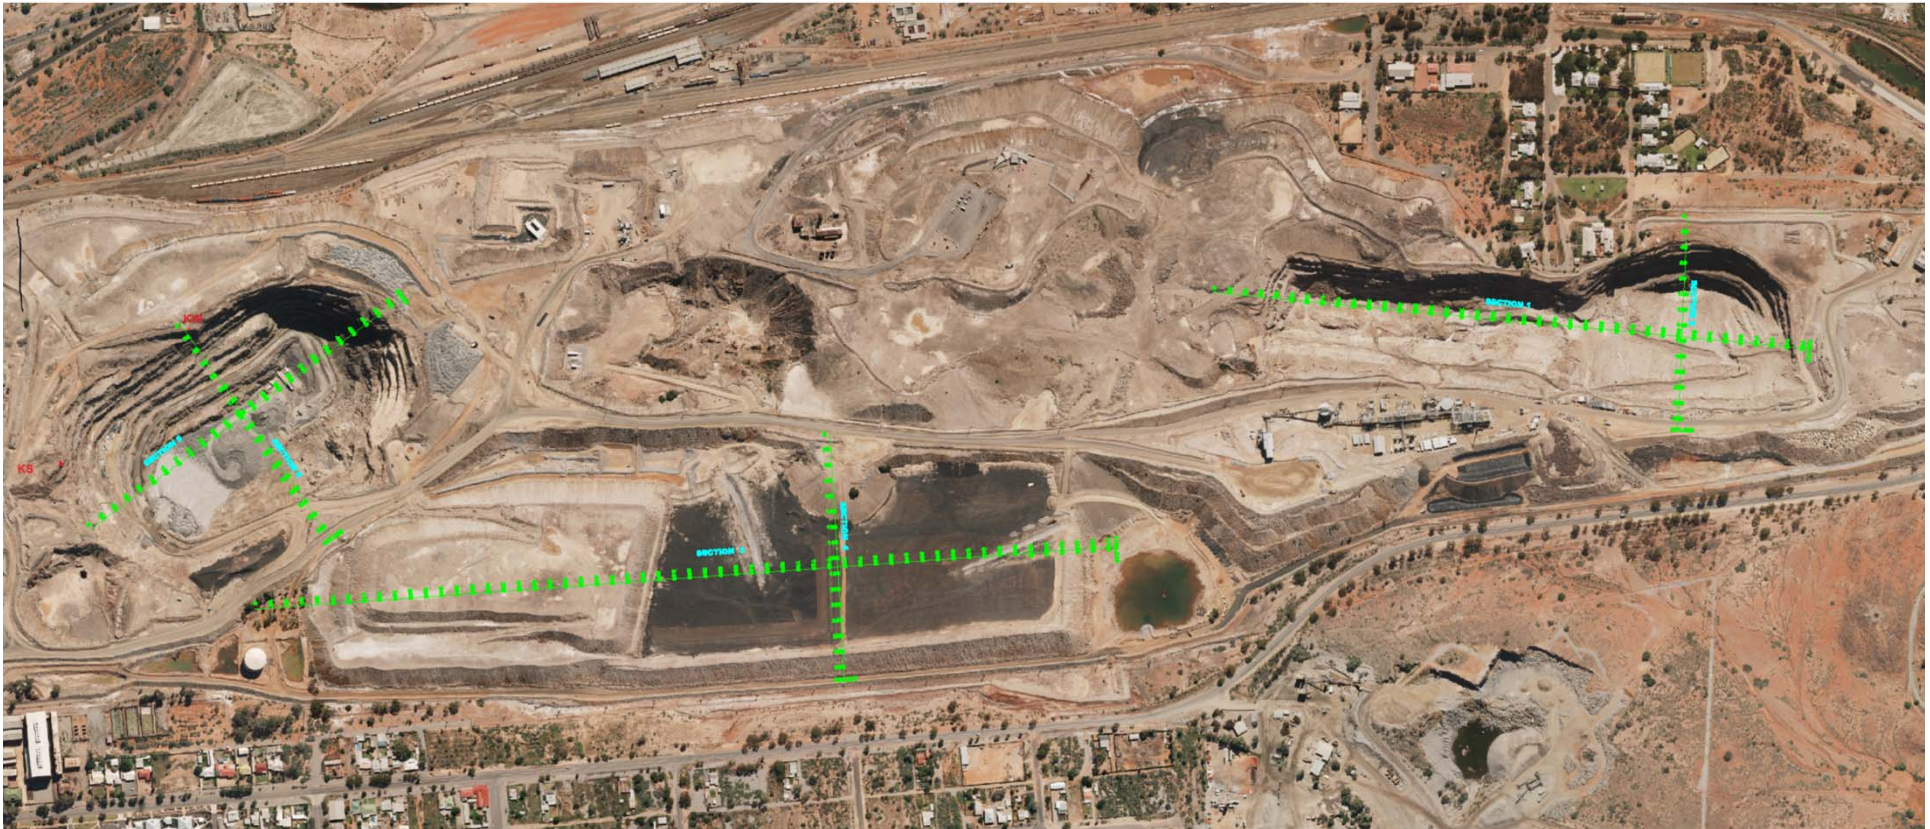
Locations shown left to right are:

Kintore Pit – active mining pit, Mt Hebbard/TSF 1 - historical tails dump, TSF 2 Blackwood Pit – active tails dam
Surveyed March 2015, image created May 2015.

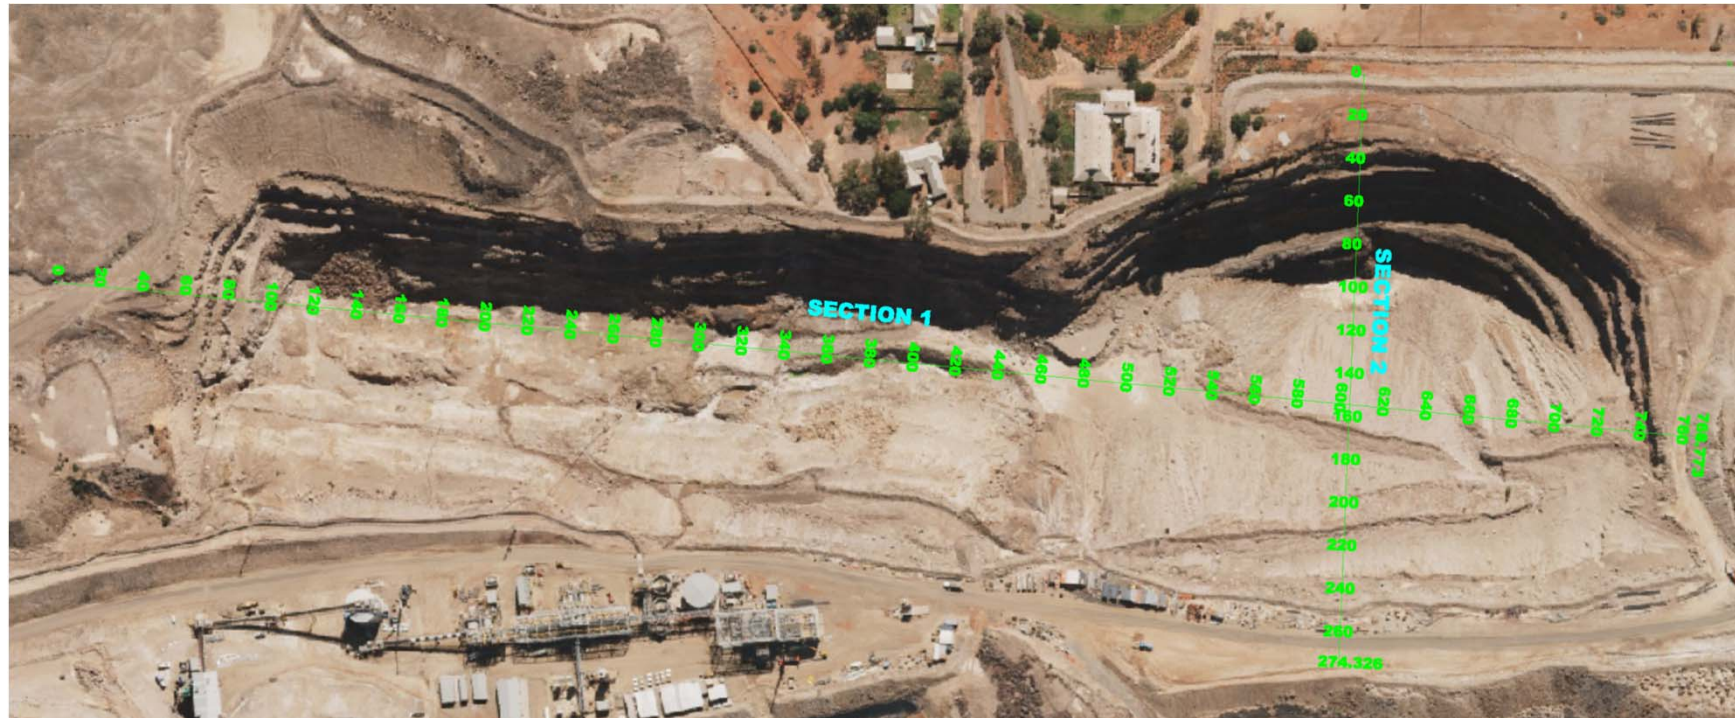
TSF 2 Blackwood Pit – active tails dam

Tailings from the process plant are deposited into the Blackwood Pit TSF, (Figure 4). This is via a ring main and is done to beach the tailings and reclaim water for re-use in the process plant from the northern end. In addition, it is designed to be able to maintain some moisture to reduce dust.

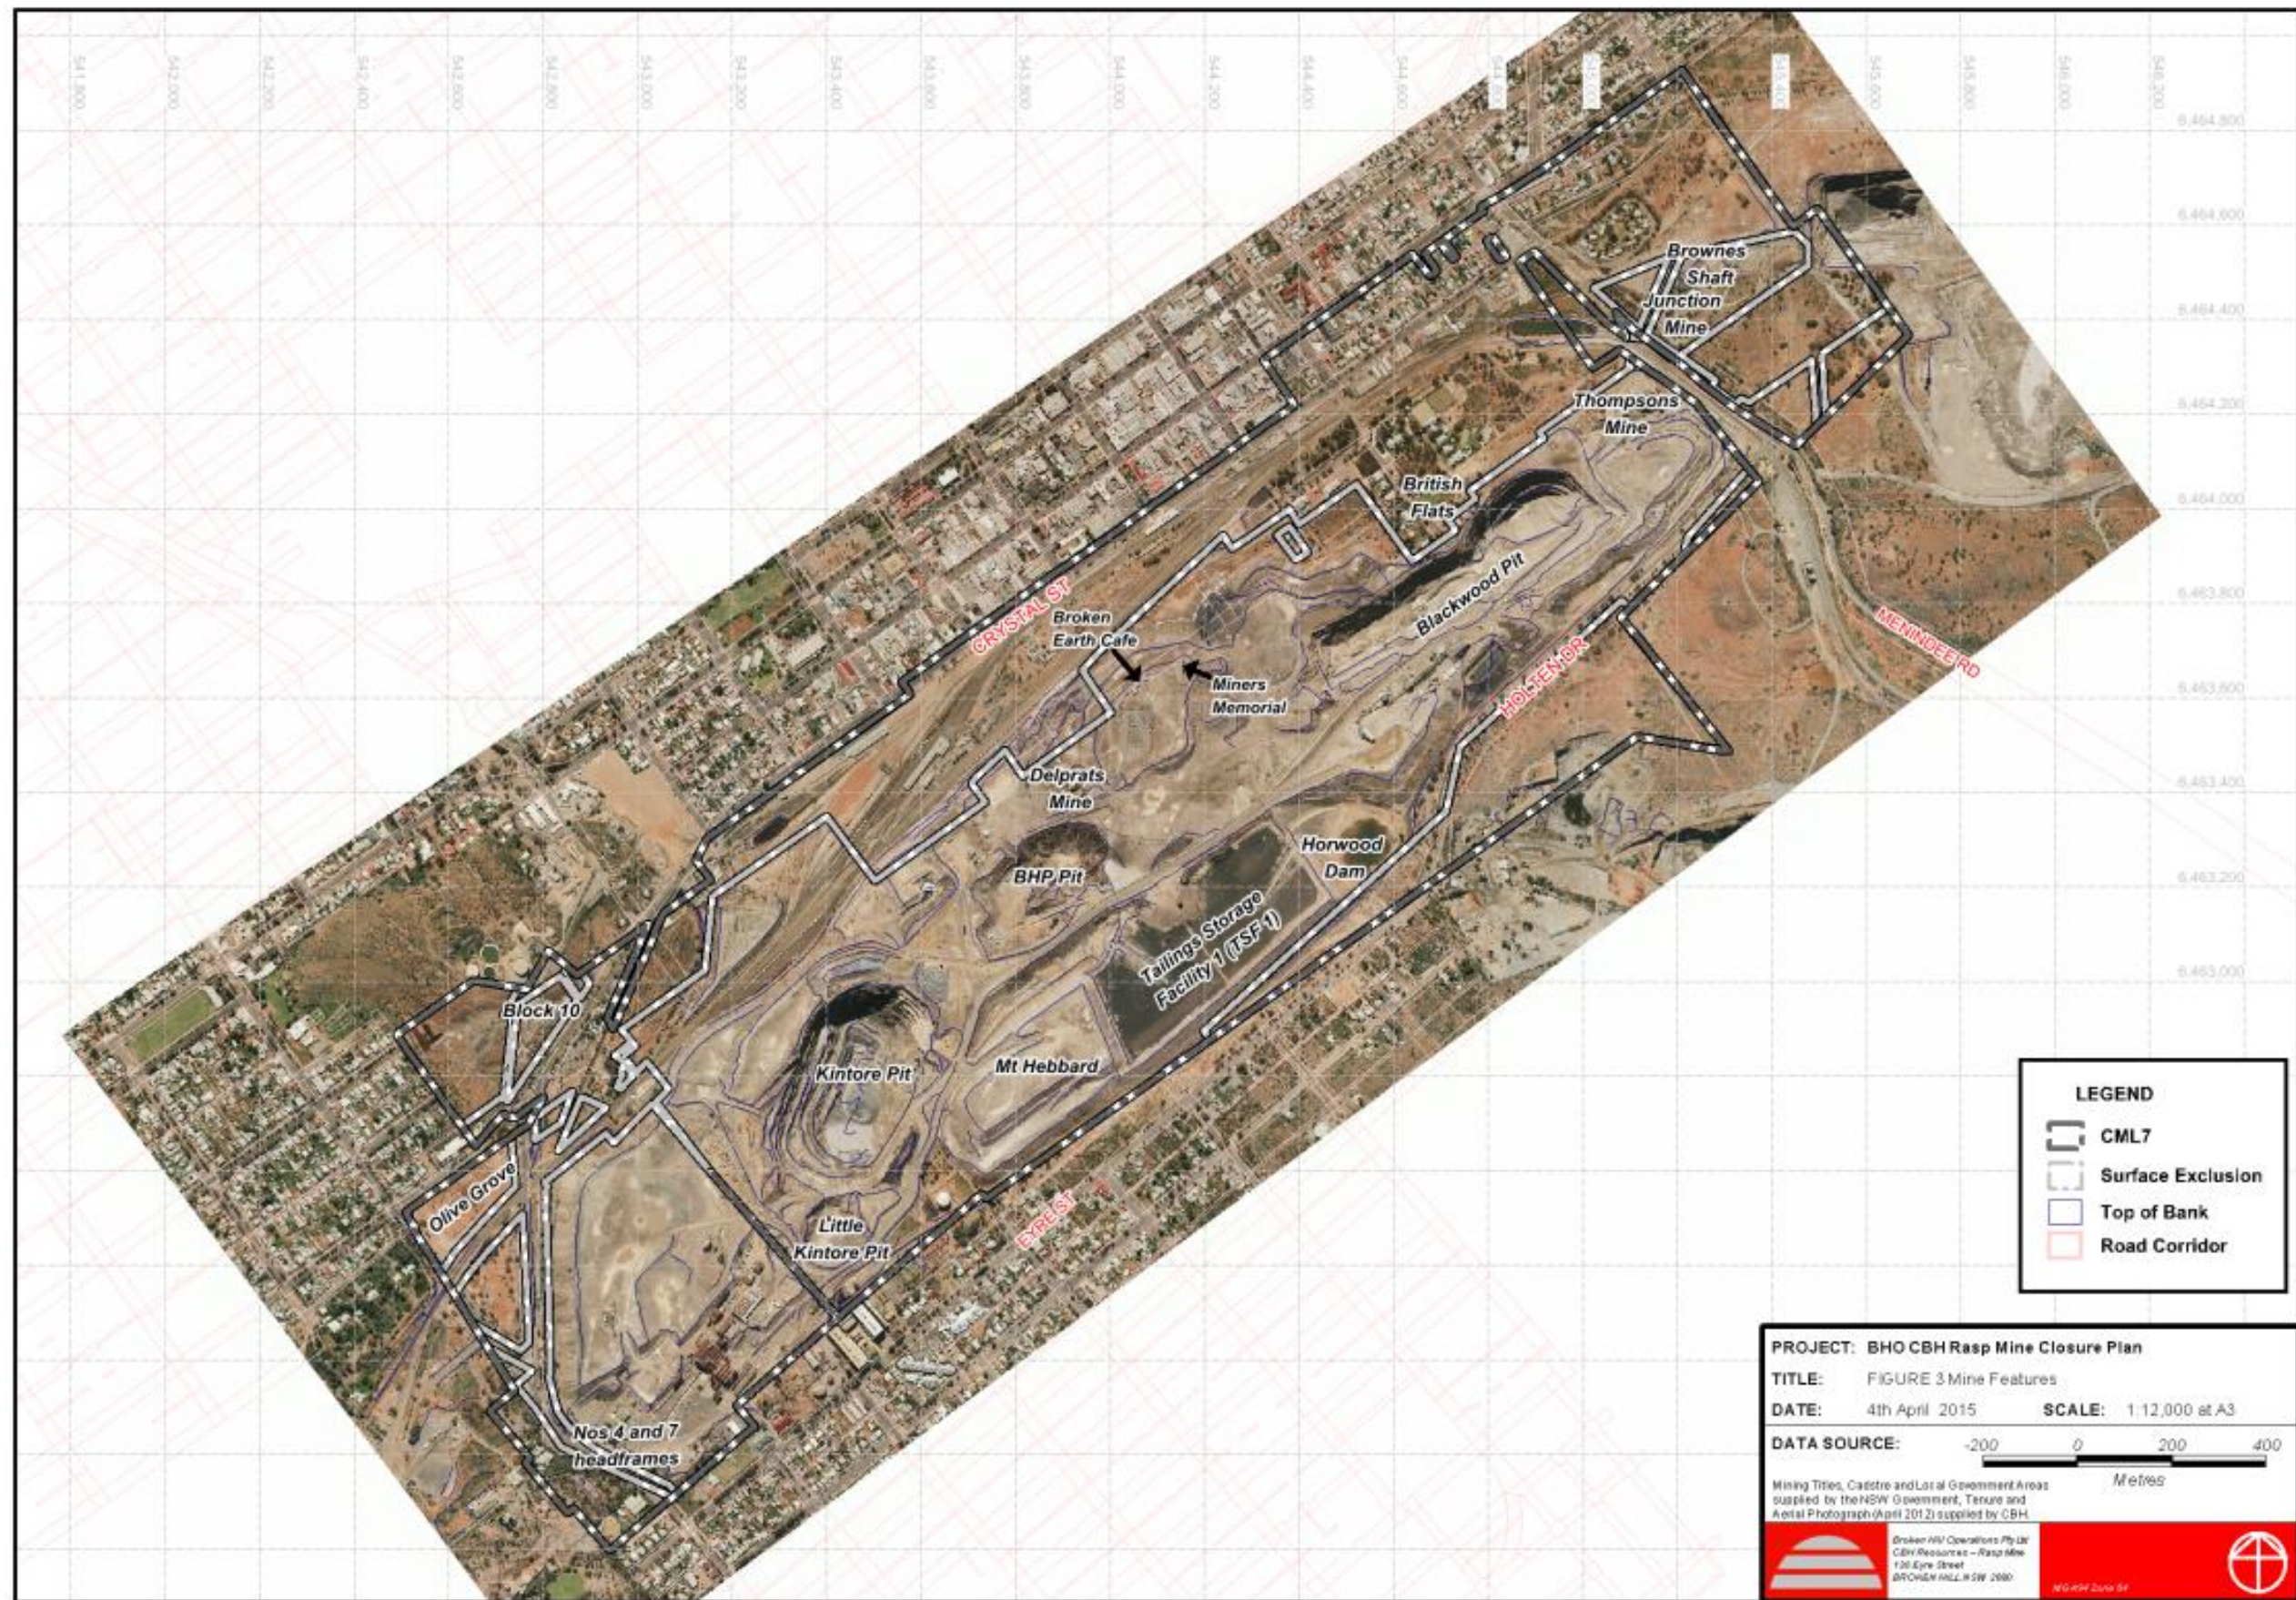
Figure 1: Aerial Overview, Rasp Mine

The Rasp Mine is located centrally within the City of Broken Hill and is surrounded by transport infrastructure, areas of commercial and industrial development and some residential housing. The Rasp Mine is bounded by Eyre Street and Holten Drive to the south and east, Menindee Road (MR 66) to the northeast, Crystal Street to the northwest and Bonanza Street and South Road (Silver City Highway SH 22) to the southwest. Residential and commercial areas are located to the west, south and north of CML7, Perilya mine developments to the north-east (North Mine) and south-west (Southern Operations) and the Blue Metal Quarry to the east. An aerial view of the Rasp Mine is provided in Figure 1.

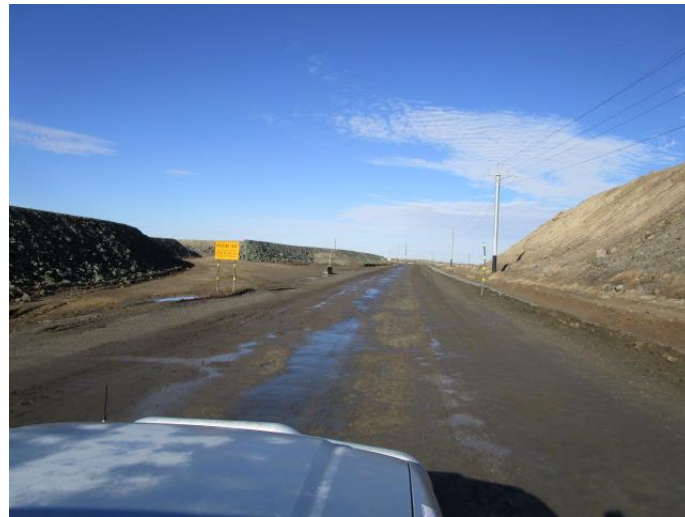
Figure 2: Bunding adjacent haul road

Works to increase the height of bunding along the haul road progressed during this time and were almost complete by the end of 2014. Waste rock from underground was used to increase the height of the eastern bund on the haul road. The geometric mean lead and zinc concentration in the waste rock was 0.2%.

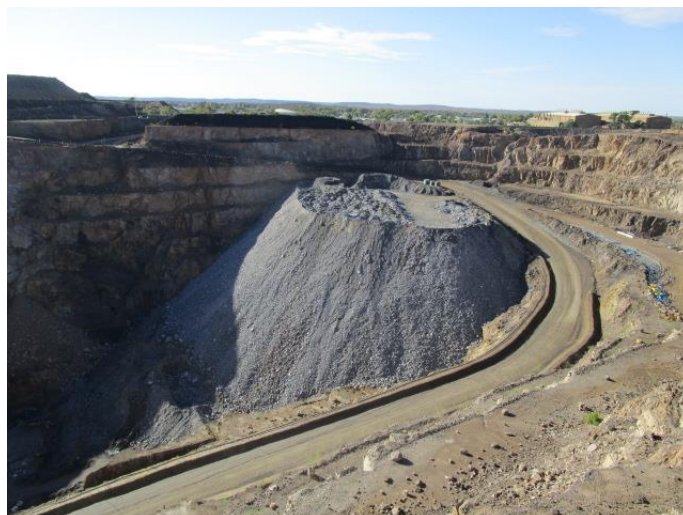
Figure 3: Waste rock stockpile inside Kintore Pit

Mine production for the reporting period is provided in Table 6. Kintore Pit stockpiles for back fill were kept at a minimum during the reporting period (Figure 3). All ore on the ROM stockpile including low grade stockpiles were processed. No more than a week's processing was kept on the ROM stockpile at any one time. Table 6 provides a summary of production from the start of the AEMR reporting period to end of the reporting period with the figures being the total cumulative amount since mining commenced. The amount of waste rock and ore produced was less than indicated in the MOP as production and personnel were reduced to increase the viability of the mine.

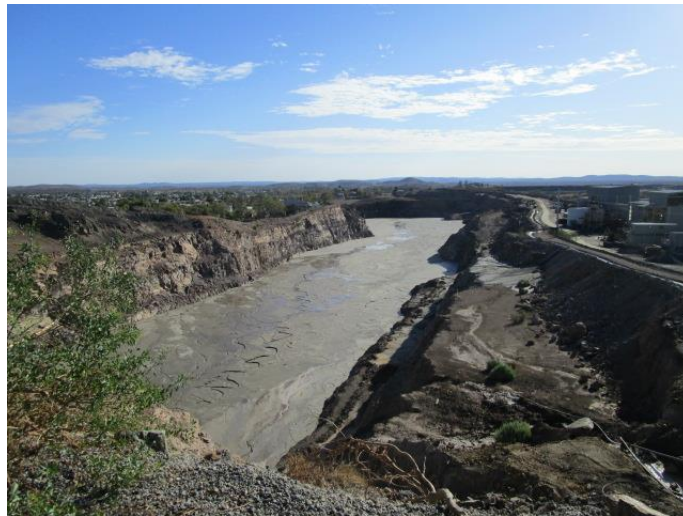
Figure 4: TSF 2, Blackwoods Pit

There is approximately 1,486,064m³ of remaining storage volume in Blackwood Pit and at the current milling rate of 500.000 tonnes per year the pit has 4.9 years remaining life assuming a uniform density of 1.65 tonnes/m³.

The tailing contains the following elements by percentage volume: Lead 0.27%, Zinc 0.31%, Copper 0.01% and Iron 2.74%. Silver is also present at 5.05g/t.

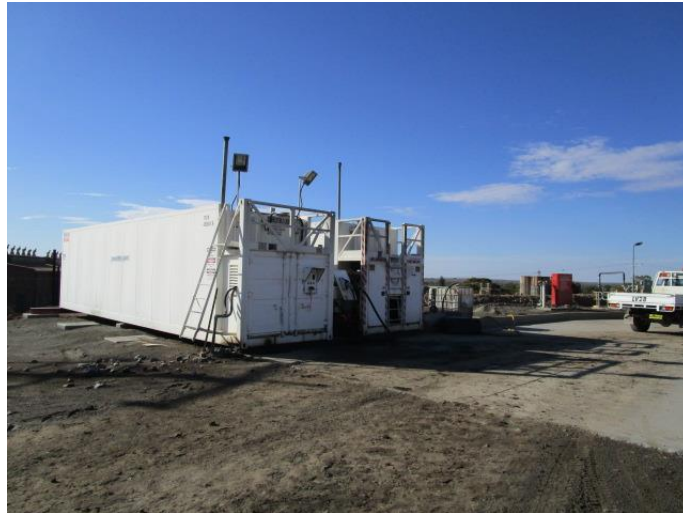
Figure 6: Above Ground Storage Tanks

Diesel is stored in two tanks each with a capacity of 68,000L. These self bunded above ground storage tanks are located east of the workshop and are sitting on a constructed concrete re-fuelling station (Figure 6). The facility has been designed and manufactured in accordance with AS1940 and AS1692. BHOP has provision for diesel storage on its Dangerous Goods Licence, UN 00C1 Diesel 150,000 L.

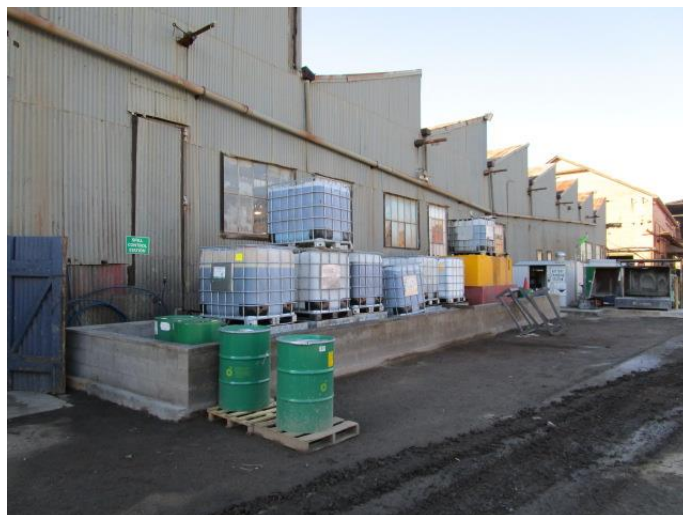
Figure 7: Lubricant and Oil Storage

Lubricants and oils are stored in individual pods located on a portable bund (Figure 7). A storage facility for these lubricants and oils has been constructed on the western side of the main workshop. It consists of a raised concrete pad incorporating drainage to a sump to facilitate cleaning.

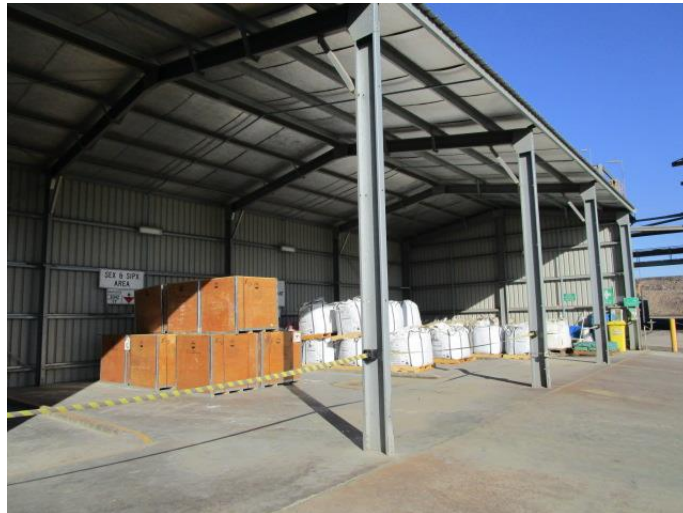
Figure 8: Reagent Storage

All reagents are stored in a purpose built storage facility designed to prevent contamination and capture spillage (Figure 8).

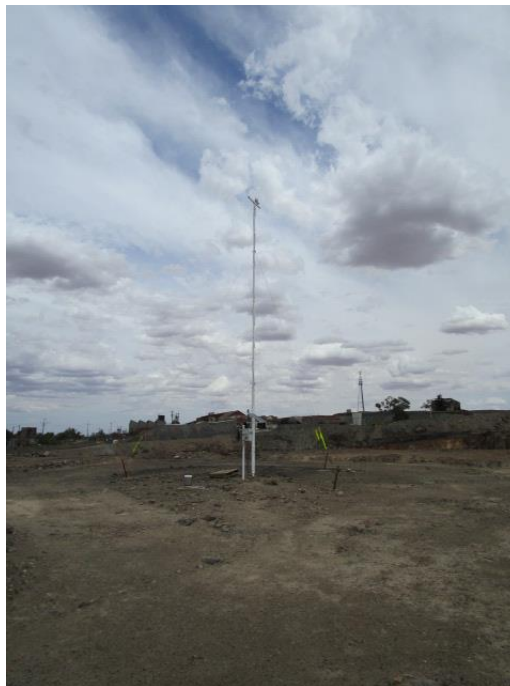
Figure 9: Vaisala Weather Station Installation

A new fully automated weather station has been installed on site (Figure 9). The new weather station replaces an Envirodata unit that had become obsolete; the new unit is a Vaisala WXT520 with telemetry. The data recorded by the site weather station is webhosted by Eco Environmental which provides updates every 15 minutes. The new weather station was sourced in compliance with a previous Pollution Reduction Program as issued by the EPA. The primary function of the site weather station is to provide localised weather data for determination of adequate noise sampling conditions.

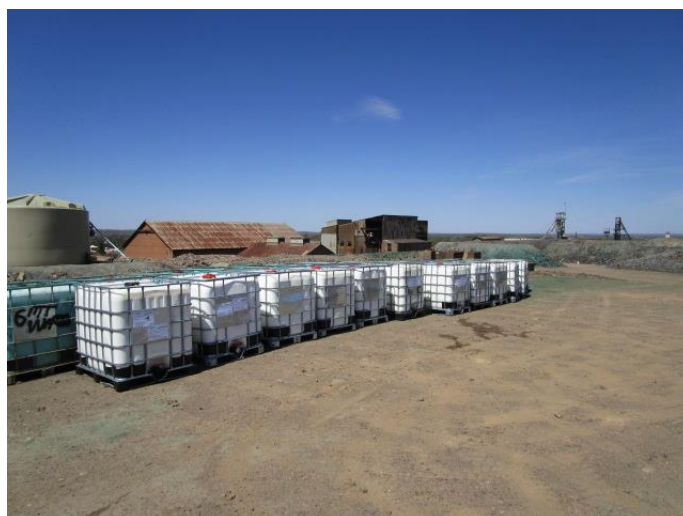
Figure 10: Total Ground Control Dust Suppressant

Dust generation is minimised on site by using RST Total Ground Control chemical dust suppressant (**Error! Reference source not found.**) on free areas and sealing the haul road and other high use roads around the site. The sealed roads are maintained by using a contracted street sweeper and the sites water truck as required. Unsealed site roads are watered with a water truck as required.

Rasp manages dust emissions from free areas by restricting access to free areas and by maintaining chemical dust suppression on a six monthly schedule.
