Rasp Mine

Zinc – Lead – Silver Project
Project Approval No. 07-0018 SSD-014

SUPPLEMENTARY INFORMATION

Modification MOD7 Utilising Rock Fill Material in BHP Pit for TSF2 Embankment Construction

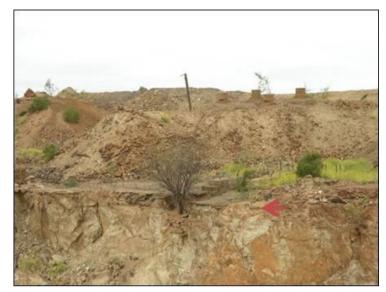
Plate 1 - Building Foundation (I305)

This item (**Plate 1**) lies approximately 30 m to the south-east of the proposed MOD7 activities. It is a large concrete, brick and stone foundation. The south end has a section of brick wall (about 10 courses of brick high) still standing and a concrete floor apron.

The centre section has two east-west aligned stone walls with concrete floors either side with a dropped section in between possibly for a stairway. Each of these walls has steel reinforcing bolts through it as has the north end of the concrete floor. The east end of each of these walls has a number of stone piers with reinforcing bolts. The north end wall (also made of stone) is leaning heavily into the pit. There are some timber beams protruding from some of the wall sections. The far north walls are also made of stone standing c. 1.5 m high and have a concrete floor apron. All of this foundation is subsiding into the pit. On the north side of the central walls there is a semicircular groove cut into the stone for a machine footing.

There is no documentary evidence to help establish the exact historical background of this feature. From inspection of early company plans it appears to correlate with the position of the 1891 Amalgamating Mill which was demolished in 1896.

Mitigation measures to protect these heritage items are fencing and signage.

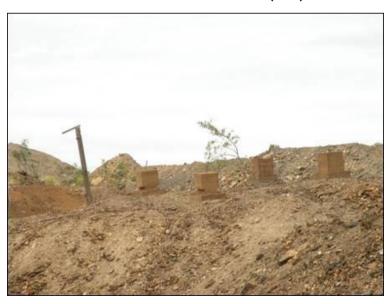
Plate 2 - Four Concrete Piers (I306)

This item (**Plate 2**) lies approximately 45 m to the proposed MOD7 activities. It consists of four concrete piers approximately 1 m in height and each with a single central foundation bolt. The piers are 1 m x 1 m at the base and 70 cm x 70 cm at the top and are spaced 5 m apart to form the four corners of a square. Origin is unknown however, estimated to be between 1890s to early 1900s.

There is no documentary evidence to help establish the historical background of this feature although it would appear to date from the BHP open cutting period in the 1890's through to the early 1900's. The open cut was no longer in use after 1907.

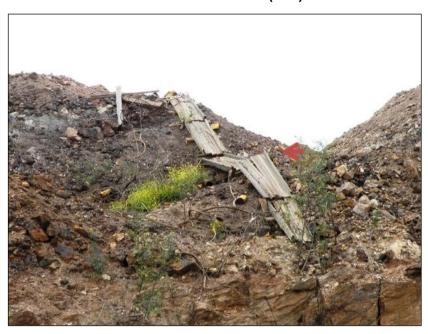
Plate 3 - Timber Chute (I309)

This item (**Plate 3**) is located on the northern upper slope of BHP Pit approximately 25 m from the proposed MOD7 activities. This feature consists of 20 m of a timber chute in two sections running down the inside of the pit from the top to approximately half way. It is 1 m wide with a slightly concave base and short single plank side walls. Each sloping section is approximately 8 m long with a short 4 m flat section in between them. With the original length unknown, this may only represent half of the structure, or it could be all of it. The extant section appears to be complete.

There is no documentary evidence to help establish the historical background of this feature although it would appear to date from the BHP open cutting period in the 1890's and early 1900's. The open cut was no longer in use after 1907.

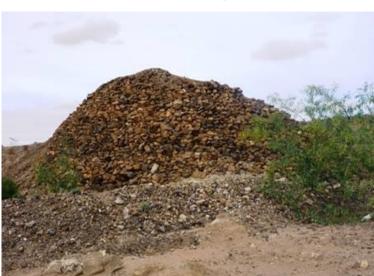
Plate 4 - Stone Retaining Wall (I308)

The date of origin for this item (Plate 4) is unknown however it was identified as likely to be significant as it is a remnant of the early BHP era, estimated to be between 1890s to early 1900s. There is no documentary evidence to help establish the historical background of this feature although it would appear to date from the BHP open cutting period in the 1890's through to the early 1900's. The open cut was no longer in use after 1907. It is a 5 m high dry stone retaining wall oriented north / south for10 m and then turning gradually to the east for 5 m.

This item lies adjacent to the access road into the Pit at a distance of 15 m, and 40 m distance to the proposed MOD7 works.

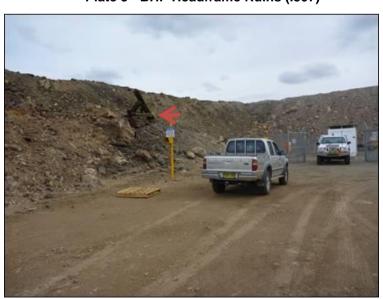
Plate 5 - BHP Headframe Ruins (I307)

This item (**Plate 5**) is located approximately 80 m from the proposed MOD7 activities and 12 m from the access road to the Explosives Store. The remains of this early headframe are probably associated with the 1891 Wigg Shaft which dates from the earliest phases of BHP's mining operations and are therefore highly significant and consist of two concrete headframe footings with timber uprights and one crossbar. The north side upright has about 1 m remaining while the south upright has 2.5 m remaining and has a number of iron bolts protruding from it. Just north of these footings is another concrete footing with no timber uprights.

This headframe may belong to one of two different shafts. It may be associated with either Knox shaft sunk in 1885 or Wigg shaft which was sunk in 1891. It is more likely that it belongs to the latter as Company records of 1895 list the shafts inside the open cut and Wigg is one of them, while Knox is not mentioned. Conversely, Knox shaft is the closest to the Amalgamating Mill and would at some stage have fallen to the open cut.

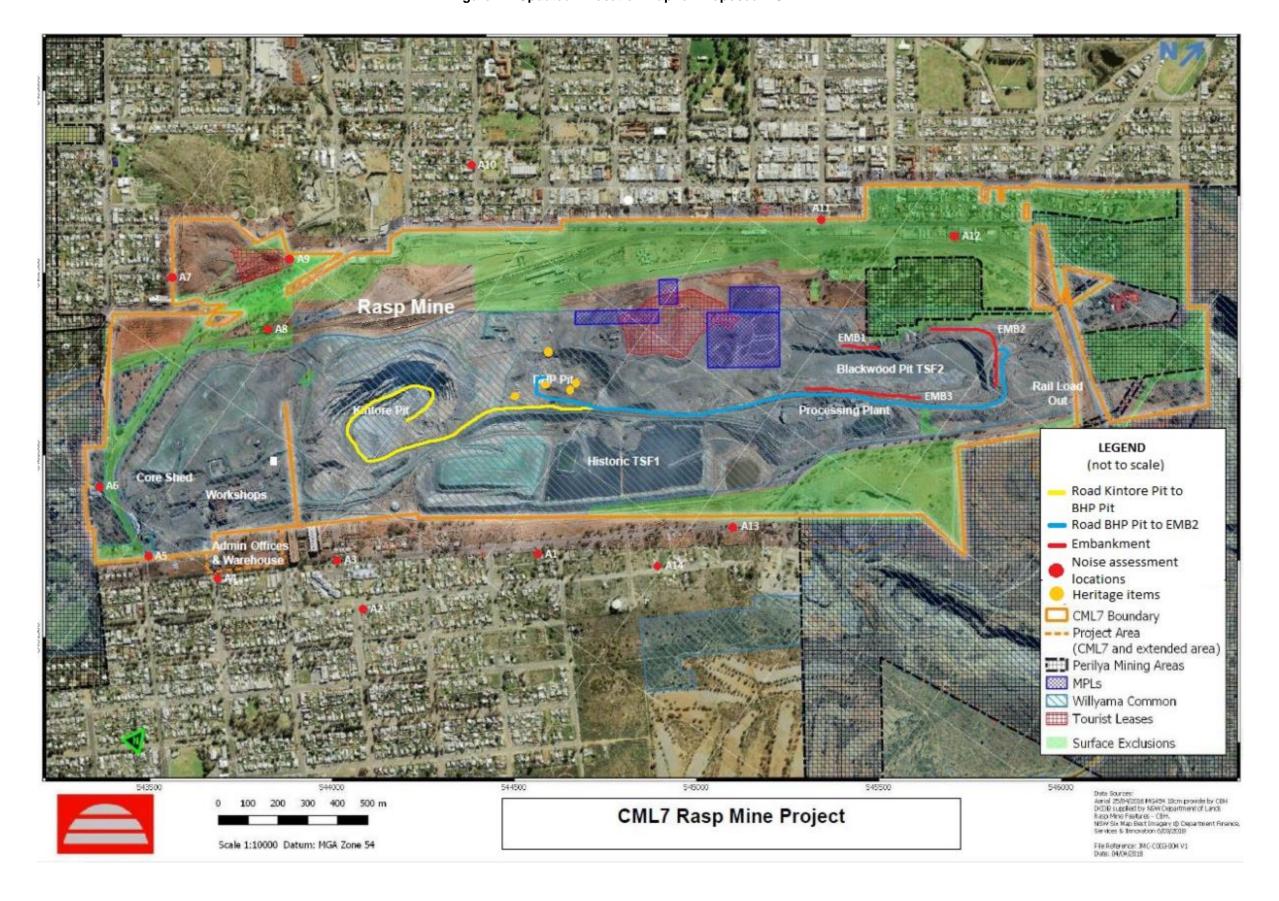
Figure 1-2 Updated – Location Map for Proposed MOD7

The following additions have been made to Figure 1-2:

- Noise assessment locations
- Access road from Kintore Pit to Embankment 2
- Access road from BHP Pit to Embankment 2
- Heritage items within BHP Pit
- Added to legend Not to Scale

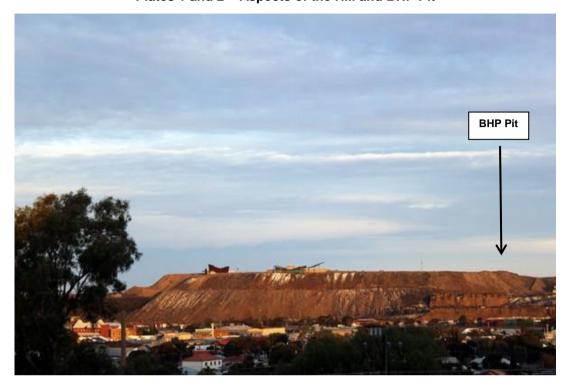
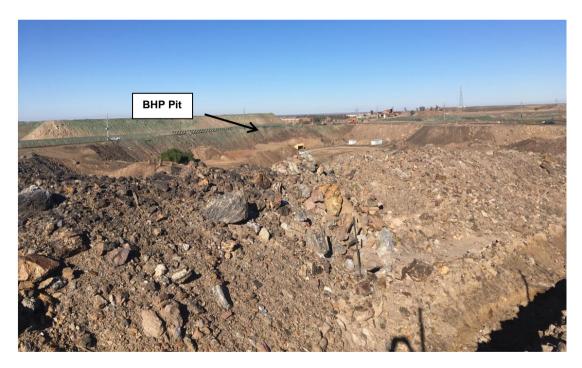
Plates 1 and 2 – Aspects of the Hill and BHP Pit

Consolidated Mine Lease 7 (CML7) is predominantly a hill surrounded by the City of Broken Hill and other mining and infrastructure. The CML7 hill consists mainly of waste rock and tailing deposits. It is one of the highest points in Broken Hill. BHP Pit is located centrally within CML7. It is a pit so the inside of the Pit is only visible from CML7, **Plates 1** provides a photograph of the 'hill' taken from the north side of Broken Hill. Plate 2 provides a view of the Pit from Federation Way located on CML7, the buildings that can be seen are the emulsion and explosives magazines. The area where MOD7 facilities will be located is in the foreground of the photograph and is not visible.
