Rasp Mine

Annual Review

1 May 2021 – 30 April 2022

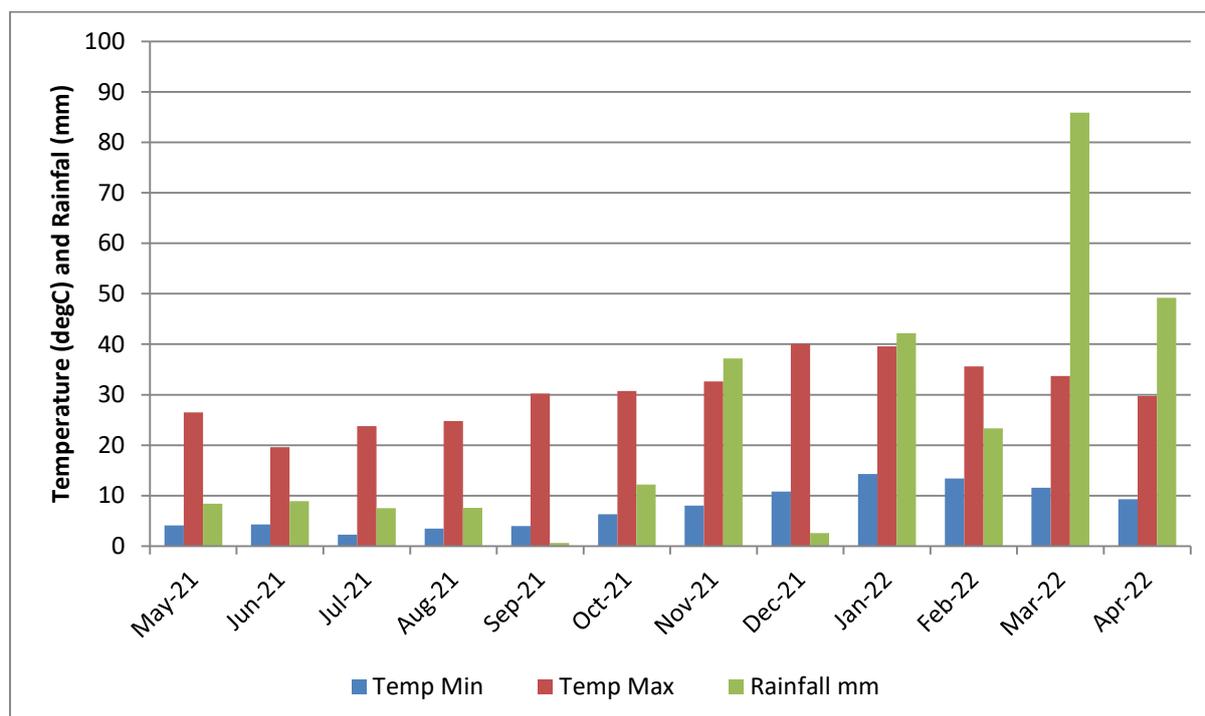
Figure 5-5-1 Weather Data for the Reporting Period

Temperatures and rainfall in the reporting period remained consistent with the BoM's long-term averages, with rainfall (286.1mm) for the period was higher than the BoM's long-term annual average of 246mm. There were 48 rain days for the period with most rain, approximately 200.6mm, falling between January and April 2022. Winds were predominantly from the south with high winds experienced during July to January.

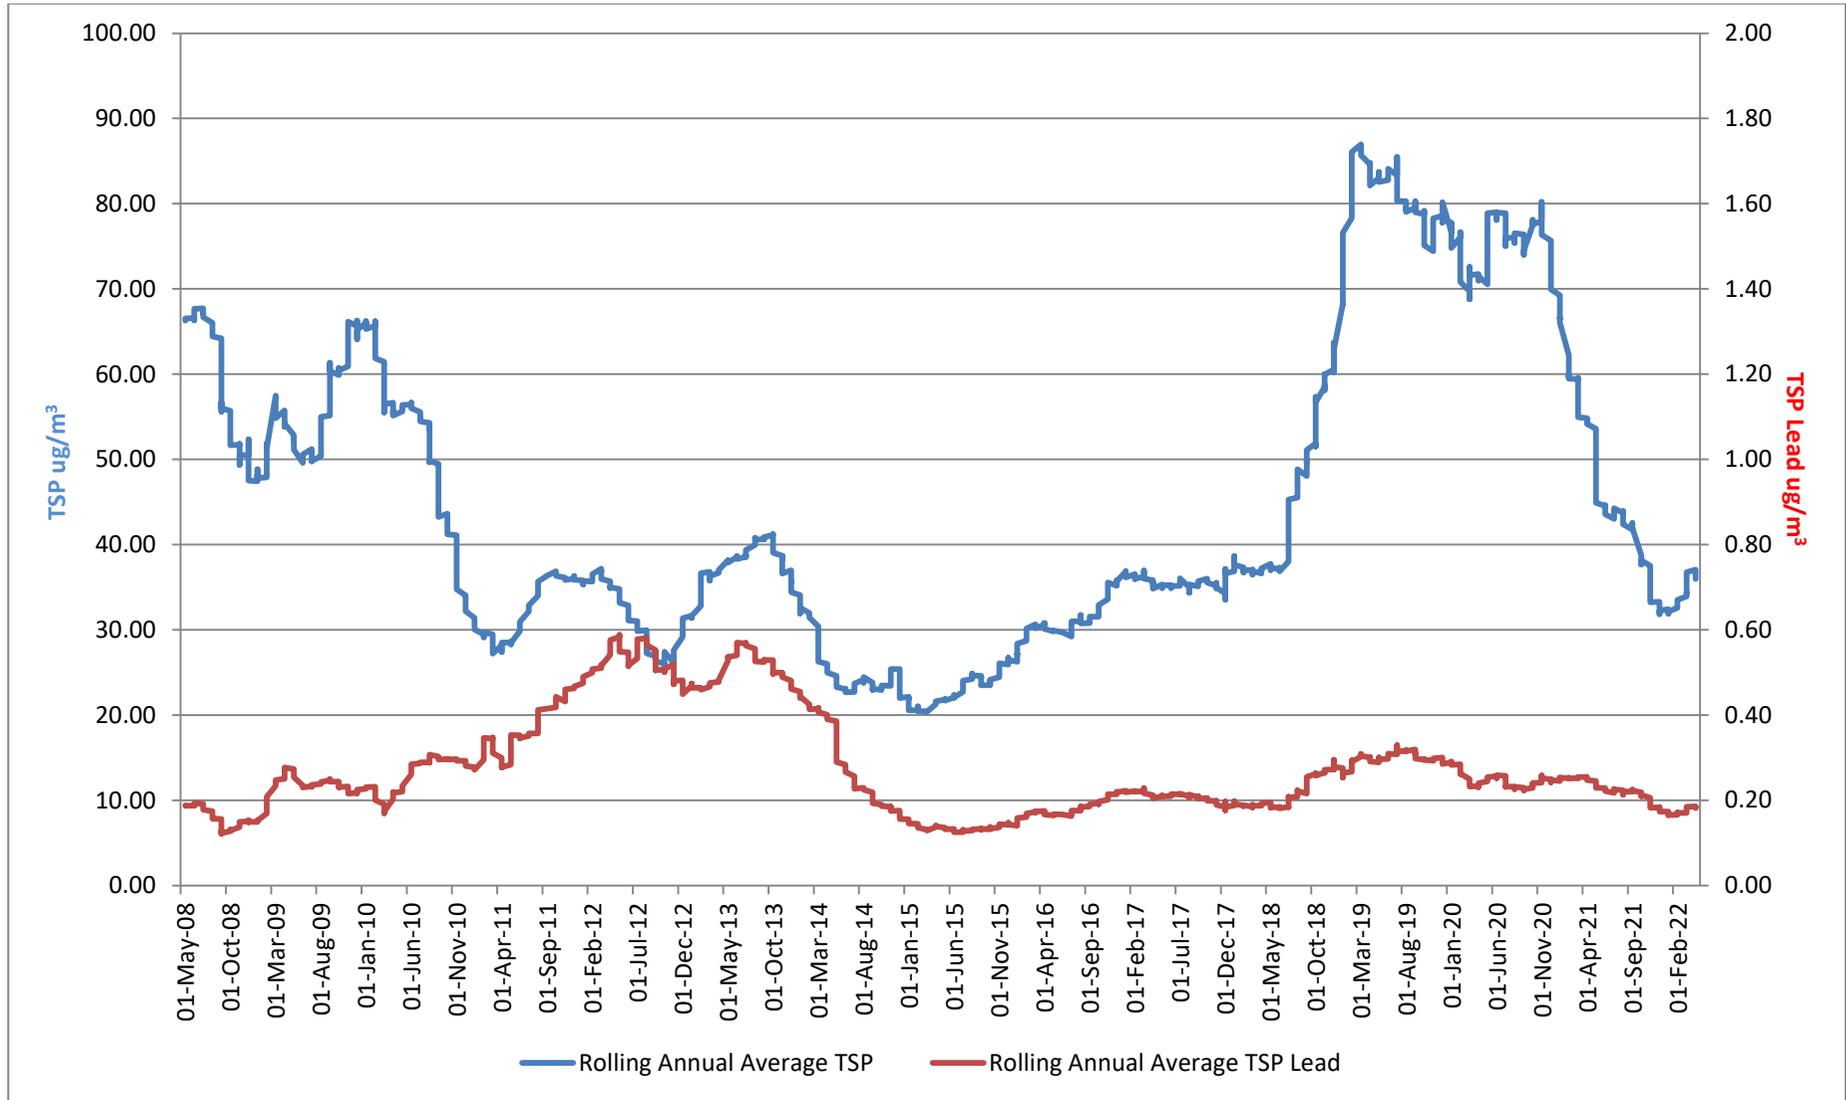
Figure 5-9 HVAS TSP and TSP-Lead Results for the Period 2008 to 2022

Figure 5-9 provides a summary of TSP and TSP-lead results from 2008 to 2022. Results for TSP are well below the EPA threshold of 90µg/m³ and 0.5 µg/m³ for TSP-lead.

As can be seen in **Figure 5-9** there is an increase in dust levels recorded in HVAS after 2016 due to the period of drought but are falling in the reporting period due to increased rainfall. Lead levels have remained stable, which suggests that much of the dust contributed is not from site and likely the result of drought conditions.

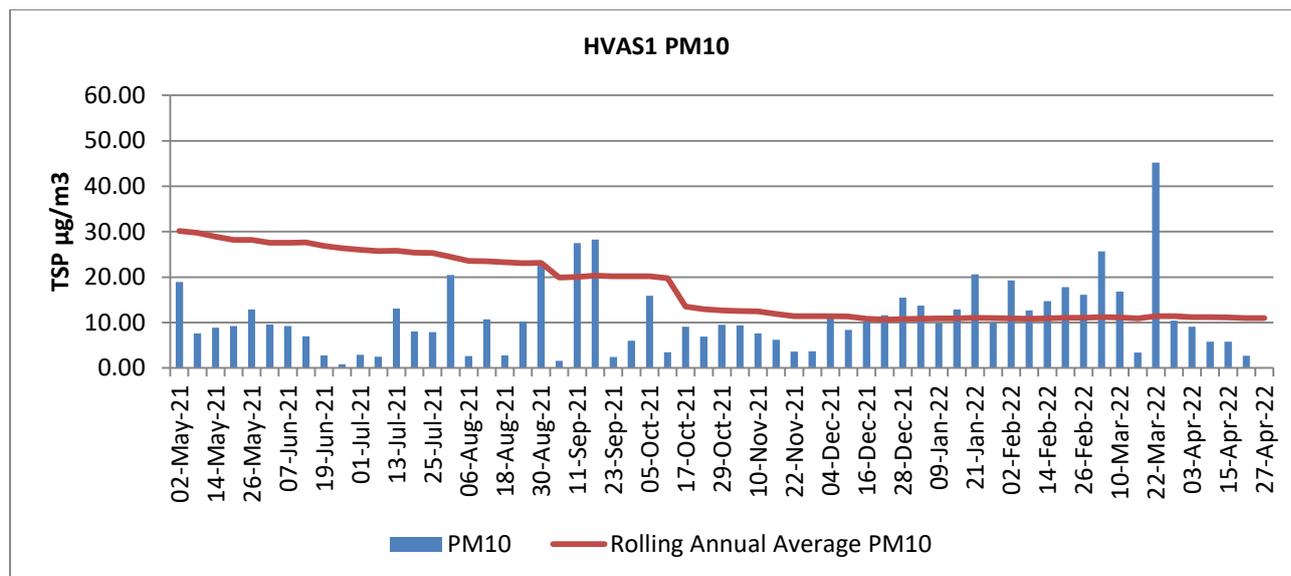
Figure 5-10 HVAS1 PM₁₀ Results for the Reporting Period

HVAS1 is used for sampling PM₁₀ and PM₁₀-lead. The average annual PM₁₀ level recorded at this monitoring point at the end of the reporting period was 11.0µg/m³, which has decreased from the previous reporting period of 30.2µg/m³ and is well below the background level of 29.1µg/m³ reported in the EA. The average annual PM₁₀ level calculation includes data collected during extreme events. Results for the reporting period are shown in **Figure 5-10** which indicates that the rolling annual average for PM₁₀ is below the criteria of 25 µg/m³, and has consistently trended downwards during the reporting period.

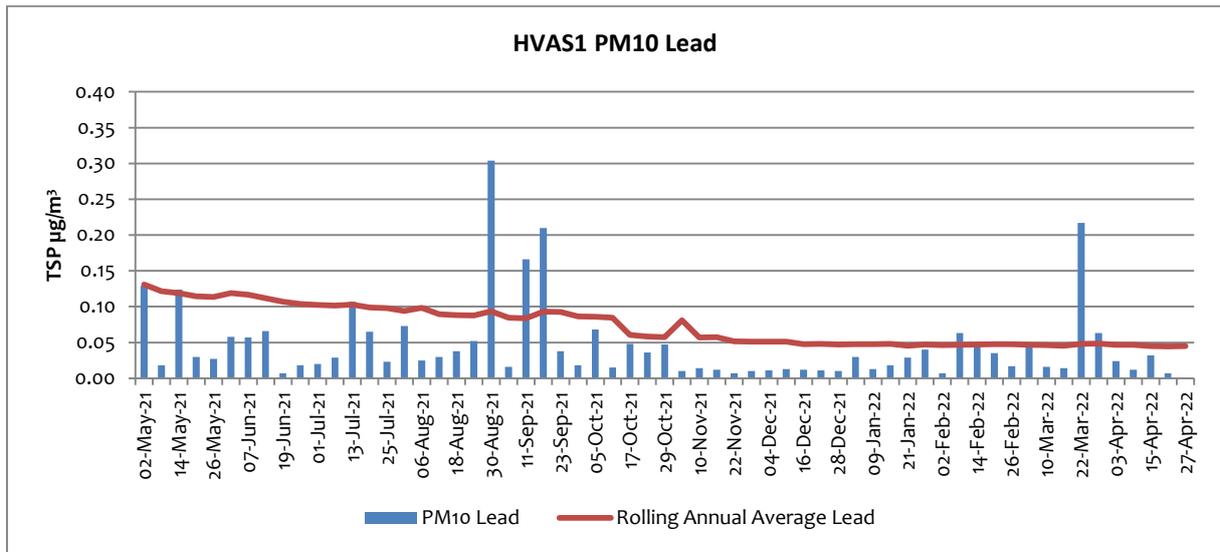
Figure 5-11 HVAS1 PM₁₀-Lead Results for the Reporting period

The annual average PM₁₀-lead concentration has decreased significantly from 0.13µg/m³ in the previous reporting period to 0.04µg/m³, **Figure 5-11**. The highest HVAS1-Lead level recorded was on 30 August 2021 (0.30µg/m³).

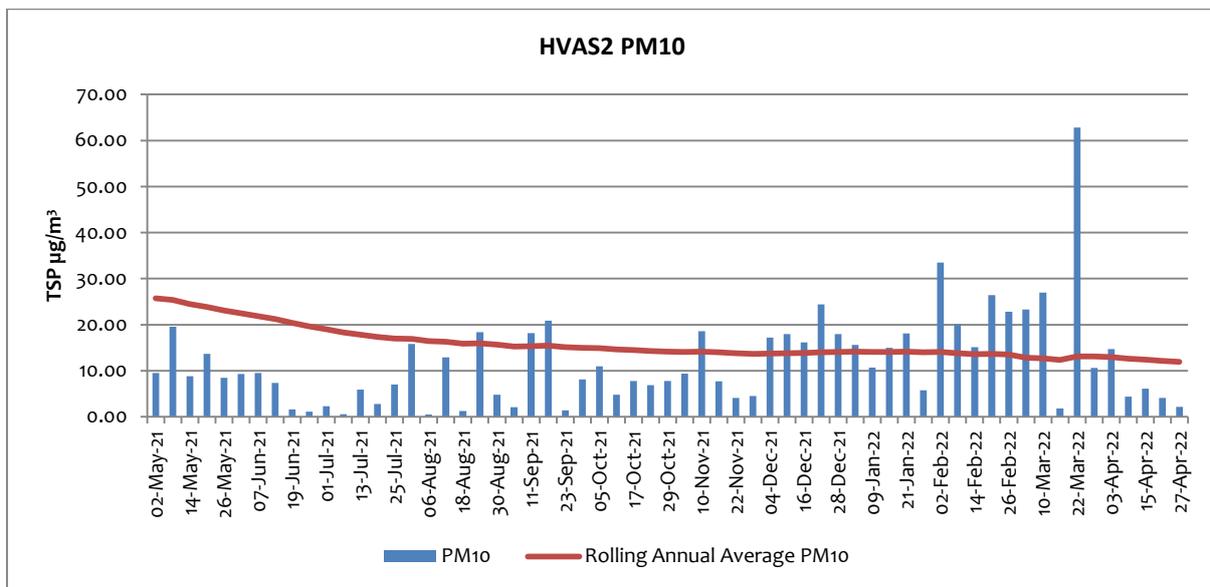
Figure 5-12 HVAS2 PM₁₀ Results for the Reporting Period

The average annual PM₁₀ level recorded at this monitoring point was 11.94µg/m³, which has decreased from the previous reporting period (25.74µg/m³), below the background level reported in the EA of 29.1µg/m³ but above the criteria of 25µg/m³ (for off-site receptors), **Figure 5-12**. Data presented includes that which may be result of external events, particularly dust storms which are expected in the spring and summer months.

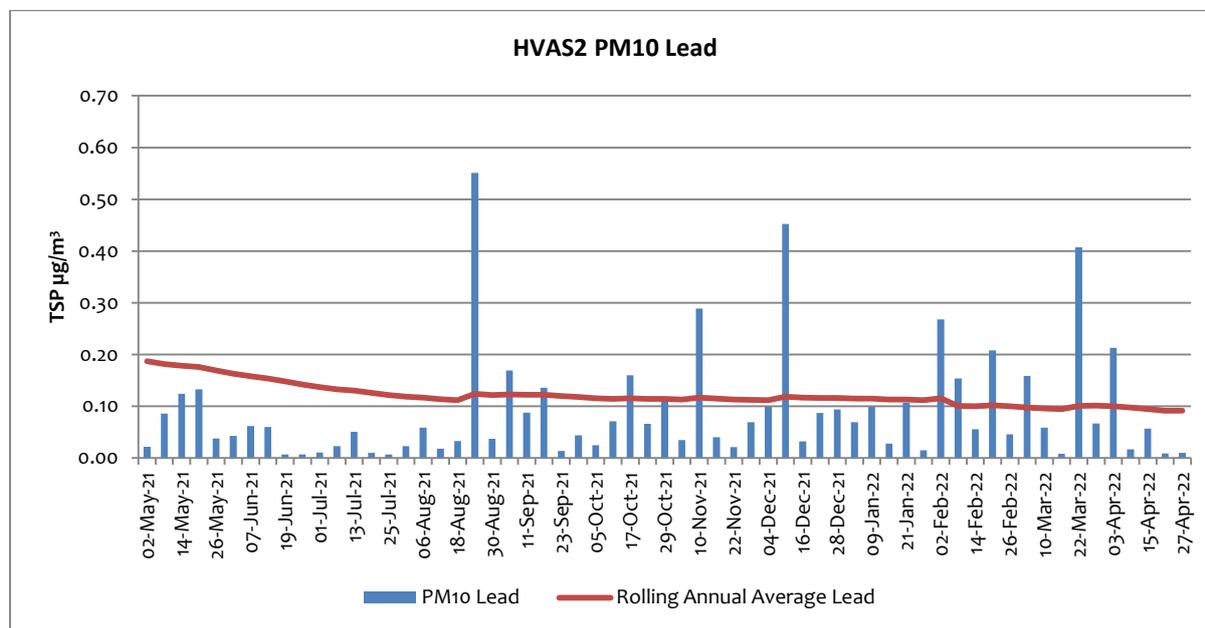
Figure 5-13 HVAS2 PM₁₀-Lead Results for the Reporting Period

The average annual PM₁₀-lead level recorded at this monitoring point was 0.09µg/m³, which is a decrease over the previous reporting period (0.19µg/m³), below the background level reported in the EA of 29.1µg/m³ and below the criteria of 25µg/m³ (for off-site receptors). **Figure 5-13**.

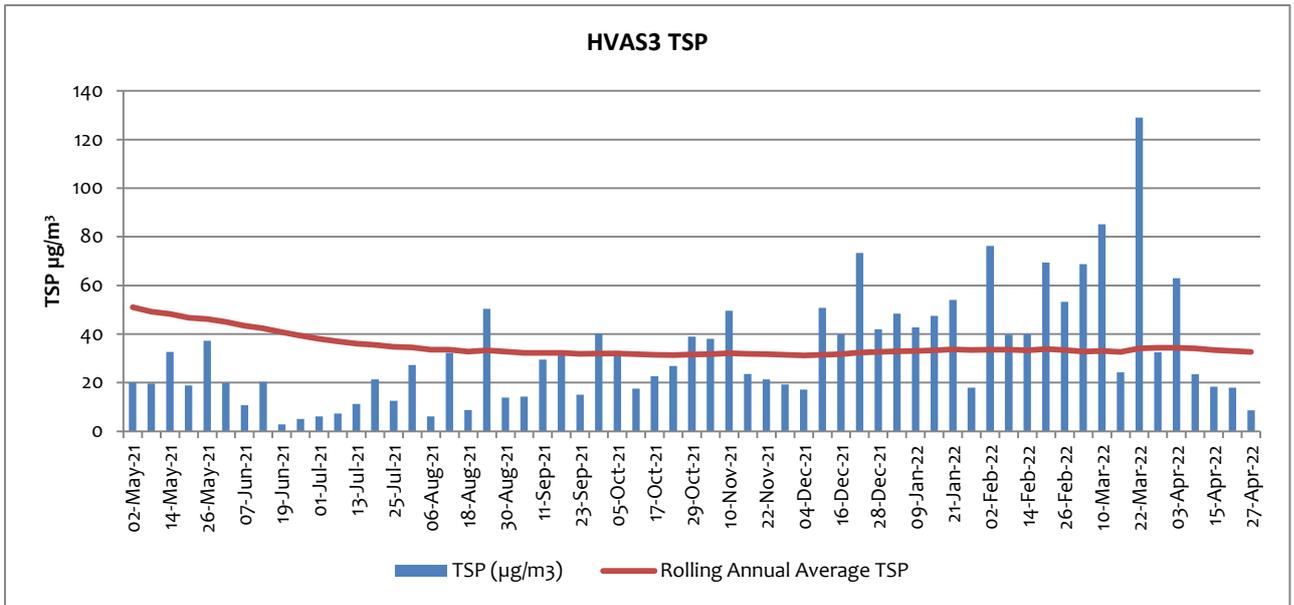
Figure 5-14 HVAS3 TSP Results for the Reporting Period

To 27 April 2022 the rolling average annual TSP level recorded at this monitoring point was $32.63\mu\text{g}/\text{m}^3$, down from $51.02\mu\text{g}/\text{m}^3$ at the beginning of the reporting period as seen in **Figure 5-14**. The rolling annual average for TSP Lead in April 2022 was $0.35\mu\text{g}/\text{m}^3$, a decrease from $0.39\mu\text{g}/\text{m}^3$ at the beginning of the reporting period. Elevated lead levels were recorded during the month of May 2022, given the wind direction for most of the month being predominately from the NW and E for the month of May, it is likely that only the results for 14 May 2022 were as a result of dust generated on site.

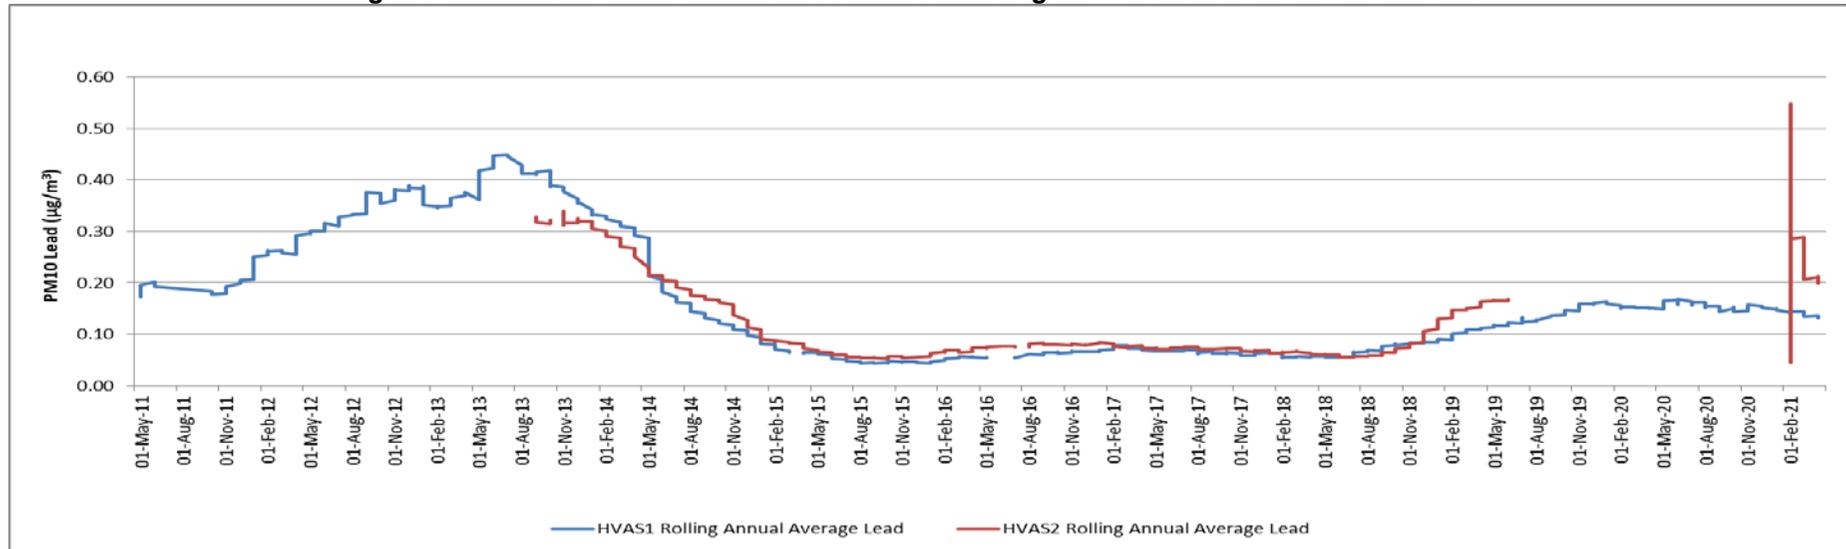
Figure 5-17 HVAS1 & HVAS2 PM10-Lead Annual Average Results for the Period 2011 to 2022

Results for the period 2011 to 2022 are shown in **Figure 5-17**. Since September 2013 when HVAS2 started operating dust levels have risen in the last few years due to the drought and frequent dust storms.

Results for the period 2011 to 2022 are shown in **Figure 5-17**.

Trends are discussed below and results for the period 2011 to 2022 are shown in **Figure 5-17**. Since May 2011 when HVAS1 started operating dust levels have fallen and then risen in the last year due to the drought and frequent dust storms.

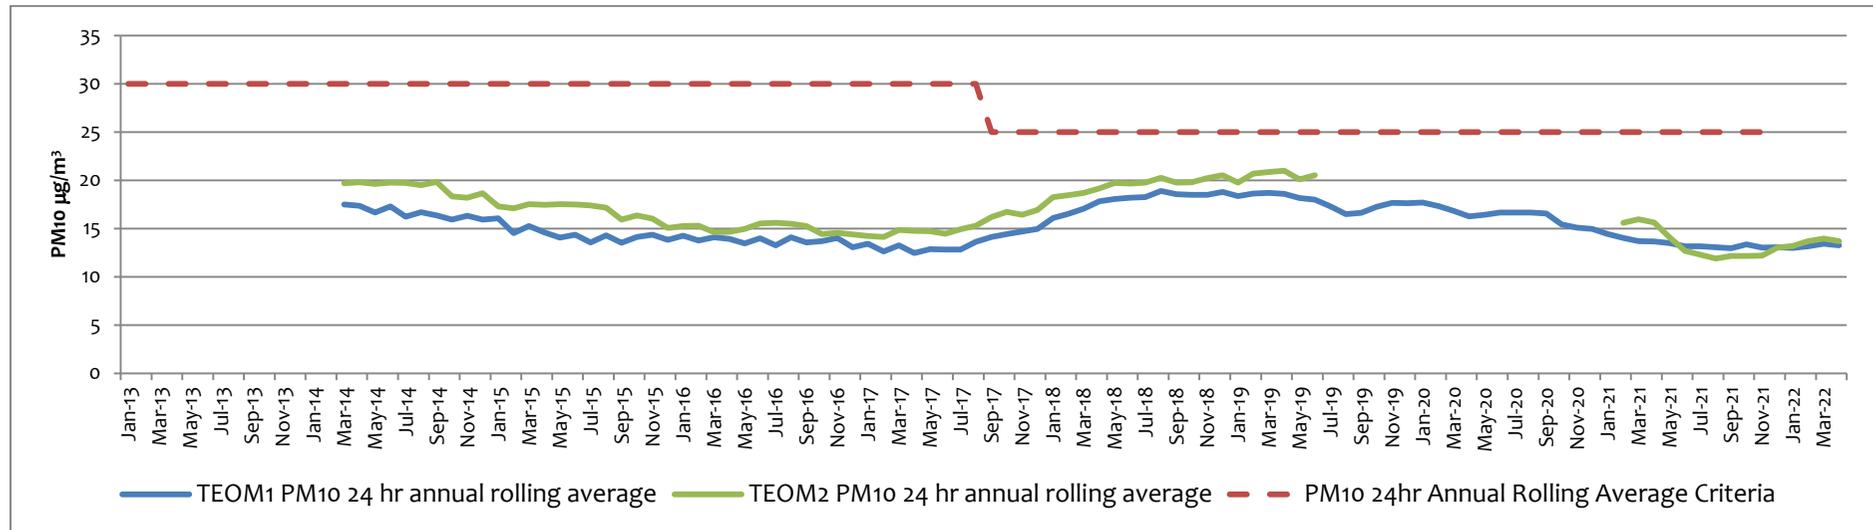
Figure 5-23 TEOM1 & TEOM2 PM10 Annual Rolling Average Results for the Period 2013 to April 2022

Monitoring results indicate that controls have been adequate to manage dust levels during the reporting period.

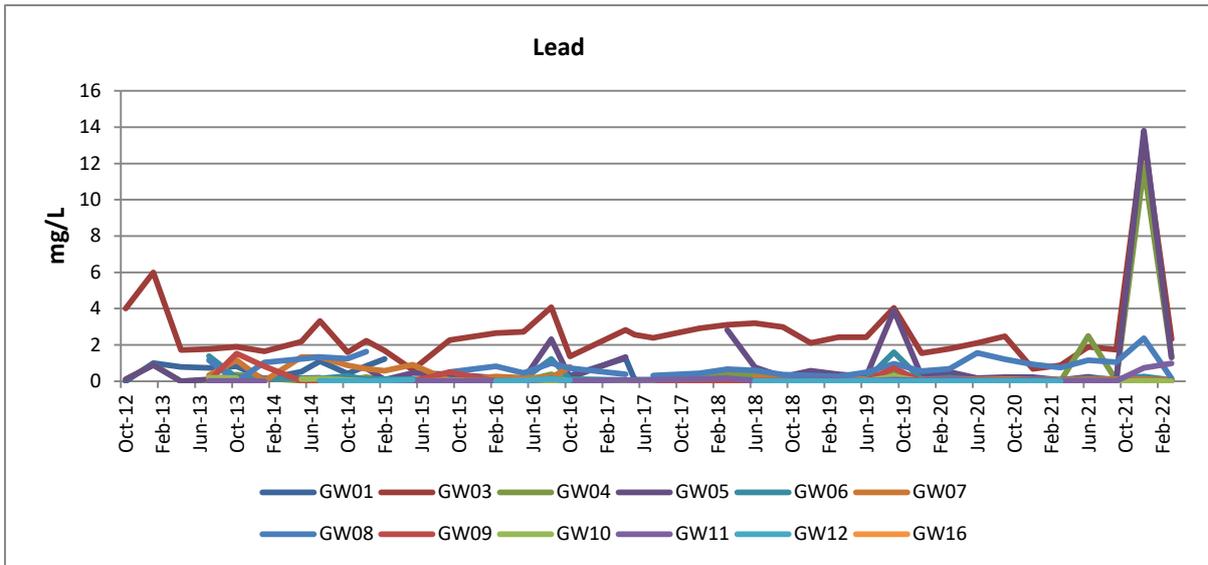
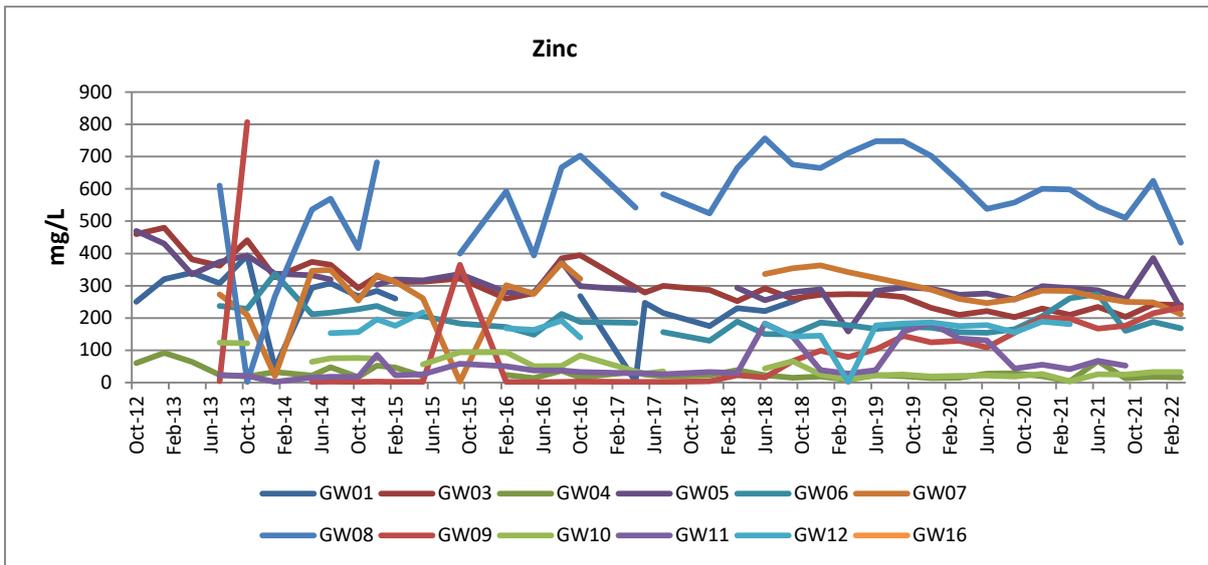
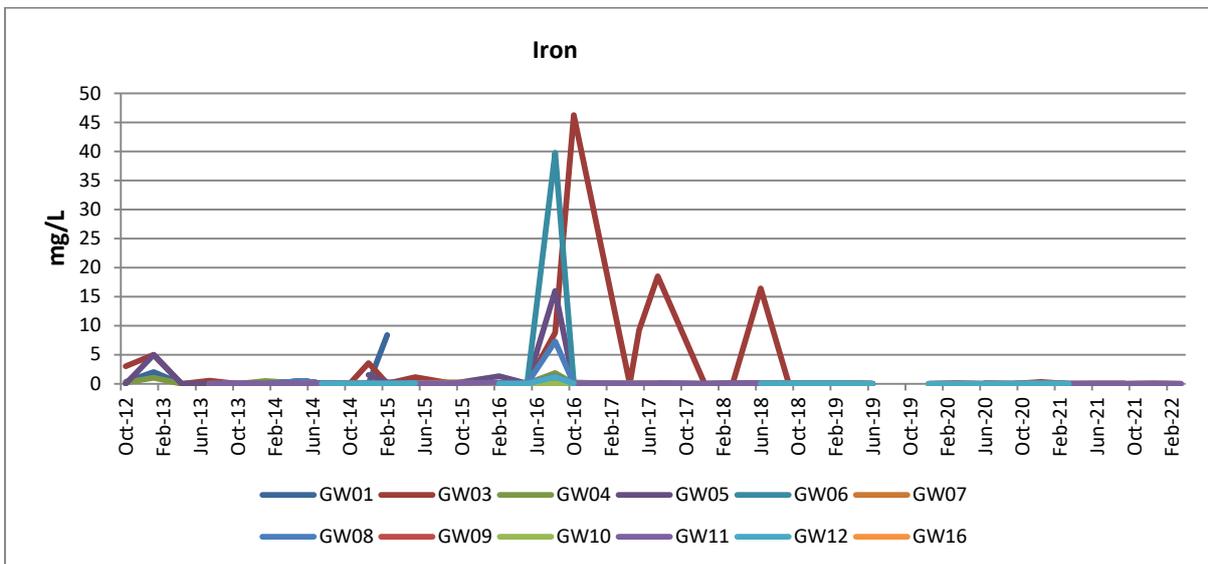
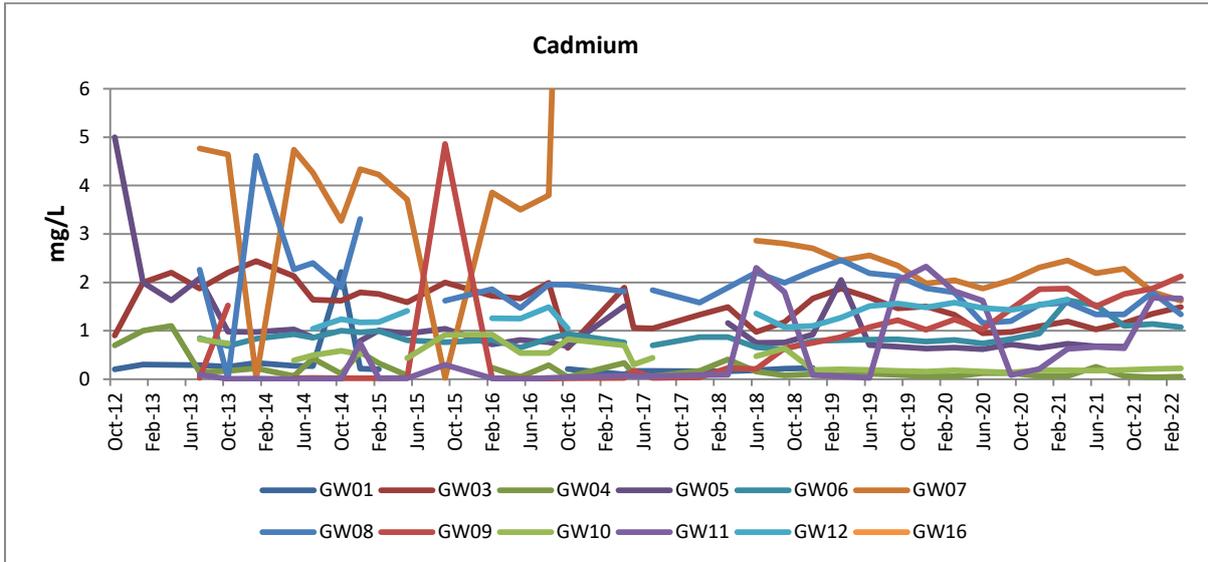
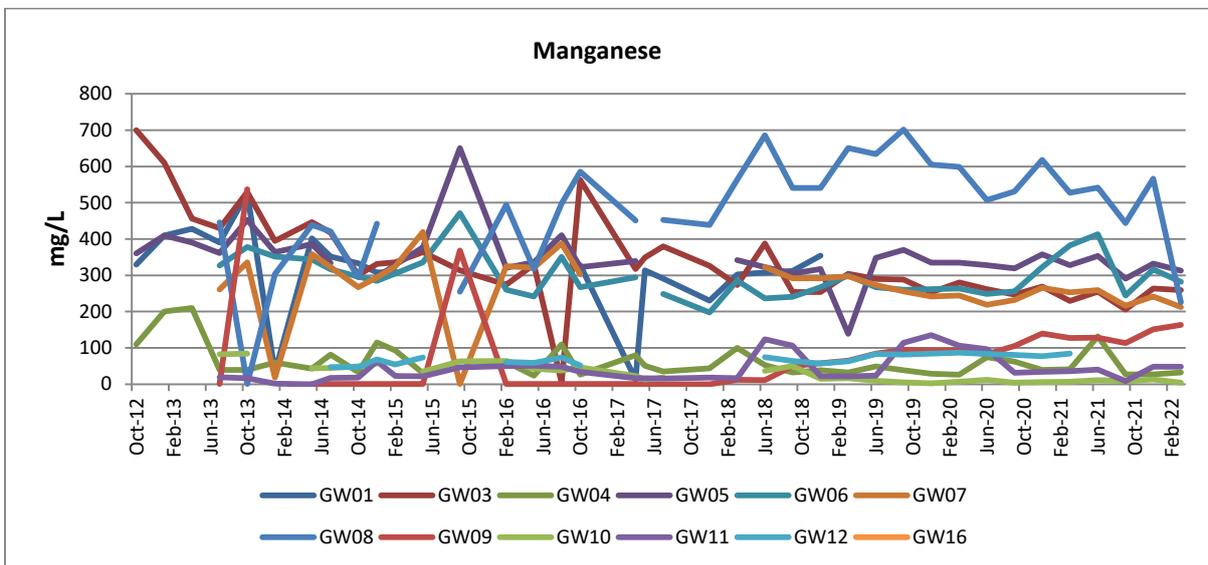
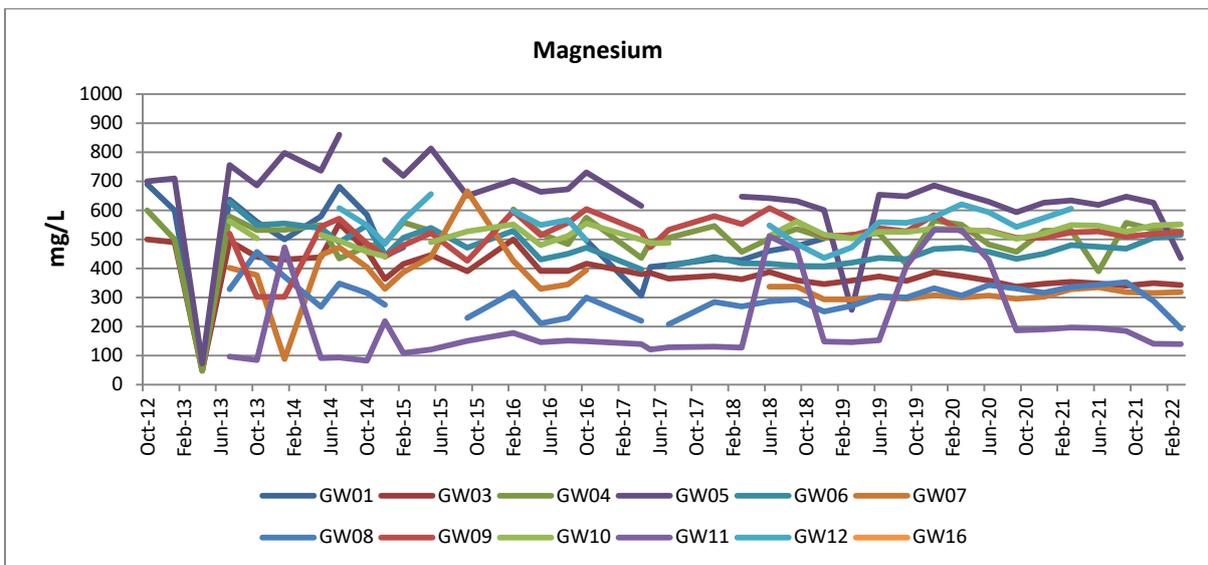
Figure 5-24 Groundwater Quality Results for the Period 2012 to April 2022

The ground water level in GW11 was slightly lower than previous periods and GW12 has gone dry which may be due to nearby exploration drilling intercepting an old working in the area. GW11 recorded elevated Cadmium, Manganese, Lead and Zinc in December and March. The same pattern occurred in 2018 and 2019 and is likely due to the tailings level in TSF2 reaching a point where a fault or crack in the pit wall has allowed water to escape. Concentrations are being monitored and levels are expected to return to normal as the fault or crack is sealed by tailings. **Figure 5-23** indicates results remain within historic ranges.

Groundwater bores are located near the eastern side of the unused historic TSF1 and extend to Horwood Dam. The intent of the monitoring bores is to monitor perched water in the area that may impact on Eyre Street Dam. The monitoring is in response to surface seepage noted in the area during intense 2011 rainfall events. All bores in the series were able to be monitored each quarter. Water levels were stable in GW3 and GW4 and falling in bores GW5 to GW10. Lead results from GW3, GW4, and GW5 were elevated in the December 2021 round of monitoring and while potentially the result of sampling contamination, results for GW4 and GW5 were slightly elevated during the February 2022 resampling event. December 2022 Lead results for these bores are not included in the graphs in March 2022 results for these bores were consistent with historic results. **Figure 5-23** indicates that results remain within historic ranges.

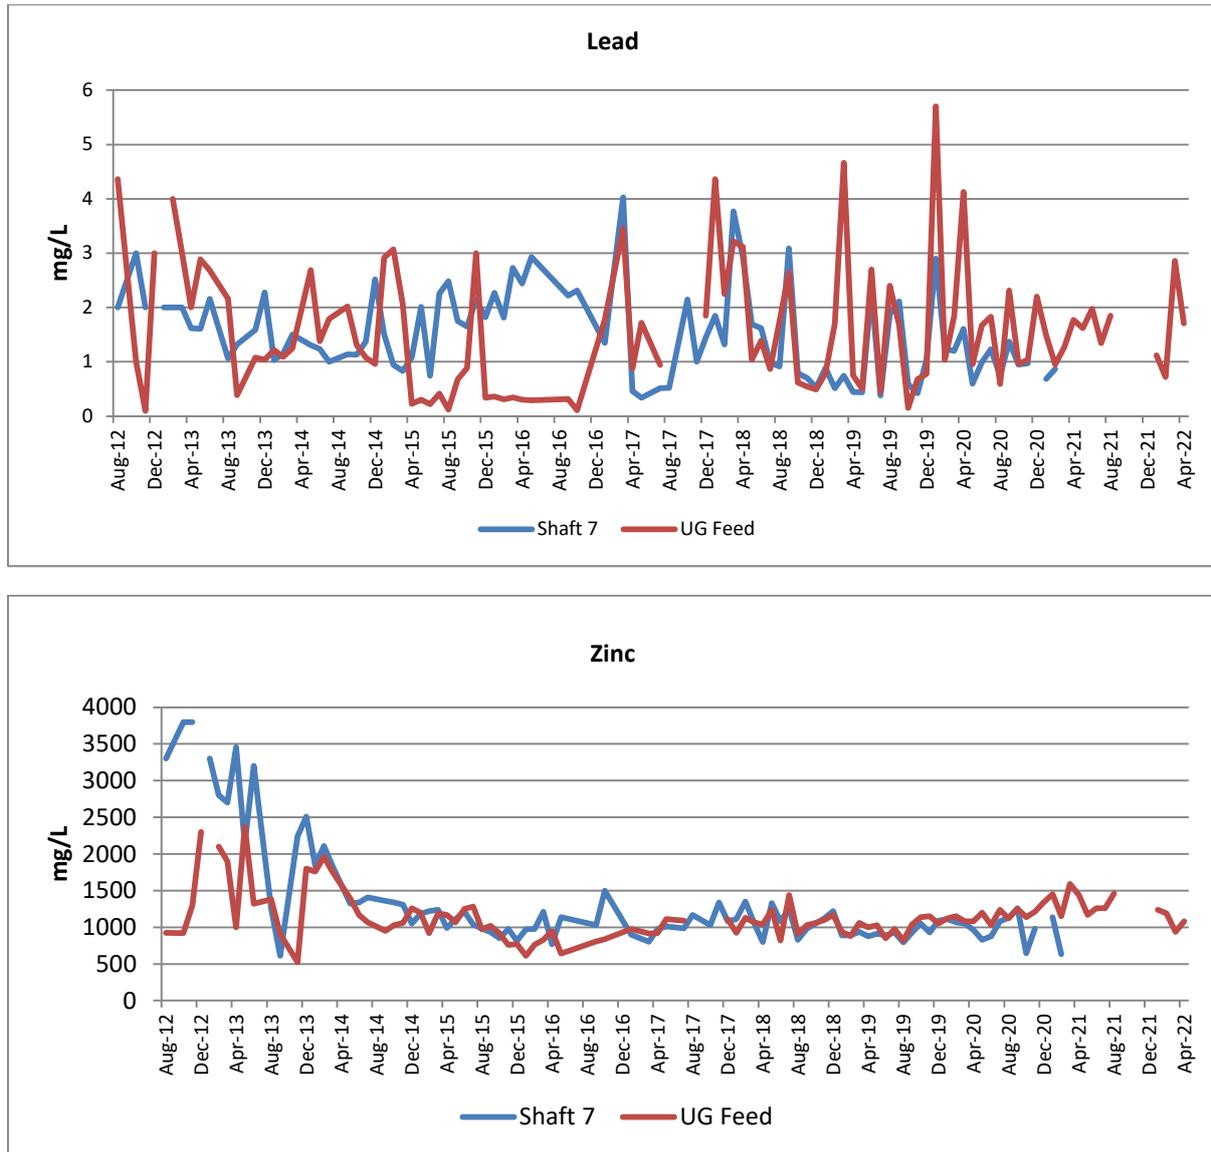
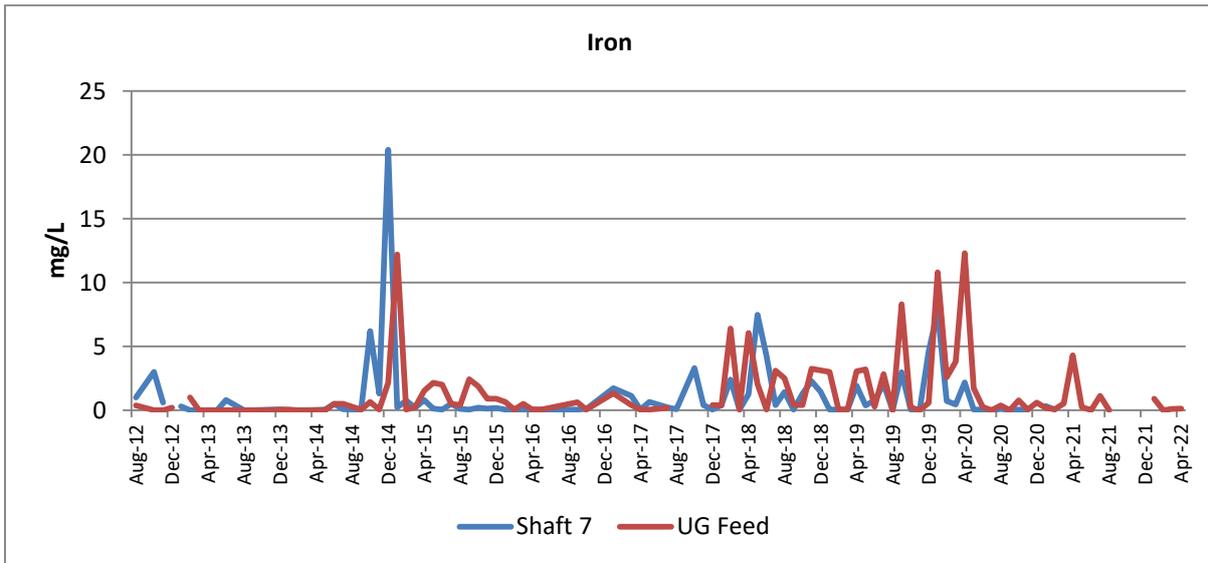
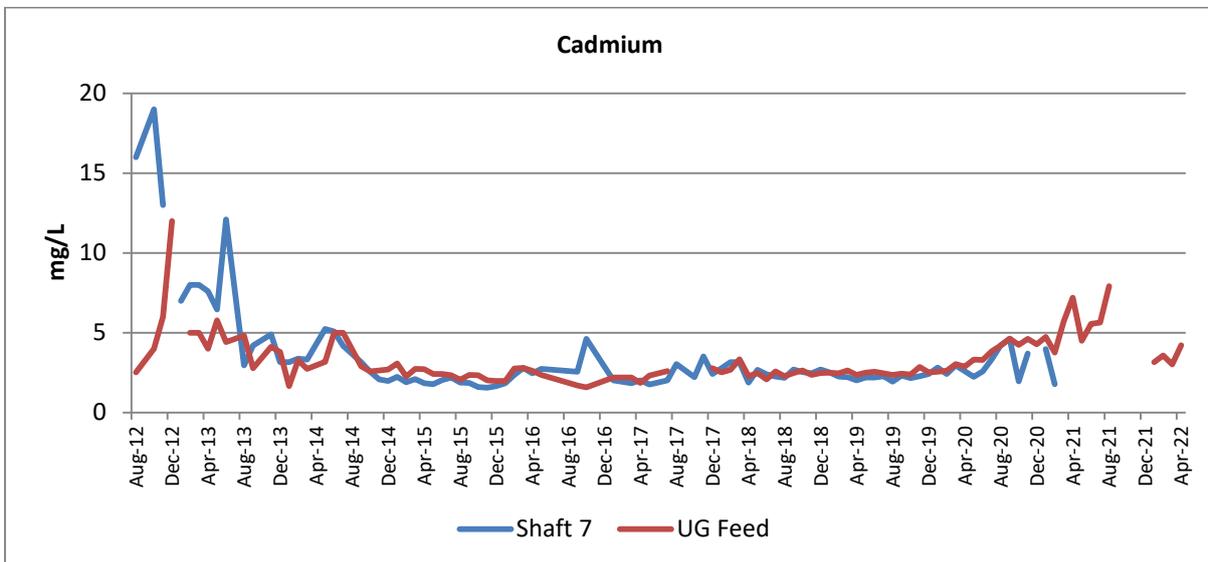
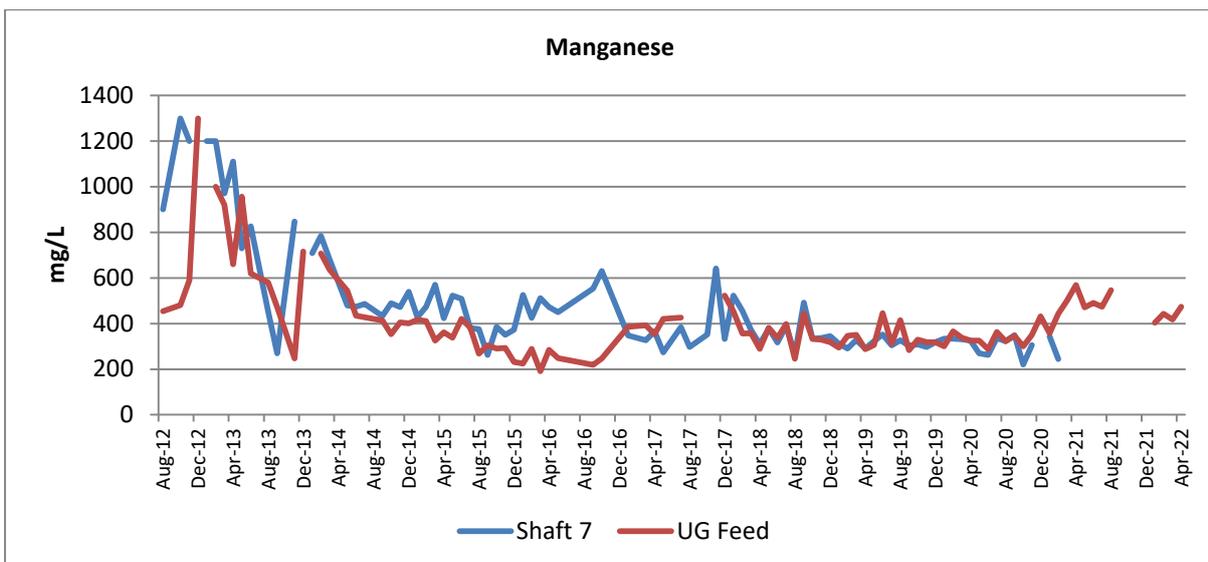
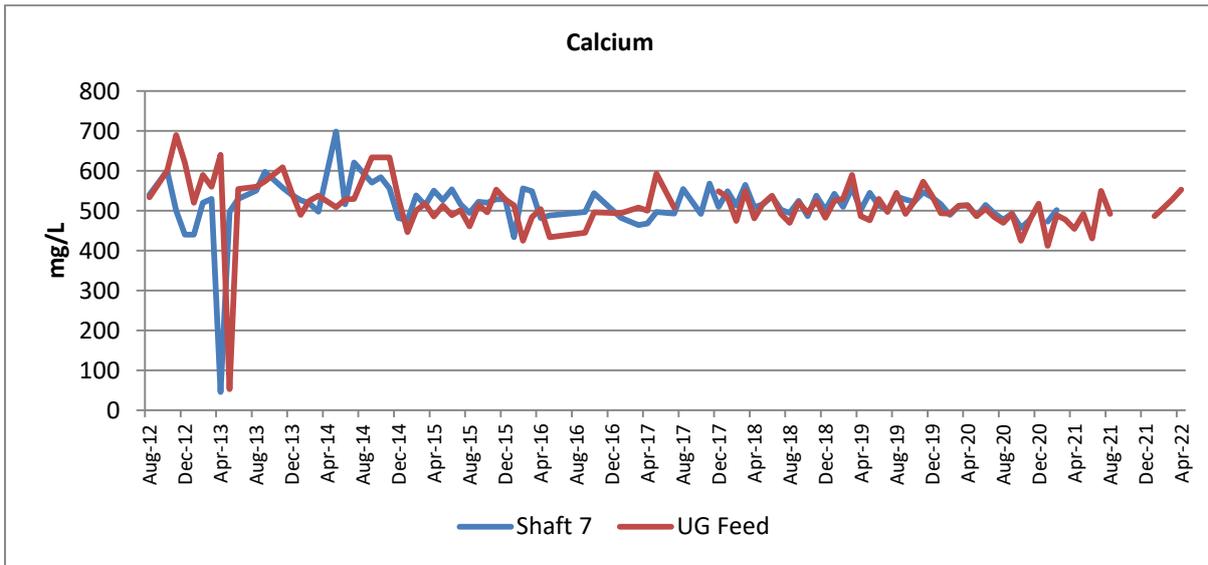
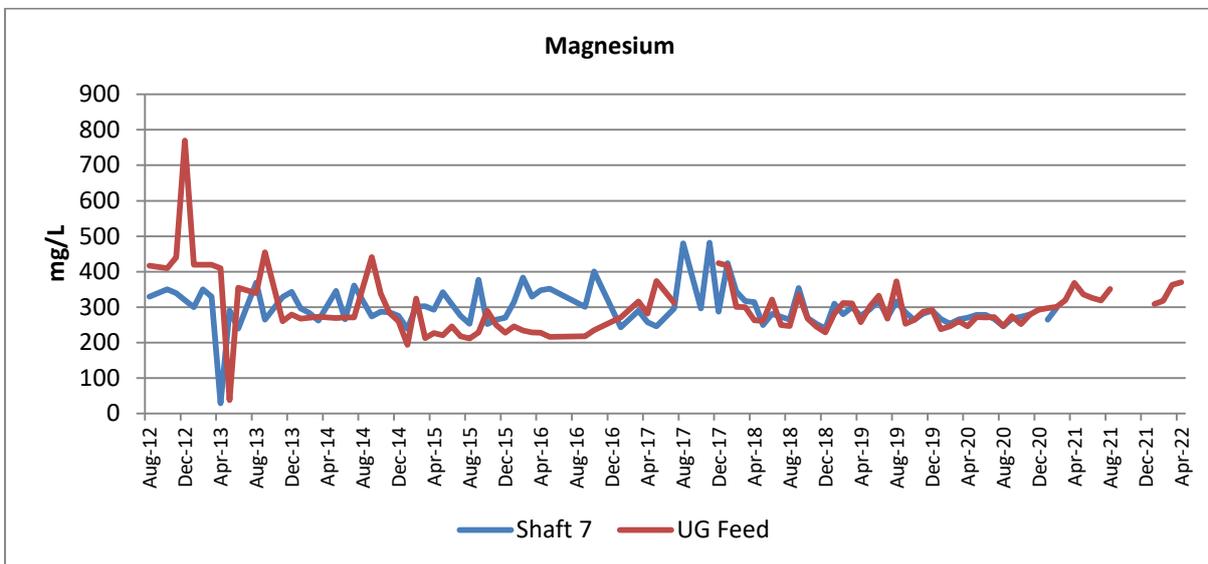
Figure 5-25 Shaft 7 & Mine Dewatering Results for Sampled Parameters - Period 2012 to Apr 2022

Figure 5-23 provides a series of graphs indicating results from commencement of operations to present (2012-2022). Results are within the historic range for all parameters.

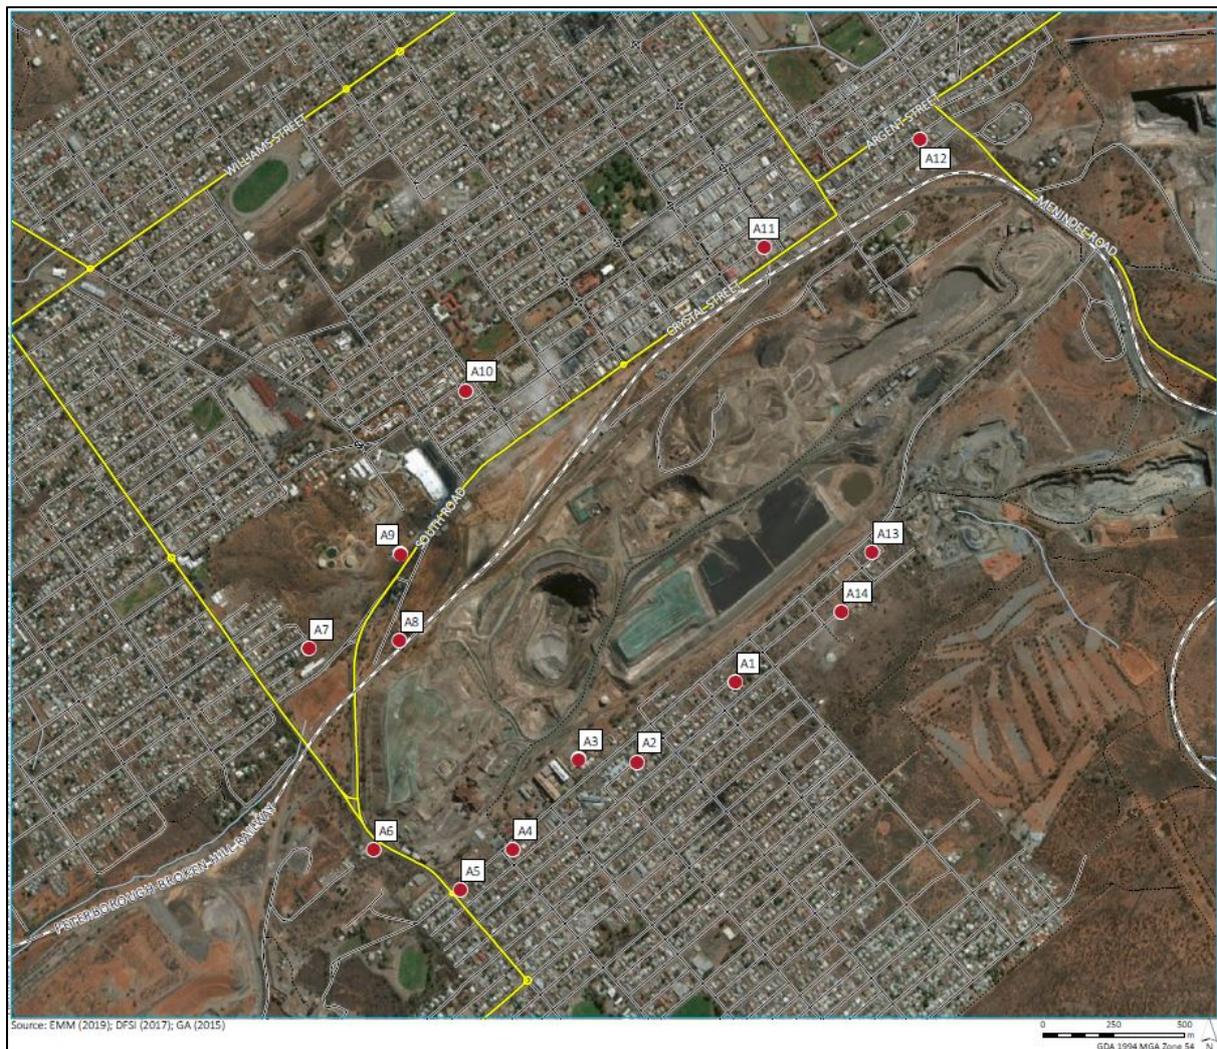
Figure 5-21 Noise Receptors

Rasp Mine LAeq,15min noise contributions (including the addition of the relevant modification factor) satisfied the relevant night-time noise limits at all assessment locations, including during attended measurements when noise limits did not apply due to adverse weather conditions
