Broken Hill Operations Pty Ltd ABN 95 103 555 862

Rasp Mine

Annual Environmental Management Report/Annual Review

1 January 2018 - 31 December 2018

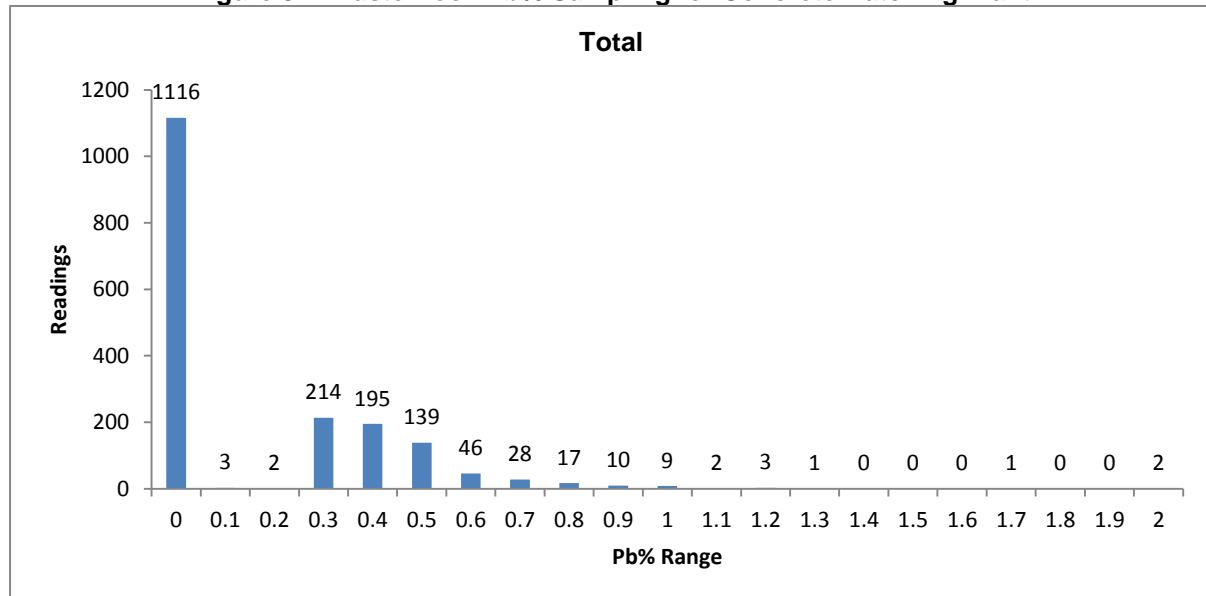
Figure 3-1 Waste Rock Pb% Sampling for Concrete Batching Plant

extension on the noise bund. The waste rock was tested prior to use to identify material suitable for use in the construction of the embankments that would minimise any increased risk to community health. A procedure for testing waste rock was developed so that the material selected averaged no more than 0.5% lead. Figure 3-1 shows the XRF test results for Pb% of lead in waste rock used in the construction of the concrete batching plant foundations and noise bund wall.

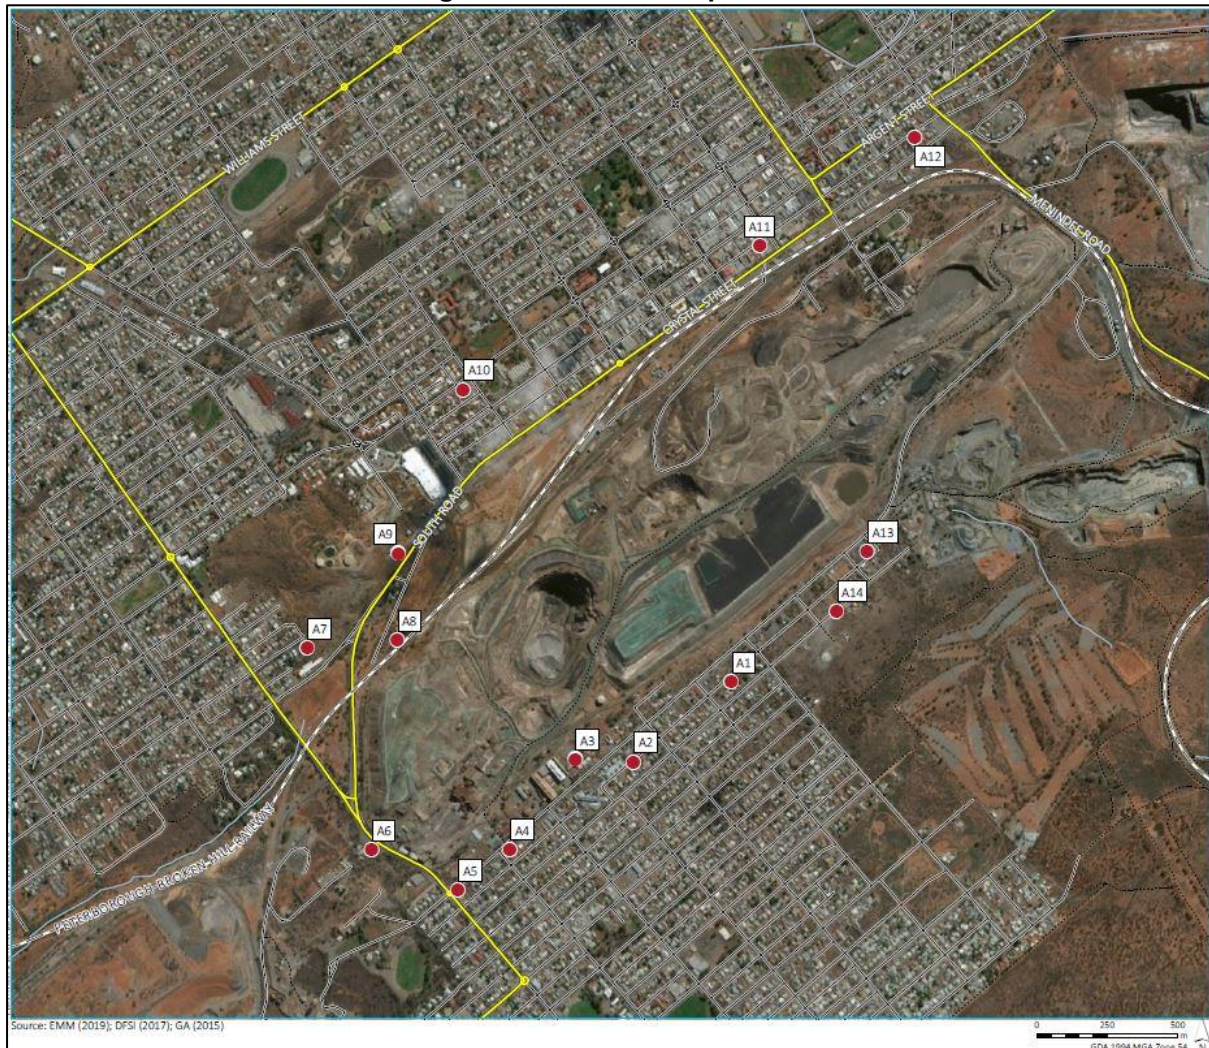
Figure 6-21 Noise Receptors 1

A total of 28 operator-attended noise measurements were completed, including two measurements at each of the 14 monitoring locations. For 11 out of the 28 samples (39%), the wind speed was above 3 m/s and therefore the noise limits did not apply for these samples according to the site's EPL. Site noise was inaudible during both measurements at locations A2 and during one of two measurements at A1, A3, A6, A7, A10, A11 and A12. Noise monitoring results are shown in **Table 6-24**.
