Rasp Mine

Annual Review

1 January 2023 – 31 December 2023

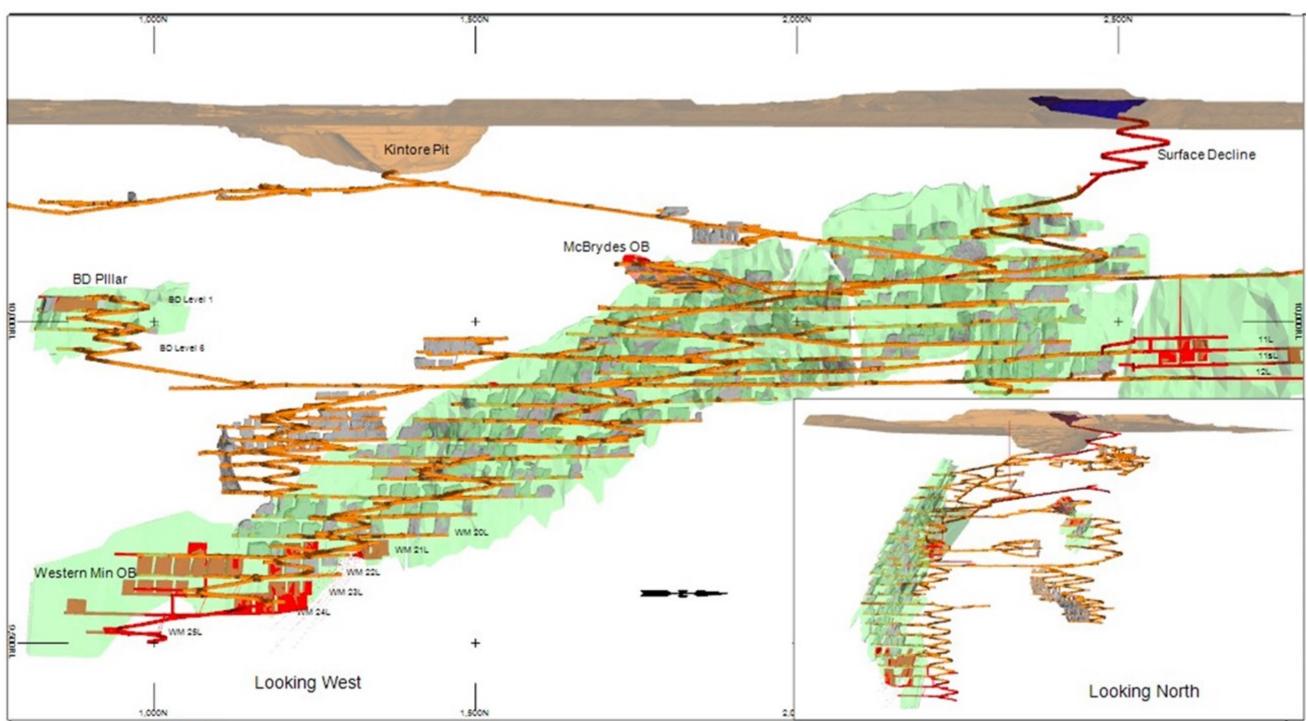
Figure 4-1 Plan 3 Mining Activities in the Reporting Period

Waste rock was used to backfill mined out stopes with a total of 181,537 t placed during the reporting period. This includes Cemented Rock Fill where conditions and requirements dictate its use.

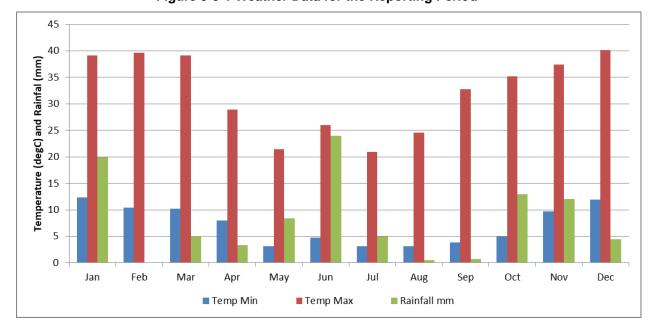
Figure 5-5-1 Weather Data for the Reporting Period

Temperatures and rainfall in the reporting period remained consistent with the BoM's long-term averages, with rainfall of 96.4mm for the period lower than the BoM's long-term annual average of 246mm. There were 52 rain days for the period. Winds were predominantly from the south with high winds experienced in the summer months.

Figure 5-5-1 and Table 5-1 provide summary weather data from the site weather station.

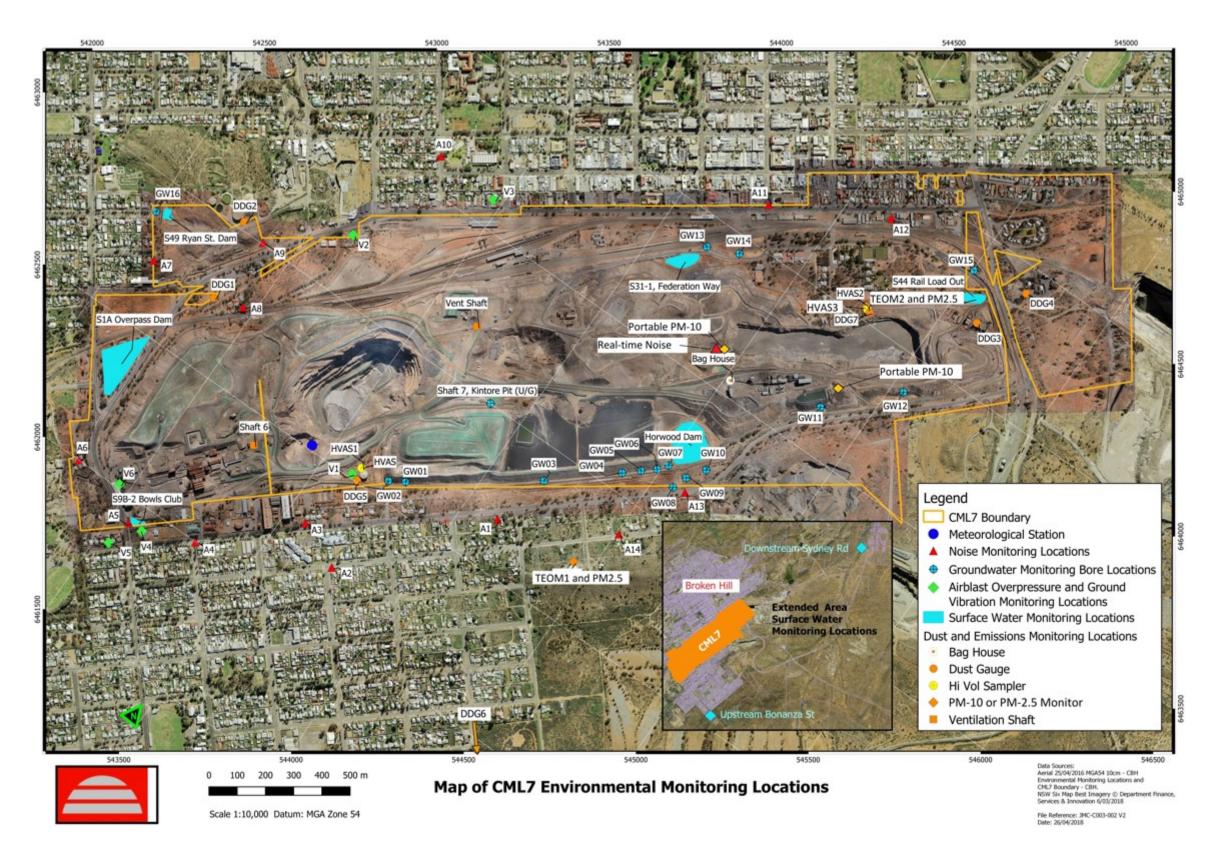
Figure 5-2 Location of Monitoring / Sampling Points

The BHO site environmental monitoring program is summarised in **Table 5-2**, locations for sampling/monitoring points are shown in **Figure 5-2**. A new weather station was installed on site in January 2019 as the previous weather station could not calculate Sigma Theta, a requirement of EPL 12559. TEOM units with the capability of monitoring PM2.5 were installed in 2022 and replaced by BAM units in March 2023.

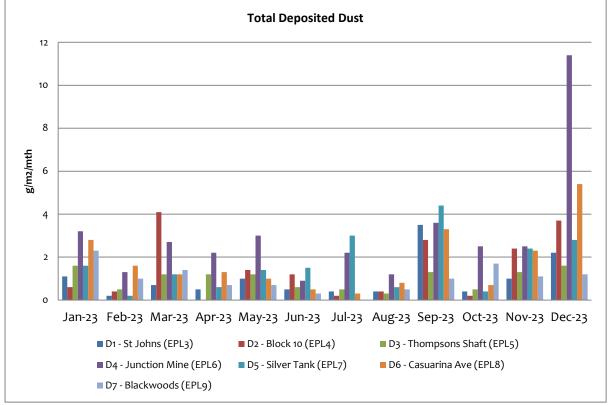
Figure 5-3 Monthly Total Deposited Dust for Results for the Reporting Period

Figure 5-3 and **Figure 5-4** show the monthly dust deposition and total deposited lead results for the reporting period. There was one occasion when a monitoring location exceeded the depositional dust level of 4 g/m²/month limit (red figures in **Table 5-5**), three less than in the previous reporting period. Highest readings occurred in the summer months when dust storms were more frequent. A number of large storms throughout the region also created an increased amount of sediment through much of Broken Hill, compounding dust storms.

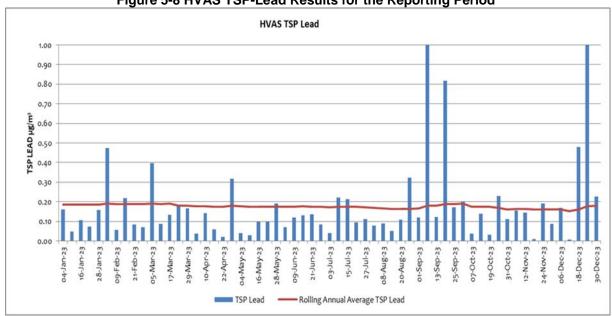
Figure 5-8 HVAS TSP-Lead Results for the Reporting Period

The highest TSP-Lead level recorded was on 24 December 2023 $(1.15\mu g/m^3)$ when winds were predominately from the SW, suggesting contribution from off-site sources.

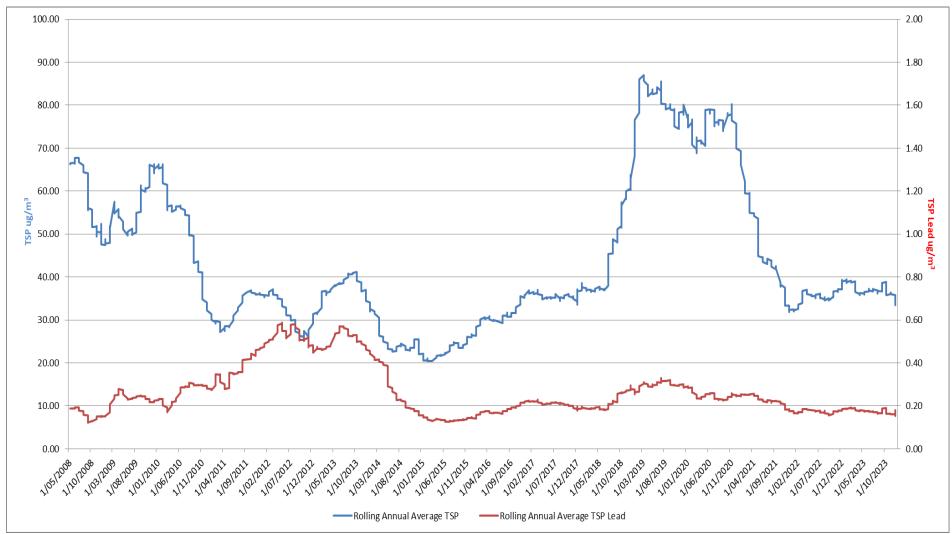
Figure 5-9 provides a summary of TSP and TSP-lead results from 2008 to 2022. Rolling annual averages for TSP are well below the annual average criteria of $90\mu g/m^3$ and EPA threshold of 0.5 $\mu g/m^3$ for TSP-lead.

As can be seen in **Figure 5-9**, there is an increase in dust levels recorded in HVAS after 2016 due to the period of drought. Dust levels decreased at the beginning of 2022 due to the heavy rainfall and increased in the 2023 summer and spring months due to the hotter and windier weather. Lead levels have fallen with slight elevation in levels towards the end of the period. This can indicate contribution from site activities but it has been found that lead levels can be elevated at this location on the southern boundary of the site when winds are predominantly from the South.

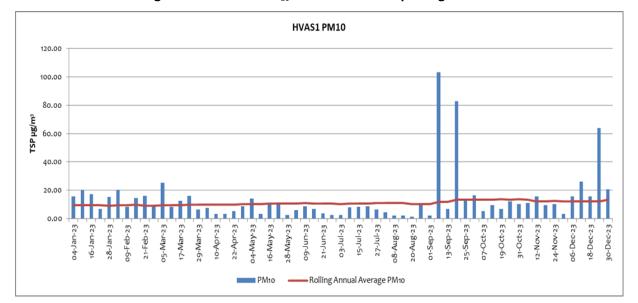
Figure 5-10 HVAS1 PM₁₀ Results for the Reporting Period

HVAS1 is used for sampling PM_{10} and PM_{10} -lead. The average annual PM_{10} level recorded at this monitoring point at the end of the reporting period was $13.3 \mu g/m^3$, which has decreased from the $9.8 \mu g/m^3$ at the beginning of January 2023 and is well below the background level of $29.1 \mu g/m^3$ reported in the EA. The average annual PM_{10} level calculation includes data collected during extreme events. Results for the reporting period are shown in **Figure 5-10** which indicates that the rolling annual average for PM_{10} is below the criteria of $25 \mu g/m^3$, and has remained consistently low during the reporting period.

The highest PM10 dust level recorded was $103\mu g/m^3$ on 7 September when winds were predominantly from the West. While there may have been contribution from Little Kintore Pit, it was likely a regional dust event on this day that contributed the bulk of the dust. Another dust storm occurred on 19 September, with winds from the WSW, when a PM10 dust level of $82.7\mu g/m^3$ was recorded.

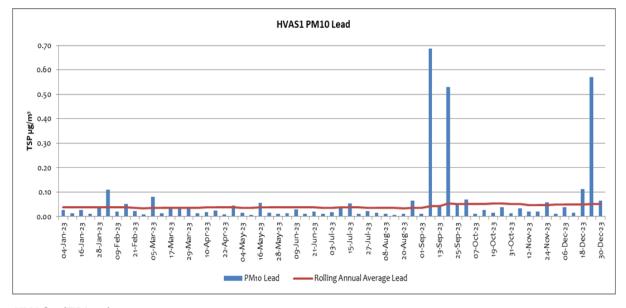
Figure 5-11 HVAS1 PM₁₀-Lead Results for the Reporting period

HVAS1 PM10 Lead results for the reporting period are shown in **Figure 5-11**. The highest Lead PM10 result recorded was $0.69\mu g/m3$ on 7 September when winds were predominantly from the West and a regional dust event was experienced in Broken Hill. It is possible that Little Kintore Pit and the Haul Road contributed dust recorded on this day. Another dust storm, with winds from the WSW, occurred on 19 September when a PM10 Lead dust result of $0.53\mu g/m3$ was recorded.

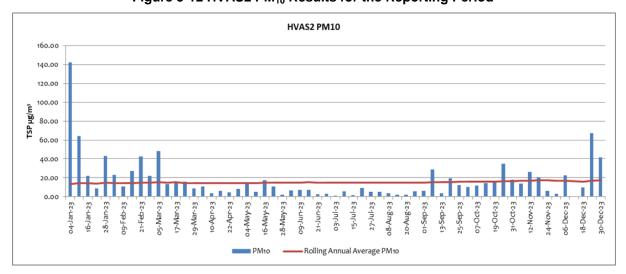
Figure 5-12 HVAS2 PM₁₀ Results for the Reporting Period

The highest recorded PM_{10} dust reading during the period was $142.00\mu g/m^3$ on the 4 January when winds were from the South suggesting contribution from Blackwoods TSF2. The annual rolling average for PM10 dust at this location is $17.4~\mu g/m^3$ at the end of December 2023, up from $13.22\mu g/m^3$ in January 2023, but below both the background level reported in the EA of $29.1\mu g/m^3$ and the criteria of $25\mu g/m^3$ (for off-site receptors), **Figure 5-12**. Data presented includes that which may be result of external events, particularly dust storms which are expected in the spring and summer months.

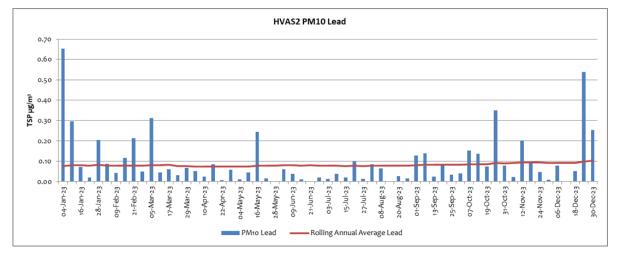
Figure 5-13 HVAS2 PM₁₀-Lead Results for the Reporting Period

The highest recorded PM_{10} Lead dust reading for the period was $0.65\mu g/m^3$ on the 4 January when winds were from the South suggesting Blackwoods TSF2 was the likely source of the dust. The rolling annual average for PM_{10} Lead in December 2023 was $0.10\mu g/m^3$, higher than the value of $0.08\mu g/m^3$ in January 2023. **Figure 5-13**.

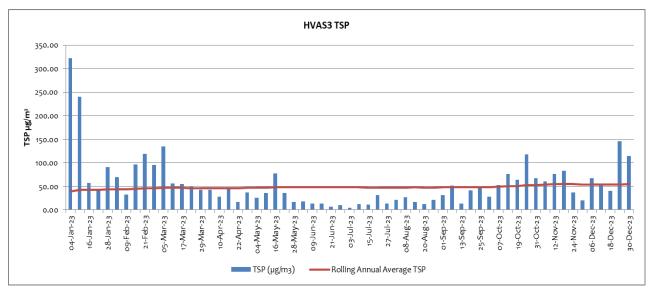
Figure 5-14 HVAS3 TSP Results for the Reporting Period

The highest TSP level recorded at HVAS3 during the reporting period was on 4 January with a result of $322.00\mu g/m^3$, when winds were from the South, suggesting that the dust source was likely Blackwoods TSF2. This was likely the result of MD6 works to redevelop TSF2 for tailings harvesting. The annual rolling average for TSP dust at this location is $55.46\mu g/m^3$ at the end of December 2023, up from $39.72\mu g/m^3$ in January 2023 as seen in **Figure 5-14**.

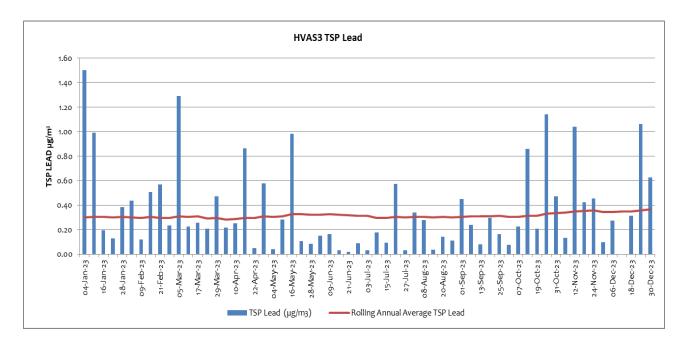
The highest TSP Lead level recorded at HVAS3 during the reporting period was on 4 January with a result of 1.50µg/m³, when winds were predominantly from the South suggesting contribution from Blackwoods TSF2. The rolling annual average for TSP Lead in December was 0.36µg/m³, up from

0.30µg/m³ in January 2023. Elevated lead levels were recorded sporadically throughout the reporting period, usually as a result of site activities around TSF2.

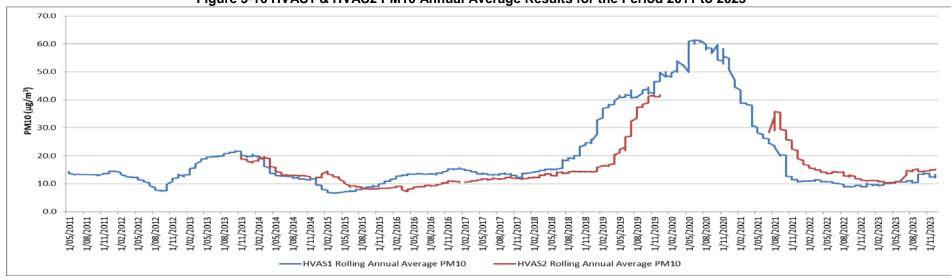
Figure 5-16 HVAS1 & HVAS2 PM10 Annual Average Results for the Period 2011 to 2023

Trends for the period 2011 to 2023 are shown in **Figure 5-16**. Since September 2013 when HVAS2 started operating, dust levels rose during the drought period of 2018 to 2021, fell during the wet year of 2022, then have risen in the last year due to the drier weather and dust storms.

Results for the period 2011 to 2023 are shown in **Figure 5-16**.

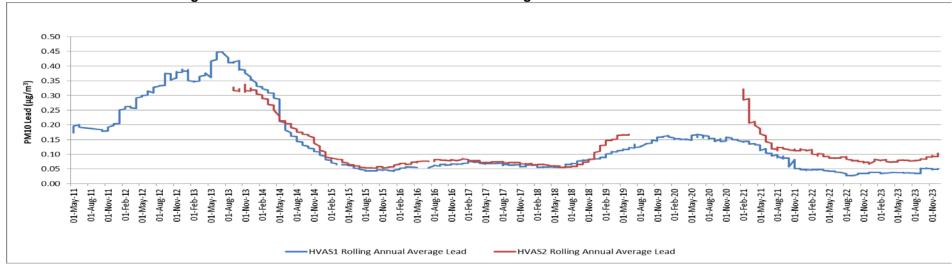
Figure 5-17 HVAS1 & HVAS2 PM10-Lead Annual Average Results for the Period 2011 to 2023

Results for the period 2011 to 2023 are shown in **Figure 5-17**. Since September 2013 when HVAS2 started operating PM10-lead levels have tracked with PM_{10} trends at HVAS2.

Results for the period 2011 to 2023 are shown in Figure 5-17.

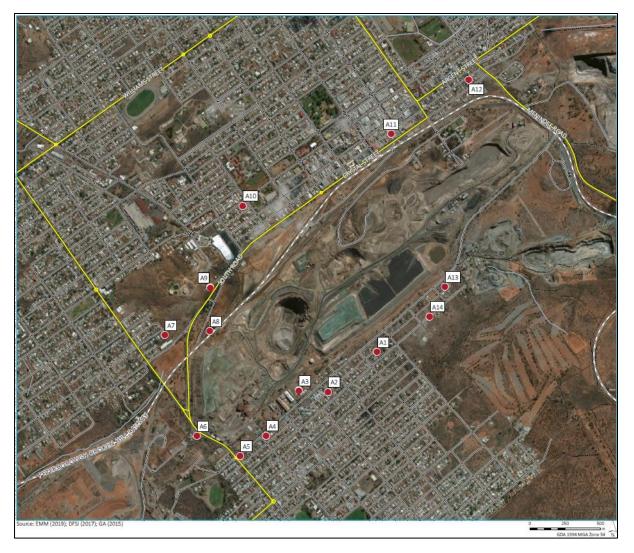
Figure 5-28 Noise Receptors

During the reporting period EMM Consulting Pty Ltd conducted a noise assessment for these receptors, **Figure 5-28**.

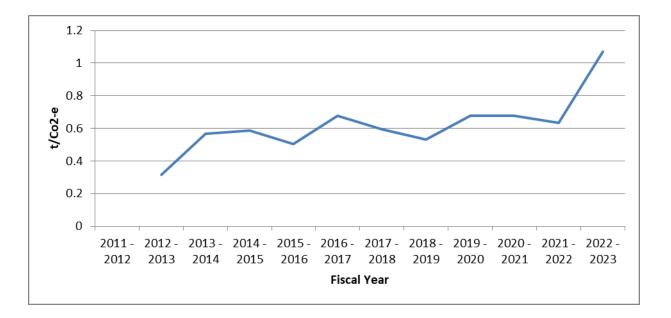
Figure 5-29 CO₂ emissions/tonne concentrate produced

Rasp Mine monitors emissions by tracking CO_2 emissions against the tonnes of concentrate produced as shown in **Figure 5-29**. The 2022-2023 fiscal period saw an increase in emissions of CO_2 /tonne concentrate due to the MOD6 construction works which included the construction of the boxcut mine access portal and TSF2 embankments.
