# Rasp Mine

## Annual Environmental Management Report

**1 January 2020 - 31 December 2020**

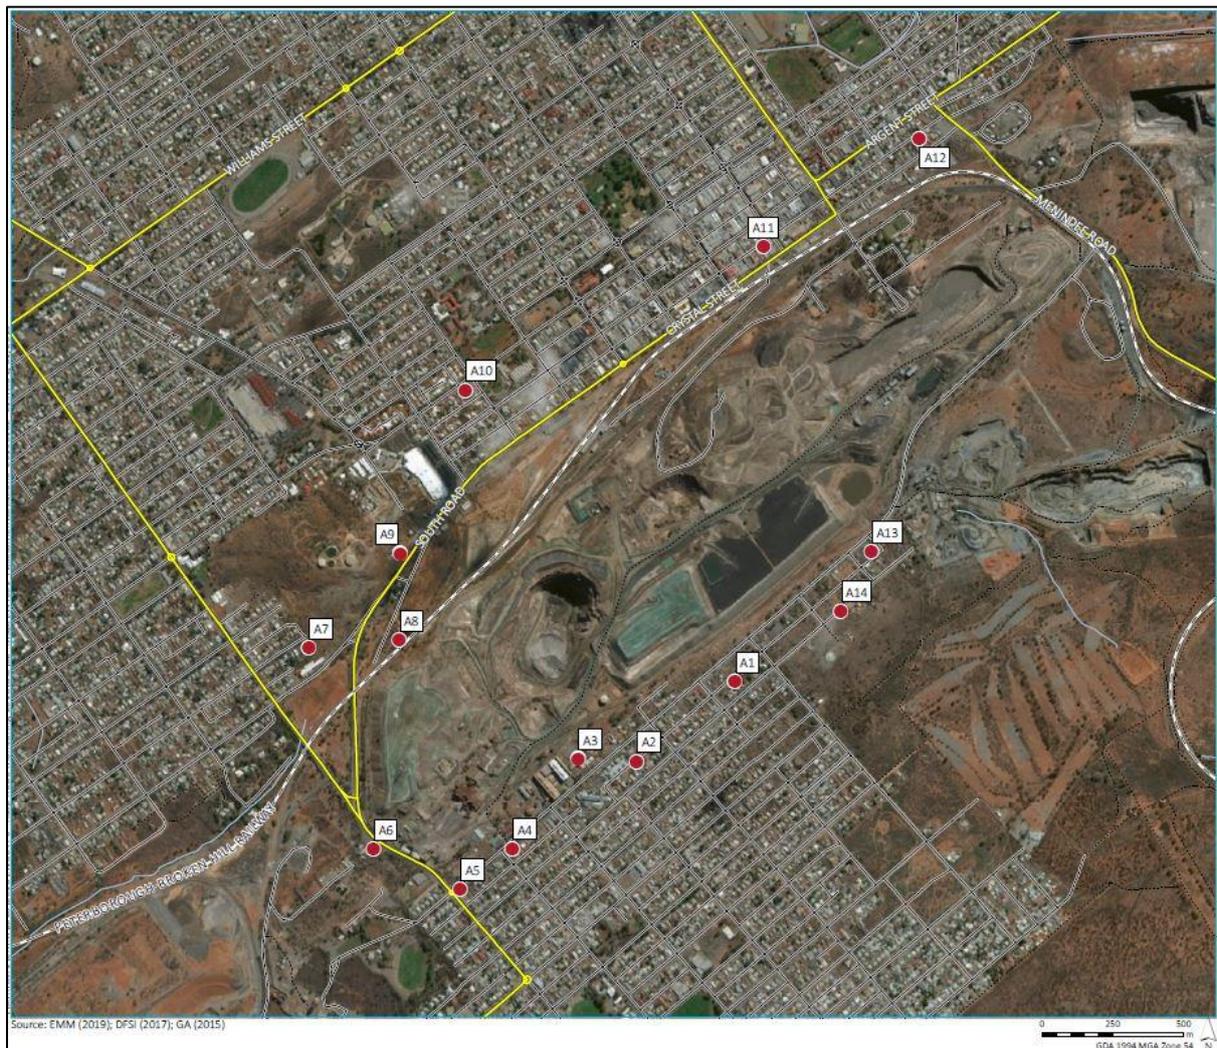
**Figure 3-19 Noise Receptors**

A total of 28 operator-attended noise measurements were completed, including two measurements at each of the 14 monitoring locations. For 2 out of the 28 samples the wind speed was below 3 m/s and therefore the noise limits did apply for these samples according to the site's EPL. Site noise was inaudible during 21 of 28 measurements. The Rasp Mine noise contributions satisfied the relevant night-time noise limits at all assessment locations. Noise monitoring results are shown in **Table 3-24**.
