Rasp Mine

Annual Environmental Management Report/Annual Review

1 January 2017 31 December 2017

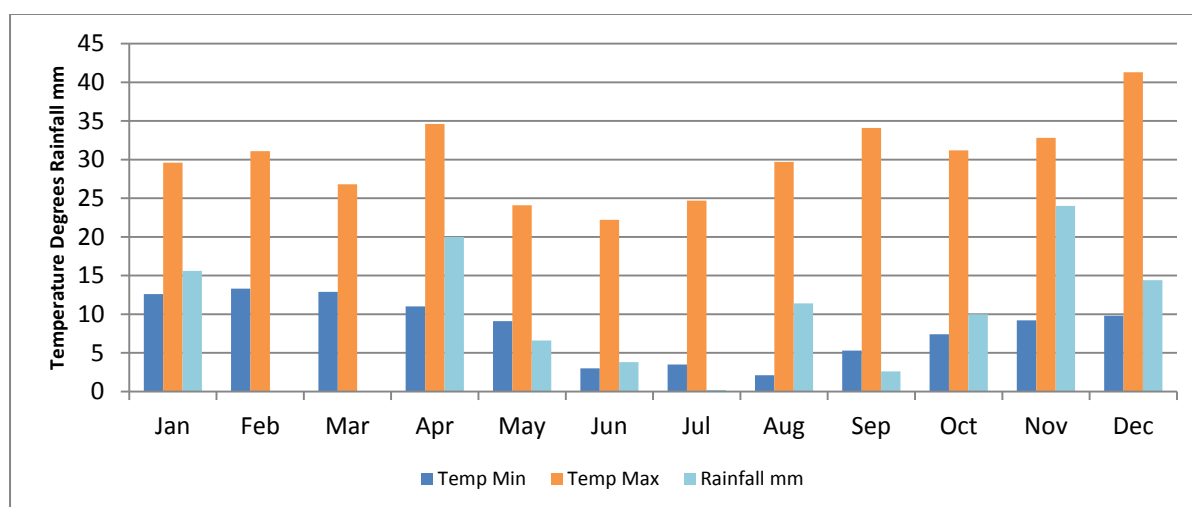
Figure 6-1 Weather Data for the Reporting Period (2017)

Figure 6-1 and **Table 6-1** provide summary weather data. This data is a combination of information from the Rasp Mine weather station and the Bureau of Meteorology station at the Broken Hill airport as the site weather station was off-line between March to June for repairs.

While temperatures in 2017 remained consistent with historical records, rainfall (108.8 mm) for the period was significantly lower than the BoM's long-term annual average of 259 mm. There were only 35 rain days for the period with most rain falling in spring (36.6 mm) and summer (30.0 mm) during periods of highest evaporation resulting in very dry conditions. Winds were predominantly from the south with high winds experienced during July to October and December.

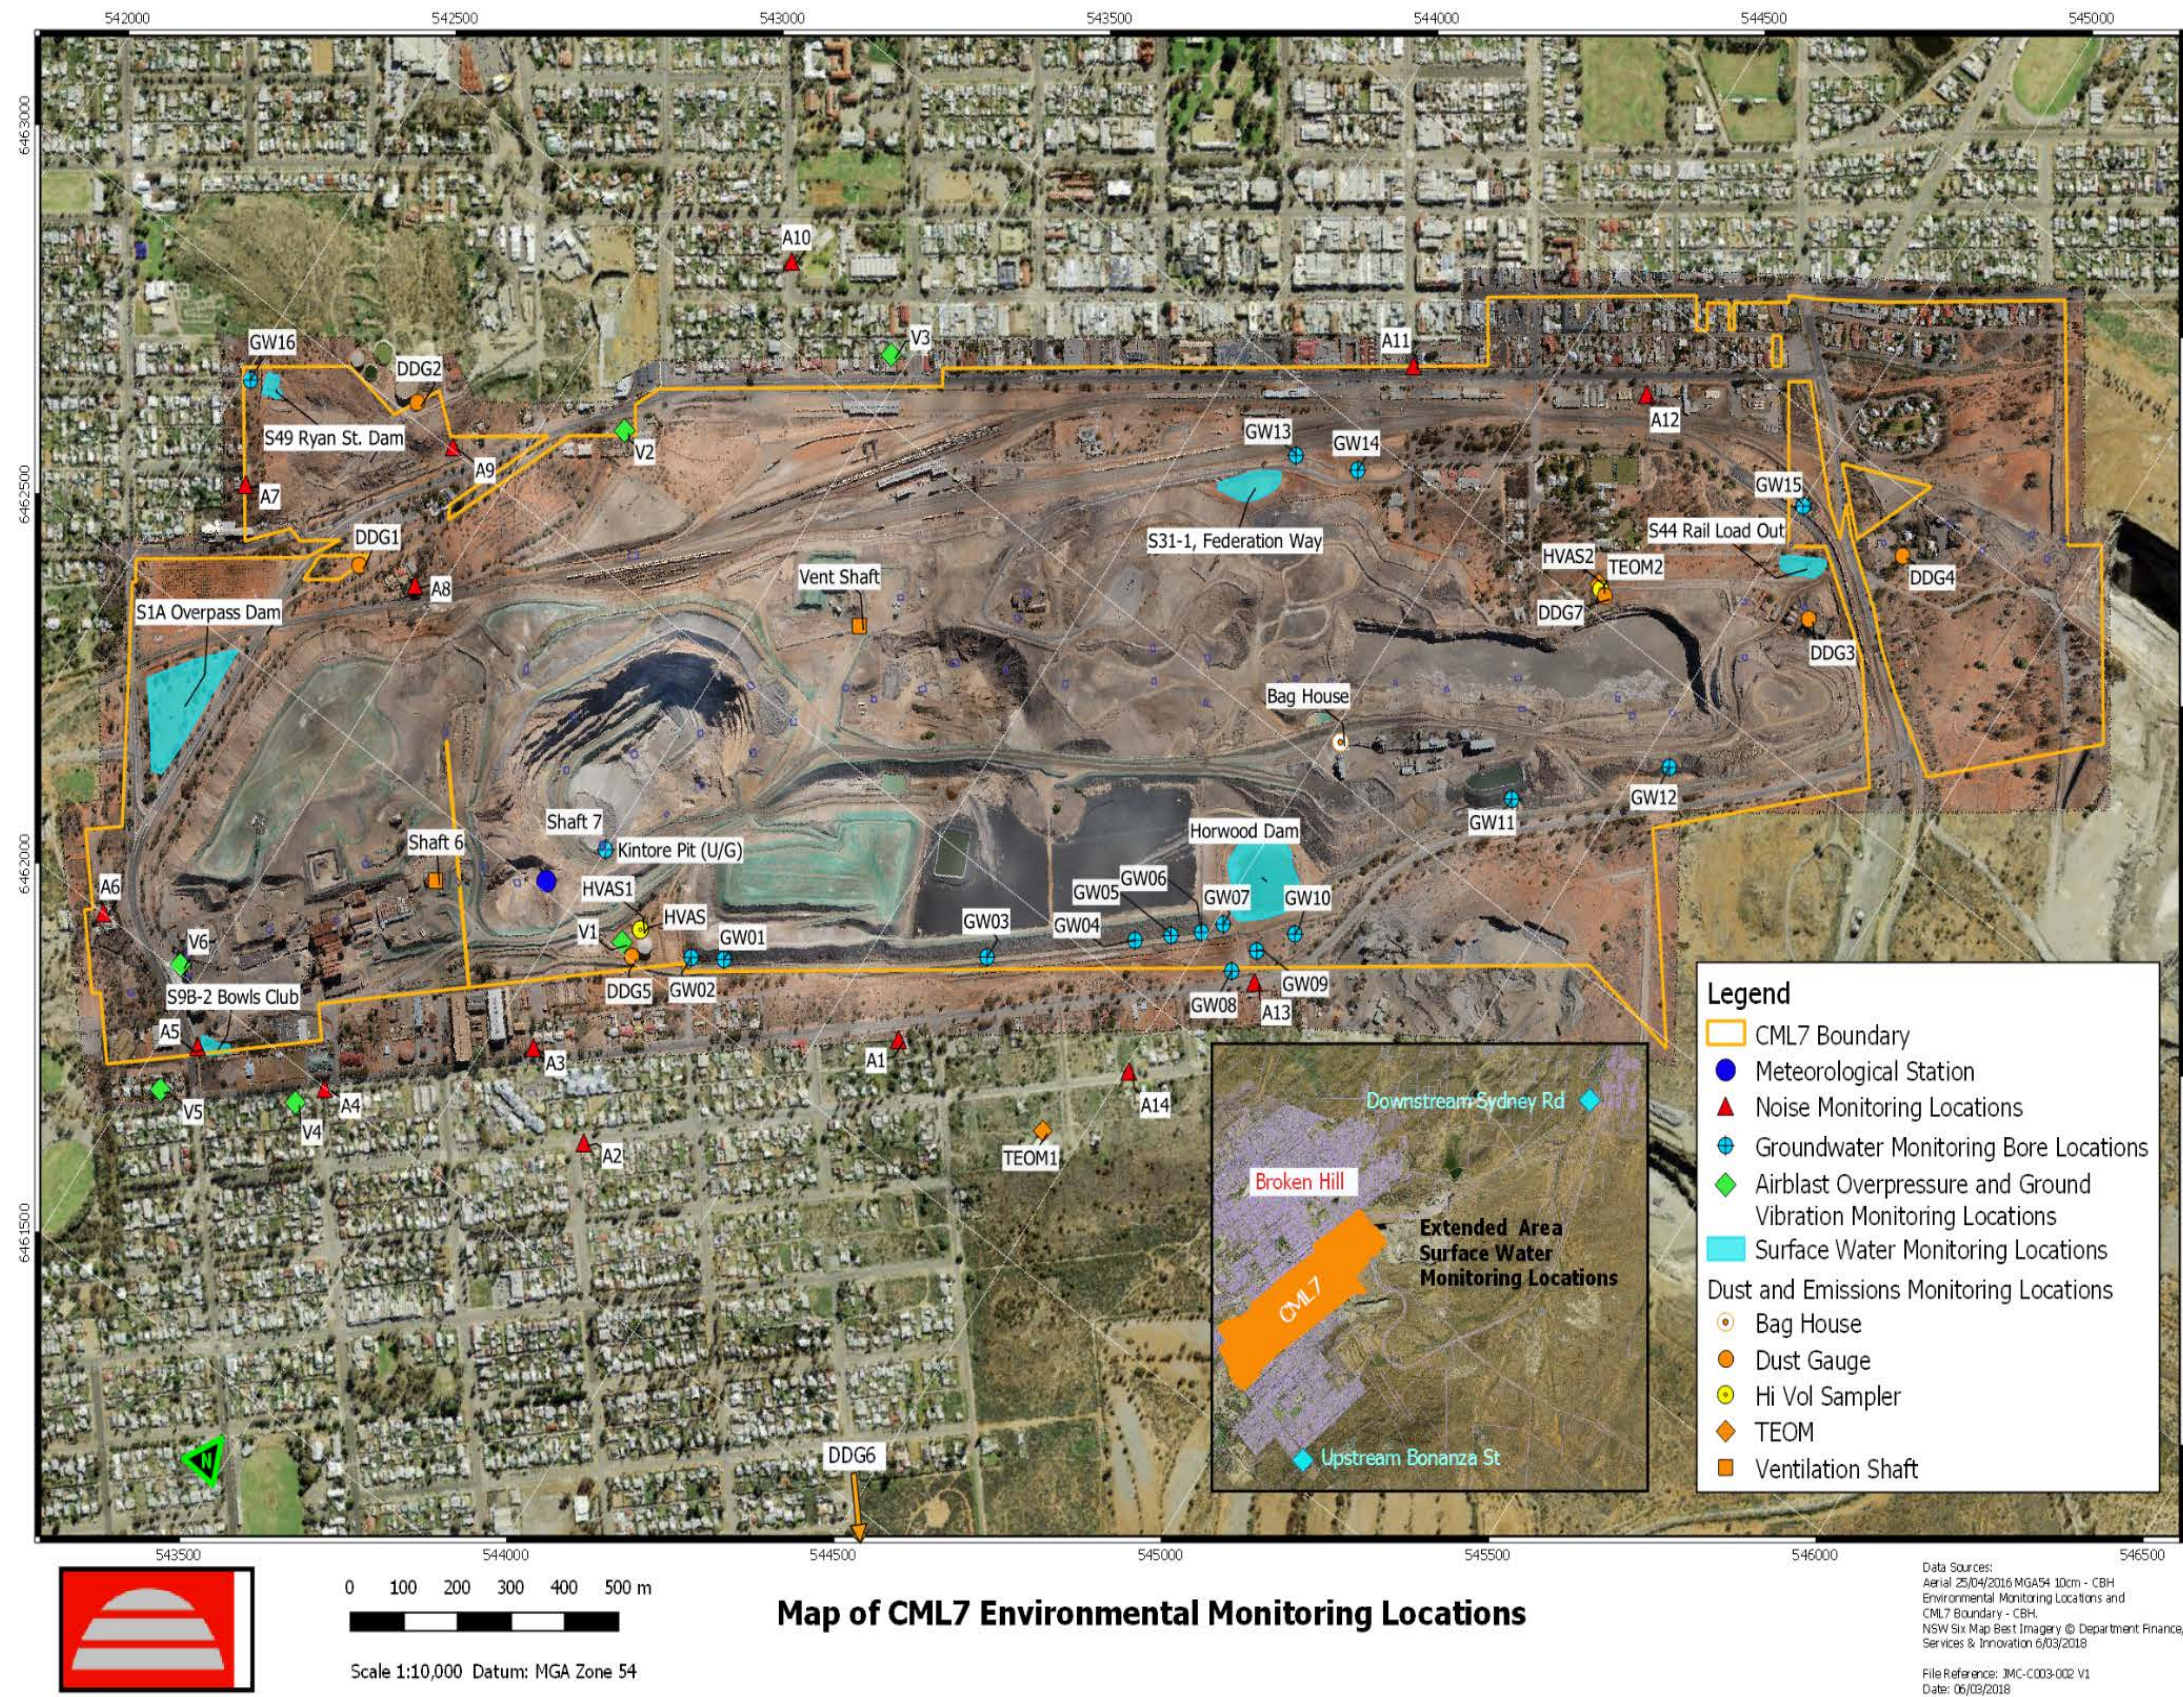
Figure 6-2 Location of Monitoring / Sampling Points

Figure 6-2 shows the sampling locations for all air quality monitoring units.

The Rasp Mine has two Tapered Element Oscillating Microbalance (TEOM) air quality monitors, which record real time PM₁₀ data. **Figure 6-2** shows the location of these monitors. **Table 6-7** lists the PM10 criteria as required by PA07_0018.

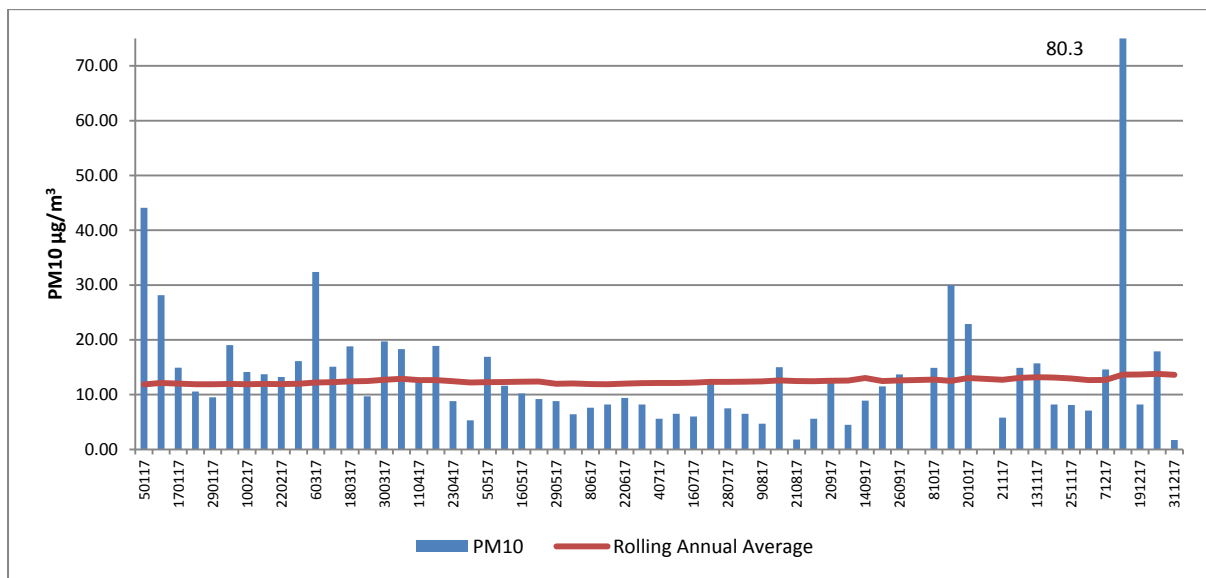
Figure 6-12 HVAS2 PM₁₀ Annual Average Results for the Reporting Period (2017)

The average annual PM₁₀ level recorded at this monitoring point at the end of the reporting period was 12.97 µg/m³, which has increased slightly from the previous reporting period (11.34 µg/m³), however it remains below the background level reported in the EA of 29.1 µg/m³ and remains well below the criteria of 25 µg/m³ (for off-site receptors), **Figure 6-12**.

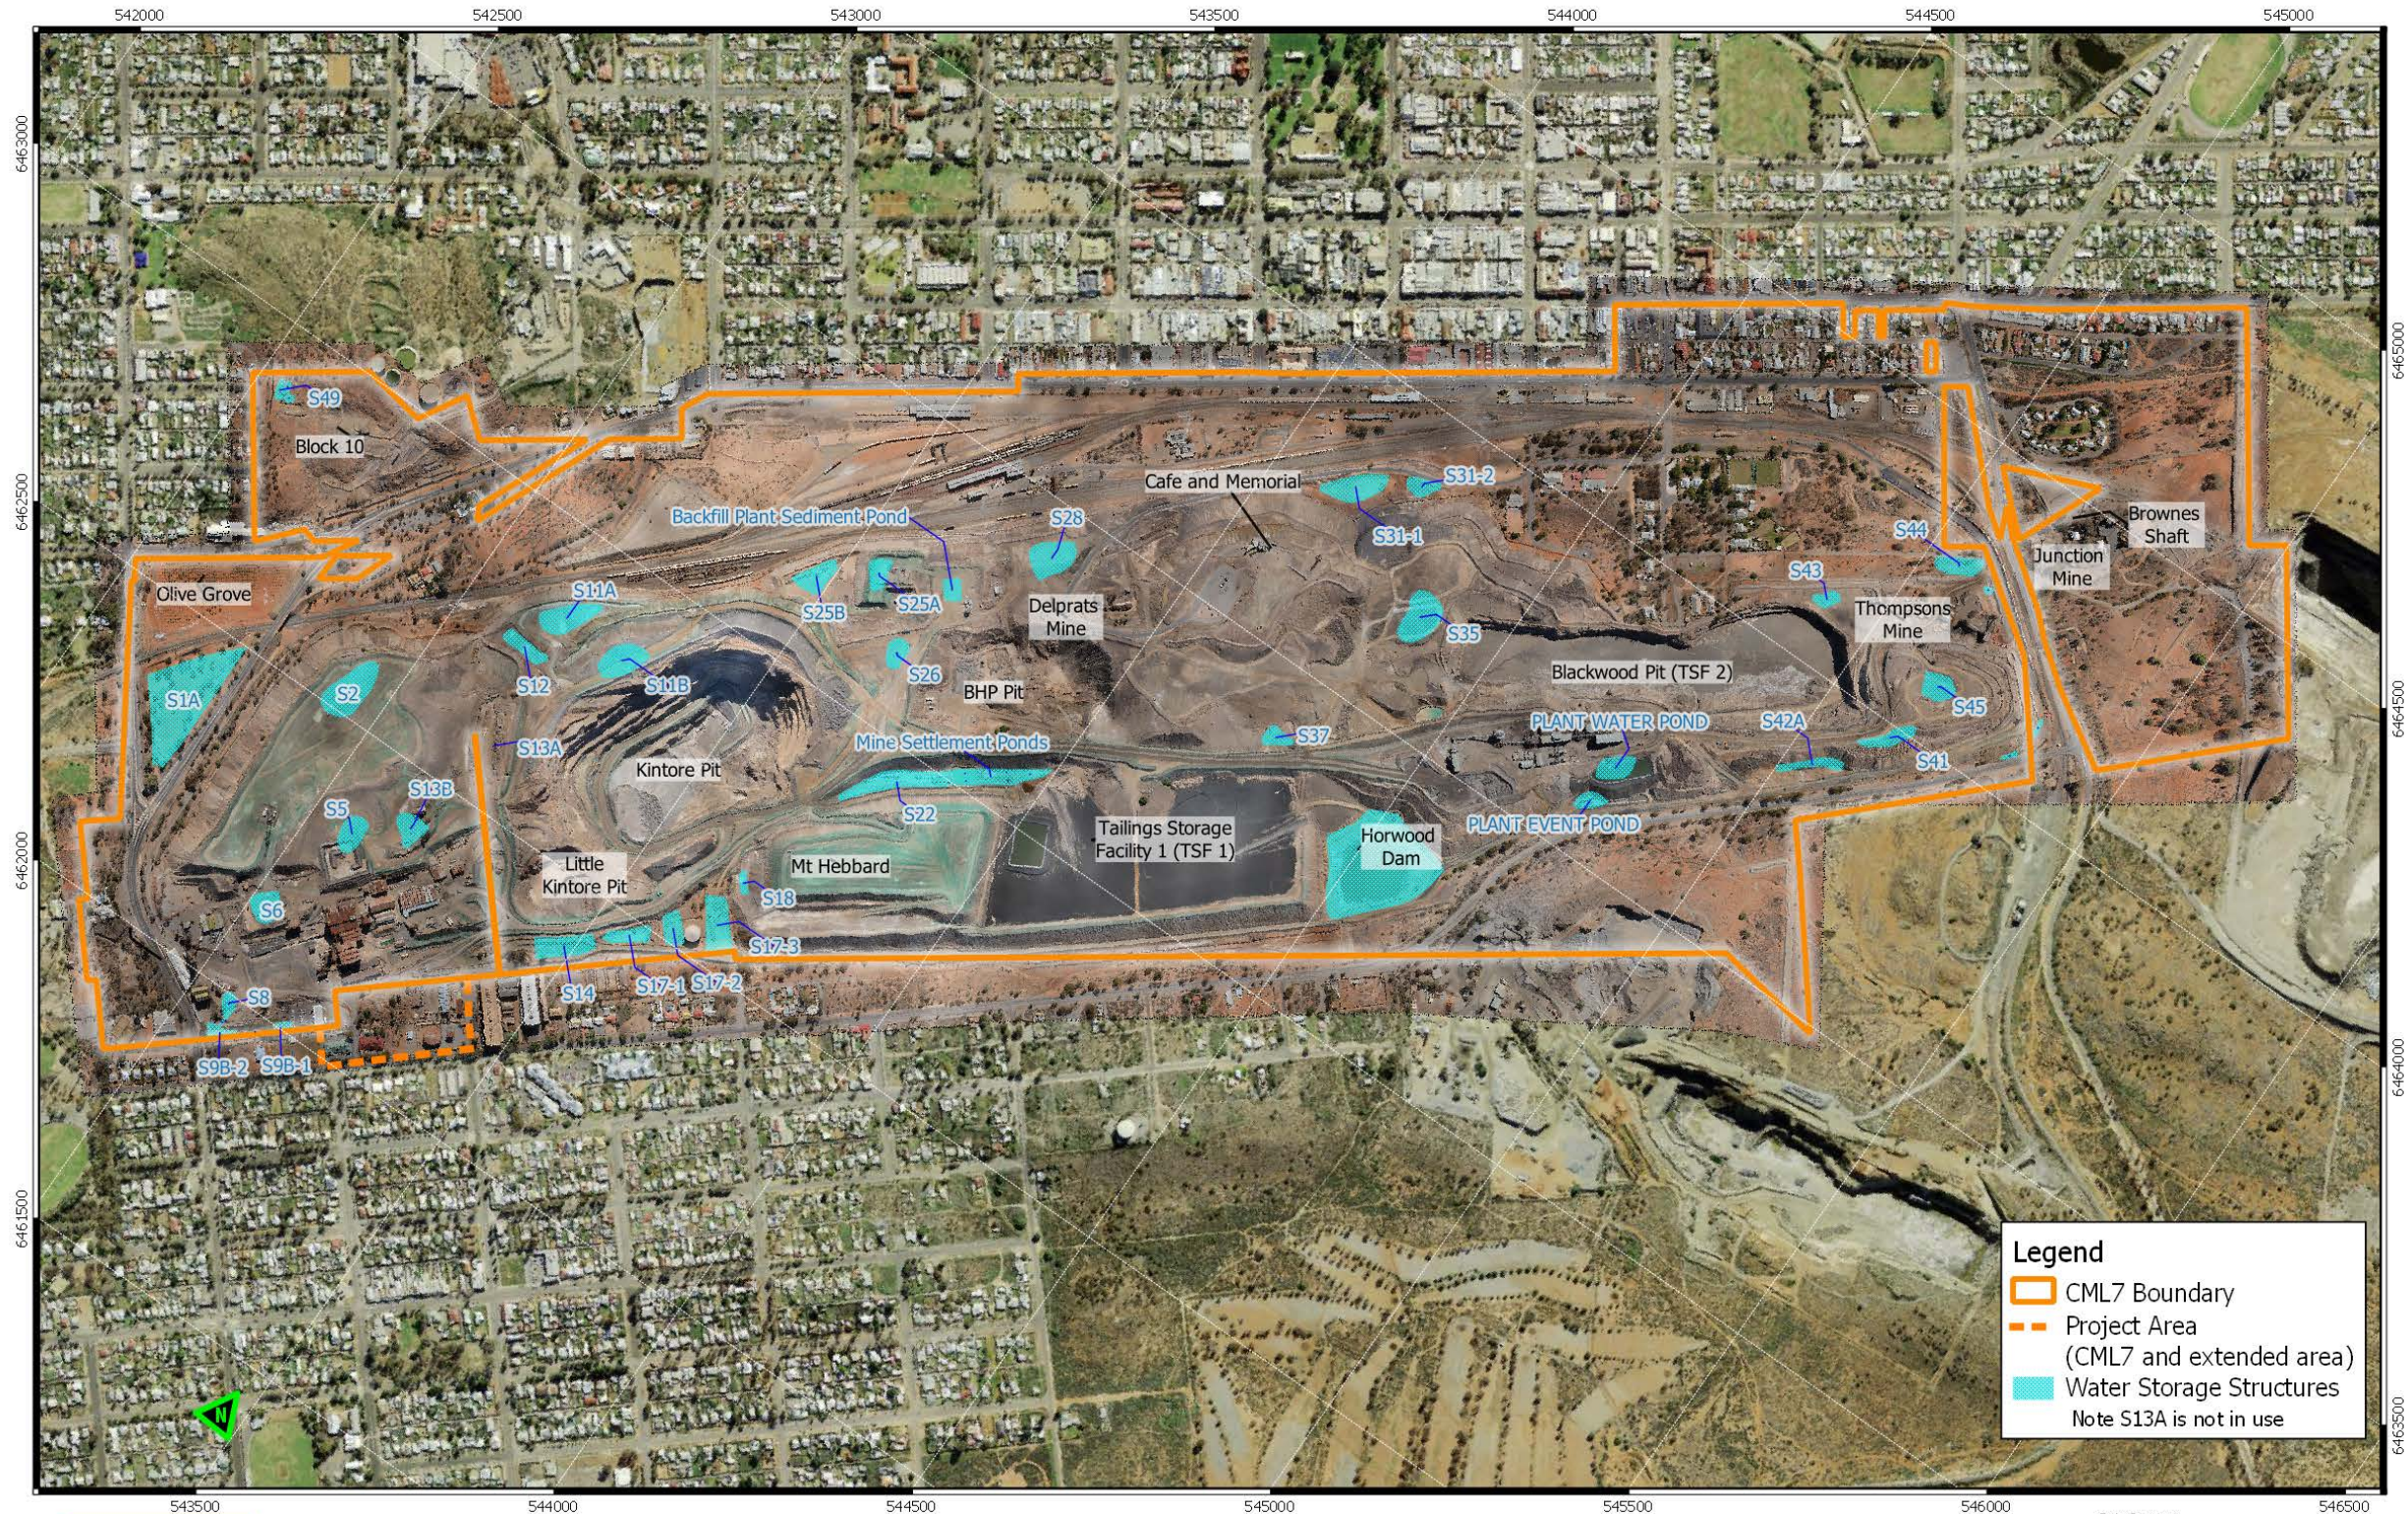
Figure 6-20 Plan 4 Storm Water Storage Ponds

All surface runoff on site is captured by diversion trenches or berms and channelled to site water storage structures. No changes were made to this system during the reporting period. **Figure 6-20 Plan 5** shows the water catchments and containment structures. **Table 6-10** provides the capacities and estimated stored water volumes at the end of the reporting period. Detailed surveying of the water storage structures is planned for the next reporting period. Surveys will be used to develop staged storage curves that will enable more accurate capacities and volumes to be determined.

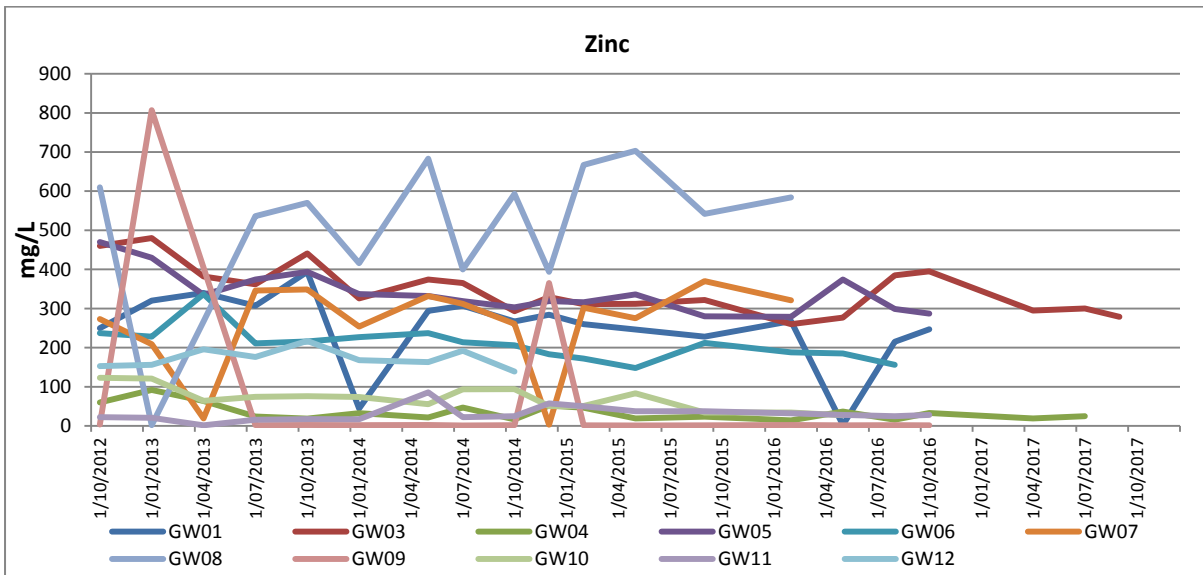
Figure 6-21 Groundwater Quality Results for Sampled Parameters for the Period 2012 to 2017

conditions. Water levels remained stable with GW9 and GW10 showing some variability. **Figure 6-21** indicates that results remain within historic ranges.

The ground water level in GW11 was steady over the reporting period and the level of GW12 decreased. the bores decreased over the reporting period with GW12 being dry in October and January. Quarterly samples were obtained from GW11 but only one sample could be obtained from GW12 due to dry conditions. **Figure 6-21** indicates that results remain within historic ranges.
