Annual Environment Management Report

Name of Mine:	Rasp Mine
Mining Titles / Leases:	Consolidated Mining Lease 7, Broken Hill
	MPLs 183, 184, 185, 186
AEMR Reporting Period	1 April 2012
	31 March 2013
Name of Leaseholder:	Broken Hill Operations Pty Ltd
Name of Mine Operator:	Broken Hill Operations Pty Ltd
Reporting Officer:	
Title	
Signature
Date

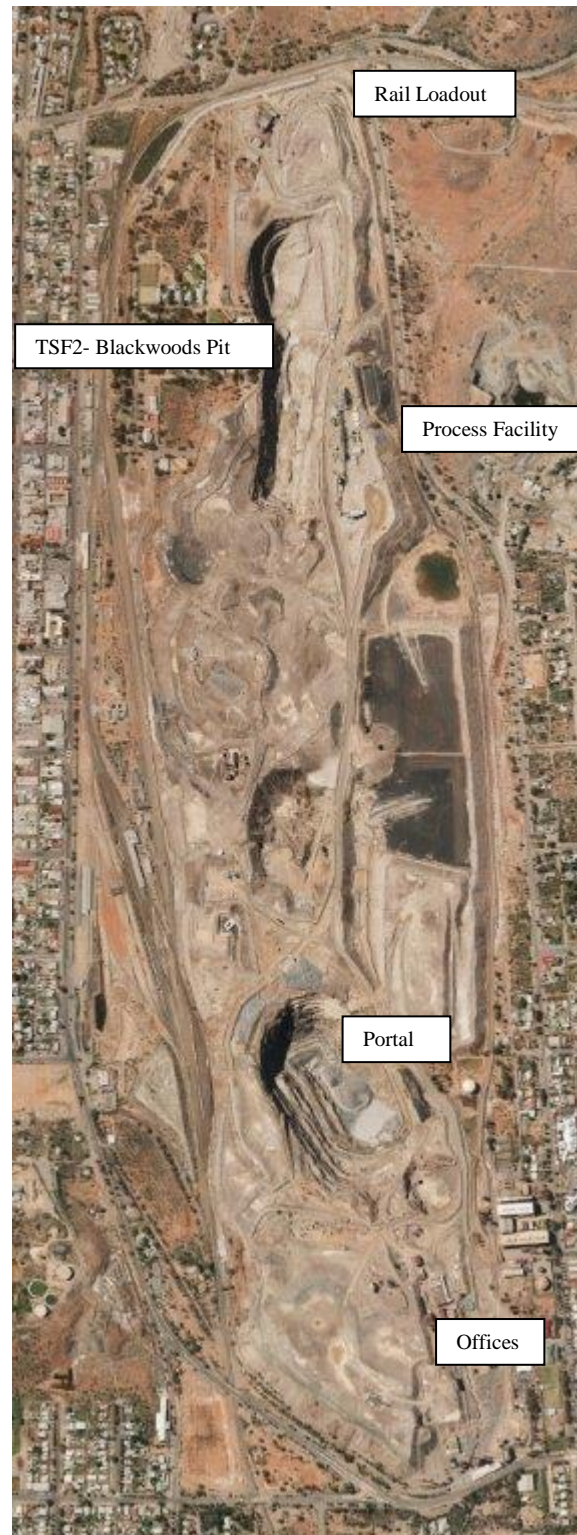
Figure 1 **Aerial view of the Rasp Mine**

The Rasp Mine is located centrally within the City of Broken Hill and is surrounded by transport infrastructure, areas of commercial and industrial development and some residential housing. The Rasp Mine is bounded by Eyre Street and Holten Drive to the south and east, Menindee Road (MR 66) to the northeast, Crystal Street to the northwest and Bonanza Street and South Road (Silver City Highway SH 22) to the southwest. These roads form part of the existing road train and B-double route through Broken Hill. Broken Hill railway station located directly to the north of the mine lies on the main Sydney – Perth railway line. Residential and commercial areas are located to the west, south and north of CML7, Perilya mine developments to the north-east (North Mine) and south-west (Southern Operations) and the Blue Metal Quarry to the east. An aerial view of the Rasp Mine is provided in **Figure 1**.

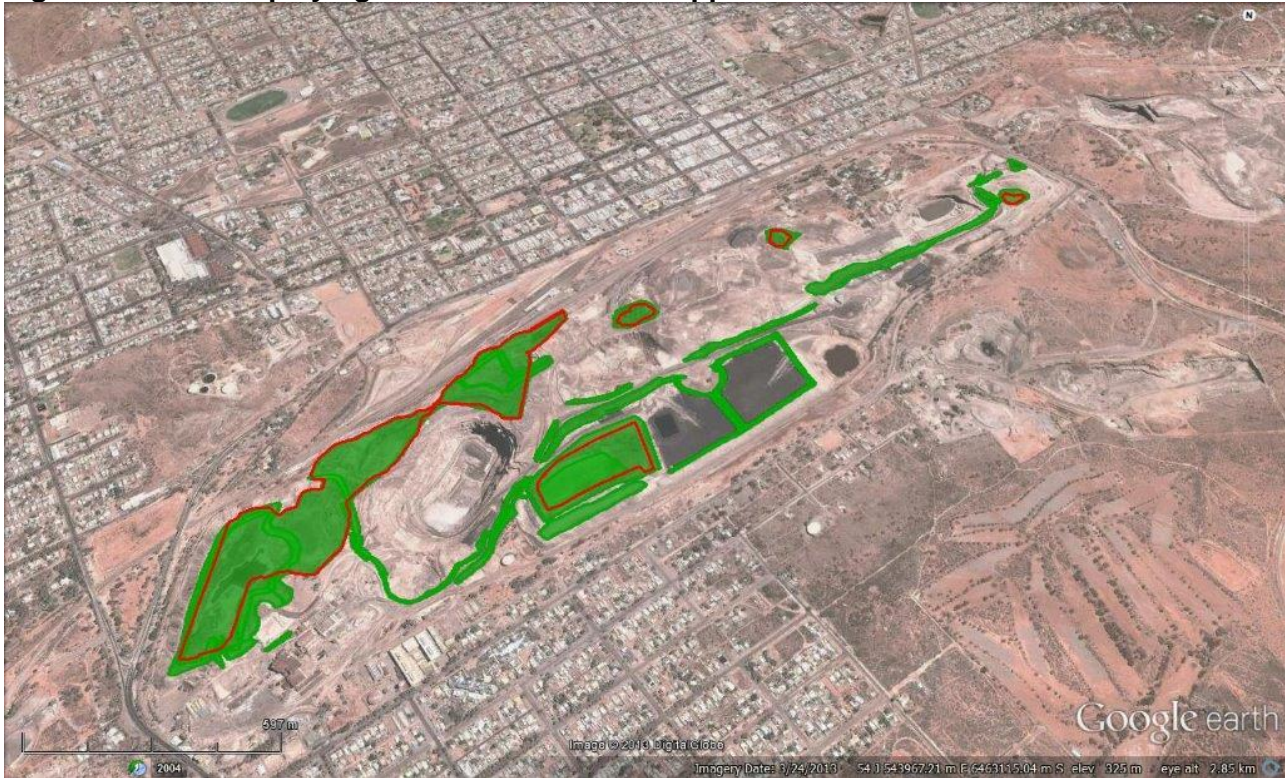
Figure 2- Aerial displaying free areas and dust suppression

Outline of Free Areas determined in the EA

Areas sprayed with Dust Suppression

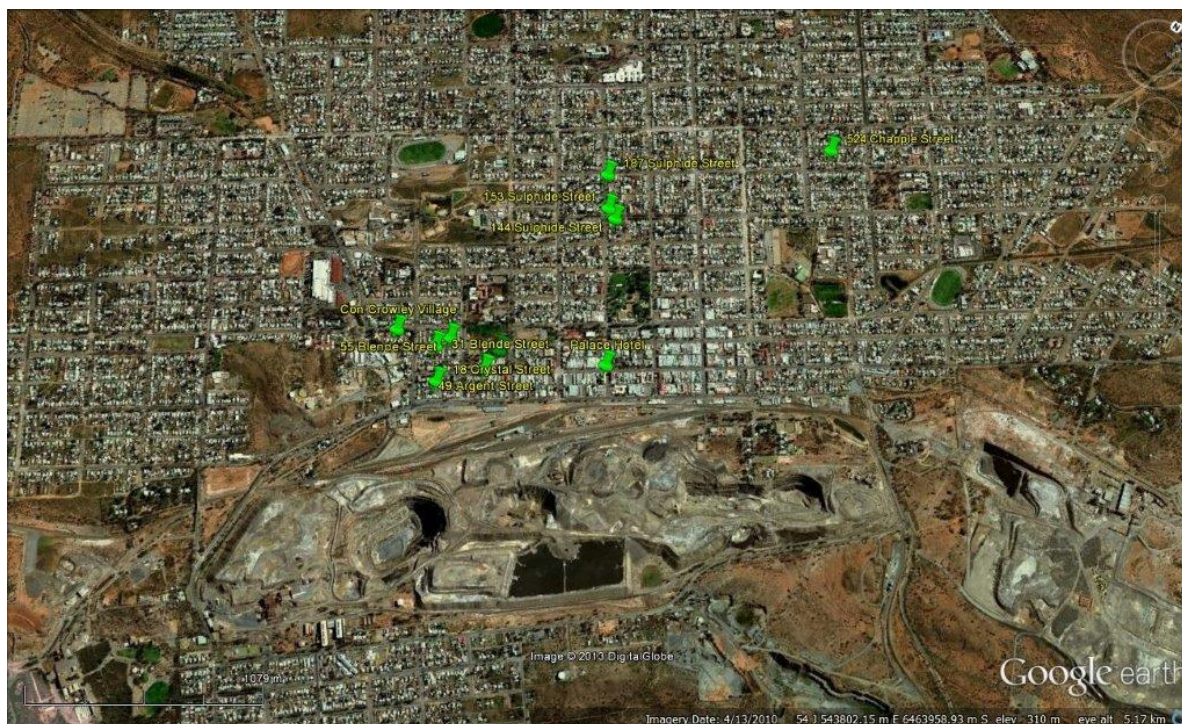
Figure 11- Roving Monitor Previous Locations

Blast monitors are installed at three locations around site as per licence requirements. A roving blast monitor was also purchased in November with the purpose of moving it around to various locations to determine more information about ground conditions and vibration movement. A total of 12 different locations have been recorded since November. These locations can be seen in figure 8
