Rasp Mine

Annual Review

1 May 2020 – 30 April 2021

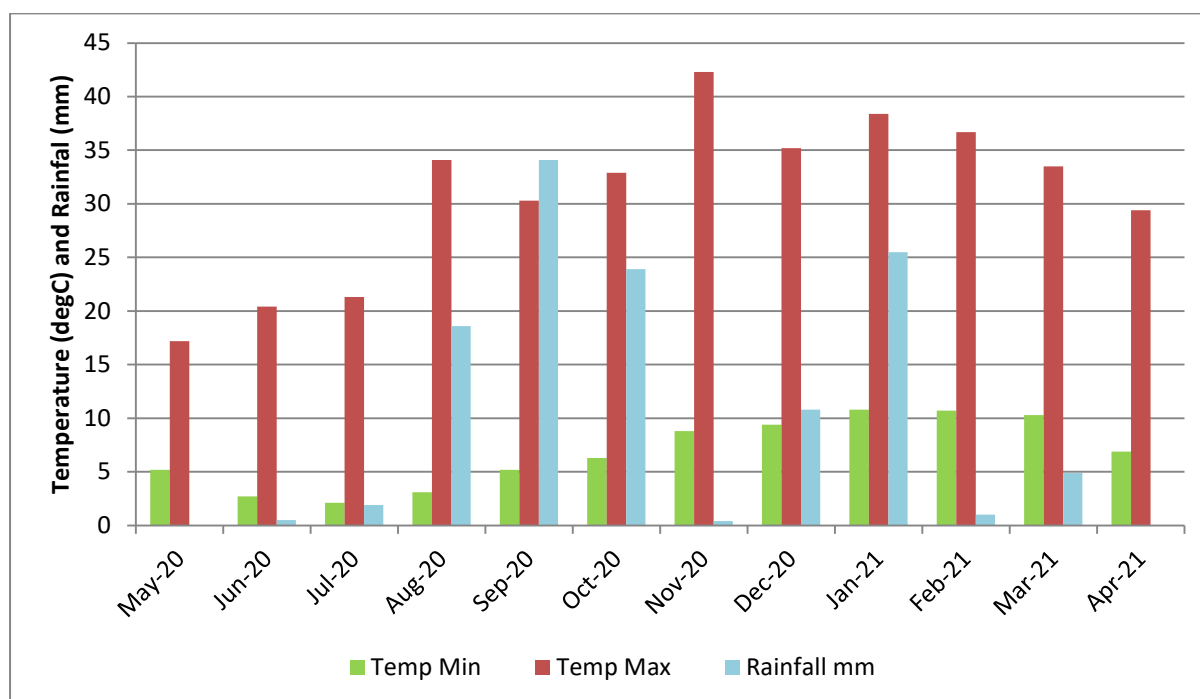
Figure 5-1 Weather Data for the Reporting Period

While temperatures in the reporting period remained consistent with historical records, rainfall (34.76 mm) for the period was significantly lower than the BoM's long-term annual average of 259 mm. There were only 32 rain days for the period with most rain falling in Autumn. Winds were predominantly from the south with high winds experienced during July to January.

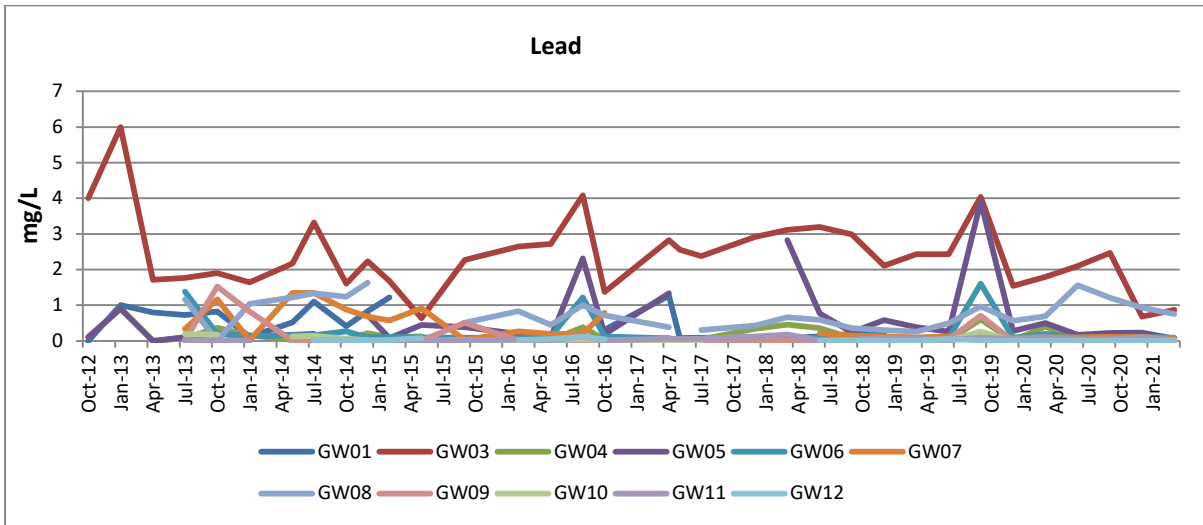
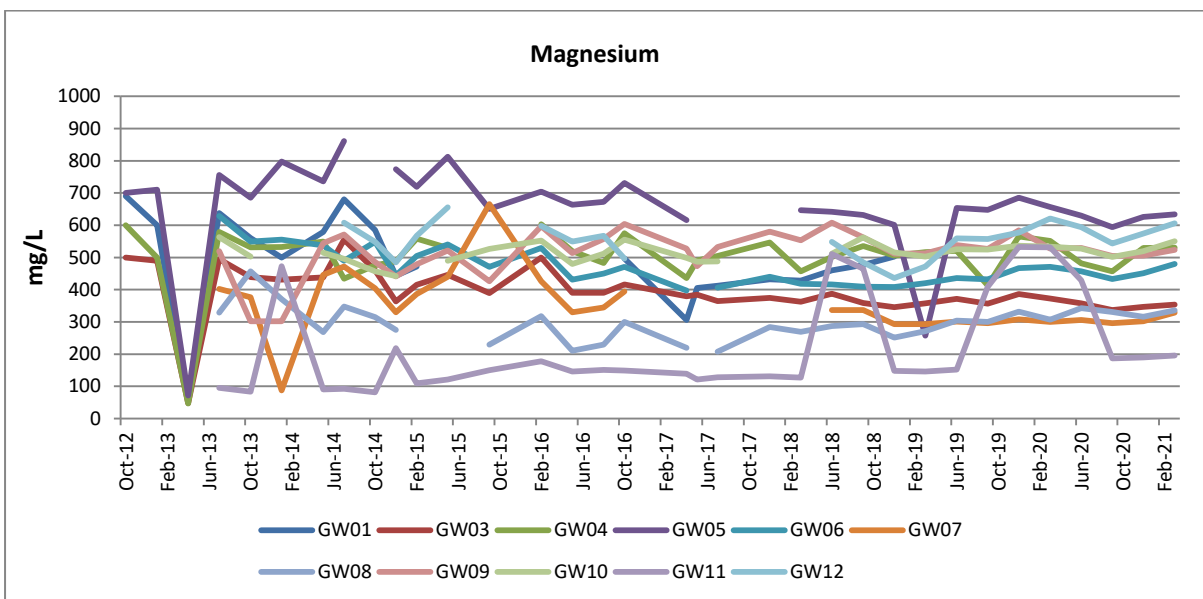
Figure 5-22 Groundwater Quality Results for Sampled Parameters for the Period 2012 to Apr 2021

Groundwater bores are located near the eastern side of the unused historic TSF1 and extend to Horwood Dam. The intent of the monitoring bores is to monitor perched water in the area that may impact on Eyre Street Dam. The monitoring is in response to surface seepage noted in the area during intense 2011 rainfall events. All bores in the series were able to be monitored each quarter. Water levels were stable in GW3 and GW4 and falling in bores GW5 to GW10. Results for all parameters have remained stable for all bores except for Lead which has fallen over the period in GW3. **Figure 5-22** indicates that results remain within historic ranges.

The ground water level in GW11 was slightly lower than previous periods and the level of GW12 is stable. GW11 recorded elevated Cadmium, Manganese, Magnesium, Calcium, Total Alkalinity, Sodium, Chloride, Sulphate, TDS and EC in September and December of 2019 and in March and June of 2020. The same pattern occurred in June and September 2018 and is likely due to the tailings level in TSF2 reaching a point where a fault or crack in the pit wall has allowed water to escape. Concentrations are being monitored and levels are expected to return to normal as the fault or crack is sealed by tailings. **Figure 5-22** indicates results remain within historic ranges.

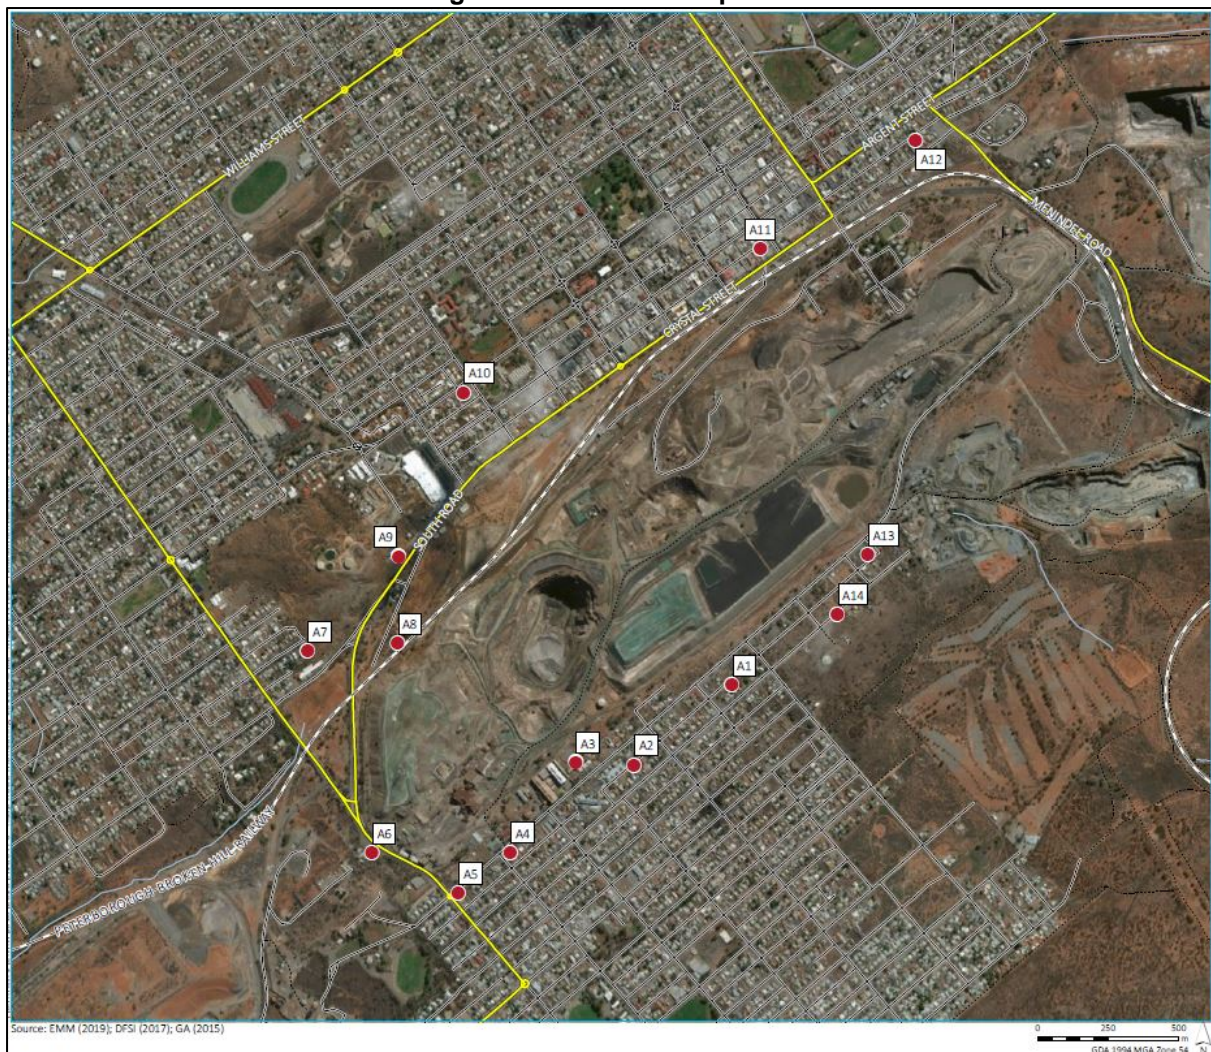
Figure 5-21 Noise Receptors

A total of 28 operator-attended noise measurements were completed, including two measurements at each of the 14 monitoring locations. For 2 out of the 28 samples the wind speed was below 3 m/s and therefore the noise limits did apply for these samples according to the site's EPL. Site noise was inaudible during 21 of 28 measurements. Noise monitoring results are shown in **Table 5-24**.
