Playground Impact Test and Surface Stability Report

Brea Mall Playground Plans

Brea Mall Playground

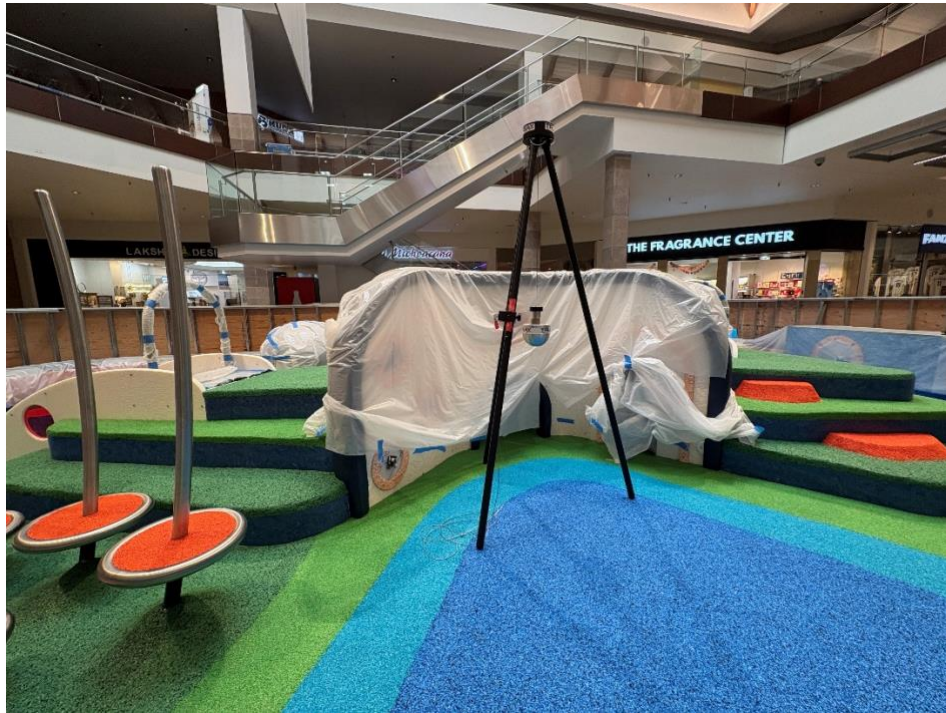
Photo 8433

Drop Location #1 Near North Portholes

The results are within ASTM 1292-17a criteria for drops from the height of [REDACTED]

Comments: None

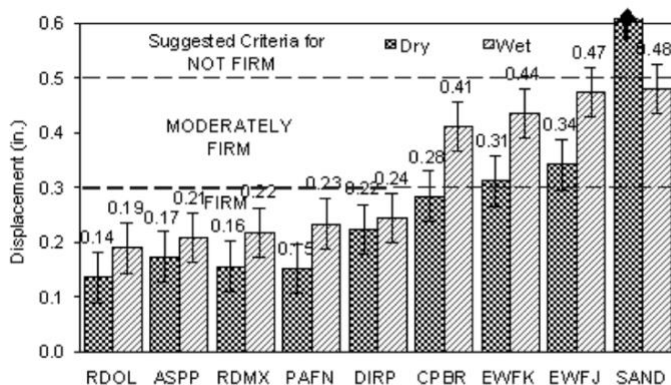
Figure 6. Rotational Penetrometer Firmness Measurements for Dry and Wet Surfaces

- **Firm Surface** - Less than or equal to 0.3 inch of displacement.
- **Moderately Firm Surface** - Greater than 0.3 inch, and less than or equal to 0.5 inch of displacement.
- **Not Firm Surface** - Greater than 0.5 inch of displacement.

Playground Surfaces that are firm to moderately firm are compliant.

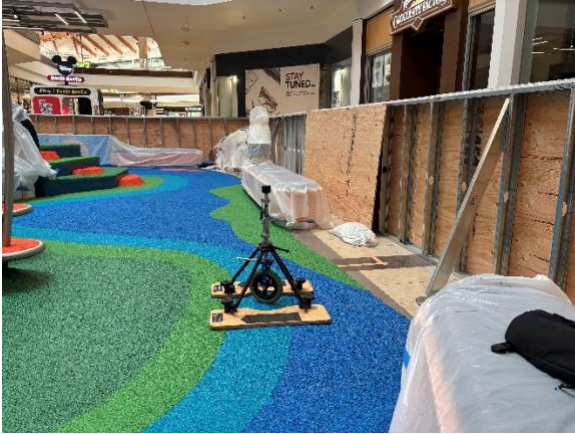
Photo 8420

Test Location	Trial #	1	2	3	4	5	6	7	AVERAGE	PHOTO
R1	FIRMNESS	0.399	0.351	0.362	0.345	0.352	0.348	0.347	0.352	8420
	STABILITY	0.407	0.381	0.383	0.369	0.372	0.364	0.372	0.375	
R2	FIRMNESS	0.478	0.439	0.422	0.649	0.417	0.438	0.399	0.439	8422
	STABILITY	0.500	0.450	0.438	0.658	0.435	0.458	0.428	0.456	
R3	FIRMNESS	0.475	0.420	0.400	0.416	0.396	0.417	0.393	0.410	8424
	STABILITY	0.502	0.440	0.413	0.420	0.405	0.418	0.401	0.419	
R4	FIRMNESS	0.386	0.370	0.360	0.363	0.364	0.354	0.361	0.364	8426
	STABILITY	0.416	0.394	0.387	0.386	0.389	0.386	0.383	0.388	
R5	FIRMNESS	0.336	0.319	0.315	0.323	0.313	0.310	0.315	0.317	8428
	STABILITY	0.349	0.328	0.337	0.329	0.319	0.316	0.314	0.326	
R6	FIRMNESS	0.414	0.485	0.394	0.349	0.430	0.346	0.341	0.387	8430
	STABILITY	0.429	0.487	0.408	0.367	0.352	0.366	0.349	0.384	
R7	FIRMNESS	0.351	0.366	0.359	0.345	0.366	0.354	0.345	0.355	8432
	STABILITY	0.378	0.379	0.379	0.362	0.373	0.374	0.360	0.373
