CASE STUDY

Engine Overheating - updated 08 July 2020 from original of August 2018

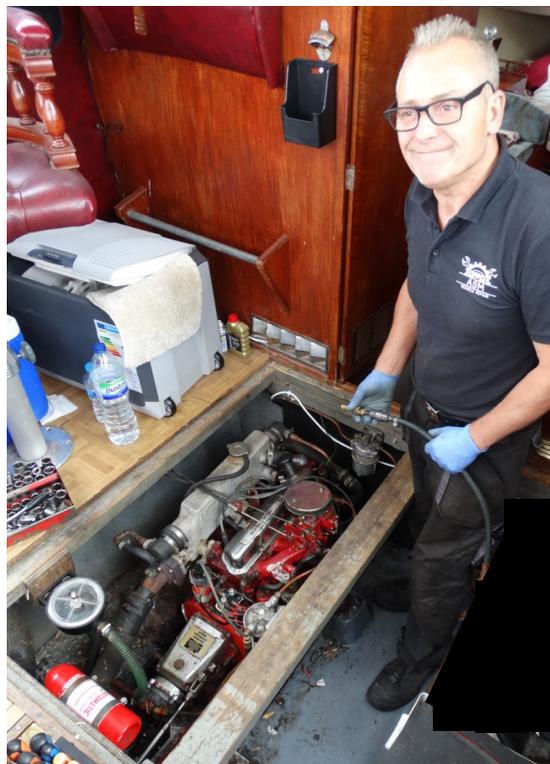
Tony arrived and suggested that he first blow-out the cooling system with a high pressure airline. He connected his line to the onboard compressor in his van and proceeded to move logically through the system. ⇒

He disconnected each removable pipe as he went around the block and heat exchanger and blasted out all the cr**. A lot came out! He also removed and discarded the thermostat!

After re-connecting all the hoses and pipes and securing the circlips, he filled the heat exchanger with coolant and started the engine.

After a run of over two hours the temperature gauge had not moved over the 70° it had been running at for the last 26 years! Also, the heat exchanger required very little topping-up.
