CASE STUDY

Gas water heater installation

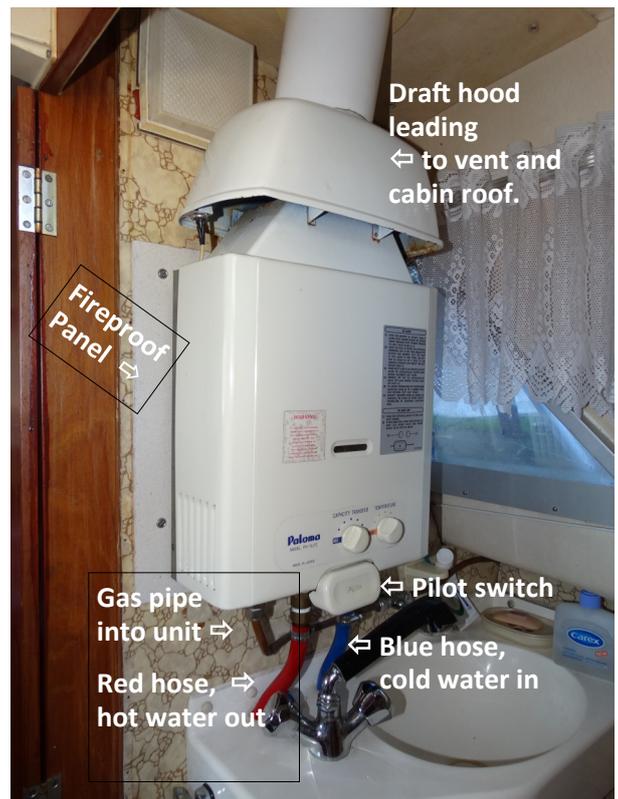
First he fitted a fireproof panel where the heater was to be fixed and then fitted the Palomo to this.

A vent had to be installed from the hood to a hole in the cabin roof. A vent was fitted and sealed on the roof. Adequate incoming ventilation was also a requirement. A vent in the door and one out through the double skinned wall ensured this provided adequate ventilation.

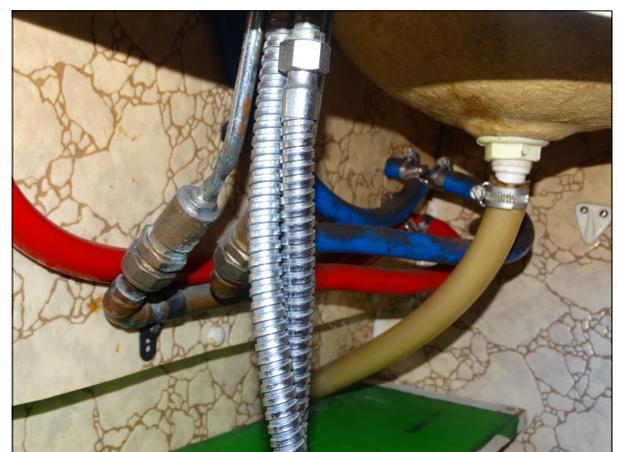
The picture on the right show the pipes and hoses under the sink in the toilet. You will note the reduction in the copper piping leading to the original taps.

Similarly, the water pipes were brought into and from the heater using a mix of flexible hoses and copper piping. Direct to the heater to the hose is blue and the red feeds to the sink/shower head and to the sink in the galley.
