# State Route 377

## Road Safety Assessment

from SR277 to SR77

October 2022

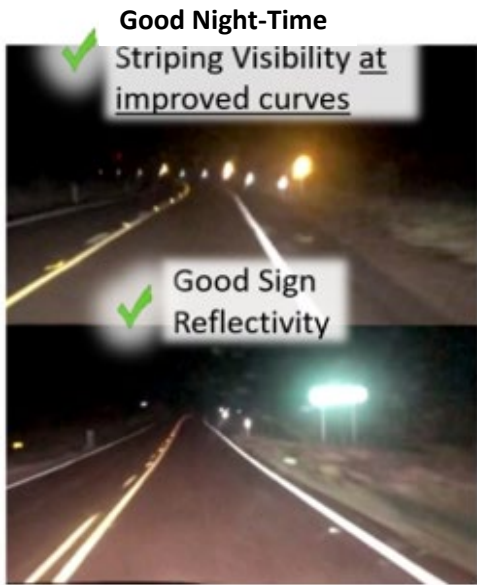
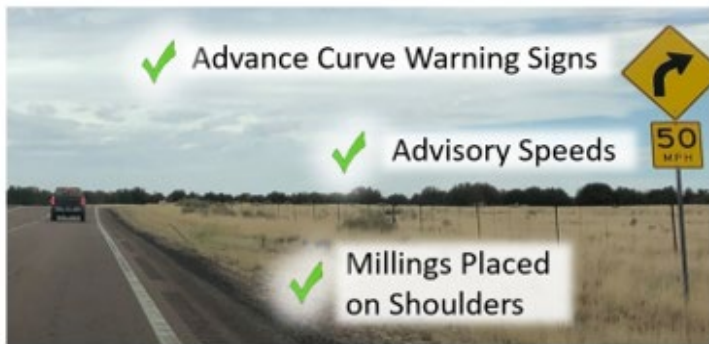
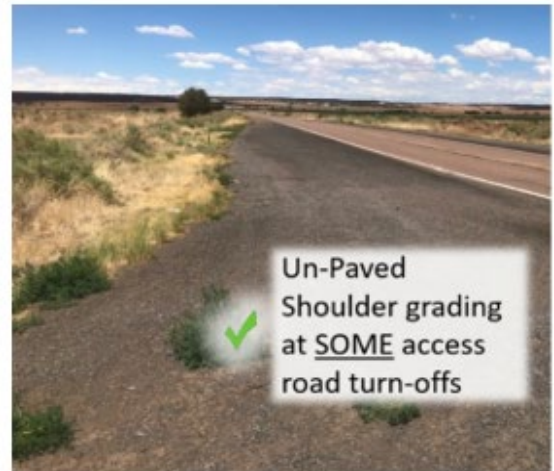
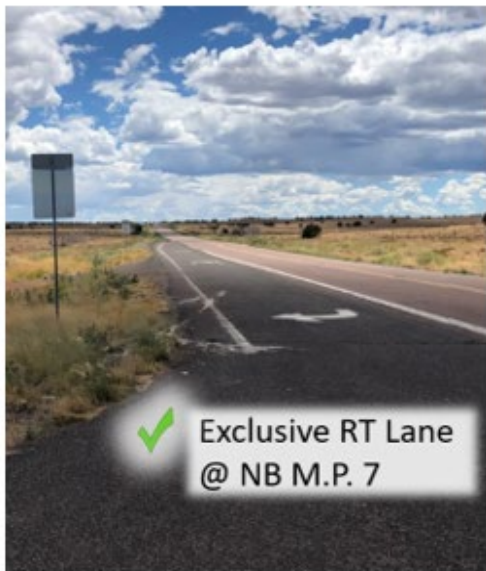
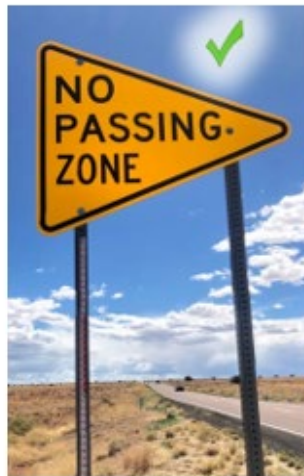
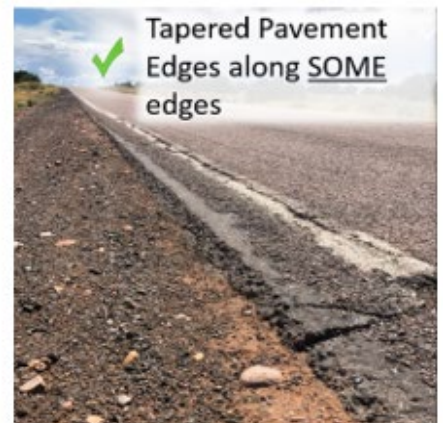
Figure 5 – Good Practices

- Significant lengths of the corridor have tapered edge of pavement, minimizing edge drop off
- Millings placed on shoulders provide benefit vs untreated

- Adequate un-paved shoulder at Despain Ranch Road and SB Zineff Road for turning vehicles to decelerate
- Exclusive northbound right-turn lane at access road at M.P. 7

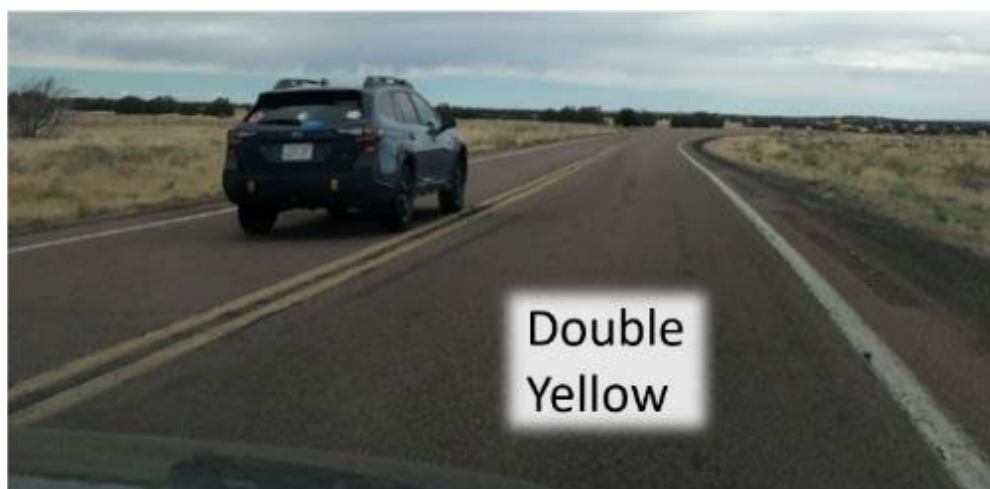
**Figure 8 – Passing in No-Passing Zone**

- Drivers were willing to pass in no passing zones even without platooning and lead car traveling at the posted speed limit, as shown in **Figure 8**. While the decision may be a demonstration of impatience, the action will only occur because the overtaking driver feels comfortable making the overtaking maneuver. However, these actions also have the potential to lead to mistakes, both by the overtaking driver and in the responses of other road users. For example, while the pass may be successful, the overtaking driver may not appreciate the limited sight distance that warrants the no passing zone, which can lead to the need for an aggressing maneuver to return to the lane after the pass or an evasive steer away maneuver by the approaching driver, either of which can lead to a runoff road event and single vehicle crash.

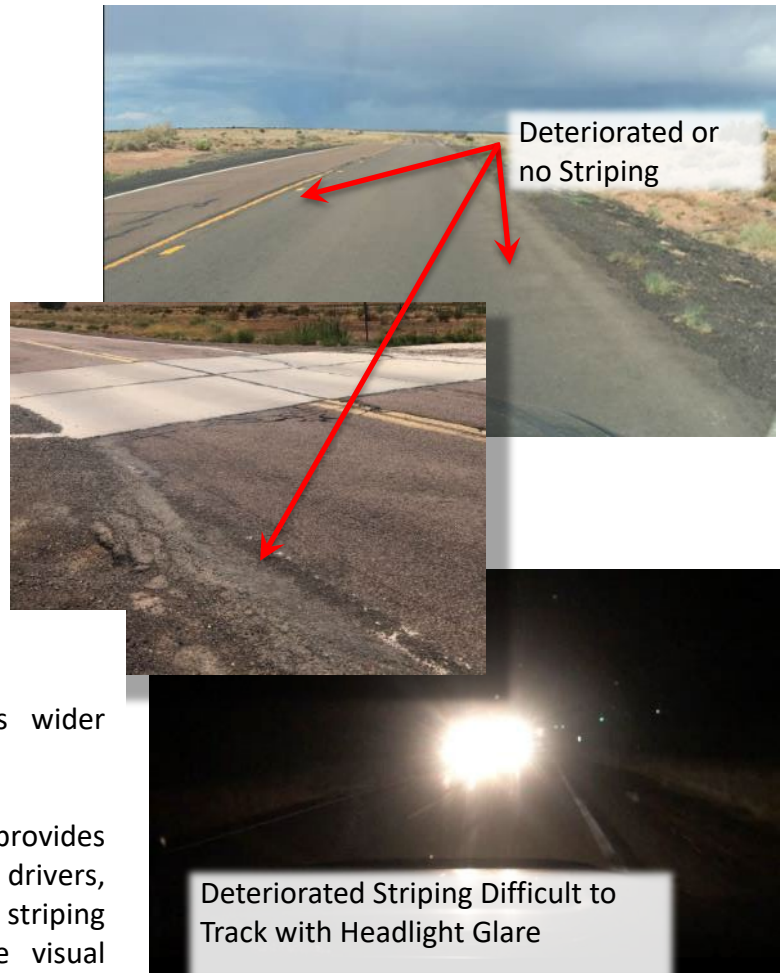
**Figure 9 – Pavement Marking Issues**

- Striping NOT along recent curve improvements is generally deteriorated, and in some places missing.
- Deteriorated striping is difficult to see at night and can contribute to losing track of lane with glare from opposing vehicles' headlights.

- Refresh striping with retro-reflective pavement markings.
- Install centerline rumble strips.
- Install edge line rumble strips (requires wider shoulder).
- Human factors considerations: Striping provides feedforward guidance for steering inputs by drivers, especially during nighttime hours. A lack of striping or poor retro reflectivity will affect the visual guidance available to drivers, especially in conditions where they may be seeking assistance.
- Estimated Cost: \$913,000 (See **Appendix C**).

- Striping on projects that are above 4,000' elevation is typically performed with dual part epoxy. The entire length of roadway should be re-striped to provide consistent appearance and lane delineation.
- Edge line and centerline rumble strips should be constructed as shown on ADOT Standard Drawing M-22 and detailed in the current ADOT Traffic Engineering Guidelines and Processes.

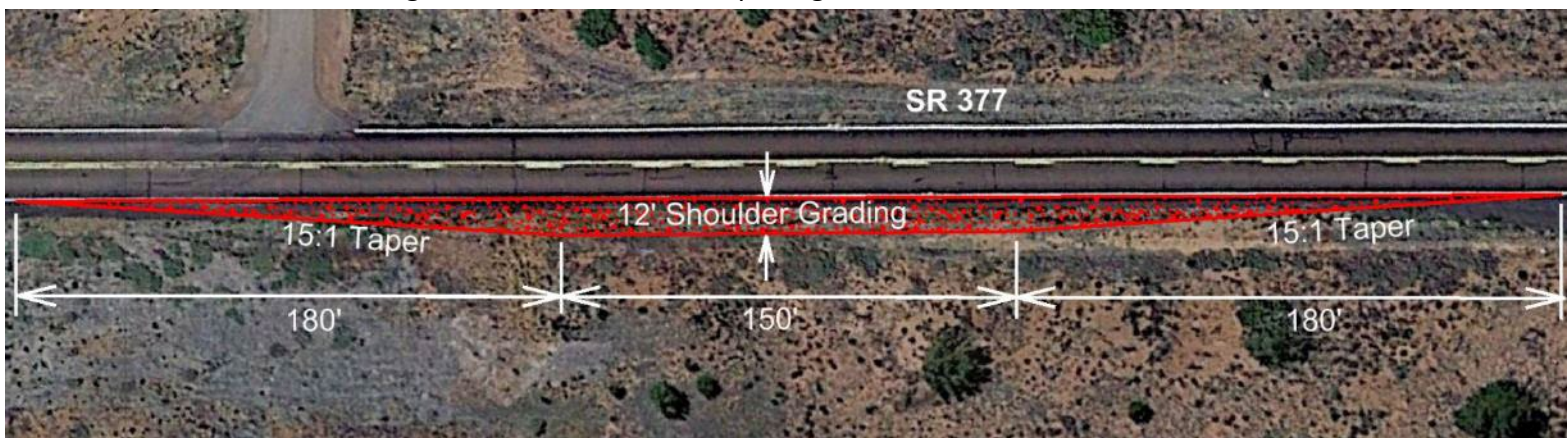
**Figure 11 – Conceptual Design for Emergency Pull-Offs**

- A schematic conceptual design for graded shoulder widening to serve as emergency pull-off is shown below. The cross slope of the pull out should match the cross slope of the adjacent pavement. Asphalt millings could be placed on top and compacted to stabilize the shoulder to make it more apparent to drivers. One improved shoulder pull out should be constructed per mile per travel direction and should be constructed at locations to best maximize existing conditions available for pulling off the road.

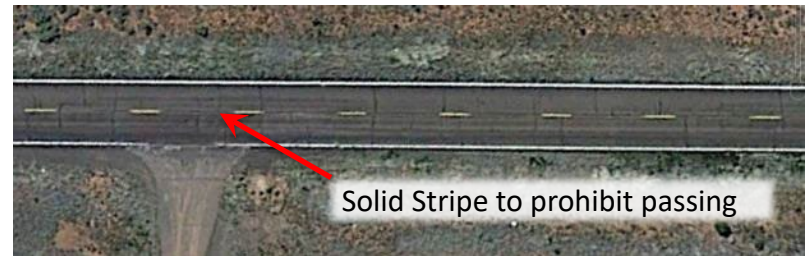
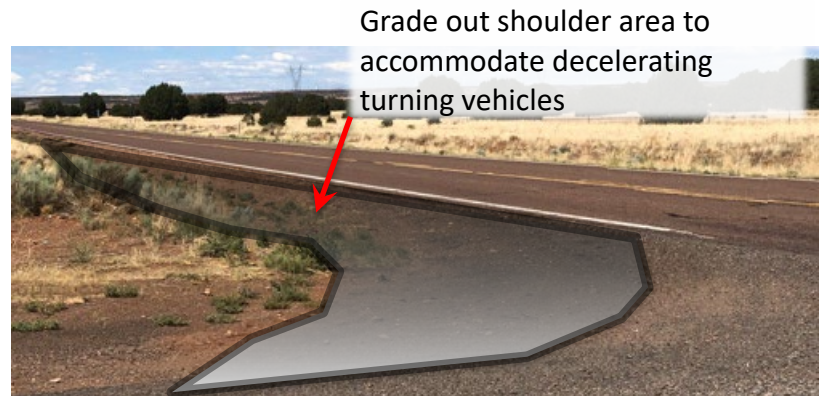
**Figure 12 – Recommendations at Access Roads**

- Multiple access roads intersecting SR 377 do not have shoulder widening or well graded unpaved shoulders to pull out of the travel way to decelerate.
- Access roads without solid yellow stripe to prohibit passing.

- Develop graded shoulder areas for more frequently used access roads (10 locations) for vehicle deceleration.
- Place solid yellow stripes in front of all access roads to prohibit passing.
- Place Advance Intersection Warning signs to warn of possibility of turning or entering traffic.
- Estimated Cost: \$123,300 (See **Appendix C**).

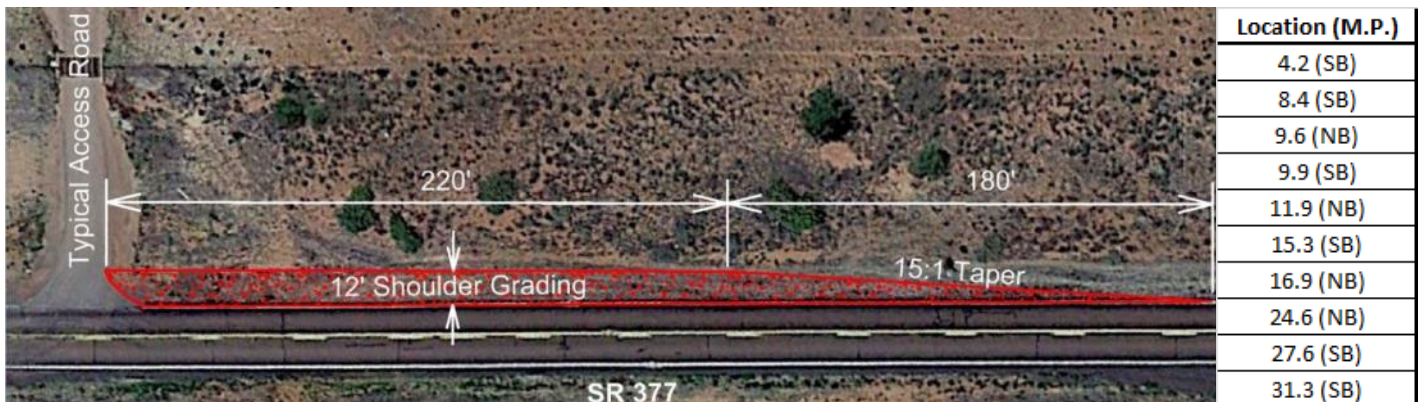
**Figure 13 – Conceptual Design for Graded Shoulder at Access Roads**

- A schematic conceptual design for graded shoulder widening to accommodate vehicles decelerating outside of the paved travel lane is shown below along with a table showing the locations where this treatment is recommended:

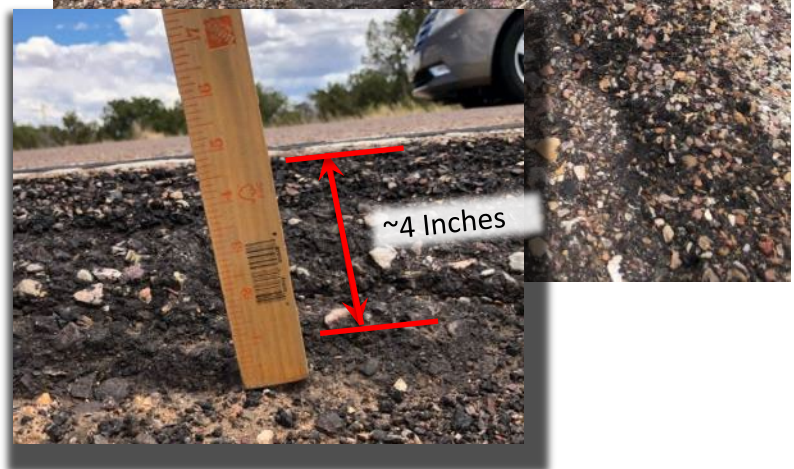
**Figure 14 – Pavement Edge Issues**

- Undesirable combination of the following:
  - Narrower (< 12 ft) lanes through the entire corridor.
  - Higher heavy vehicle percentage (14%).
  - Minimal edge of pavement beyond edge stripe.
  - Edge of pavement elevation drop offs over 3", difficulty maintaining soil or millings at edge.
  - Driver shy distance pushes wheel path near edge.
  - Crash reports indicate vehicles leaving edge of road and overcorrecting.

- Construct widened paved shoulders with safety edge.
  - Widened shoulders will allow edge line rumble strips.
  - "Shoulder Drop Off", "Low Shoulder", "No Shoulders" Warning signs as interim condition at appropriate locations.
- Estimated Cost: \$47 Million (See Appendix C).

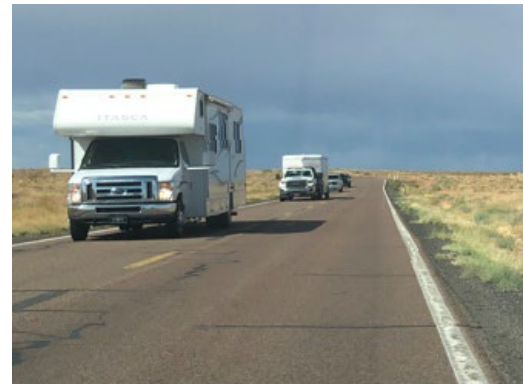
**Figure 16 – Passing Related Issues**

- Human factors
  - Willingness to pass at no passing zones.
  - Impatience behind platoons of vehicles.
- Higher heavy vehicle percentage (14%)
  - Heavy vehicles are more likely to be passed.
  - Heavy vehicles are more difficult to pass.
- Recent traffic growth
  - Large recent growths in volume.
  - Higher volumes will increase passing interactions.
- Evaluation of Crash Data
  - Majority of fatality crashes are head-on.
  - Significant number of opposing side swipe crashes.
  - Many non-fatal crashes relating to passing could have been fatal.

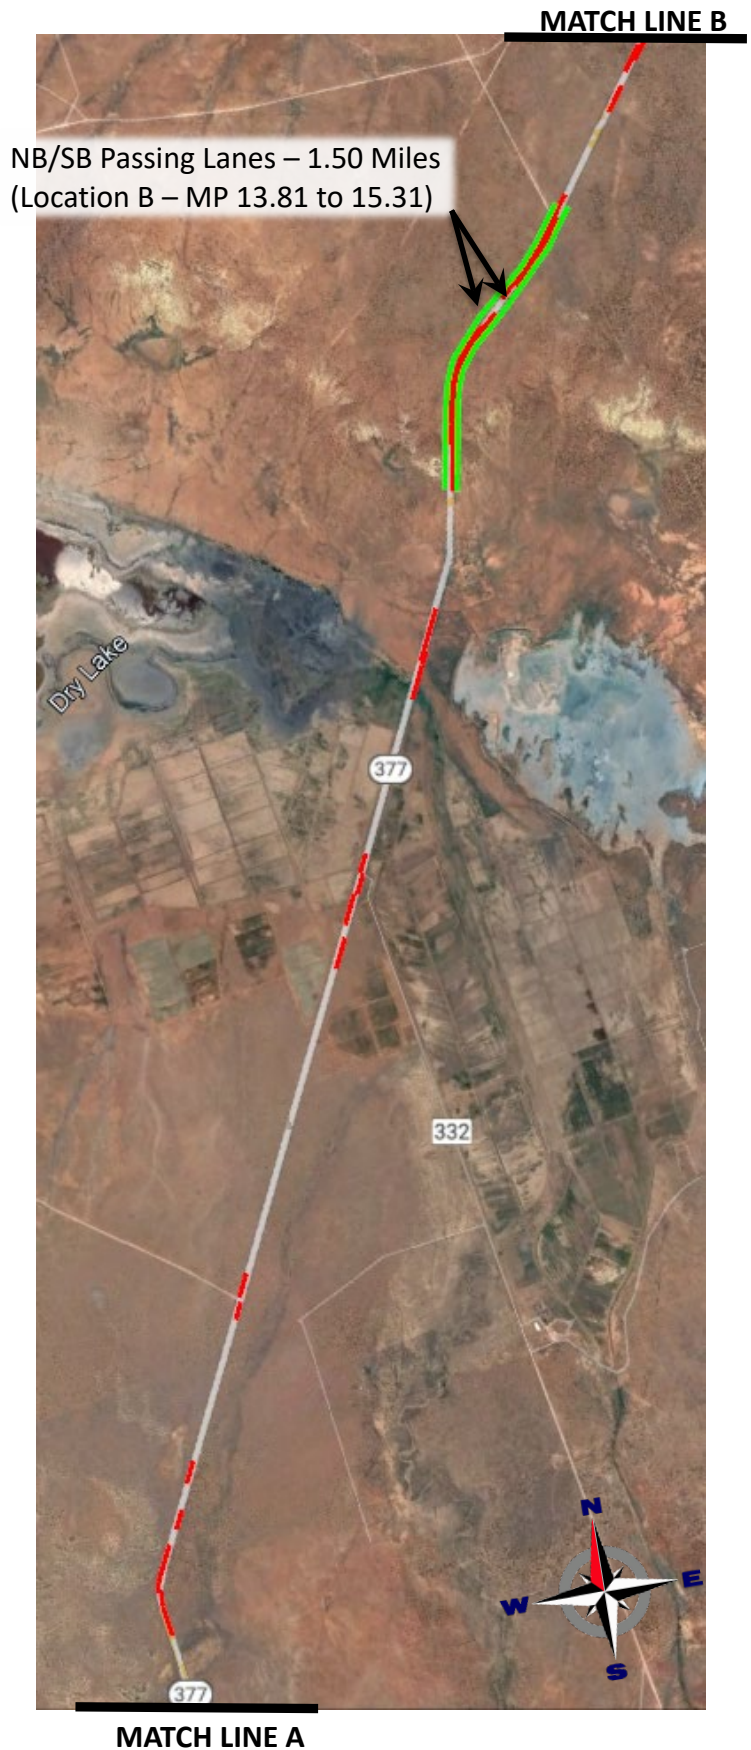
**Figure 17 – Existing/Proposed Passing Zones**

- Using the criteria above, preliminary locations for recommended 1.50 mile long passing lanes were chosen to provide passing opportunities at existing no passing zones. Generally, these locations were selected on segments that would avoid conflict with existing access roads and would not fall on long segments of straight roadway where passing is easier.

- Passing lane recommendations include an 8’ wide adjacent shoulder, additional widening to include widening the existing narrow travel lanes to 12’ wide, matching the new 12’ wide passing lane width.

- The recommended passing lane locations assumes that NB and SB passing lanes are constructed adjacent to each other to minimize conflicts with access roads, however final locations should be evaluated further in a scoping report and preliminary design to consider existing roadway features and design configurations to accommodate constraints.
