SAUK\_SOLAR\_POC

# Solar Thermography Pro Report

Generated for  
LIDAR Drone Services

Generated on  
Jun 06, 2025

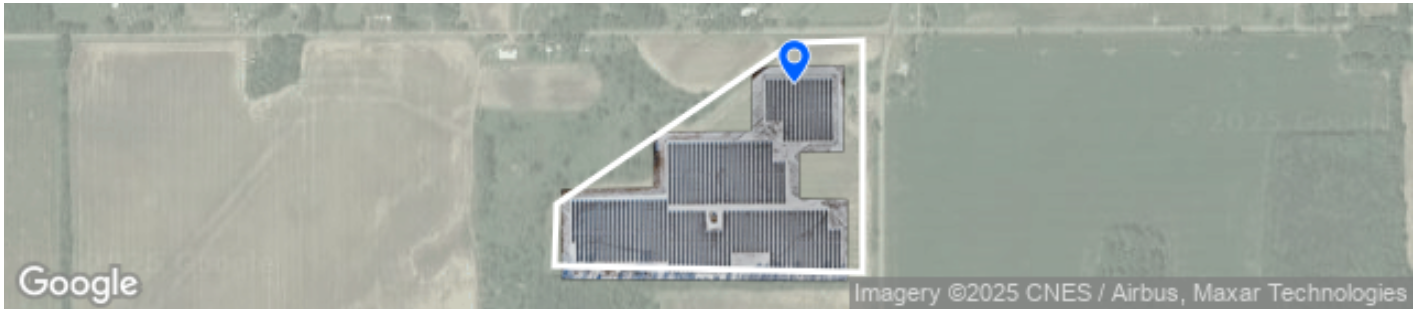
## #9 - Thermal Anomalies #1124 Ticket

ID	9	Status	To Do
Created By	Ryan Pierce	Anomaly Type	Single bypassed
Anomaly Cause	Physical internal	Remedial Action	Quick Fix
Longitude	-85.0820635 °	Latitude	42.0720358 °
Zone	north region

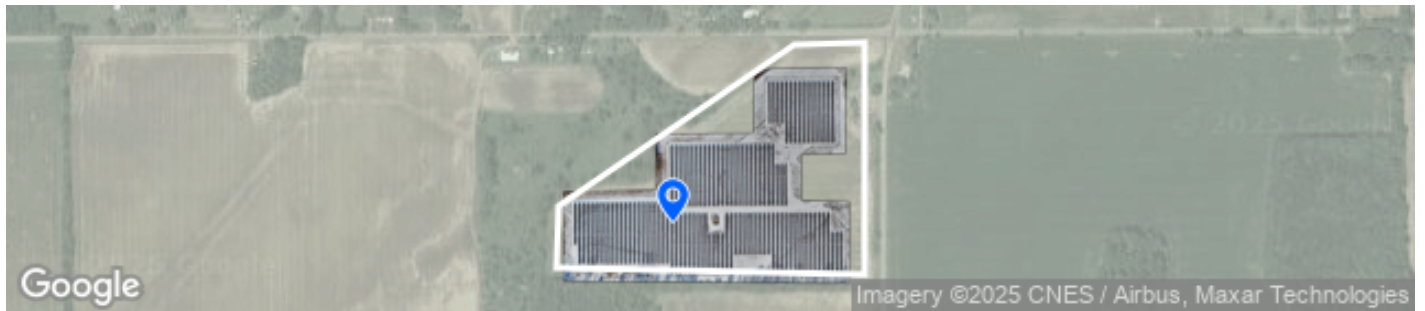
## #22 - Thermal Anomalies #1149 Ticket

ID	22	Status	To Do
Created By	Ryan Pierce	Assignee	Marcus Adams
Anomaly Type	Single bypassed	Anomaly Cause	Physical internal
Remedial Action	Quick Fix	Longitude	-85.0844593 °
Latitude	42.0700873 °	Zone	south region

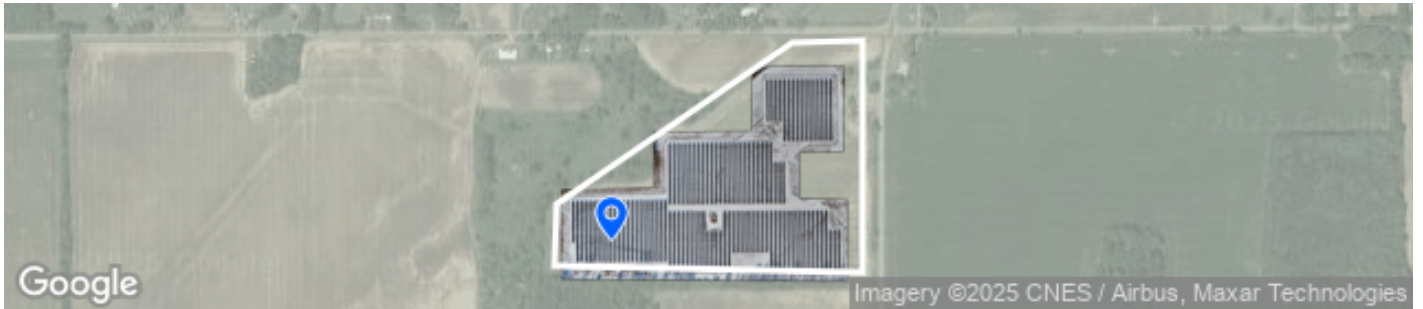
## #24 - Thermal Anomalies #1159 Ticket

ID	24	Status	To Do
Created By	Ryan Pierce	Assignee	Marcus Adams
Anomaly Type	Single bypassed	Anomaly Cause	Physical internal
Remedial Action	Quick Fix	Longitude	-85.0856052 °
Latitude	42.0697734 °	Zone	south region

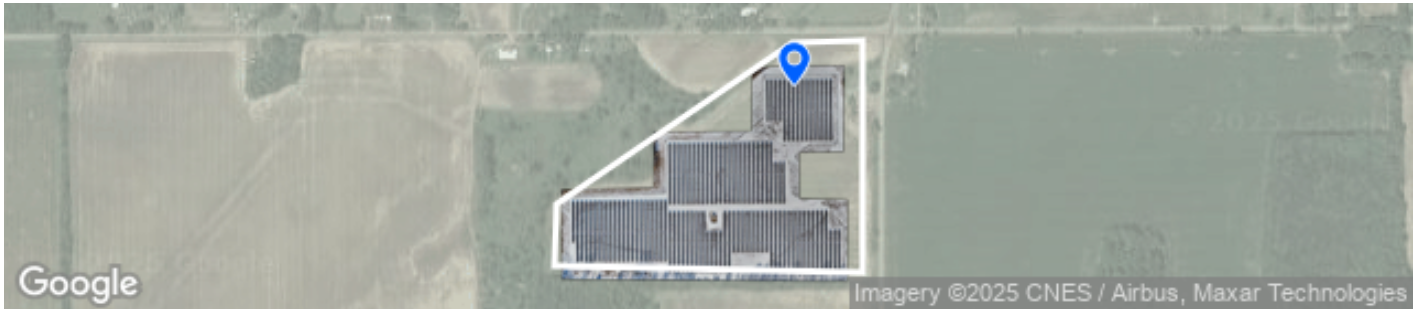
## #25 - Thermal Anomalies #1125 Ticket

ID	25	Status	To Do
Created By	Ryan Pierce	Anomaly Type	Single bypassed
Anomaly Cause	Physical internal	Remedial Action	Quick Fix
Longitude	-85.0820635 °	Latitude	42.0720153 °
Zone	north region

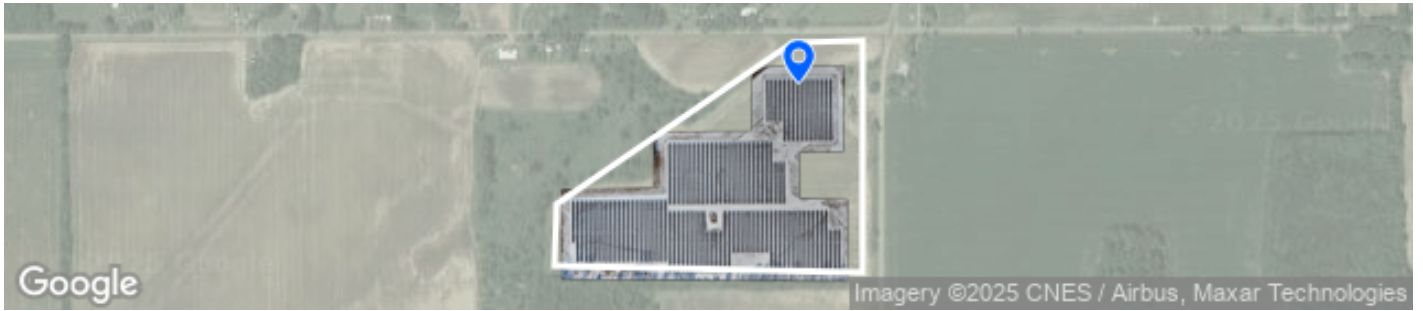
## #26 - Thermal Anomalies #1126 Ticket

ID	26	Status	To Do
Created By	Ryan Pierce	Anomaly Type	Double bypassed
Anomaly Cause	Physical internal	Remedial Action	Quick Fix
Longitude	-85.0819815 °	Latitude	42.072037 °
Zone	north region

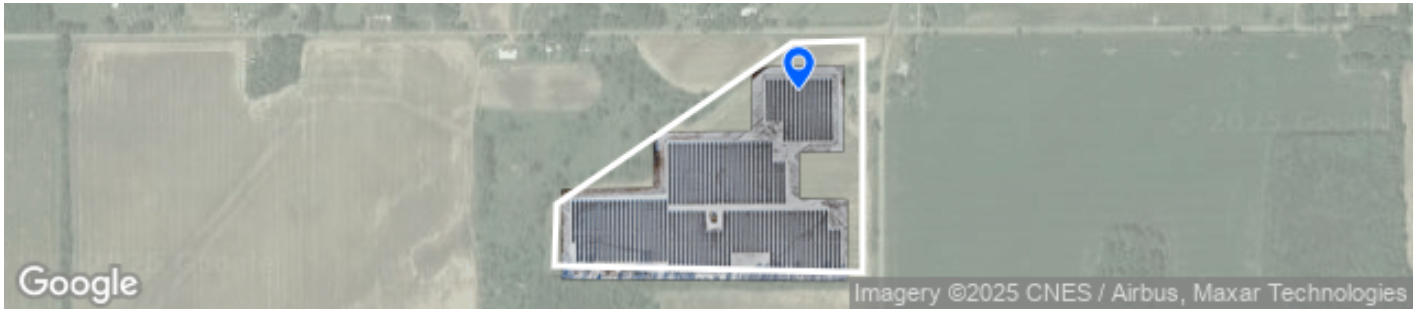
## #28 - Thermal Anomalies #1128 Ticket

ID	28	Status	To Do
Created By	Ryan Pierce	Anomaly Type	Single bypassed
Anomaly Cause	Physical internal	Remedial Action	Quick Fix
Longitude	-85.0819804 °	Latitude	42.0719521 °
Zone	north region

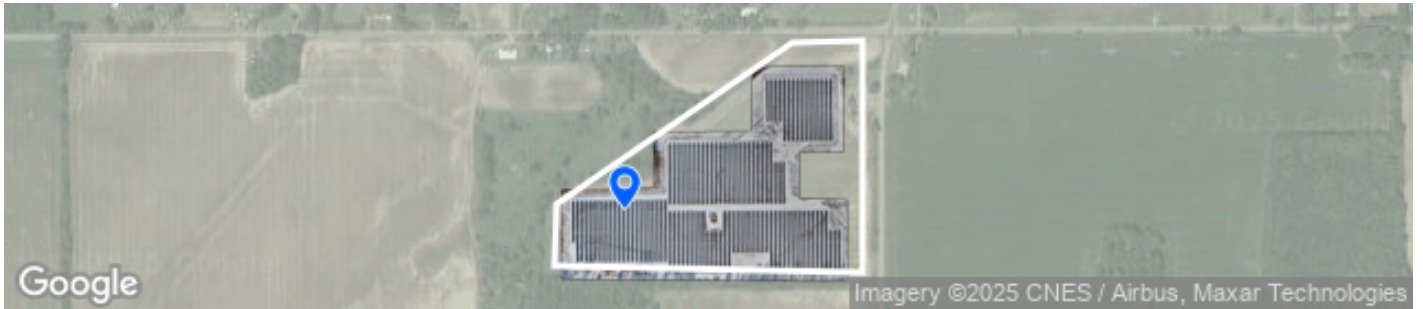
## #42 - Thermal Anomalies #1157 Ticket

ID	42	Status	To Do
Created By	Ryan Pierce	Assignee	Marcus Adams
Anomaly Type	Single bypassed	Anomaly Cause	Physical internal
Remedial Action	Quick Fix	Longitude	-85.0853652 °
Latitude	42.0702357 °	Zone	south region
