# Home Inspection Report

12345 Sample Street  
Wichita, KS 67202

Prepared For: Sample Client

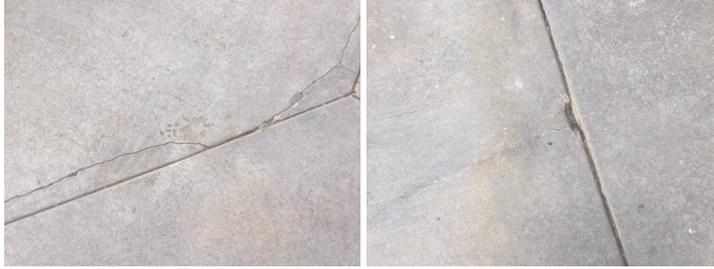
Driveway: Concrete - **Minor cracks due to settling on driveway. Recommend further monitoring or evaluation by licensed contractor.**

1. Driveway: Concrete - **Minor cracks due to settling on driveway. Recommend further monitoring or evaluation by licensed contractor.**

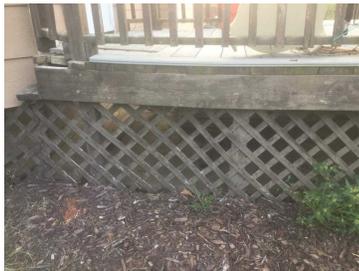
Deck: Treated wood - **Loose handrails and balusters on deck. The main rafters have a slight sag. Recommend repair or replacement on hand rails. Recommend further monitoring or evaluation by licensed contractor on deck frame.**

2. Deck: Treated wood - **Loose handrails and balusters on deck. The main rafters have a slight sag. Recommend repair or replacement on hand rails. Recommend further monitoring or evaluation by licensed contractor on deck frame.**

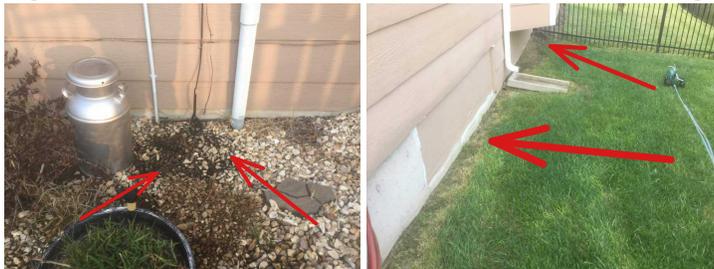
Grading: Minor slope - **Grading has negative slope and water is pooling against the foundation. Recommend adding fill dirt to fix grading issues.**

1. Grading: Minor slope - Grading has negative slope and water is pooling against the foundation. Recommend adding fill dirt to fix grading issues.

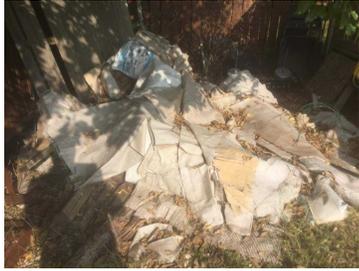
Fences: Wrought iron - **Trash build up next to fence. Recommend removing to prevent termites.**

3. Fences: Wrought iron - **Trash build up next to fence. Recommend removing to prevent termites.**

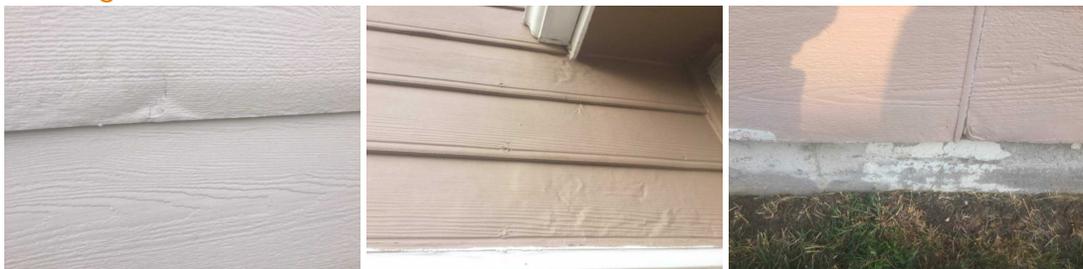
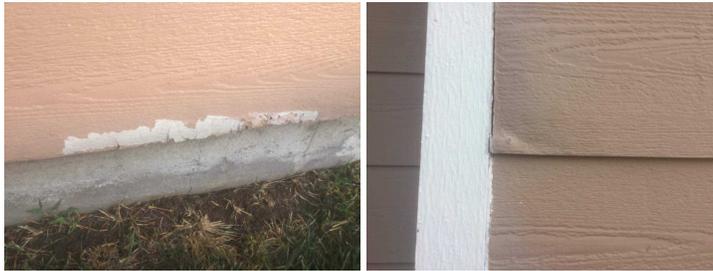
Type: Brick veneer, Wood - **Moisture stains, rot noted, and deterioration at the bottom of siding. Recommend further repair or replacement by licensed contractor as this can lead to additional water intrusion and damage.**

4. Main Exterior Surface Type: Brick veneer, Wood - Moisture stains, rot noted, and deterioration at the bottom of siding. Recommend further repair or replacement by licensed contractor as this can lead to additional water intrusion and damage.

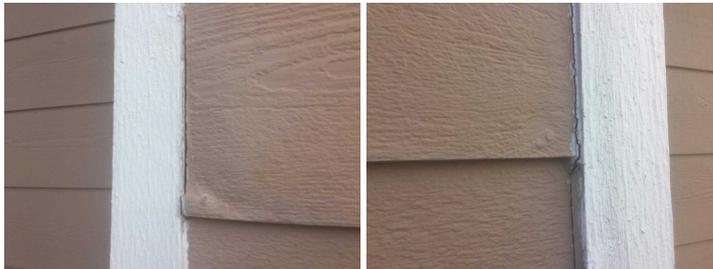
Trim: Wood - Spacing was noted at trim where it meets the siding. The creates a gap for water to enter and cause additional damage. Recommend re-caulking and painting to provide a better seal.

2. Trim: Wood - Spacing was noted at trim where it meets the siding. This creates a gap for water to enter and cause additional damage. Recommend re-caulking and painting to provide a better seal.

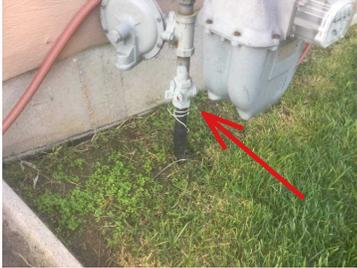
15. Acceptable Main Gas Shut Off Valve: Located at gas meter

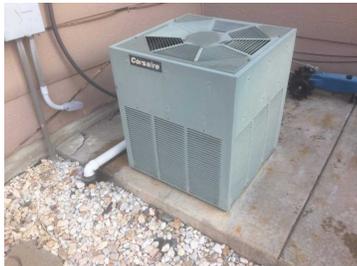
- 1. Acceptable      A/C System Operation: Functional
- 2. Acceptable      Condensate Removal: Plastic tubing
- 3. Acceptable      Exterior Unit: Pad mounted

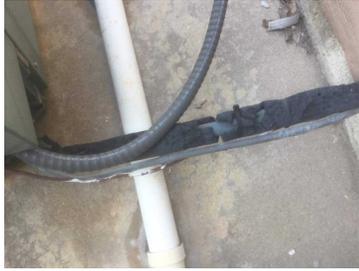
Refrigerant Lines: Serviceable condition - Torn insulation, A qualified air conditioning contractor is recommended to evaluate and estimate repairs.

5. Main AC System Refrigerant Lines: Serviceable condition - Torn insulation, A qualified air conditioning contractor is recommended to evaluate and estimate repairs.

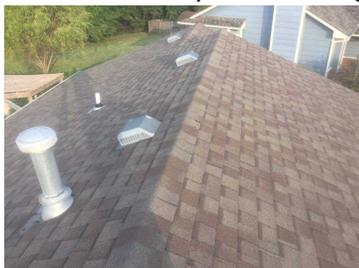
2. Acceptable Material: Asphalt shingle

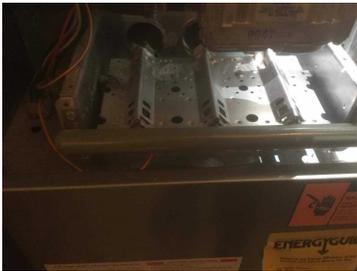
3. Model Number: RGDJ-07EAUER Serial Number: EB5D302F030001284
4. Type: Boiler system Capacity: Unknown
5. Area Served: Whole building Approximate Age: 30 years
6. Fuel Type: Natural gas
7. Acceptable Heat Exchanger: 3 Burner

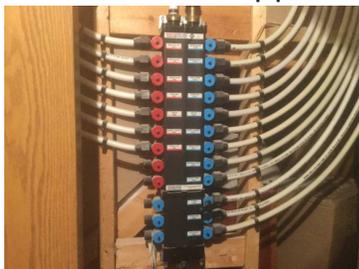
- 3. Acceptable Water Lines: Copper, PEX

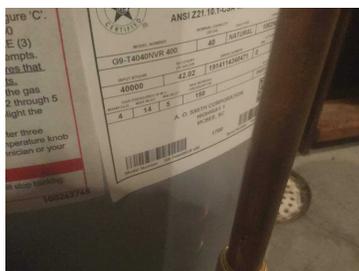
- 8. Acceptable     Water Heater Operation: Adequate
- 9. Manufacturer: A.O. Smith

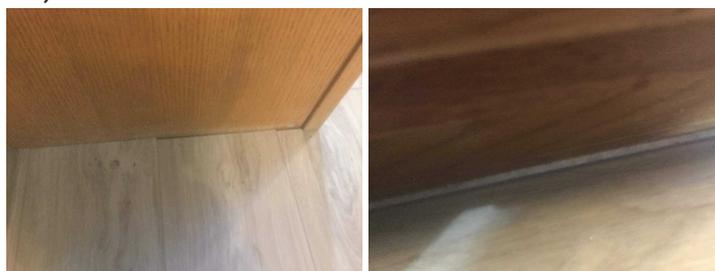
1. Acceptable     Cooking Appliances: Whirlpool
2. Acceptable     Ventilator: Whirlpool
3. Acceptable     Disposal: Badger
4. Acceptable     Dishwasher: Frigidaire
5. Air Gap Present? Yes
6. Acceptable     Refrigerator: Samsung
7. Acceptable     Microwave: Whirlpool
8. Acceptable     Sink: Stainless Steel
9. Acceptable     Electrical: 110 VAC GFCI
10. Acceptable    Plumbing/Fixtures: PVC
11. Acceptable    Counter Tops: Formica
12. Acceptable    Cabinets: Wood
13. Acceptable    Ceiling: Texture paint
14. Acceptable    Walls: Paint and tile
15. Marginal      Floor: Hardwood - Gaps present where floor meets cabinets and may allow for water damage in the event of a leak/spill. Recommend repair or replacement by licensed contractor.

6. 1st Floor Kitchen Floor: Hardwood - Gaps present where floor meets cabinets and may allow for water damage in the event of a leak/spill. Recommend repair or replacement by licensed contractor.

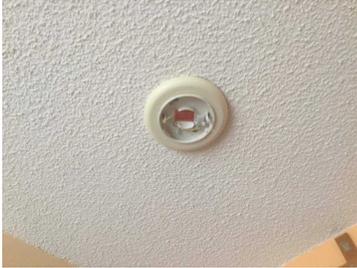
9. Not Present    Smoke Detector: **Although hard wired, smoked detector is missing.**

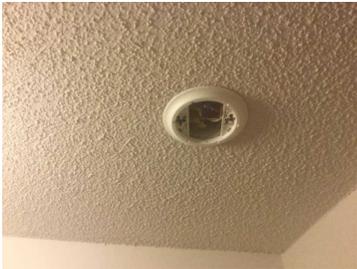
10. Acceptable    Closet: Single  
11. Acceptable    Ceiling: Texture paint  
12. Acceptable    Walls: Paint  
13. Acceptable    Floor: Carpet  
14. Acceptable    Doors: Wood  
15. Acceptable    Windows: Vinyl slider  
16. Acceptable    Electrical: 110 VAC  
17. Acceptable    HVAC Source: Heating system register  
18. Not Present    Smoke Detector:

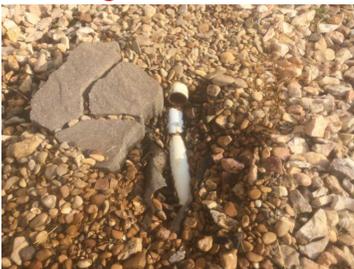
3. Main Basement Sump Pump: Submerged - Pipe leaving house from sump pump is broken at the ground. Recommend repair or replacement by licensed plumber.
