RE: Woodard & Curran Report - Good Harbor Creek

MEMORANDUM

DATE: December 22, 2022

This Bacterial Source Investigation Summary Memorandum describes the results of drainage and sanitary sewer infrastructure investigations conducted proximal to Good Harbor Creek and surface water sampling events conducted within Good Harbor Creek. The purpose of these investigations was to evaluate the potential source(s) of elevated bacteria concentrations previously detected in surface waters collected from Good Harbor Creek that caused sporadic closures of Good Harbor Beach and/or Good Harbor Creek to recreational activities during the 2021 and 2022 recreational seasons.

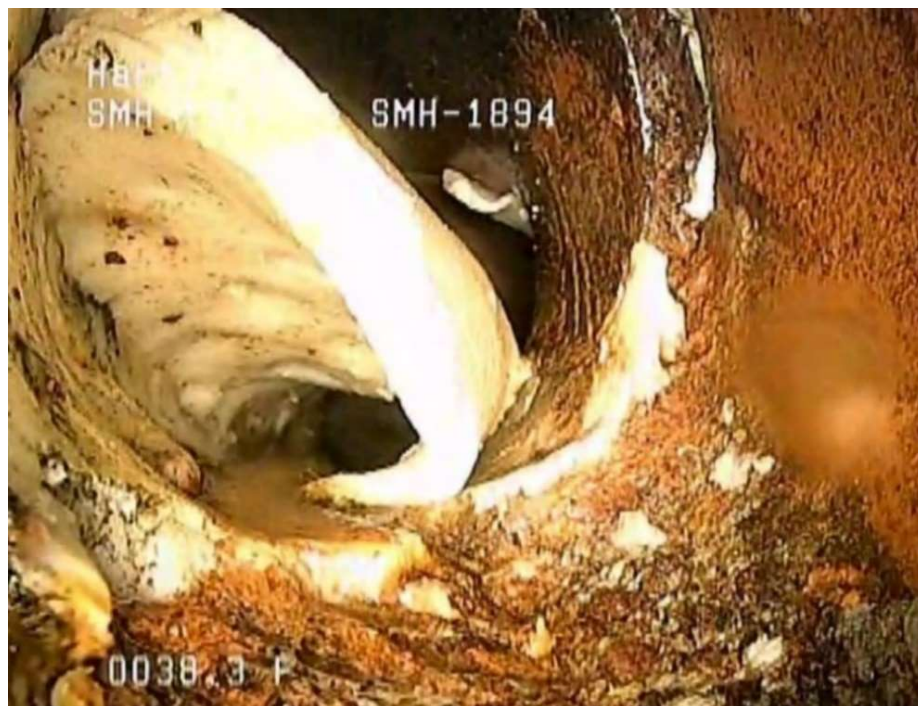
Beginning at SMH-1985, it was observed that the 8-inch pipe had a Cured-in-Place-Pipe (CIPP) installed and original pipe material was unknown. Four sewer service connections were observed in the pipe segment downstream, which all showed evidence of infiltration. Additionally, heavy grease deposits were observed along the top of the main sewer pipe and sewer services, which is evidence of surcharging within the sewer main. Build-up of fats, oils, and greases (FOG) were observed at the top of the sewer main and service connections located approximately 38 and 46 linear feet downstream of SMH-1895, as shown in **Photograph 1** and **Photograph 2** below.

Photograph 1: Fats, oils, and greases observed 38 feet downstream of SMH_1895

- Perform additional CCTV investigations within the upstream contributing sewershed area contributing to the Hartz Street sewer main. Although it is currently unknown if the surcharging in the system is being caused fully or partially by the presence of FOG, it is critical to identify and eliminate sources of excessive FOG.

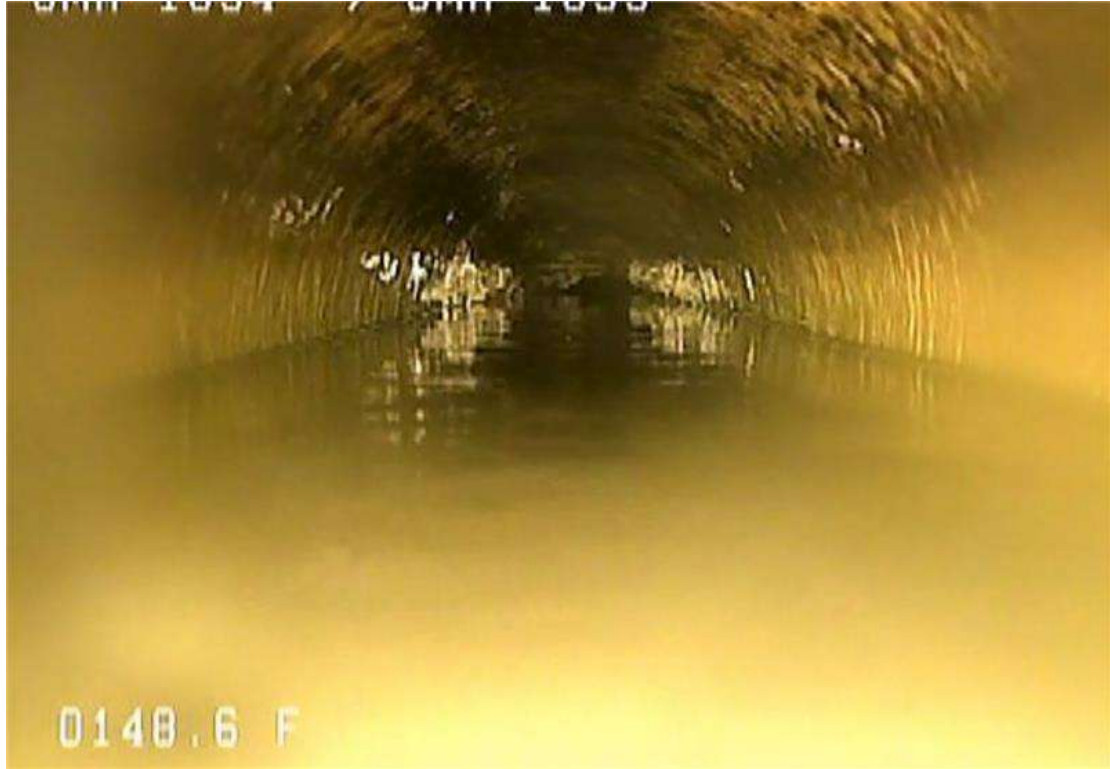
Evidence of infiltration drips were identified approximately 30 linear feet downstream of SMH_1894 and grease deposits were observed in several locations, extending to the downstream sewer manhole, SMH_1893. Beginning at approximately 60 linear feet downstream of SMH_1894, Next Level observed both major and minor sags in the sewer main, causing standing water and limiting the ability to fully inspect this portion of the pipe. A major sag located approximately 145 linear feet downstream of SMH_1894 is shown in **Photograph 3** below.

Photograph 3: Major pipe sag observed 145 linear feet downstream of SMH_1894

Based on the completed inspection of the 8-inch sewer main on Hartz Street from SMH_1895 to SMH_1892, we recommend the following rehabilitation and additional investigations to confirm the source of sanitary sewerage exfiltration, further investigate the source of FOG within the system and identify operational issues that could be causing surcharging:

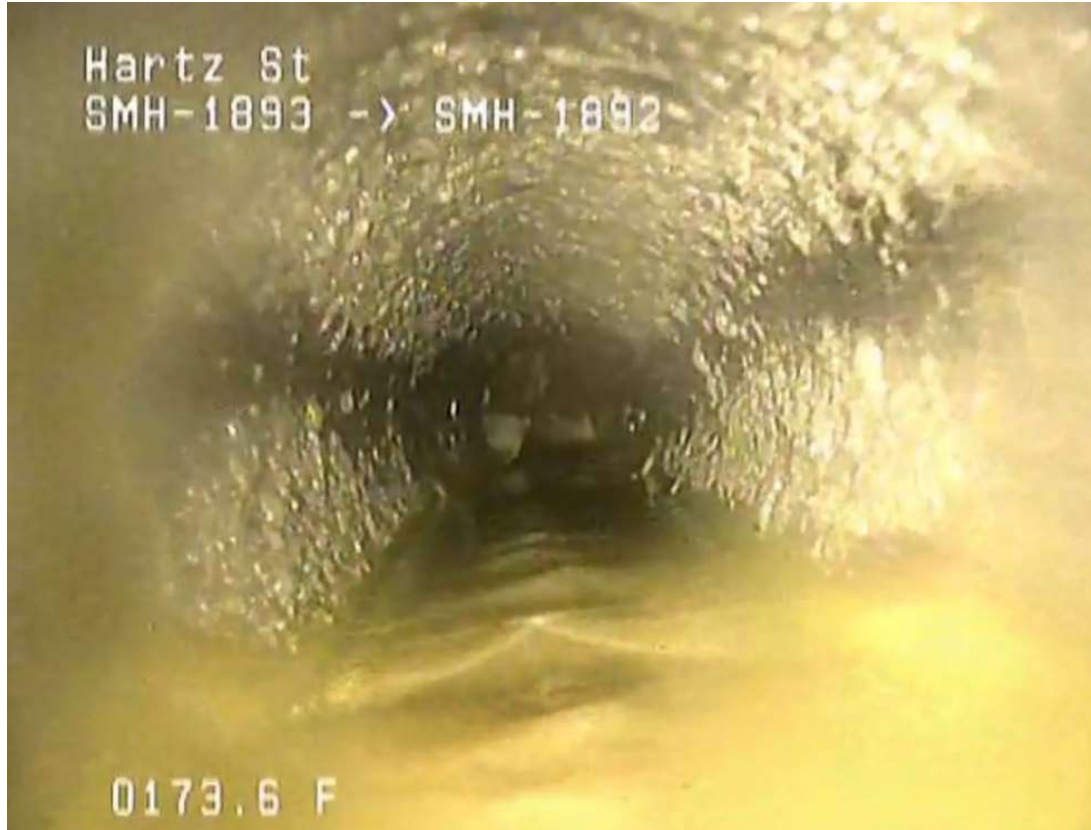
Next Level moved to the next downstream manhole, SMH_1893, to finish their inspection of this portion of the Hartz Street 8-inch sewer main. This pipe segment also had a CIPP liner installed. Infiltration staining approximately 78 linear feet downstream of SMH_1893 and grease deposits throughout the entire pipe segment were observed. Grease was observed at the top of the pipe in some locations, as shown in **Photograph 4** below, which is evidence of surcharging within the sewer main.

Photograph 4: Grease observed at the top of the pipe approximately 110 linear feet downstream of SMH_1893.

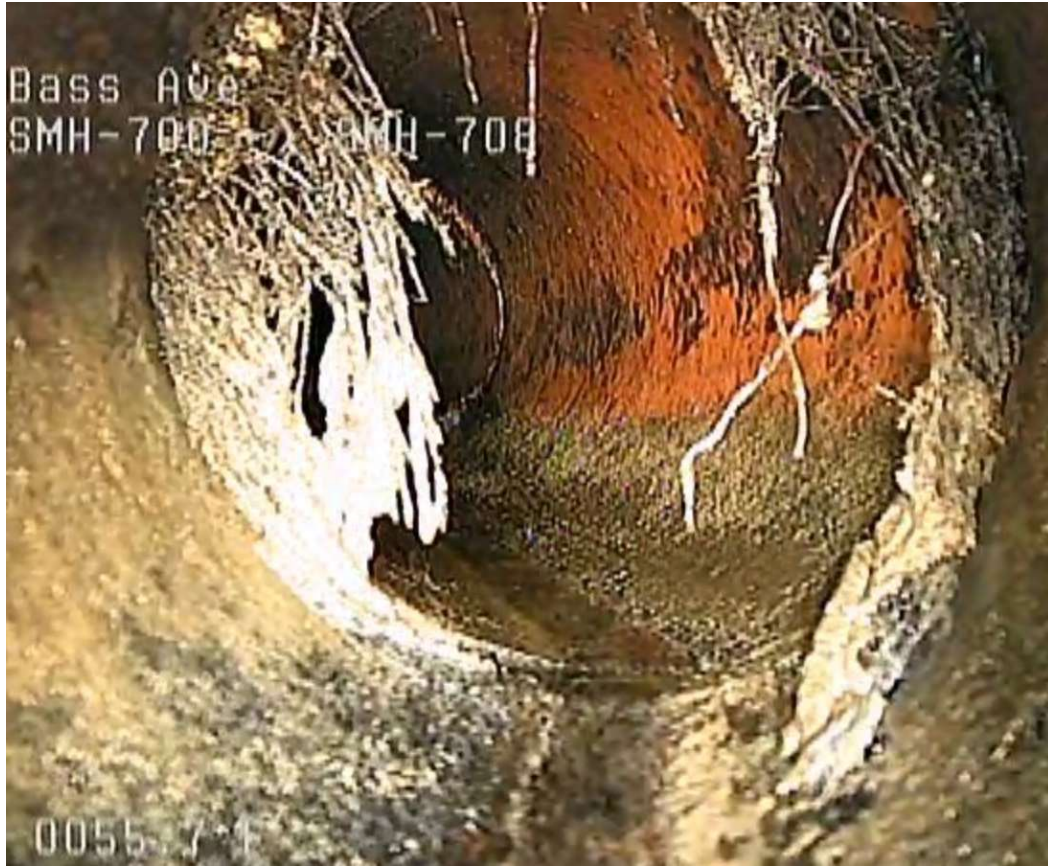
Next Level inspected a portion of the cross-country sanitary sewer line that runs from Neptune Place to Bass Ave to evaluate the potential of sewage exfiltration from defects in the pipe. Next Level were unable to access the full length of the pipe for inspections due to obstructions caused by wrinkling of the pipe's CIPP liner. Next Level observed two sewer services in the pipe segment downstream of sewer manhole SMH_700. Both sewer services were not sealed with grout, exhibited penetrations from tree roots, and showed evidence of infiltration. If infiltration is present at each of these locations, which are adjacent to Good Harbor Creek, it is likely that high flows and surcharging in the sewer main could cause exfiltration of sewage into the surrounding soils. **Photograph 5**, below, shows one of the sewer service connections.

Photograph 5: Sewer service located approximately 56 linear feet down stream of SMH_700

- Perform root removal and grouting of the sanitary service connections found to be in poor conditions. This will eliminate the possibility of sewerage exfiltration sources at the service connections.

- Once service connection rehabilitation is complete, utilize a lateral launching CCTV camera to perform inspection the sanitary service laterals on the Neptune Place Cross-Country sewer main. This will confirm the condition of the service laterals and identify any sewerage exfiltration sources.
