Puyallup River Gorge - Aerial Mapping Survey

Summary Report

Electron Hydro, LLC

Draft Report, Rev. 0

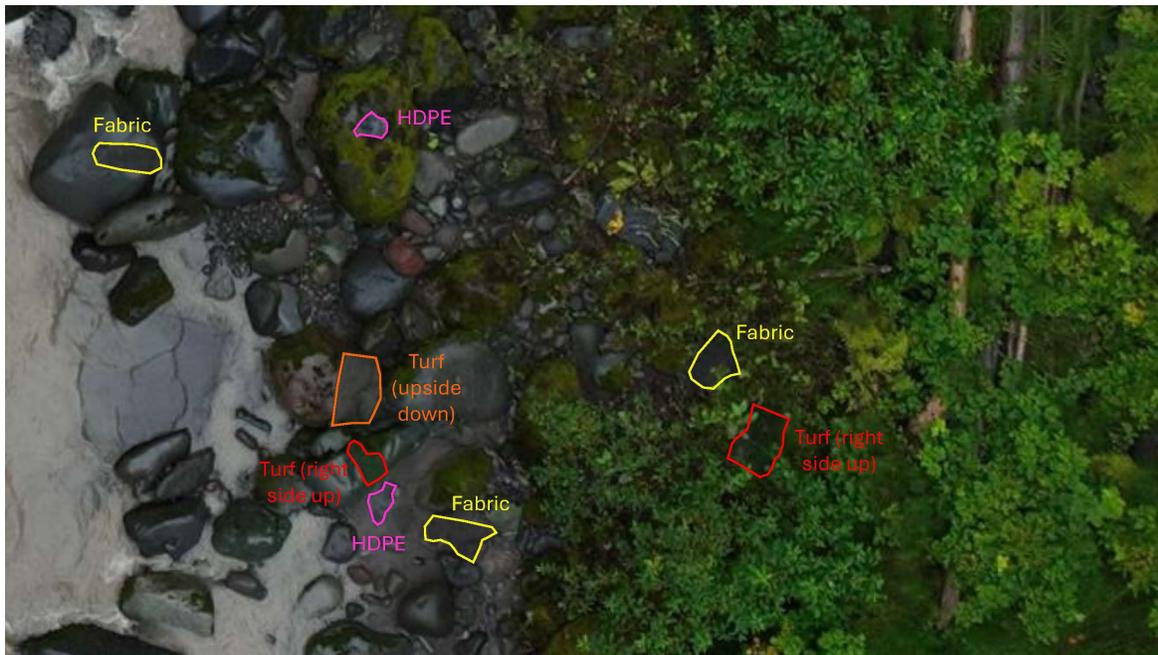
Figure 1 Sample debris placed along river for multispectral camera calibration.

Prior to flying the reach, a calibration flight was made to capture the multispectral signature of the possible debris in the river. Two staff members hiked down into the canyon and placed sample pieces of debris that had been retrieved from other parts of the river and placed them in the channel upstream of the canyon entrance (Figure 1, photos of debris located in Appendix). A pilot then captured imagery of the river with the debris incorporated along the water's edge using the Mavic 3 for multispectral band calibration. The debris included artificial grass (turf), placed right-side up and upside-down, as well as black HDPE and fabric. All debris placed for calibration was then collected and returned to Electron Hydro.

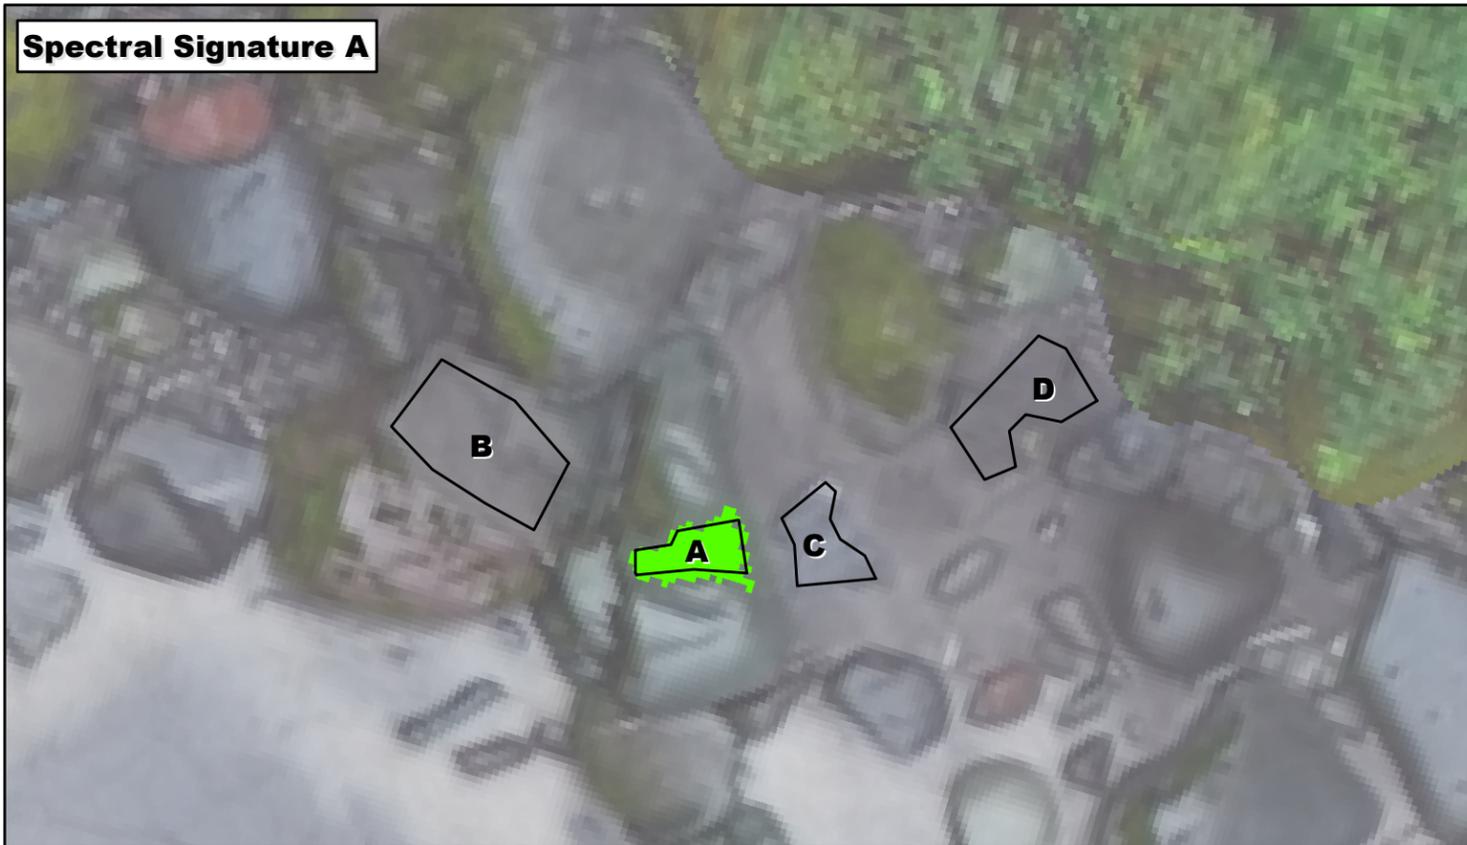
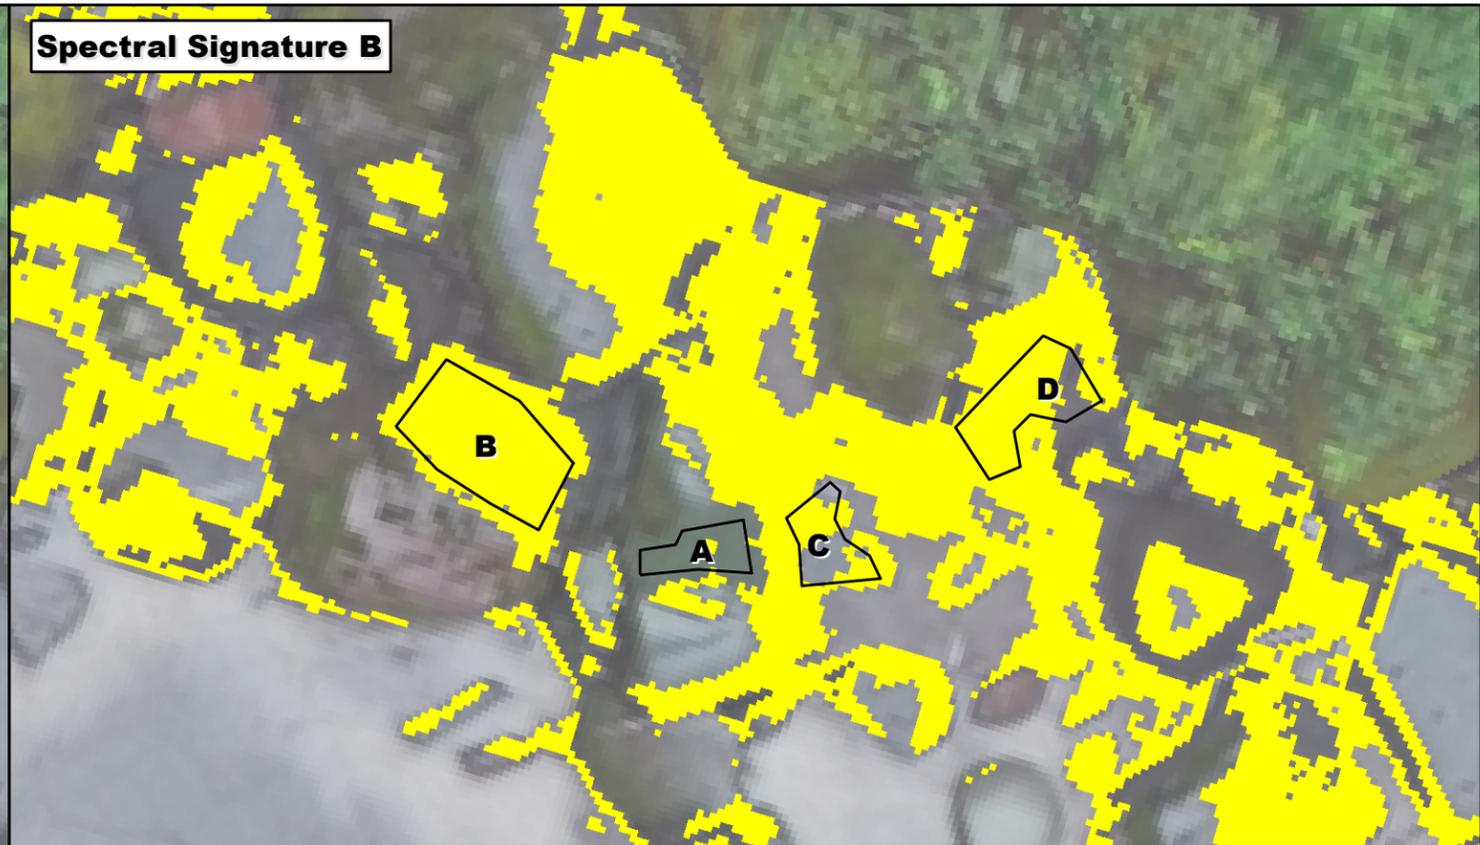
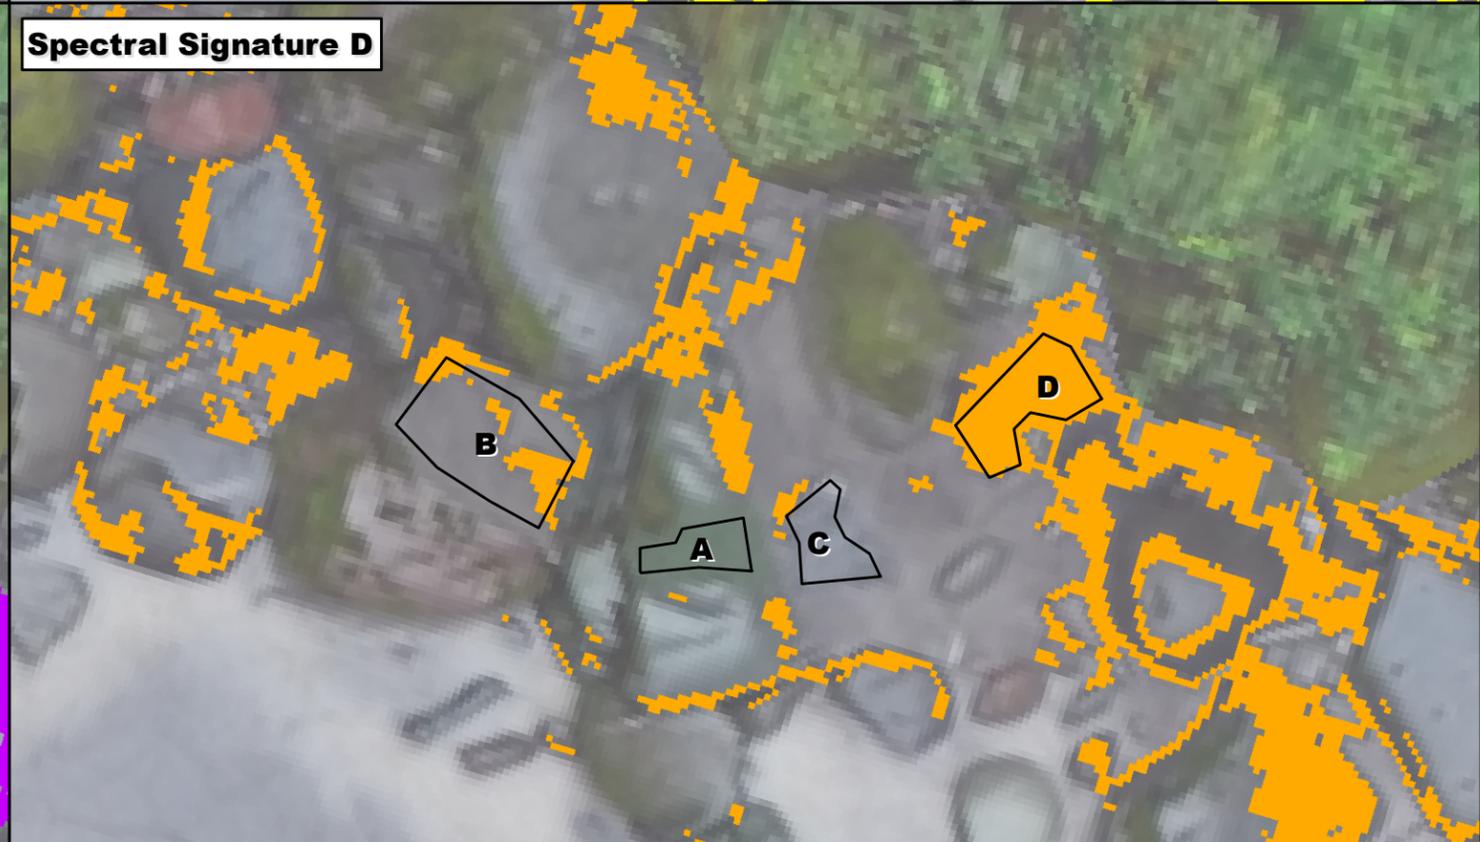
Sample Spectral Signature Composite Masks Map

A second method utilized a mask of overlapping spectral signatures (NIR, RE, R, and G bands) to isolate locations where those spectral bands, and presumably debris, can be found in a given multispectral raster. To do this, the minimum and maximum spectral range for each light band was calculated from the calibration flight for each debris type (see Tables 1-4 for full range of statistical values). Then, for every debris type, a new raster, referred to as a mask, was created of all areas where the band ranges overlap spatially, therefore filtering or excluding any spatial areas that fall outside of this range. This mask can then be overlain on top of the orthomosaic to visualize and identify the possible locations of debris across the landscape, shown in Appendix B.

***Note: No debris could be positively identified. A spectral signature is a unique combination of wavelength reflectance patterns that distinguishes one material from another. See Tables 1 through 4 for the approximate spectral signatures.**

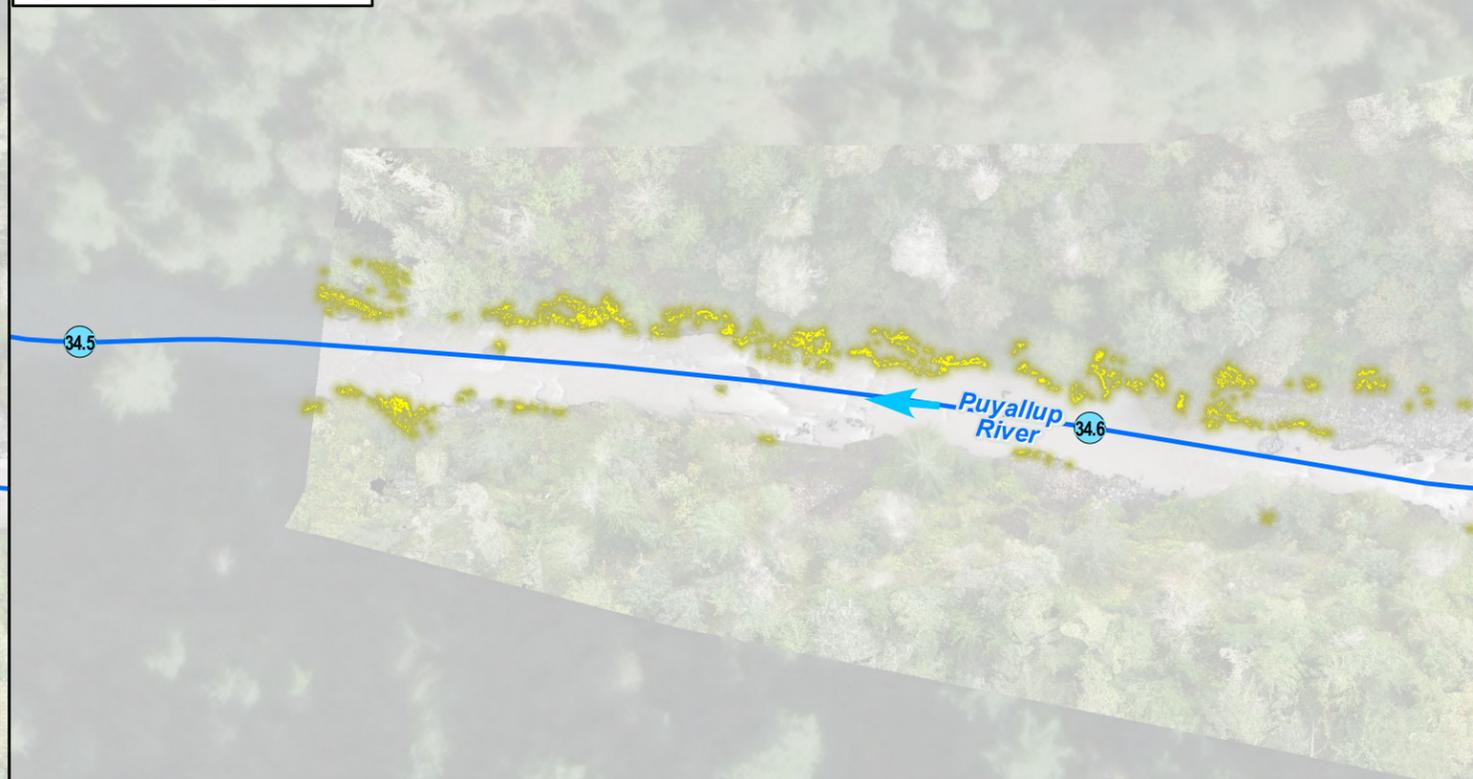
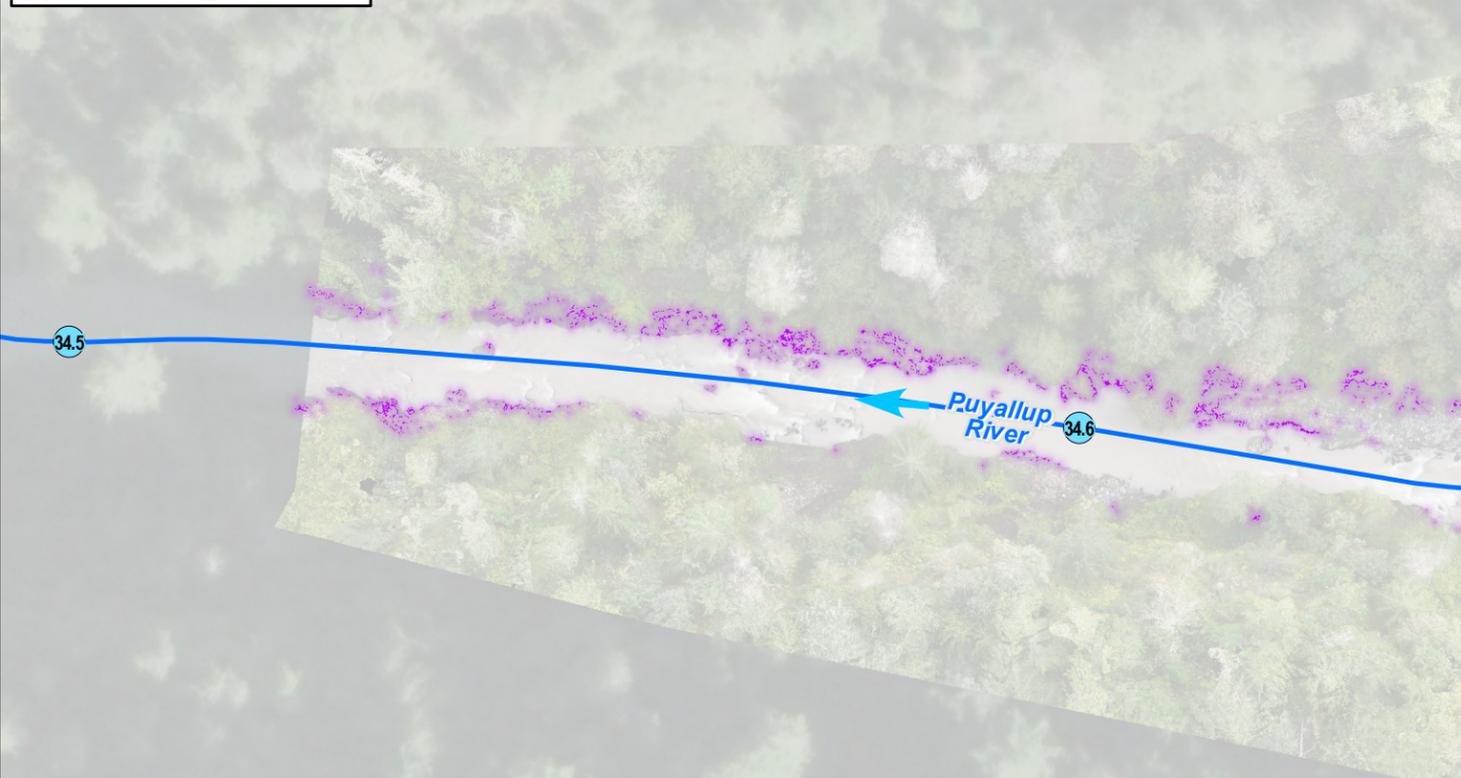
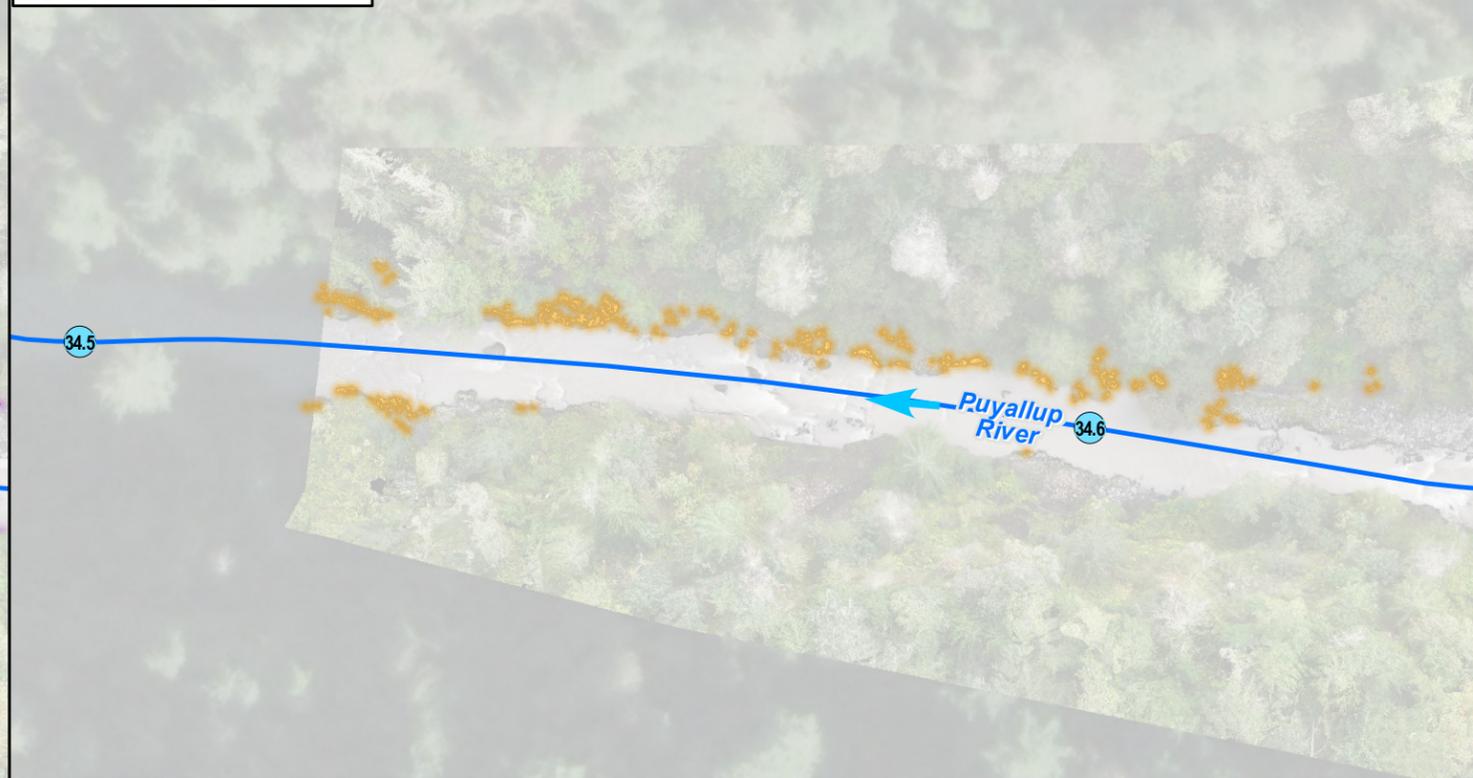
Sheet 1 of 10 **APPENDIX C**

***Note: No debris could be positively identified. A spectral signature is a unique combination of wavelength reflectance patterns that distinguishes one material from another. See Tables 1 through 4 for the approximate spectral signatures.**

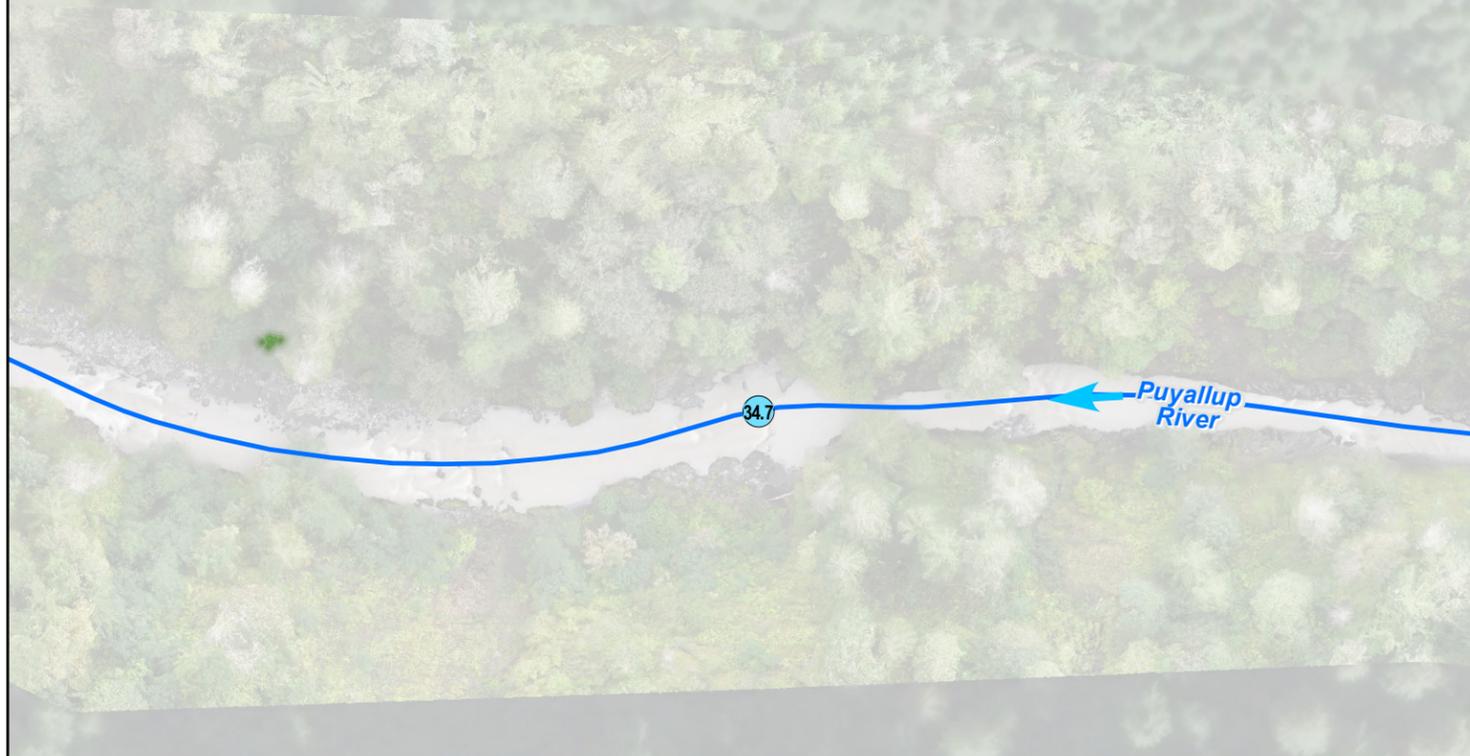
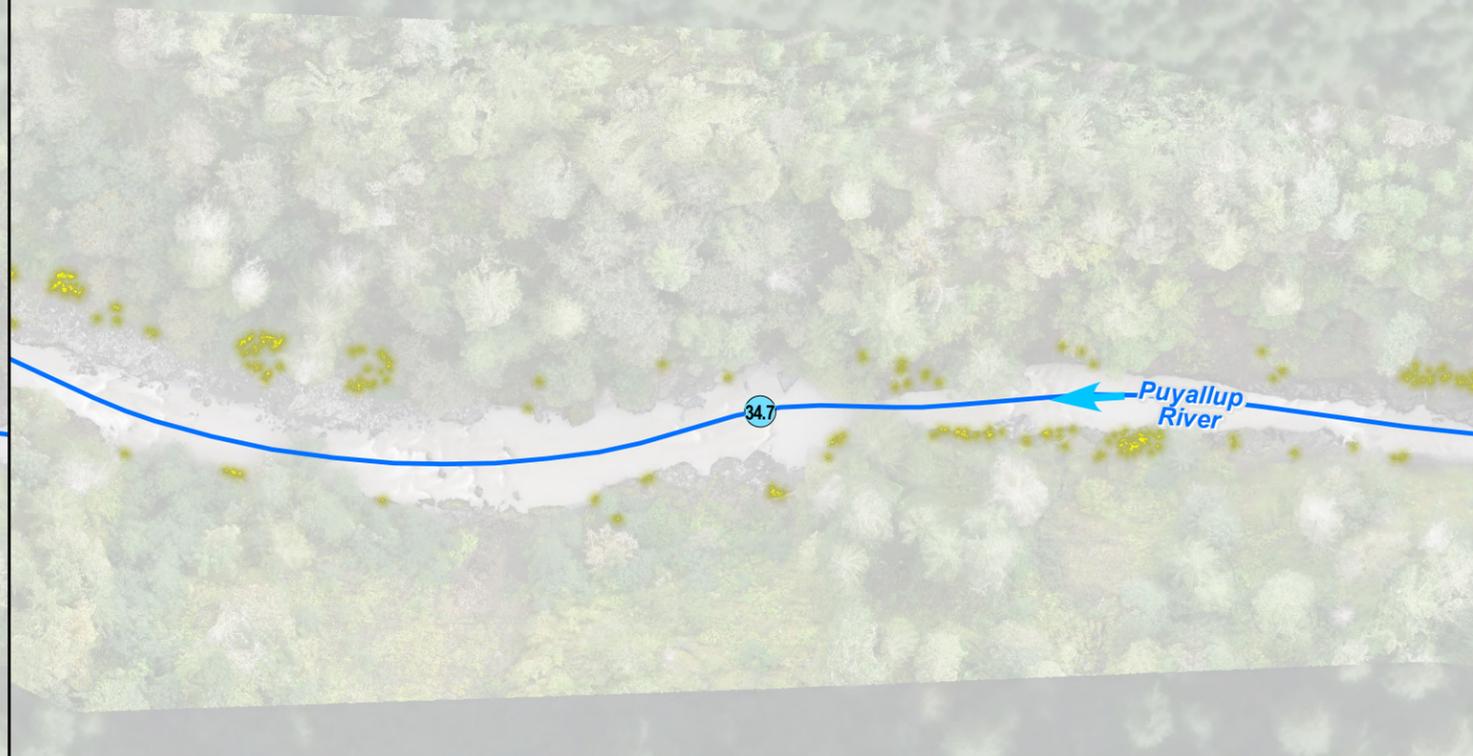
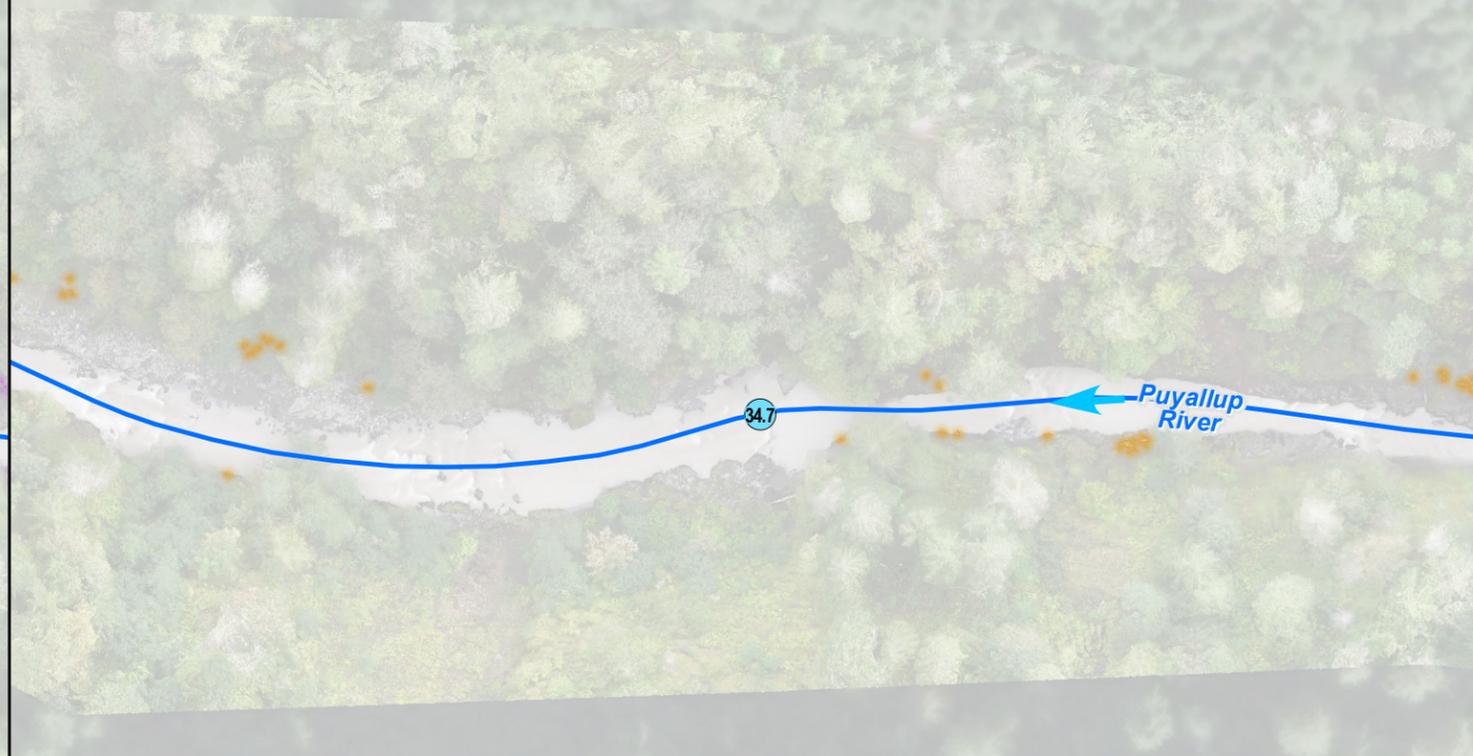
Sheet 2 of 10 APPENDIX C

***Note: No debris could be positively identified. A spectral signature is a unique combination of wavelength reflectance patterns that distinguishes one material from another. See Tables 1 through 4 for the approximate spectral signatures.**

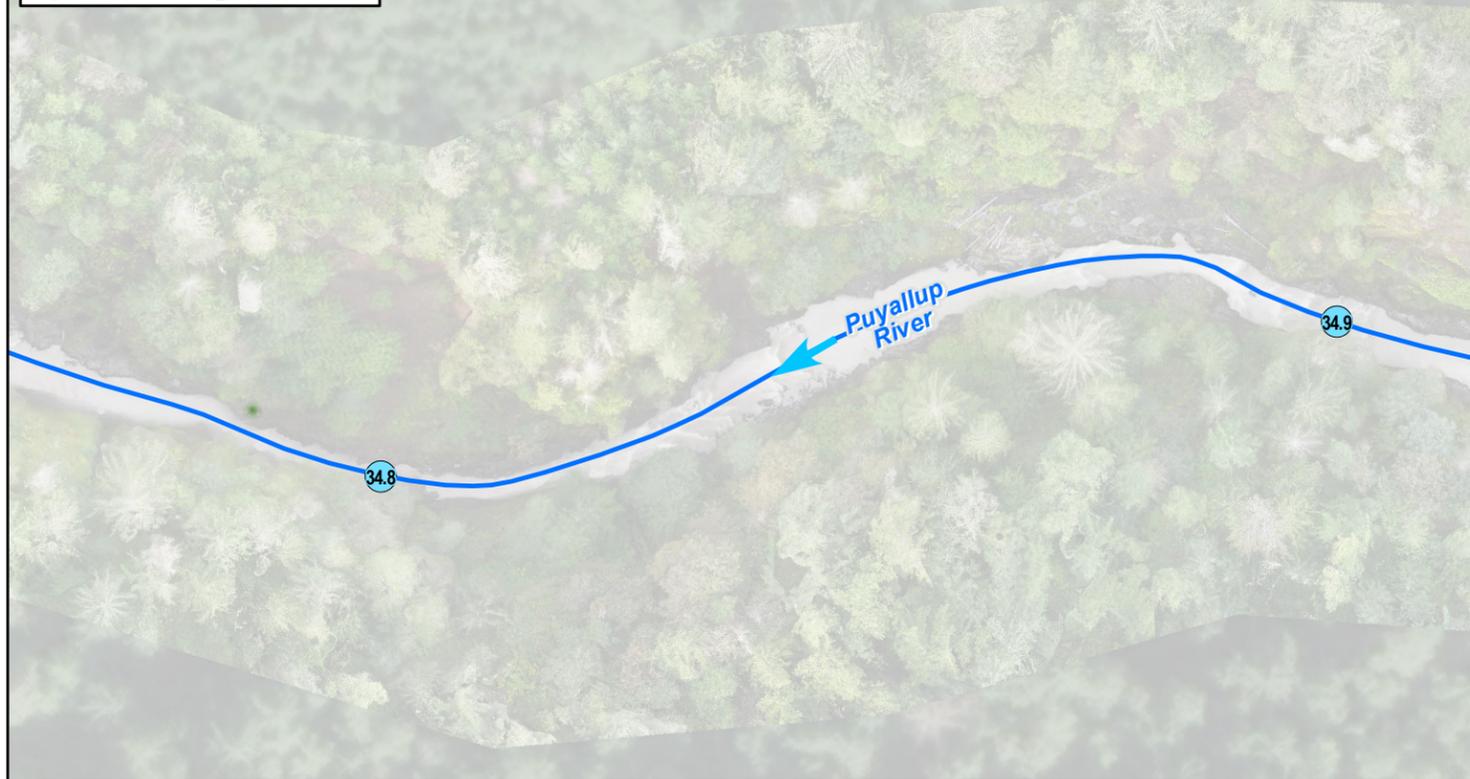
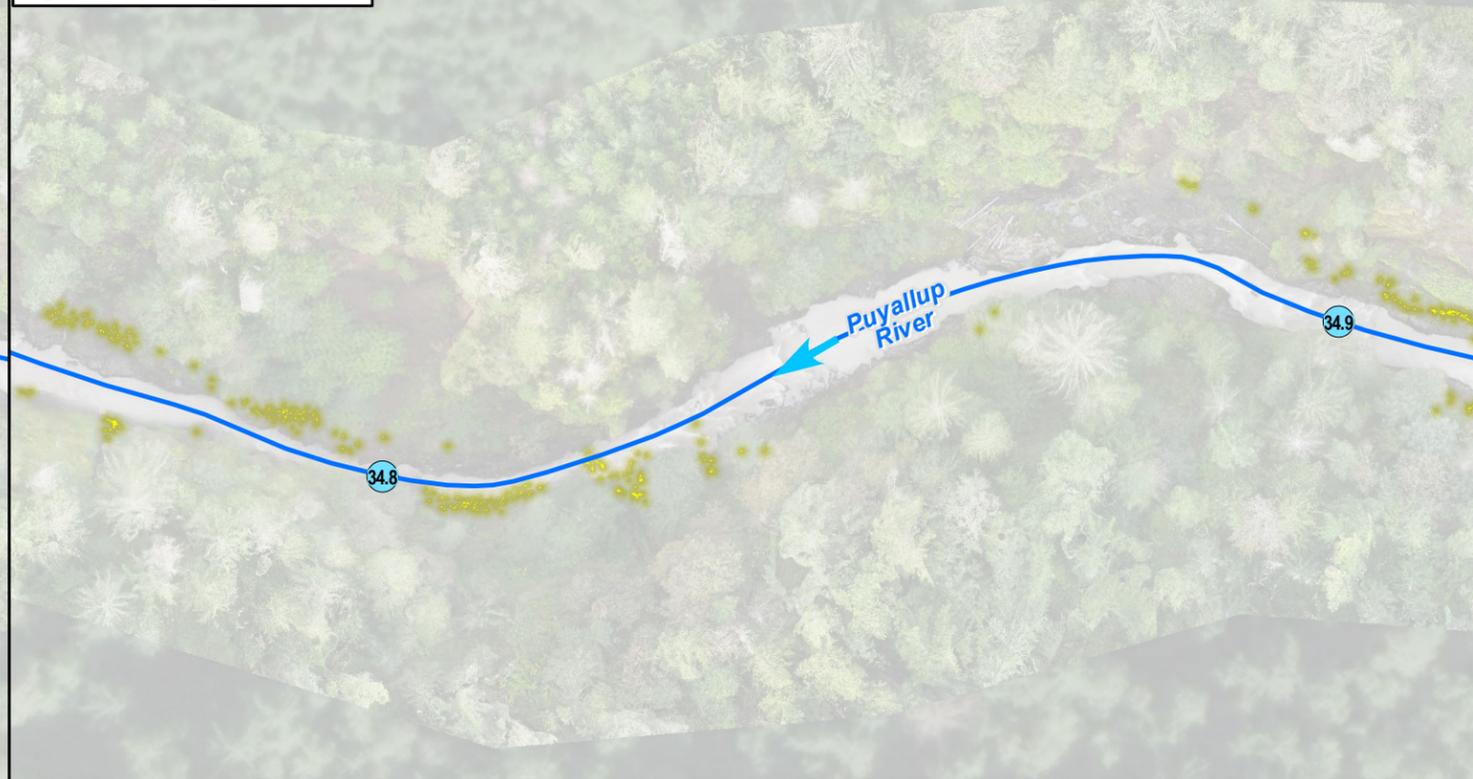
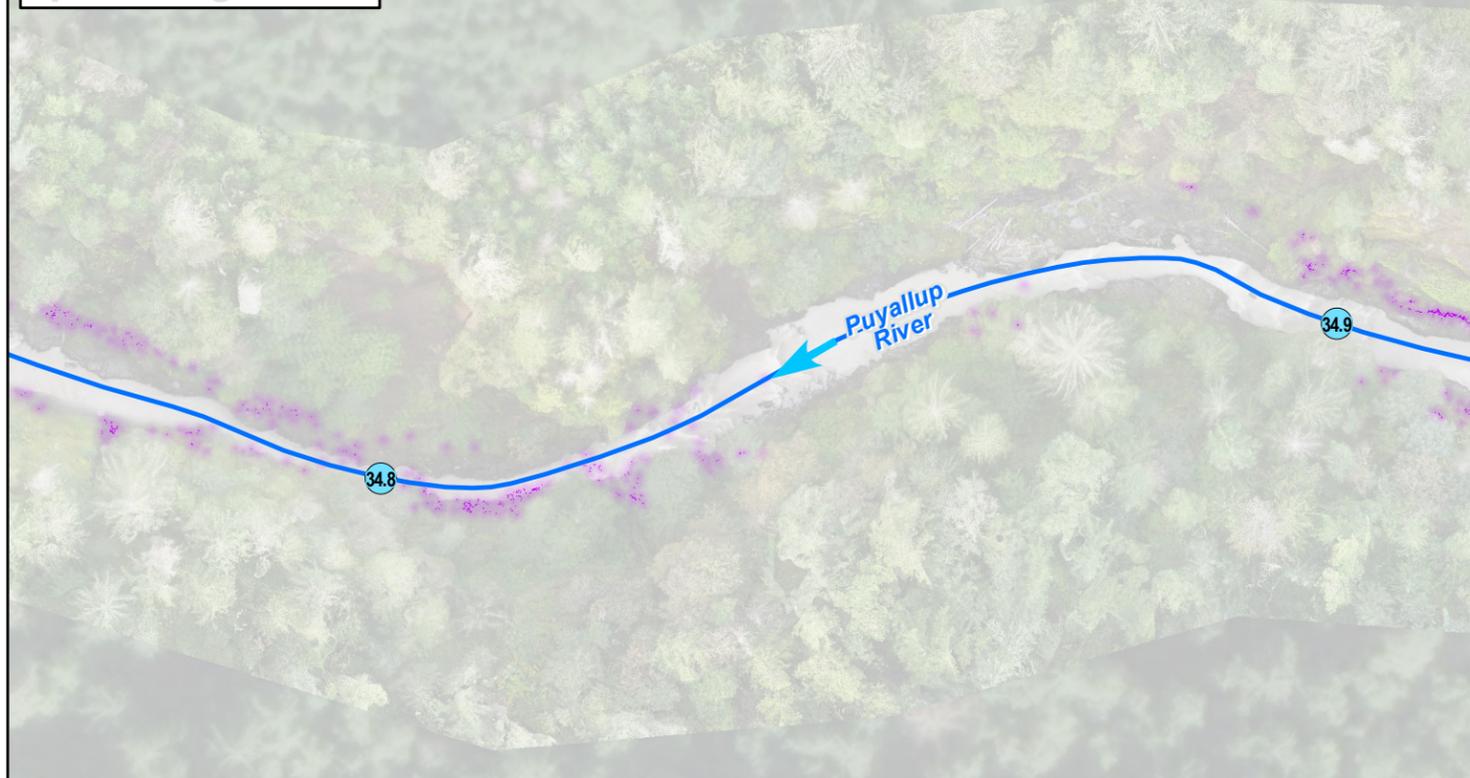
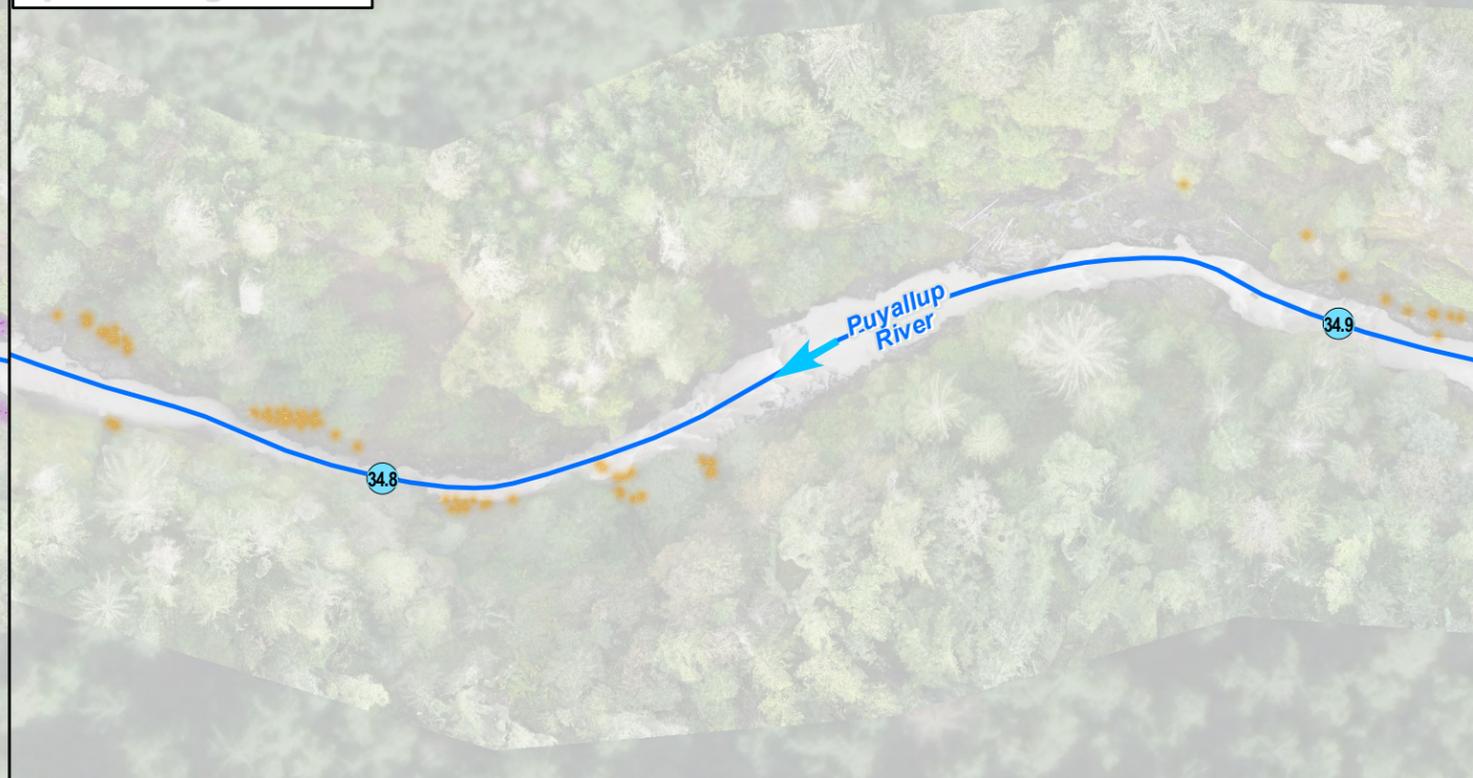
Sheet 3 of 10

***Note: No debris could be positively identified. A spectral signature is a unique combination of wavelength reflectance patterns that distinguishes one material from another. See Tables 1 through 4 for the approximate spectral signatures.**

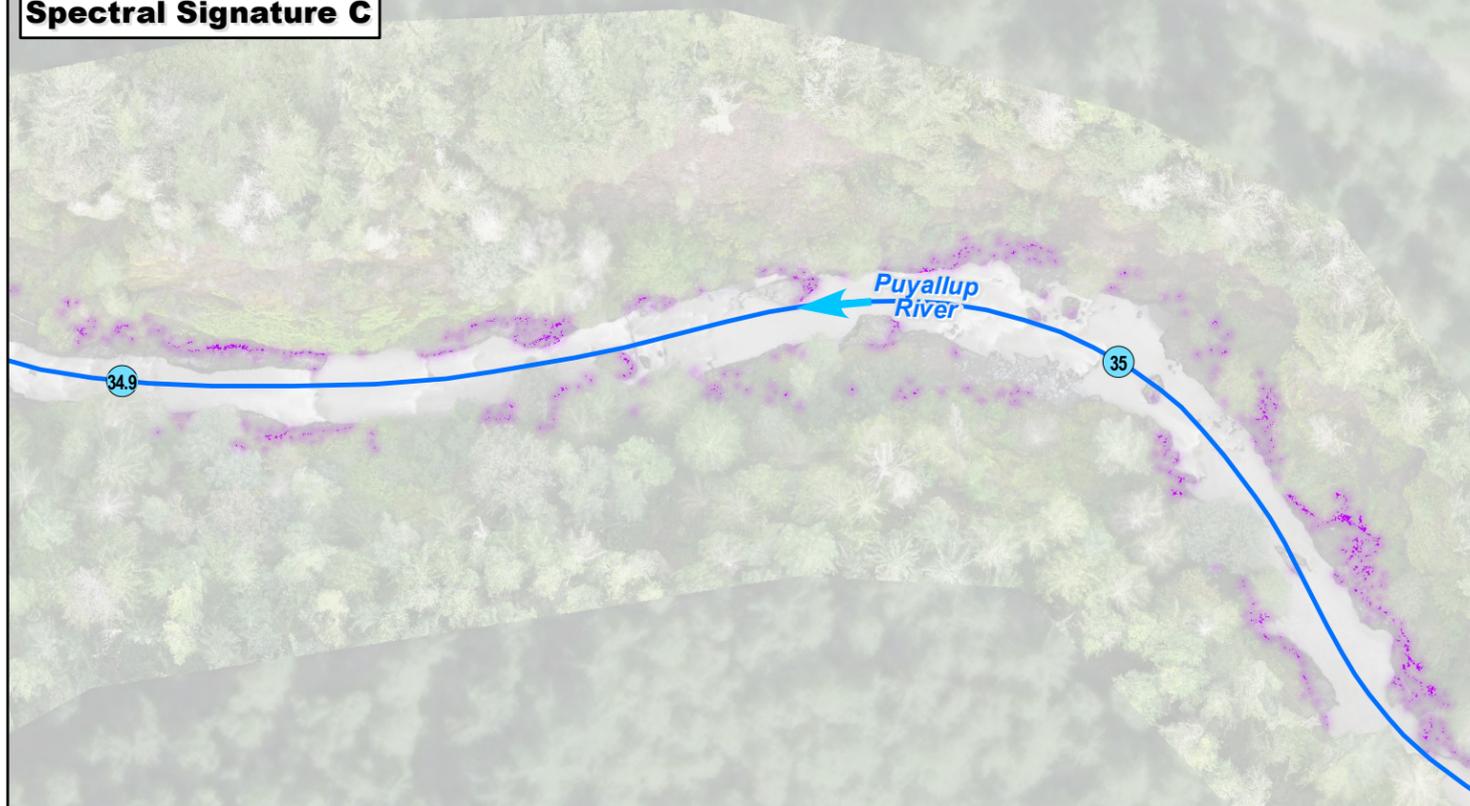
Sheet 4 of 10 APPENDIX C

***Note: No debris could be positively identified. A spectral signature is a unique combination of wavelength reflectance patterns that distinguishes one material from another. See Tables 1 through 4 for the approximate spectral signatures.**

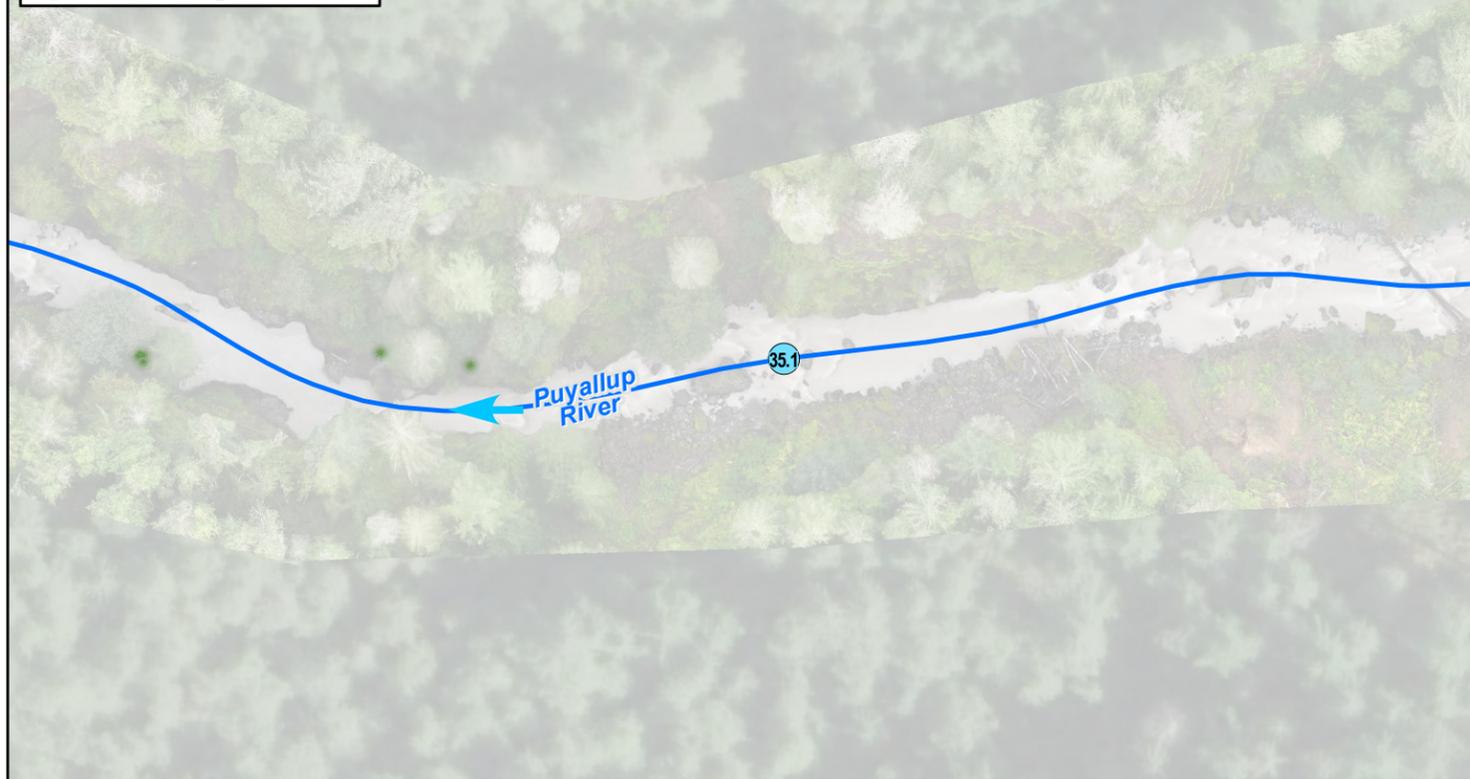
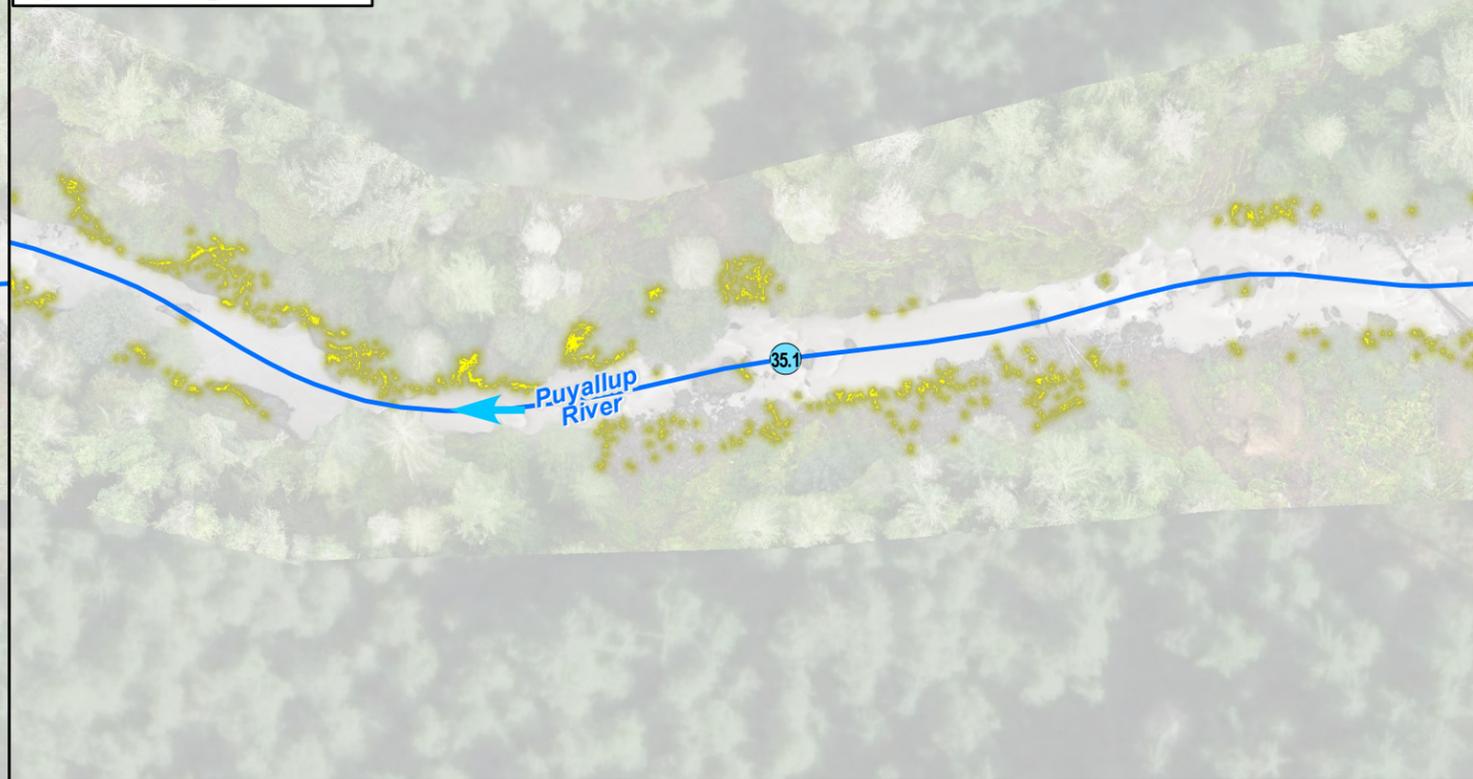
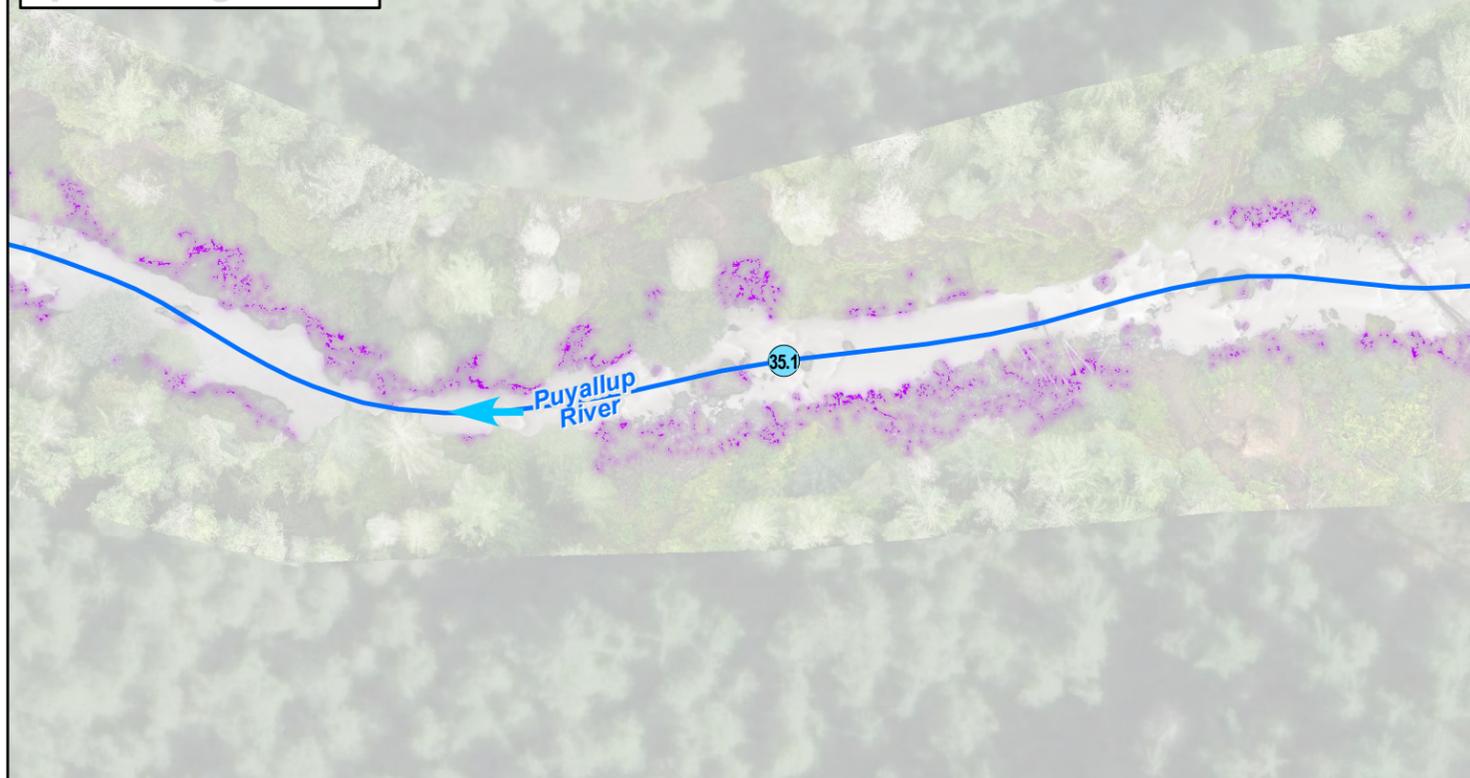
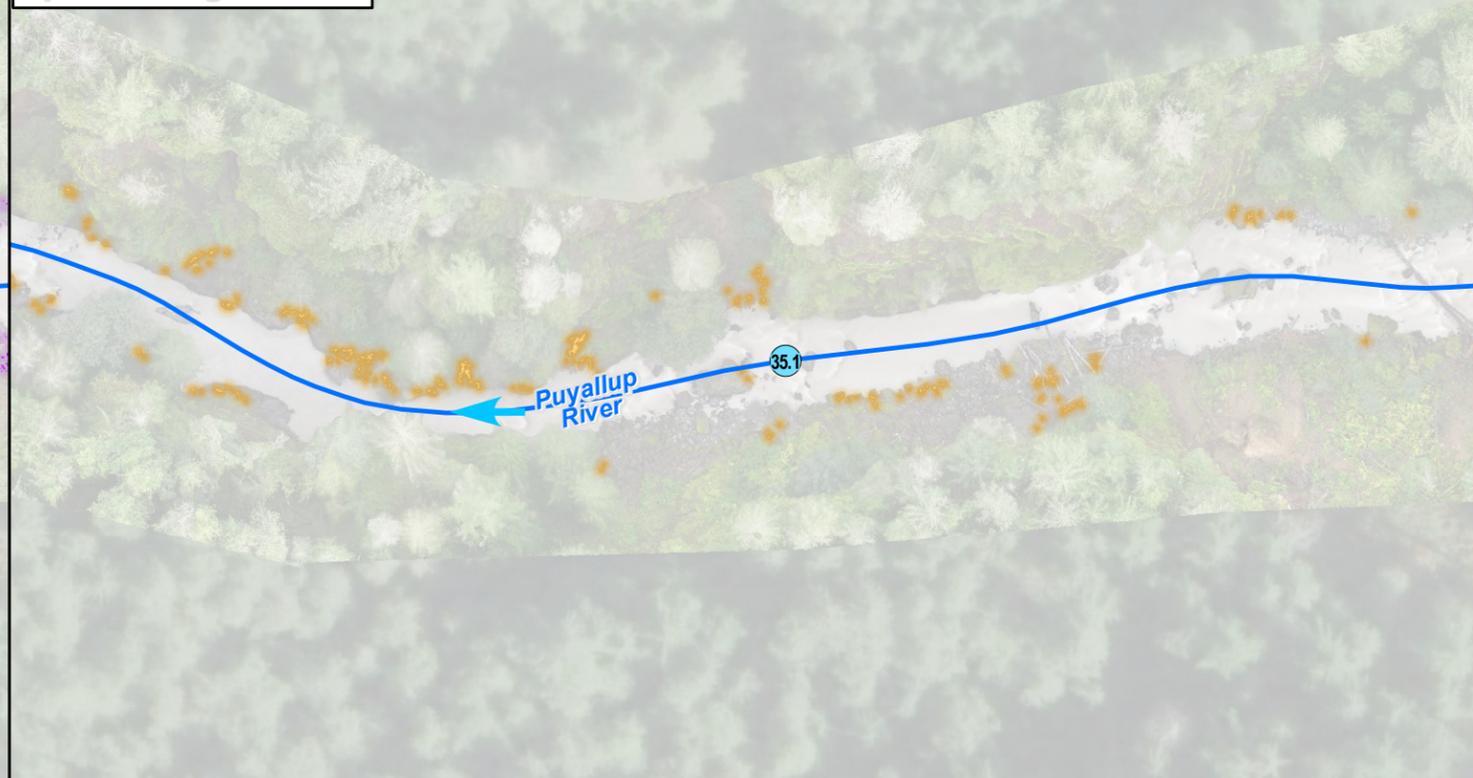
Sheet 5 of 10

***Note: No debris could be positively identified. A spectral signature is a unique combination of wavelength reflectance patterns that distinguishes one material from another. See Tables 1 through 4 for the approximate spectral signatures.**
