Puyallup River Gorge - Aerial Mapping Survey

Summary Report

Electron Hydro, LLC

Draft Report, Rev. 0

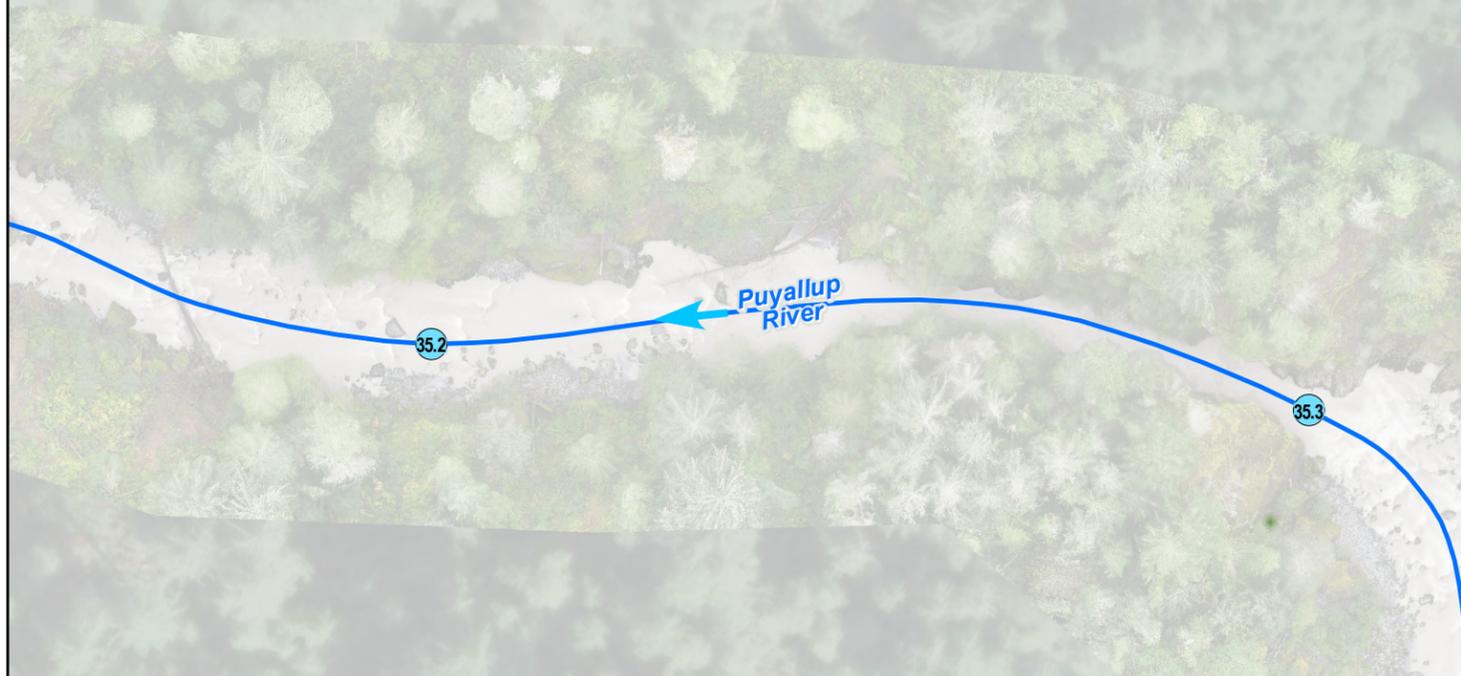
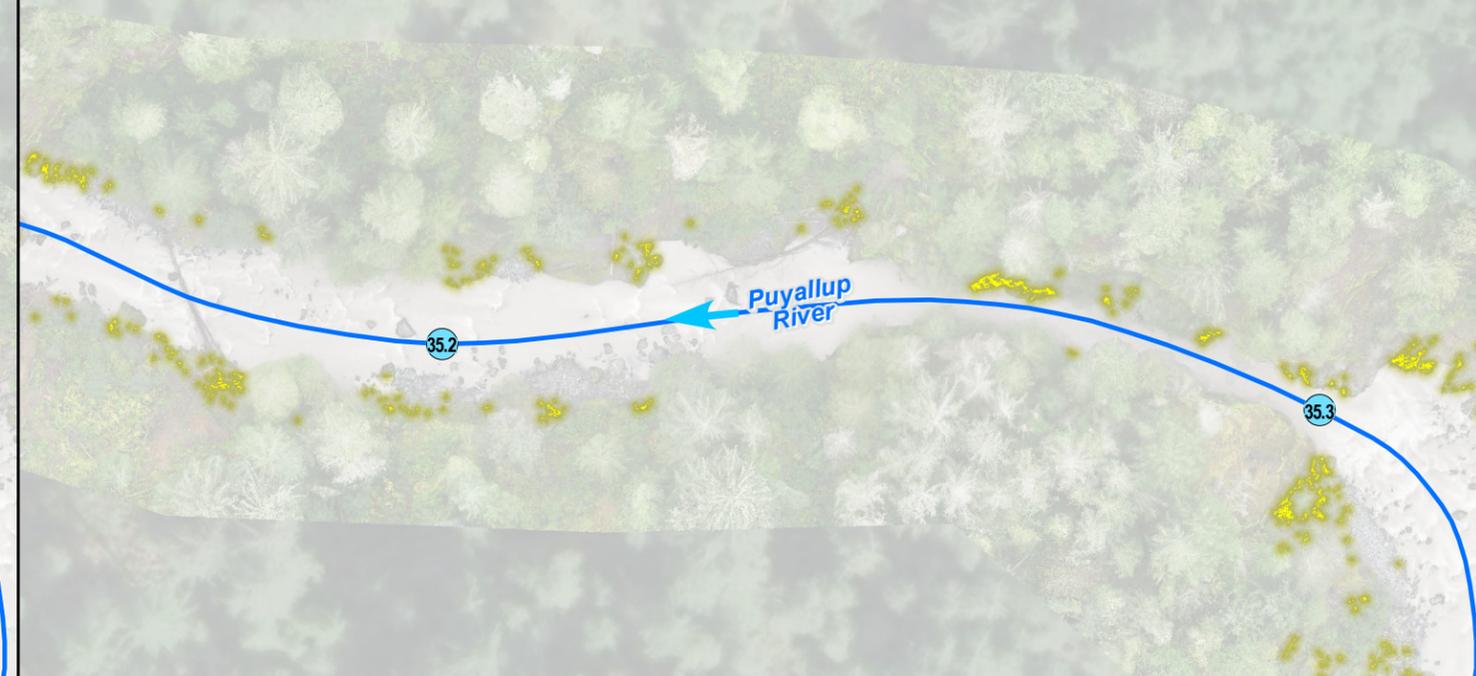
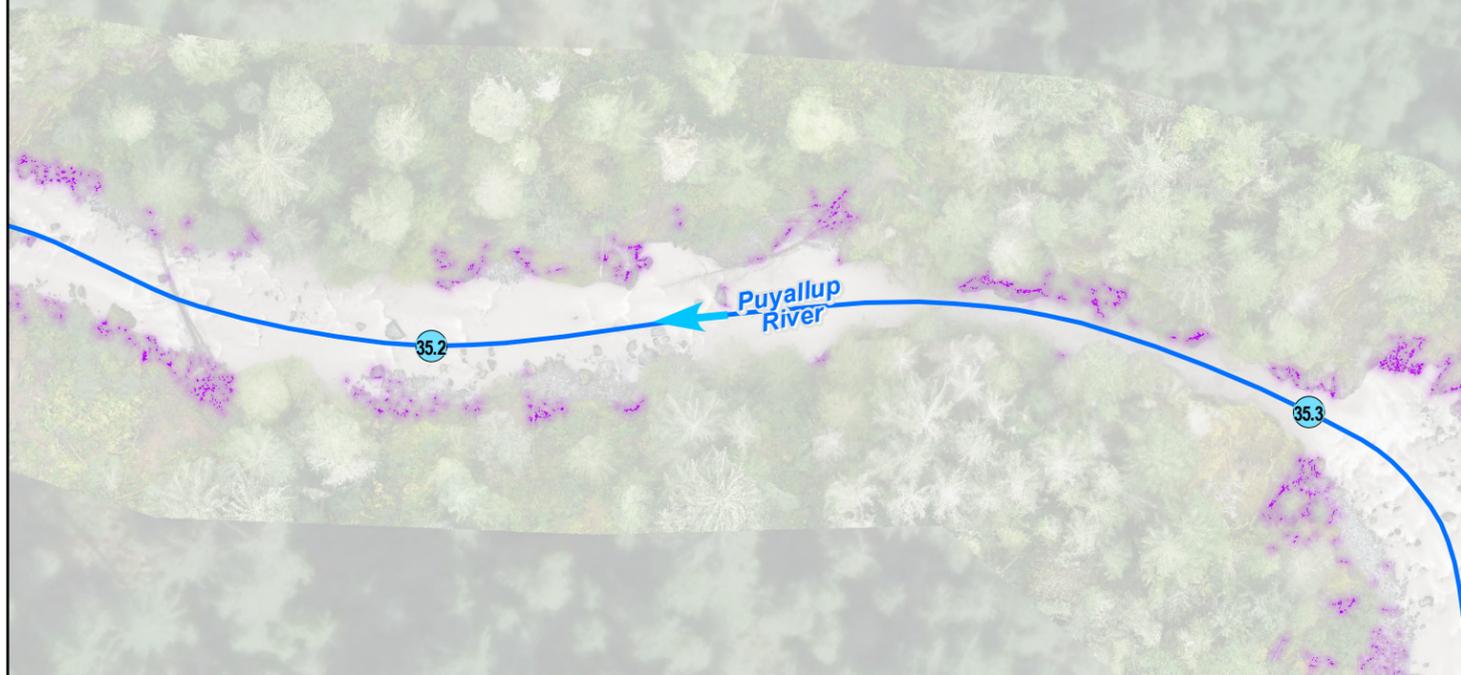
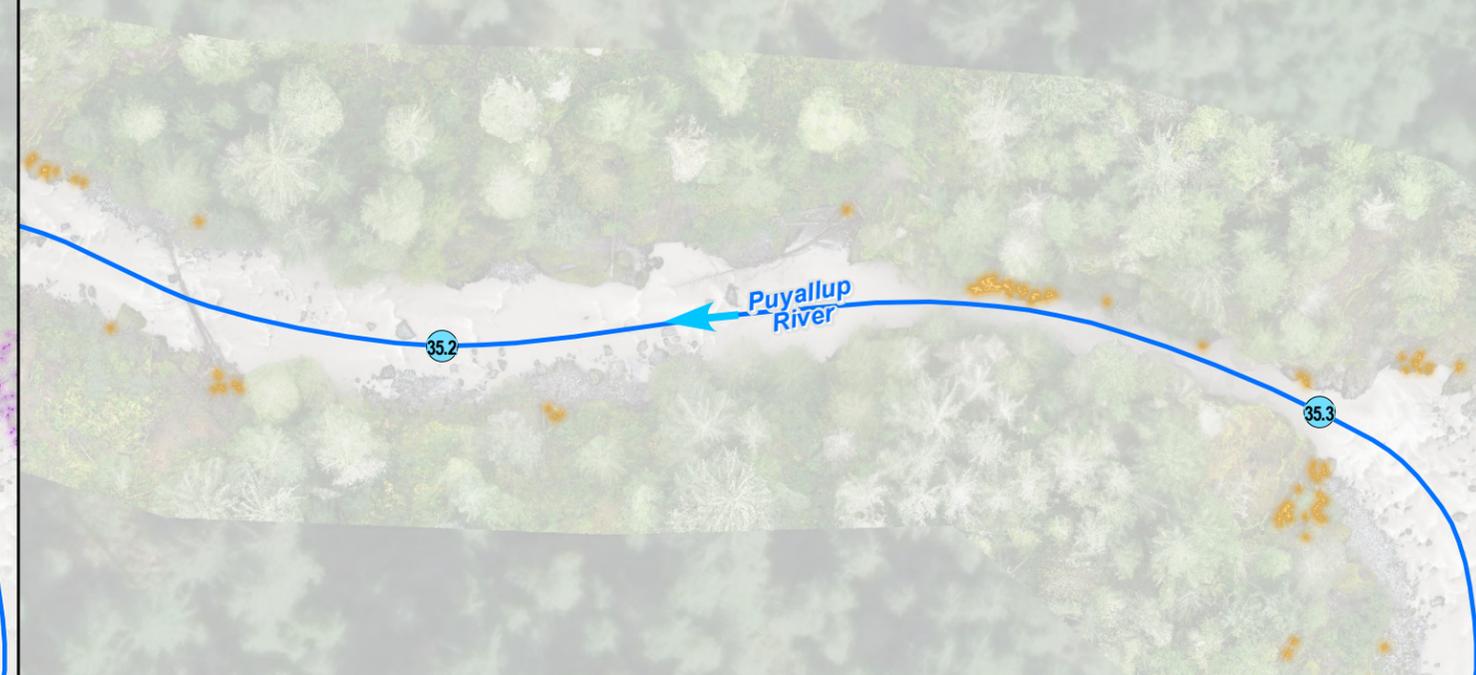
Sheet 6 of 10 APPENDIX C

***Note: No debris could be positively identified. A spectral signature is a unique combination of wavelength reflectance patterns that distinguishes one material from another. See Tables 1 through 4 for the approximate spectral signatures.**

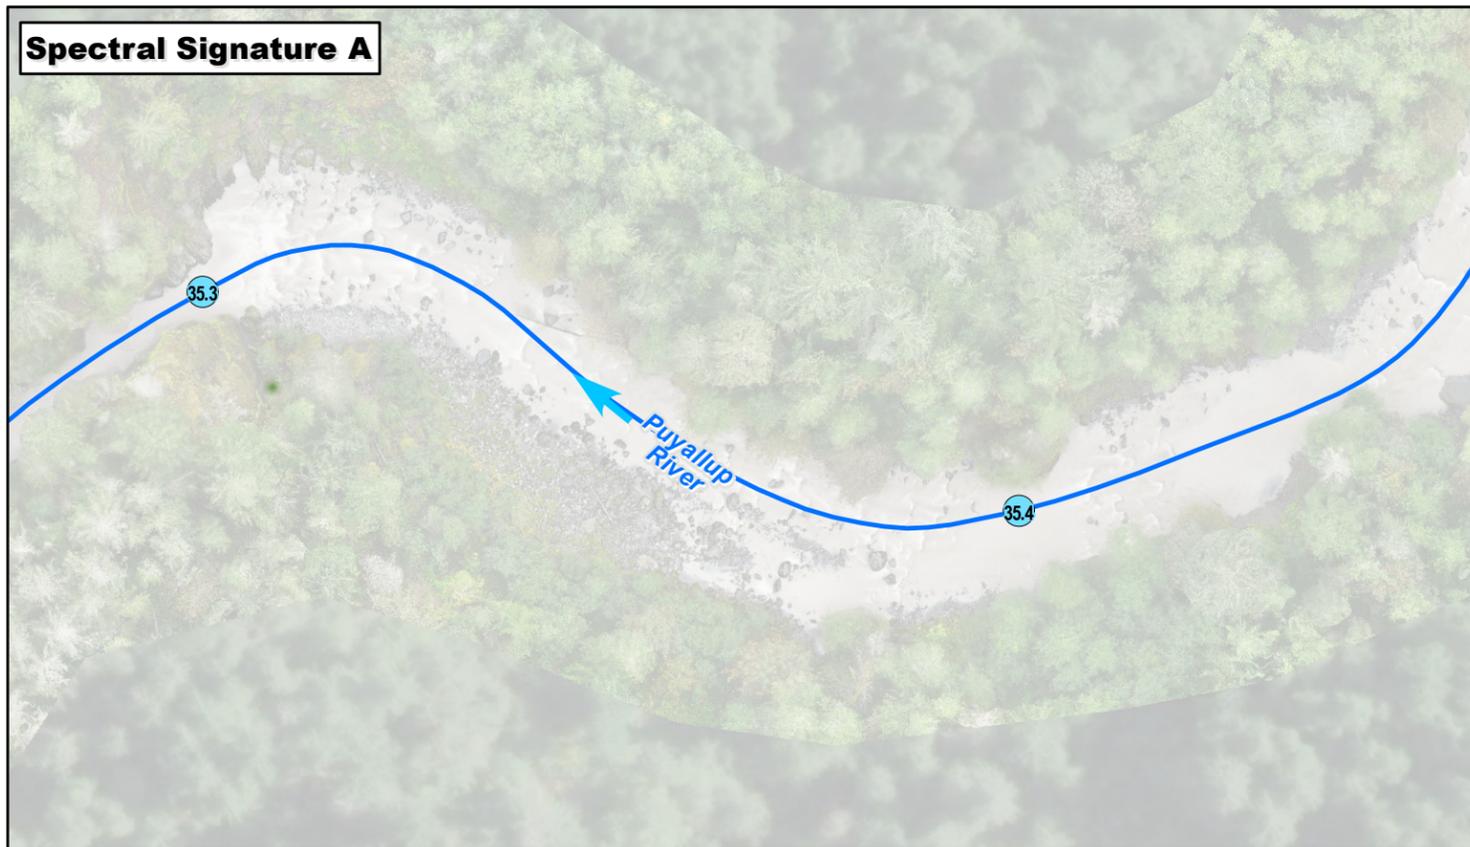
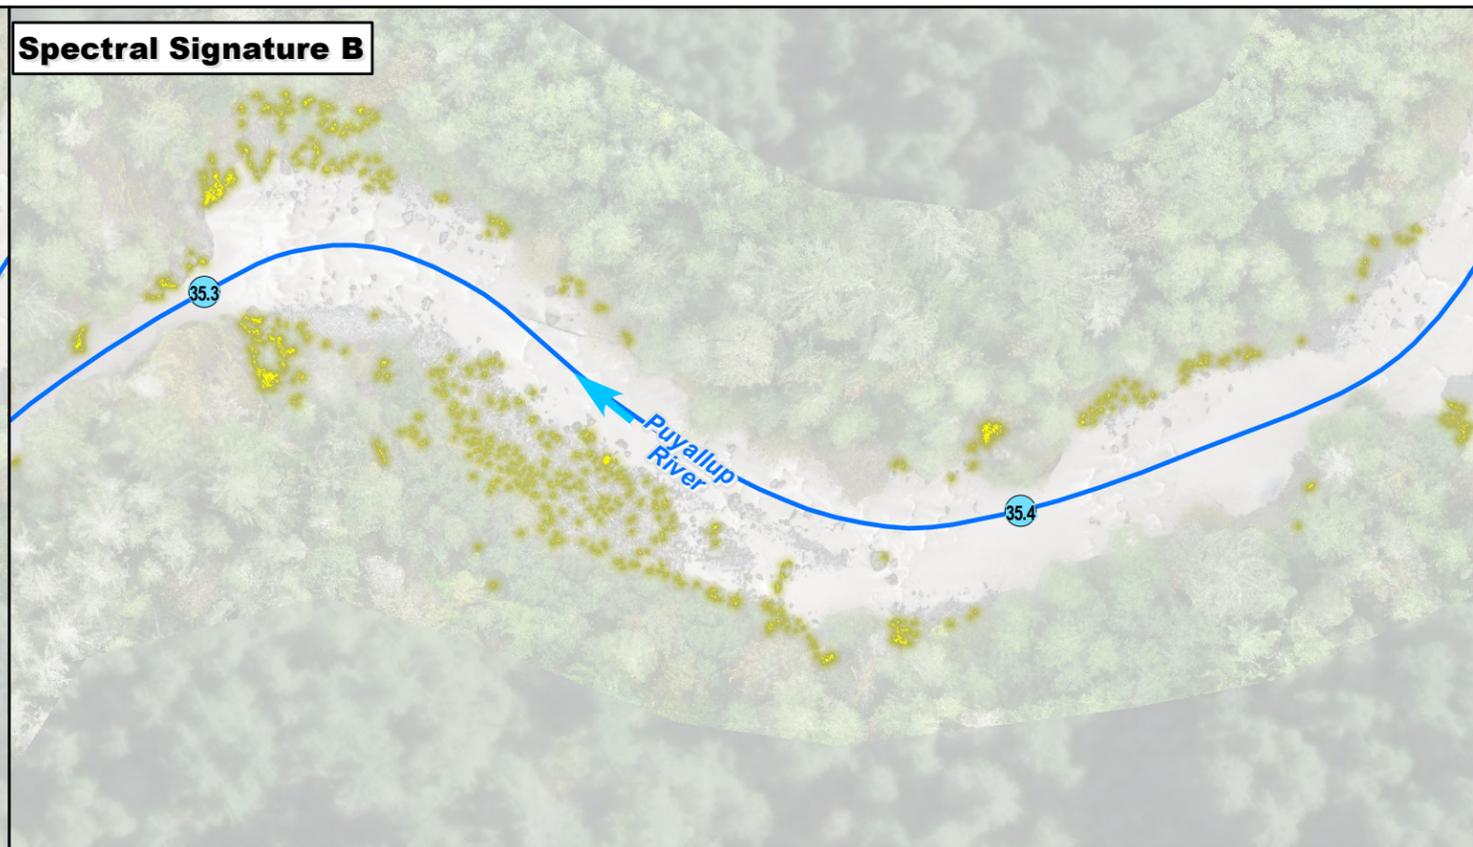
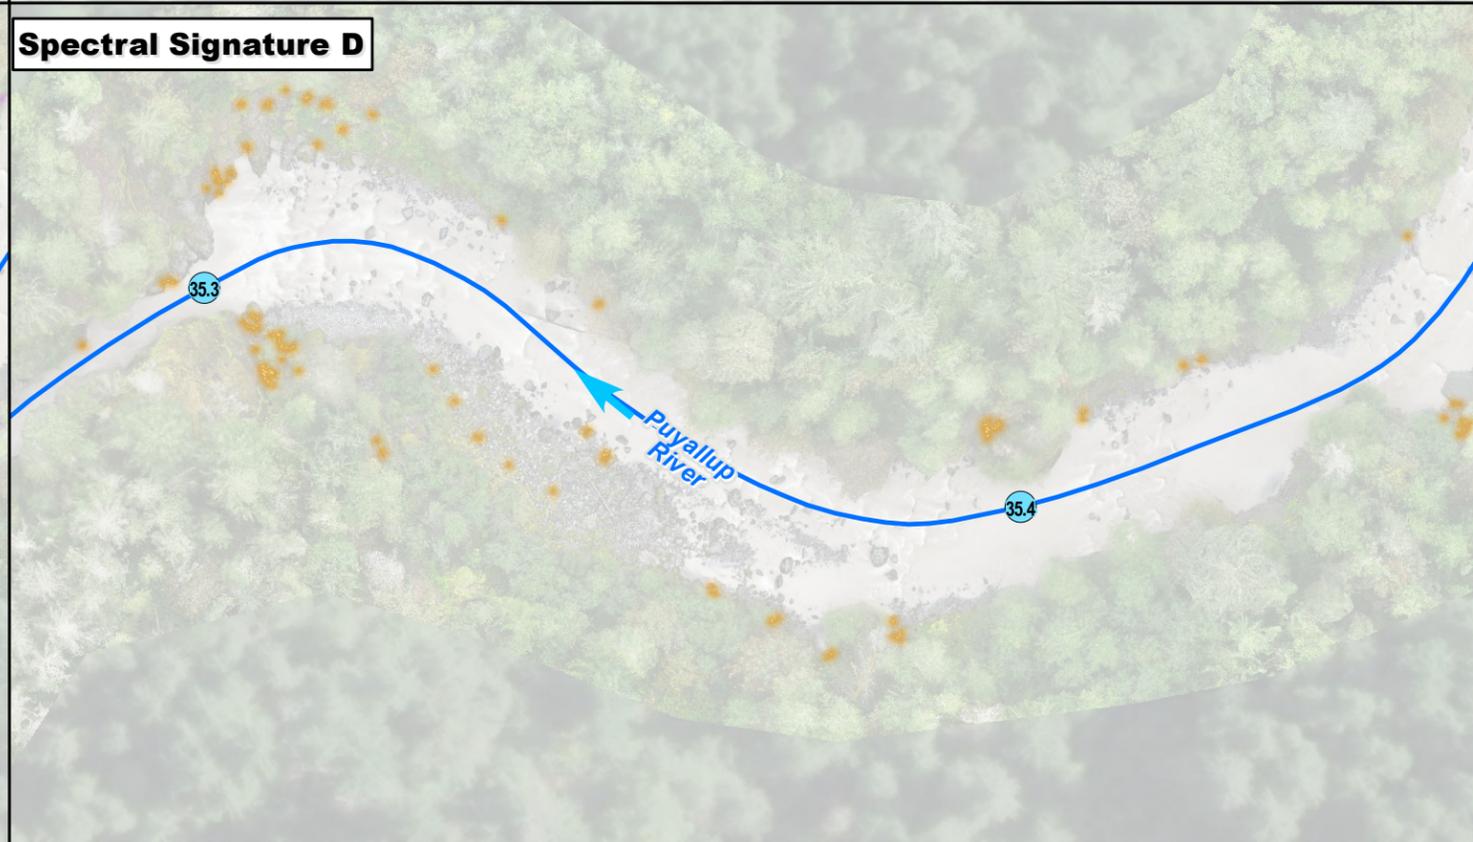
Sheet 7 of 10 APPENDIX C

***Note: No debris could be positively identified. A spectral signature is a unique combination of wavelength reflectance patterns that distinguishes one material from another. See Tables 1 through 4 for the approximate spectral signatures.**

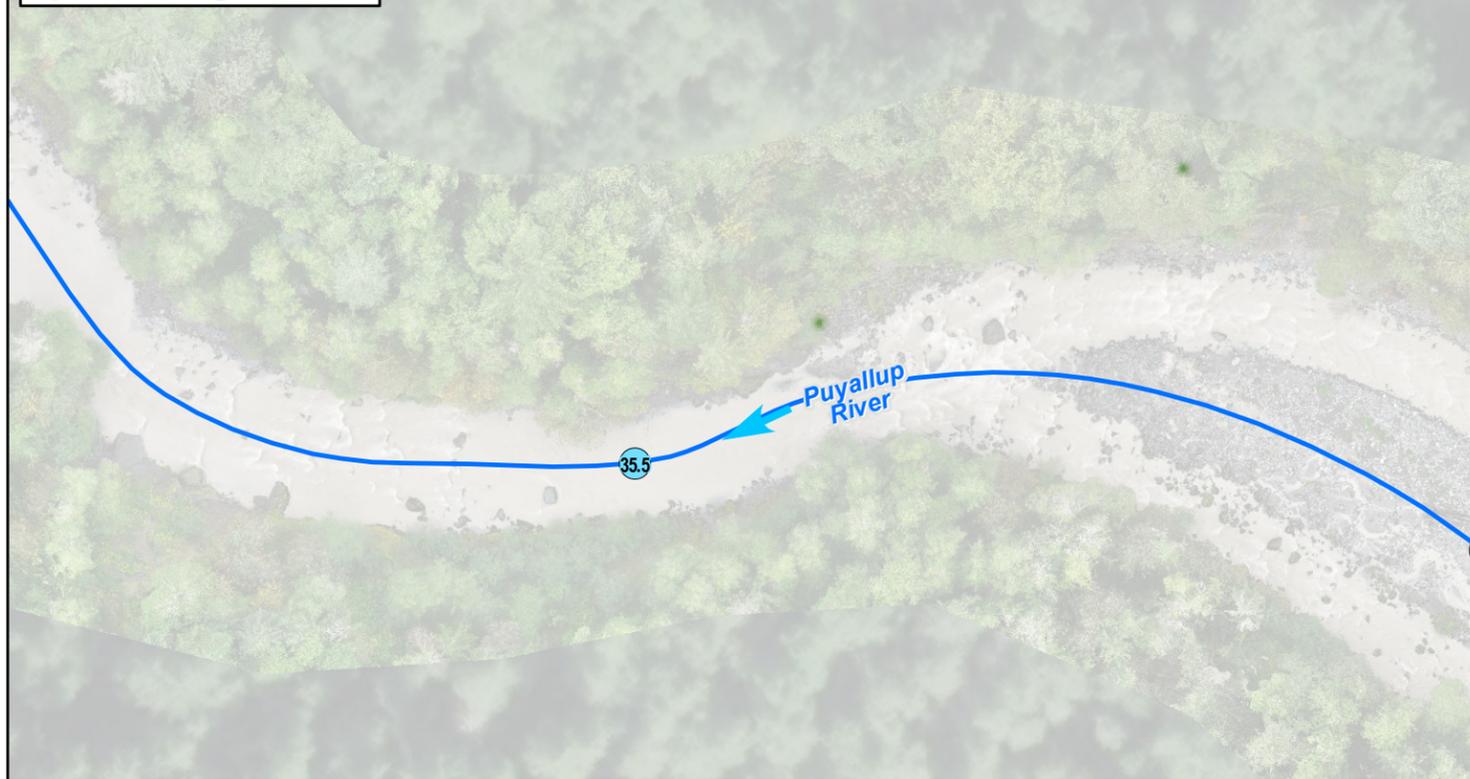
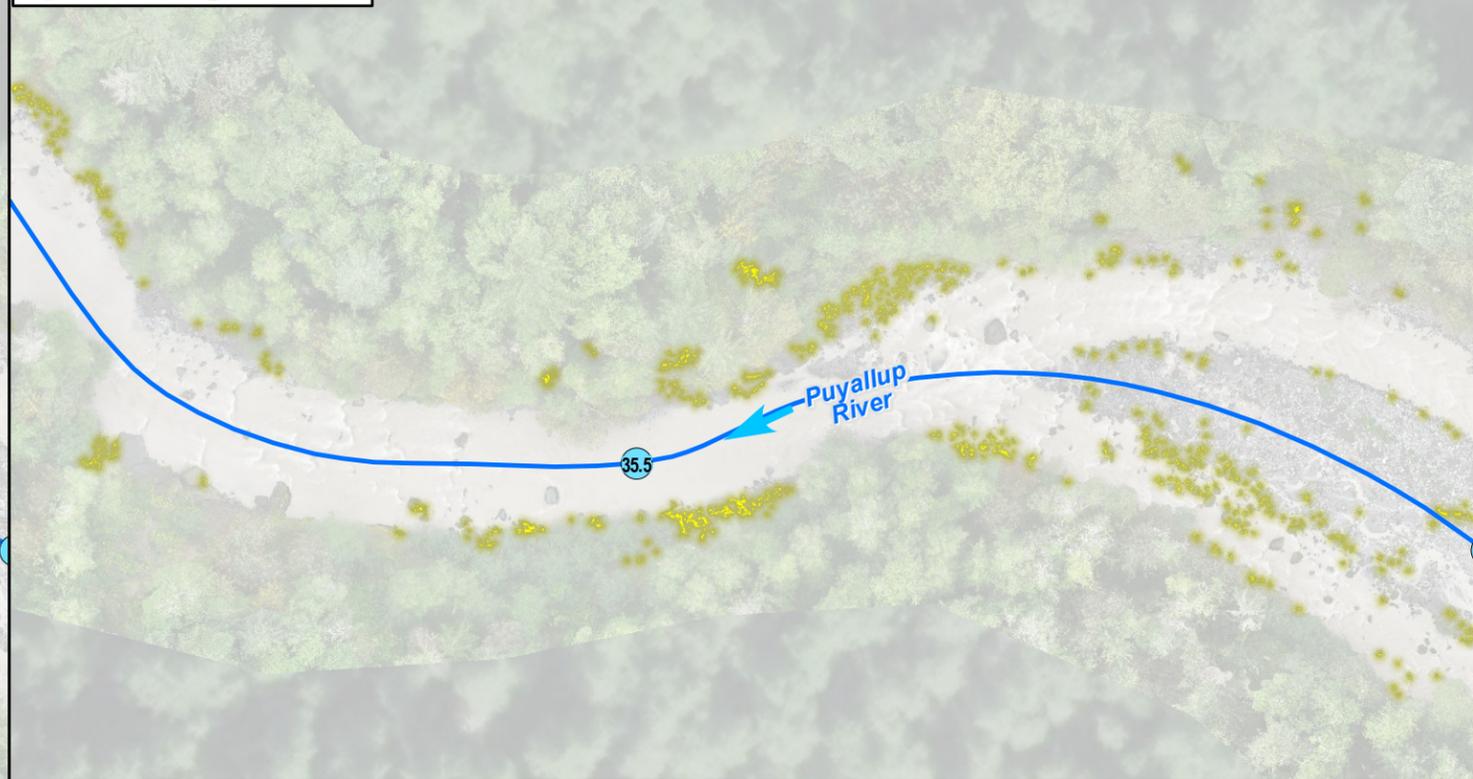
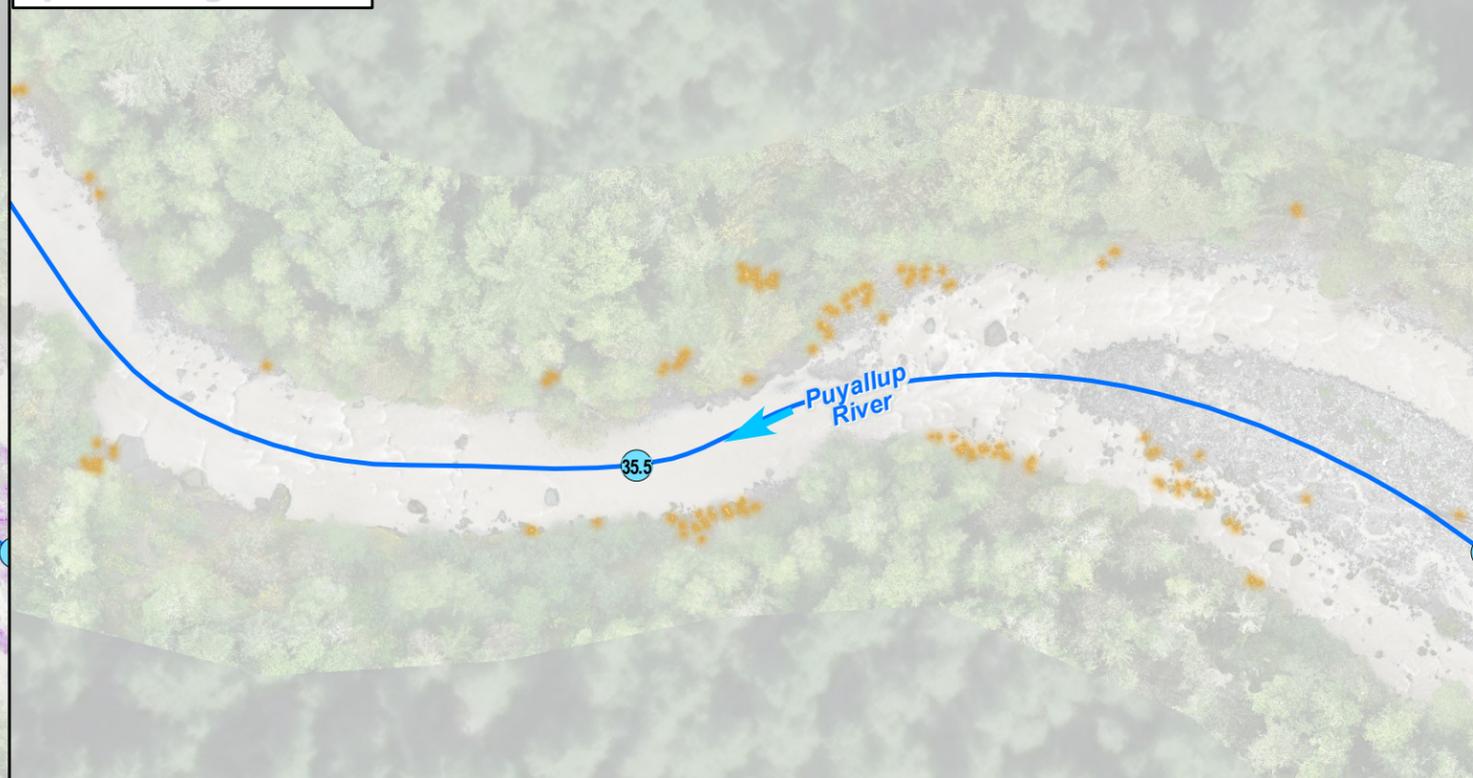
Sheet 8 of 10 **APPENDIX C**

***Note: No debris could be positively identified. A spectral signature is a unique combination of wavelength reflectance patterns that distinguishes one material from another. See Tables 1 through 4 for the approximate spectral signatures.**

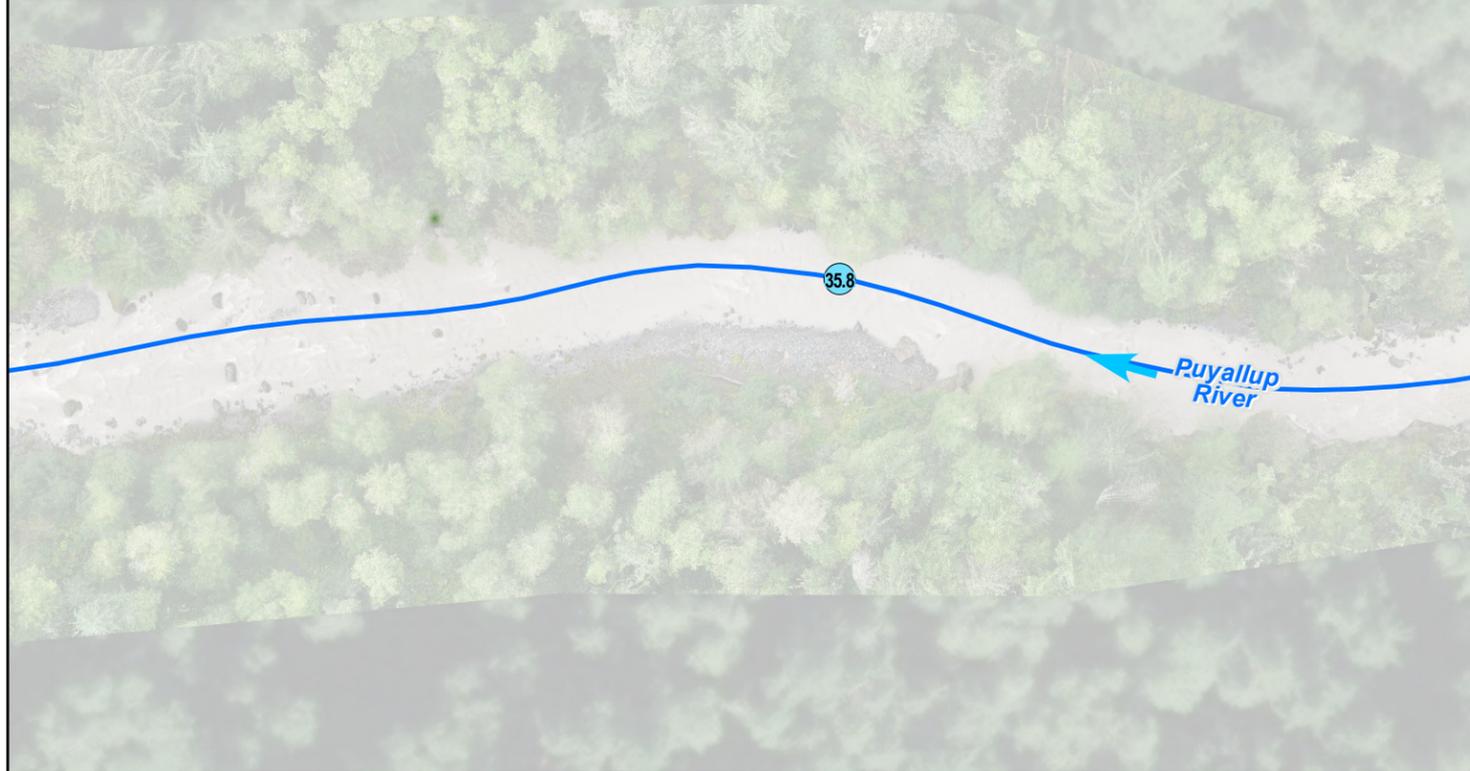
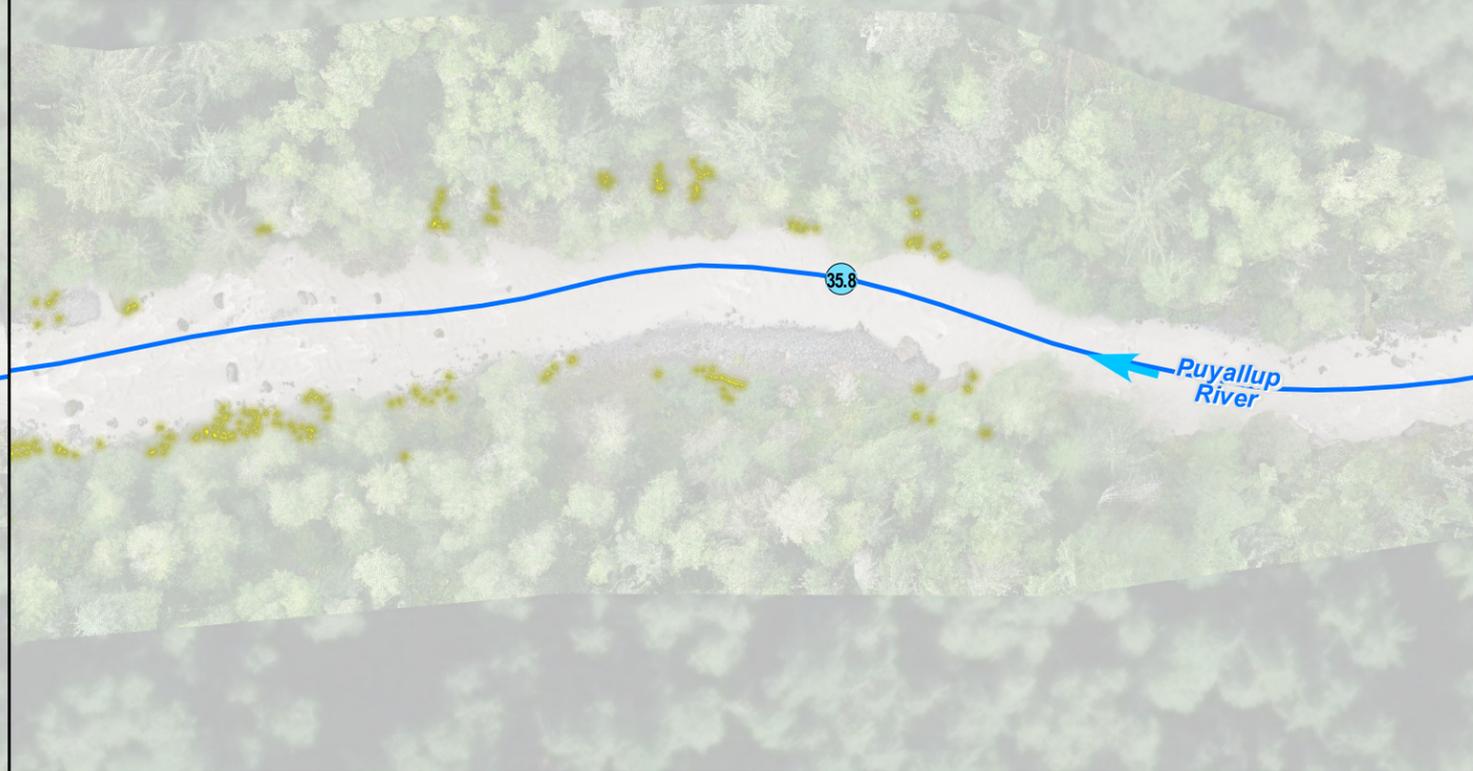
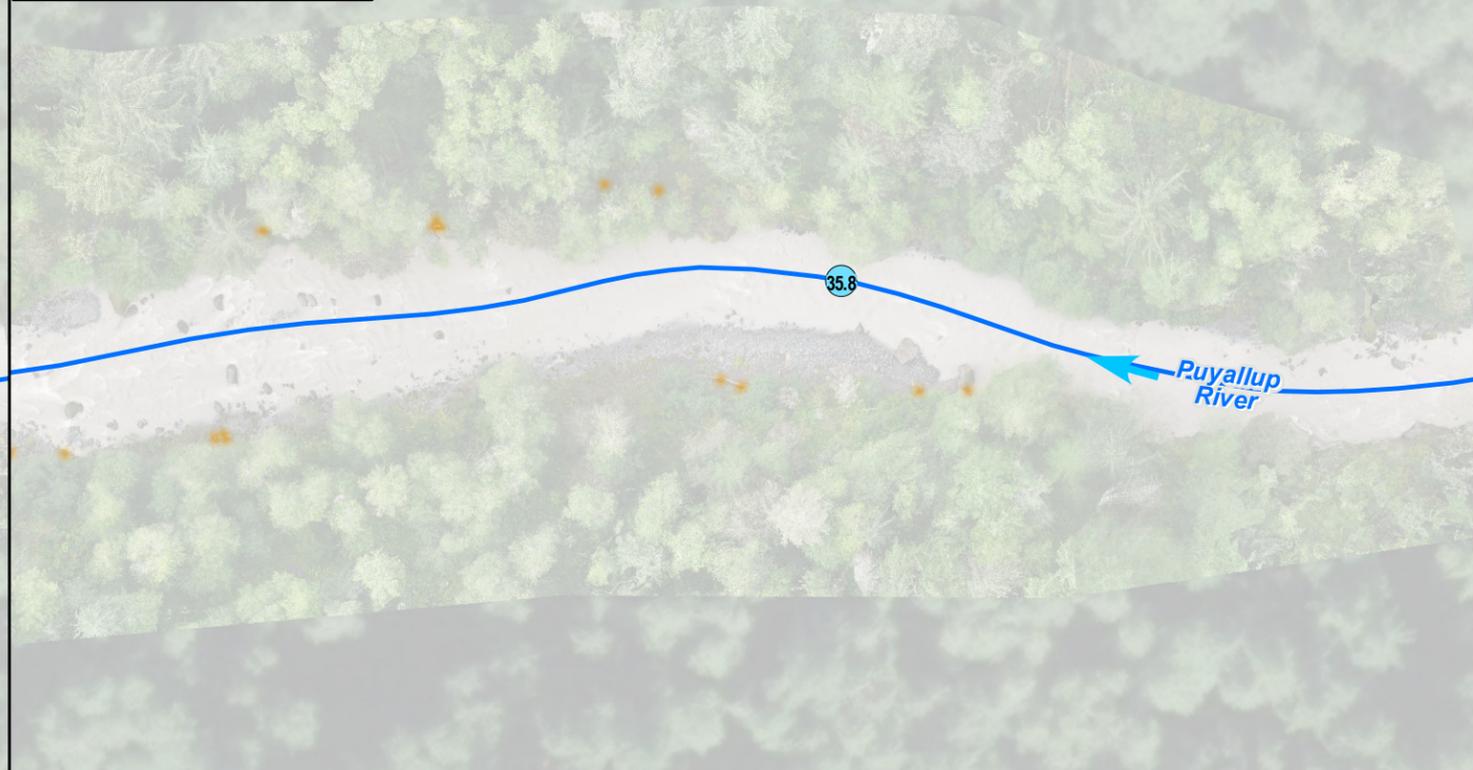
***Note: No debris could be positively identified. A spectral signature is a unique combination of wavelength reflectance patterns that distinguishes one material from another. See Tables 1 through 4 for the approximate spectral signatures.**
