**1978 90' Bering Sea Crabber**  
**"Big Blue"**

# **Report of Marine Survey**

**Report of Condition/Valuation of the Fishing Vessel**

**November 15, 2021**

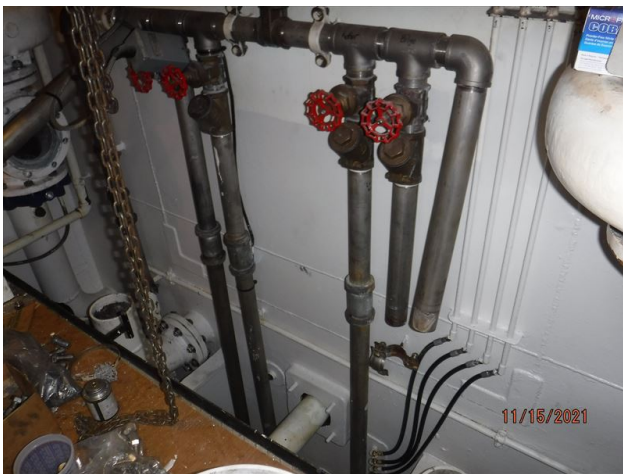
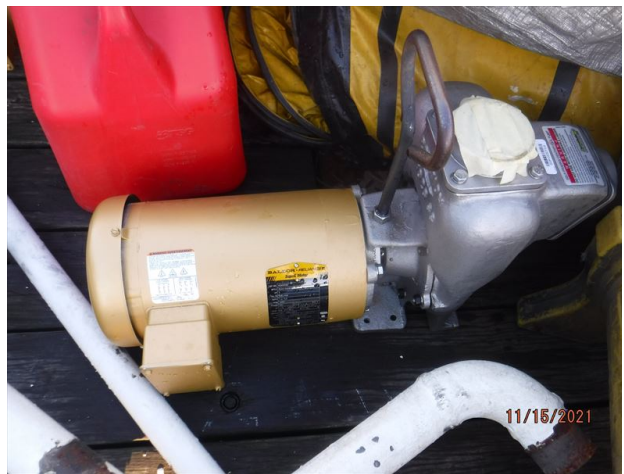
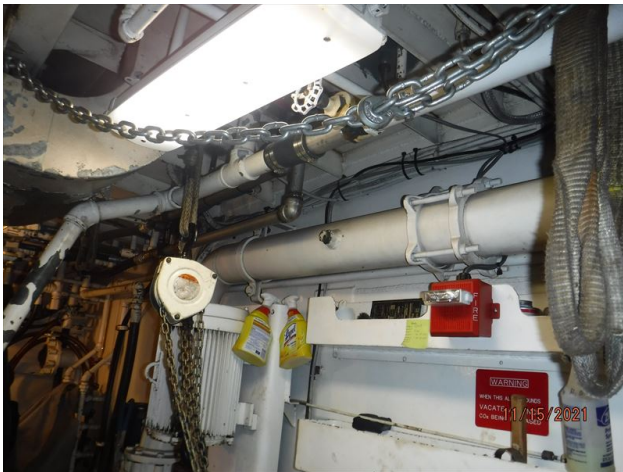
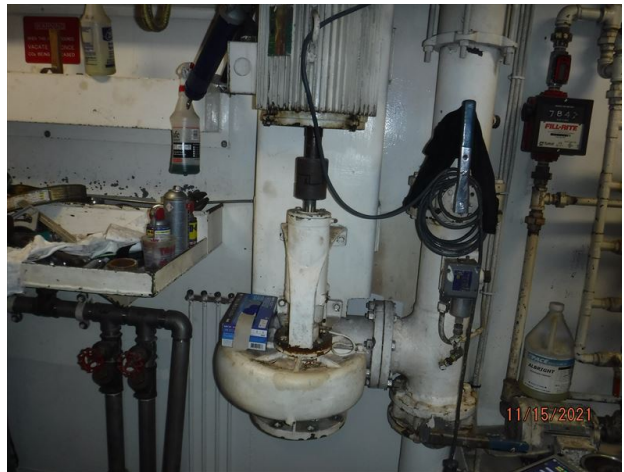
Two bilge manifolds. The smaller 2" manifold is all stainless steel piping. There are three (3) bilge pickups from the 2" manifold, one (1) for each bilge. The 2" manifold is also plumbed for (salt water) deck wash down (reference External Equipment > Washdowns). The larger of the two manifolds is a 6" crab tank circulation system serviced with Two (2) Deming 6" x 6" 20 Hp 208 VAC electric crab pumps. The system has been entirely renewed 2021.

-Two (2) Deming 6" x 6" 20 Hp 208 VAC electric crab pumps

- two (2) Banjo 2" pumps

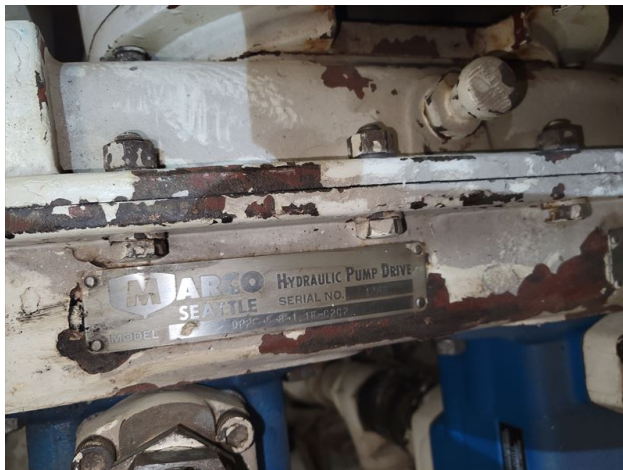
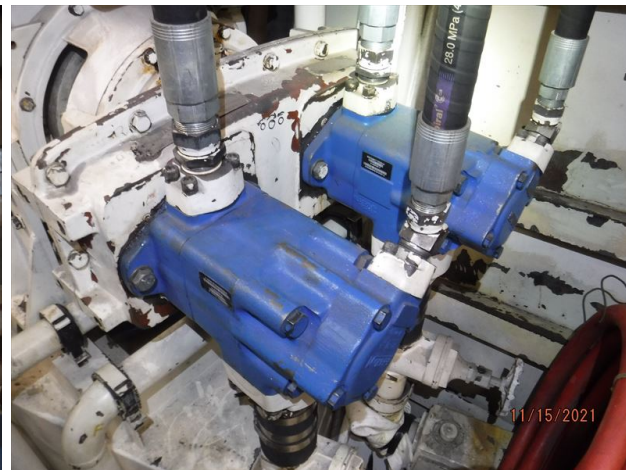
Two (2) Vickers dual 35/25 hydraulic pumps on a Marco DP26 pump drive PTO, Genset #1 port side. This system allows total hydraulic capacity to run 60 gallons of oil per minute at 2000 psi. There is an integral oil flow sensor in the pump that ramps the pumps up from a constant low 200 psi when the genset is running to full capacity when a remote flow valve is manually operated. This single flow valve will send a flow signal to either genset.

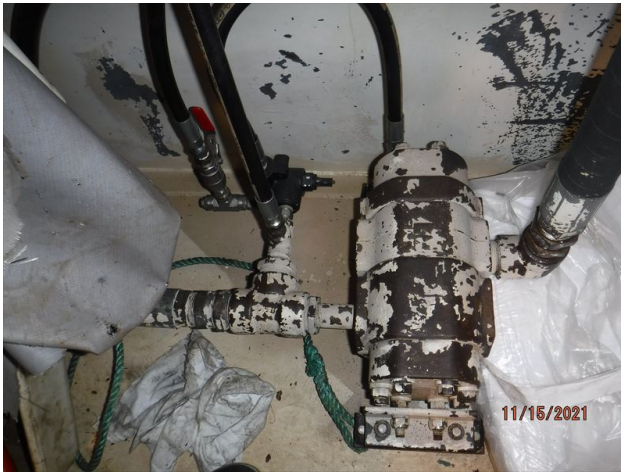
Engine room mounted oil flow splitter allows each system to service deck gear at variable flow rates

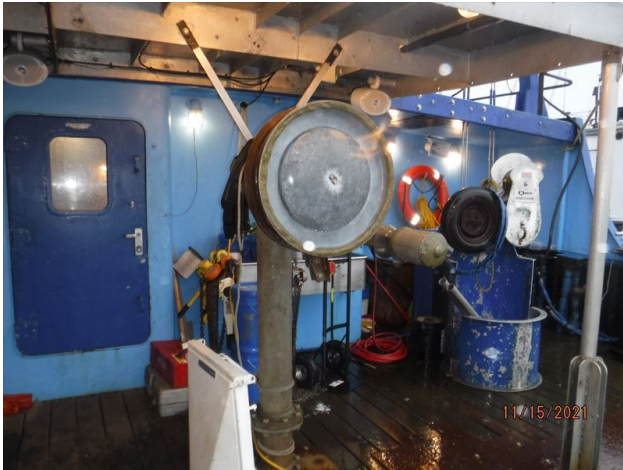
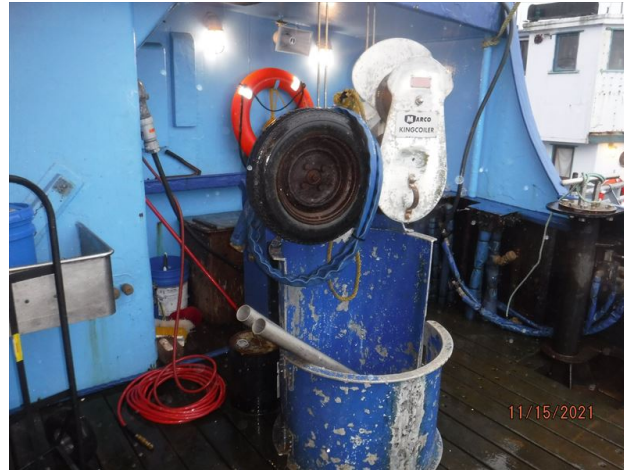
Hansen 8x8 double action pot launcher with dogs  
Mustad hook cleaner  
Marco longline auto baiter  
24" Marco hauler  
Aluminum sorting bins  
Marco King Coiler  
22" Marco crab block and davit

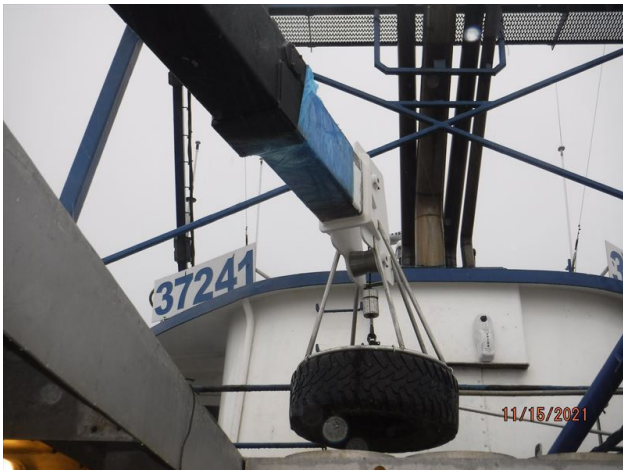
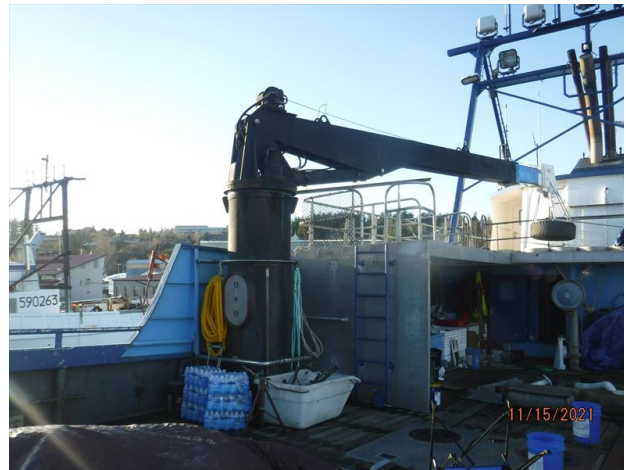
North American 8-ton extension deck crane with hydraulic Roltzer 2000 winch attached. The tip end and crab pot stabilizer have been recently rebuilt in stainless steel

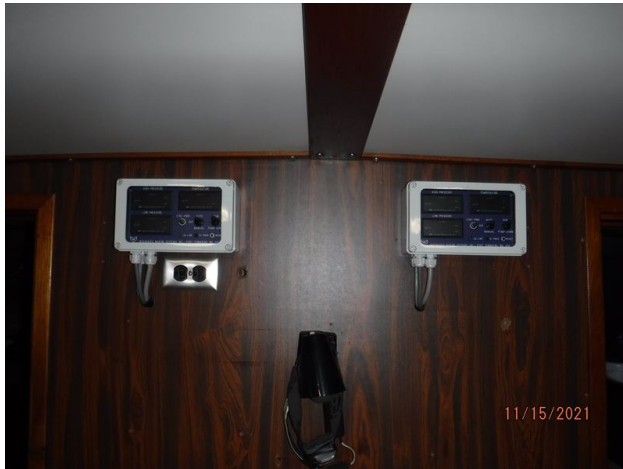
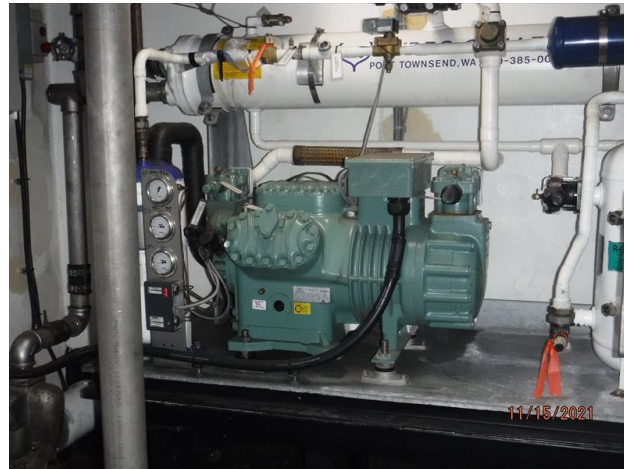
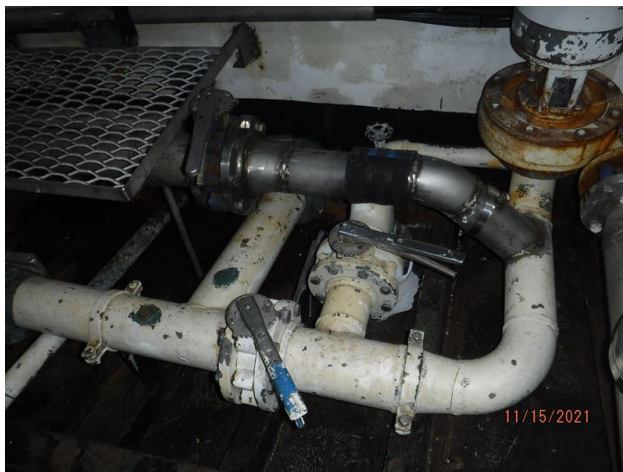
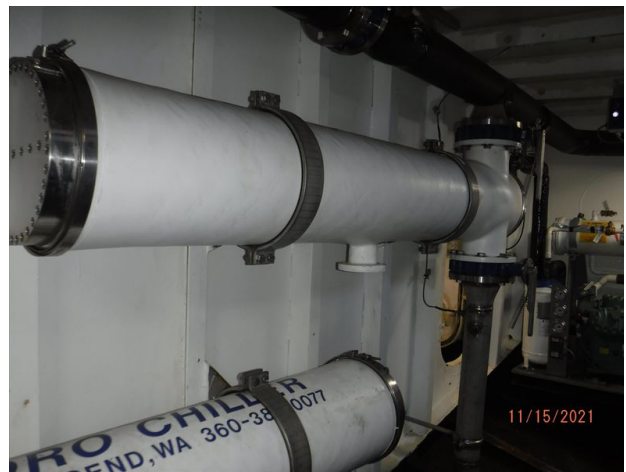
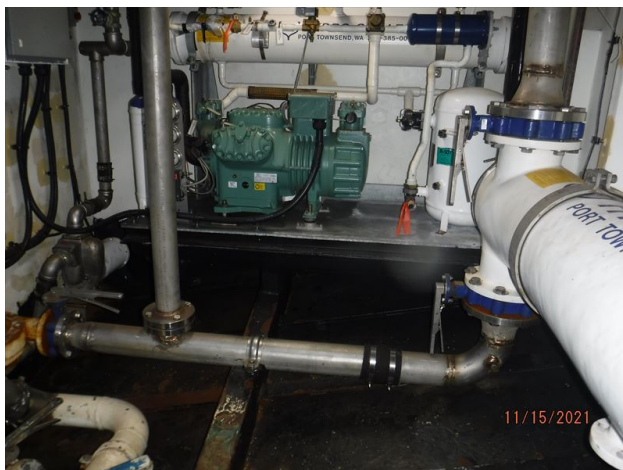
Two IMS chillers, 32.5 ton each with Carrier compressors. Stainless manifolds and titanium Hydro Chiller chiller tubes. R-507 gas. Each unit has two (2) control boxes, one at the wheel house helm, one in the compressor room with a 4" refrigerated seawater circulation manifold.

-Two (2) Vertiflo 4" x 4" self priming centrifugal refrigeration manifold pumps.

Two (2) 2" 208 volt condensor pumps

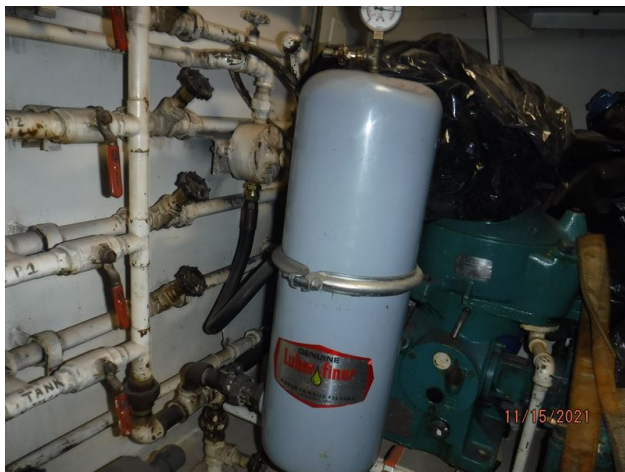
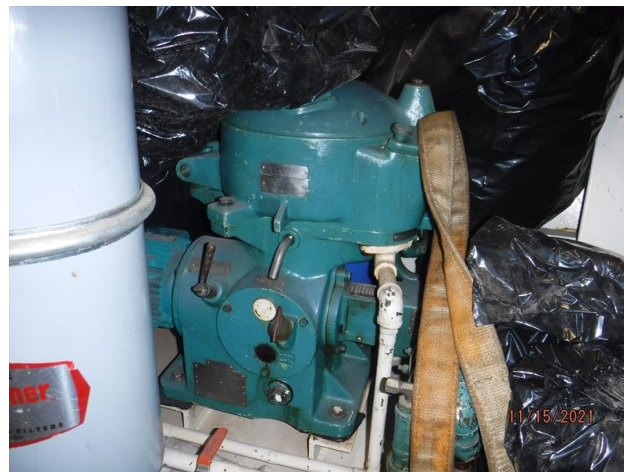
LubriFiner LP970-250 prefilter. West Falia fuel centrifuge OTB 2-00-66, demonstrated, rebuilt 1998.

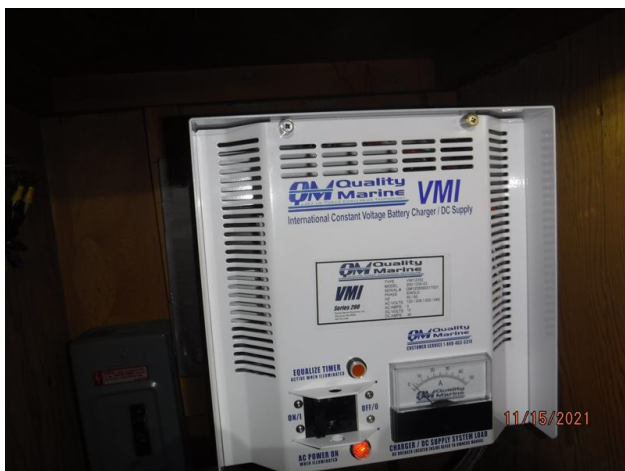
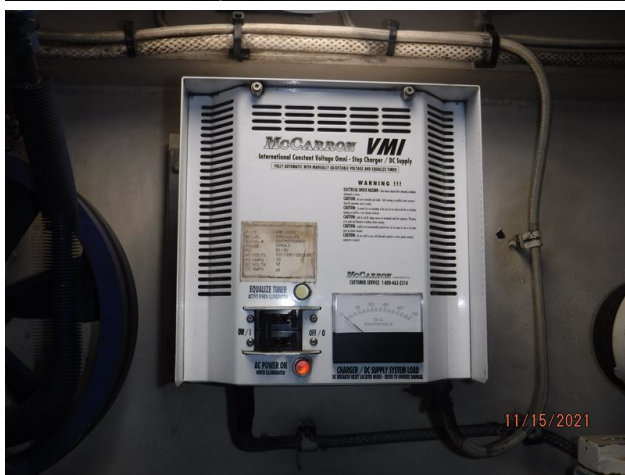
One (1) McCarron 12 volt 40amp constant volt charger

Two (2) Quality Marine VMI 12 volt 35 amp charger, input volts 120/208/220/240

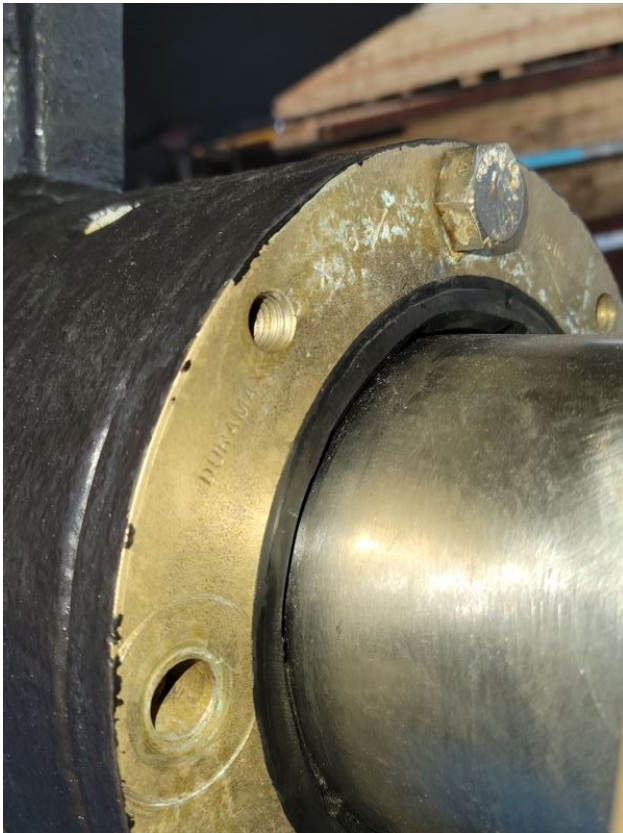
Duramax bronze encased rubber, newly installed 2021

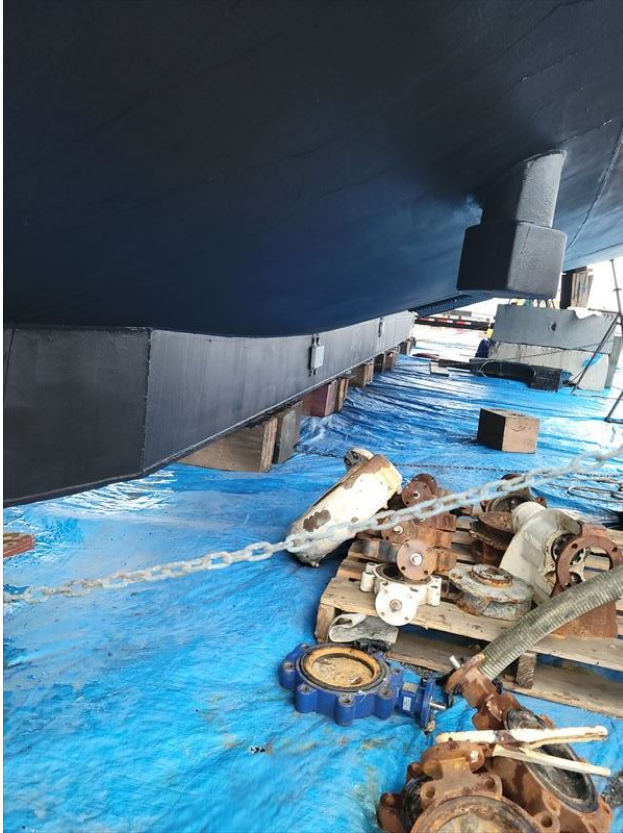
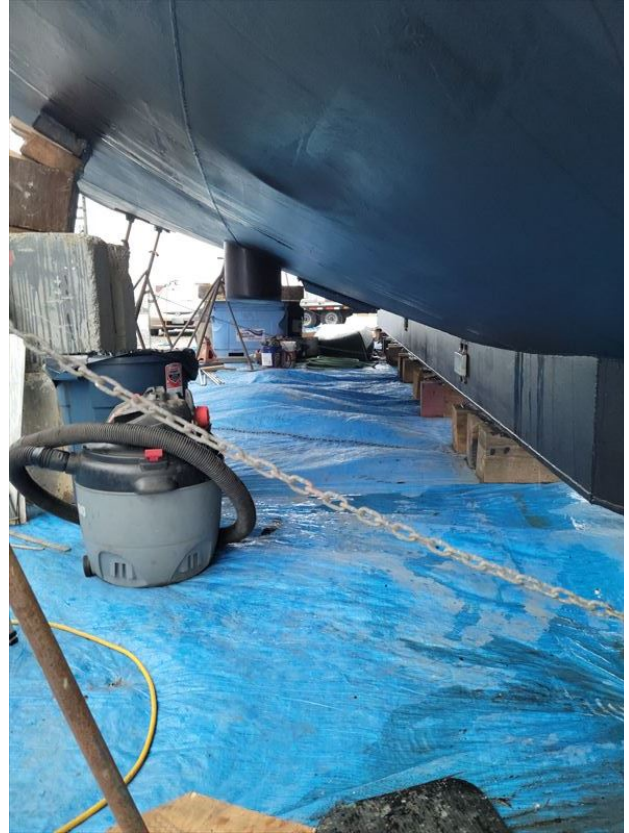
540 pounds new zinc annodes twenty seven (27) total

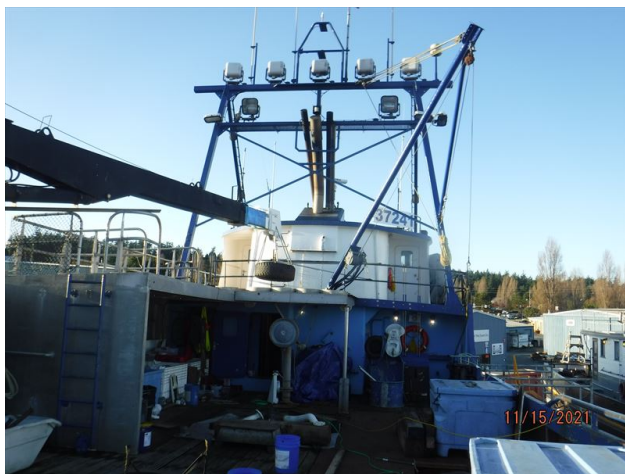
Steel A-frame with expanded metal cat-walk. There is a light platform above the catwalk with sodium lights mounted. Aft facing deck lights and picking lights are mounted at the catwalk. The radio antennas are mounted on small auxilliary steel mast mounting poles across the lighting platform
