1996 26' Robalo 2660 Cuddy

"Tuff Stuff"

Report of Marine Survey

Pre-Purchase Of The Vessel

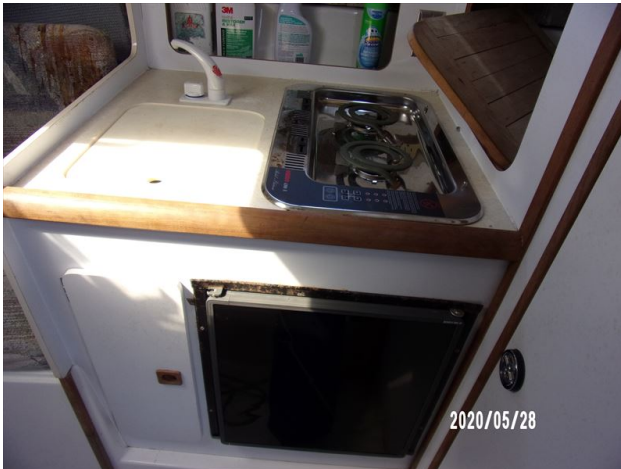
STOVE

Origo 4300 E alcohol/electric

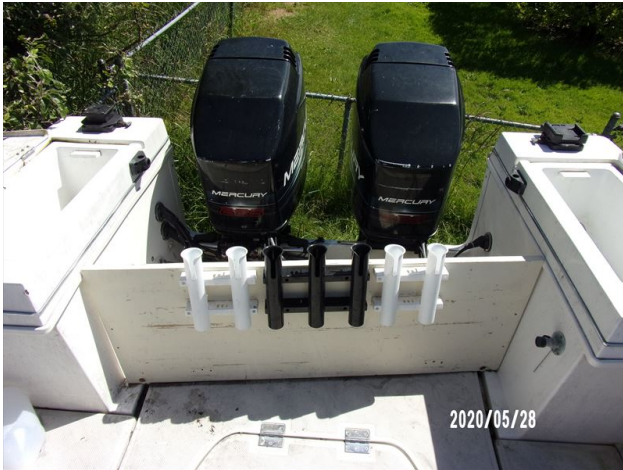
ENGINE MODEL

Twin Mercury Off Shore

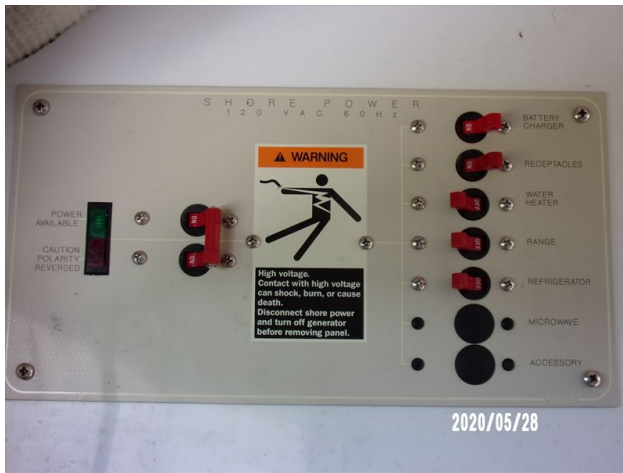
AC ELECTRICAL POWER OUTLETS

The AC outlet was tested using a UL Listed Circuit Tester. The GFCI protected outlet did not trip at its test button.

The GFCI electrical outlets located in the **** failed to trip with a UL Listed Circuit Tester and by their test buttons.

Replace the outlet, as necessary.

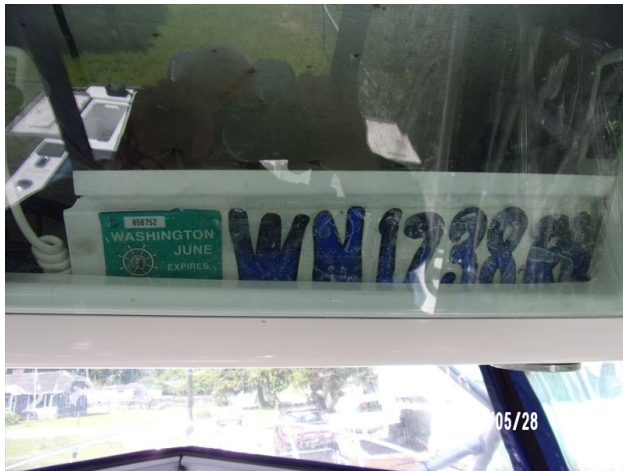
STATE REGISTRATION COMPLIANCE (33 CFR 173)

The vessel's State Registration Numbers were not displayed according to U.S.C.G. Standards.

FINDING C-6
The vessel's State Registration Numbers were not displayed according to U.S.C.G. Standards.
RECOMMENDATION
Properly display State Registration Number for compliance. Numbers must be painted or permanently attached to each side of the forward half of the vessel. The numbers must be read from left to right, and of a color that is contrasting with the background color. The validation sticker must be affixed within six inches of the registration number. No other letters or numbers may be displayed. Nearby lettering must be in plain, vertical block characters of not less than 3 inches in height. Spaces or hyphens between letter and number groupings must be equal to the width of a letter other than "I" or a number other than "1".
