1. Roofing • Sloped roofing

Condition: Asphalt shingles • Damage

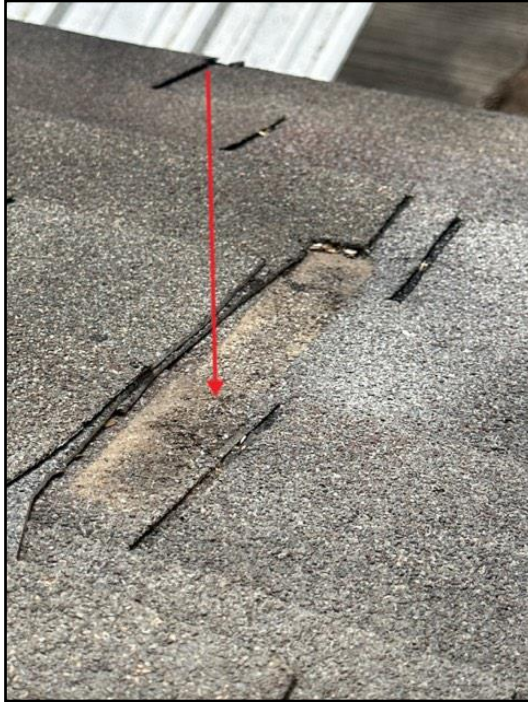
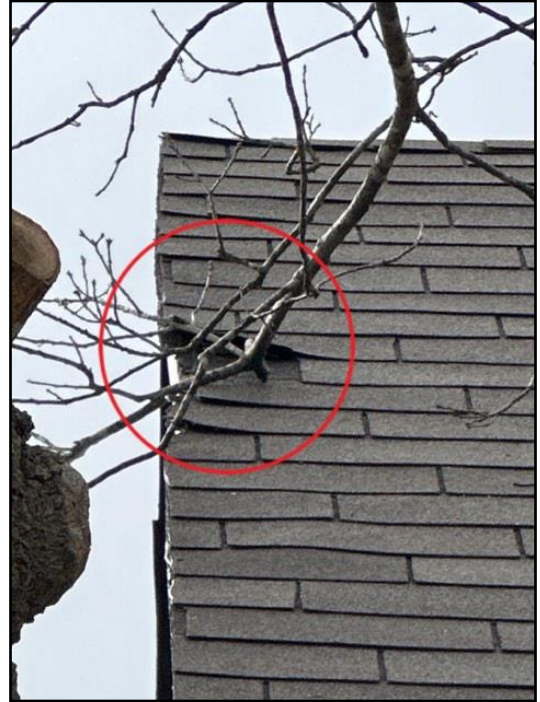
Location: Exterior east/rear

Tree limb has caused damage to the asphalt shingles recommend a professional licensed roofing contractor and arborist make repairs

Action: \$ Allowance \$500

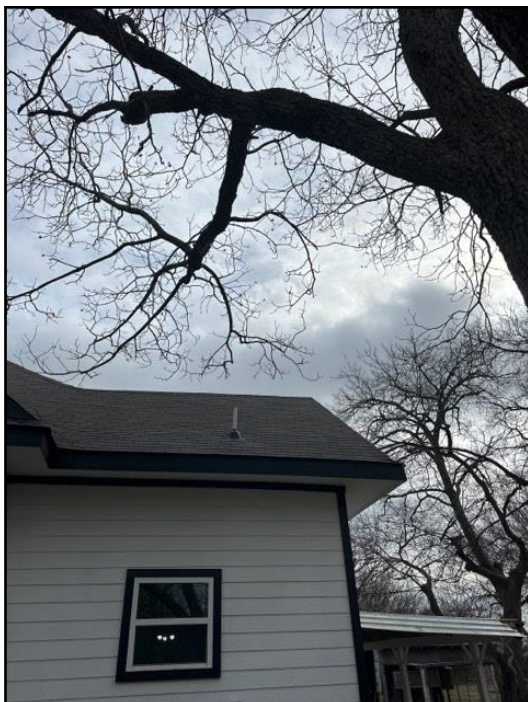
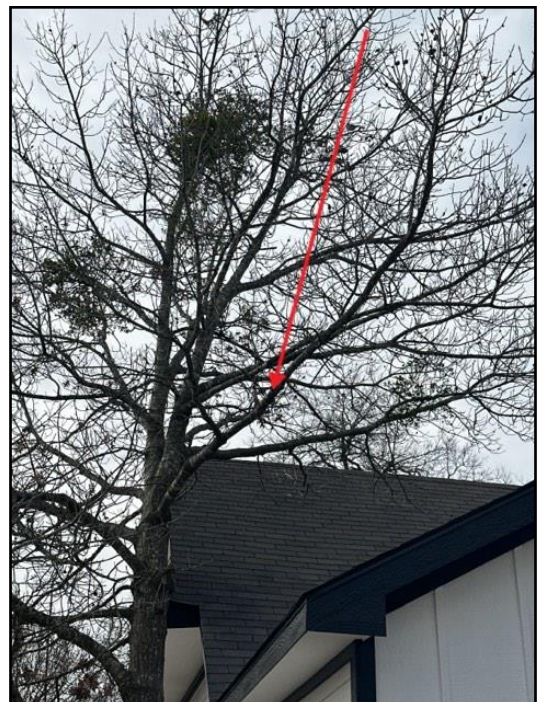
2. Roofing • Sloped roofing

Condition: Asphalt shingles • Tree branches touching roof

Location: Exterior east roof/various locations

Recommend a professional licensed tree arborist make repairs

Action: Repair

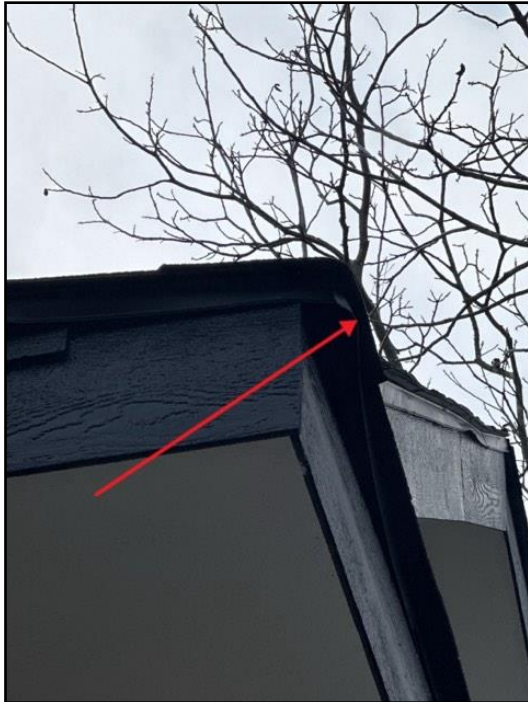
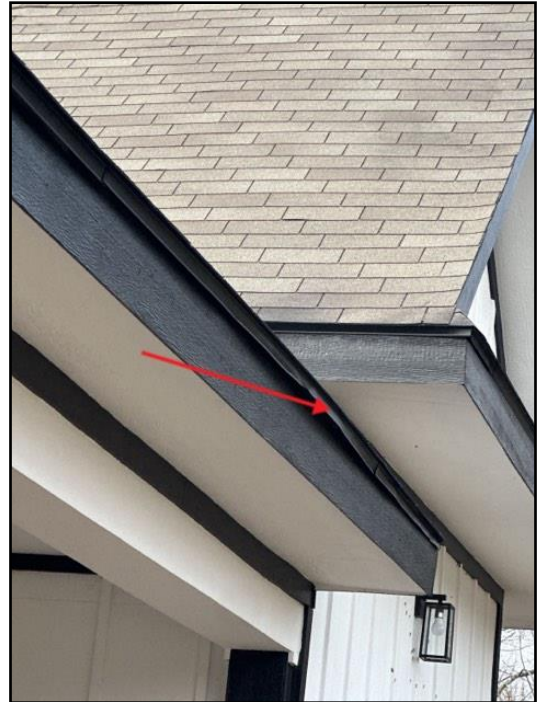
3. Roofing • Sloped roof flashings

Condition: Drip edge flashings • Loose

Location: Exterior front/various locations throughout the exterior

Drip edge loose, recommend a professional licensed contractor make repairs

Action: Repair

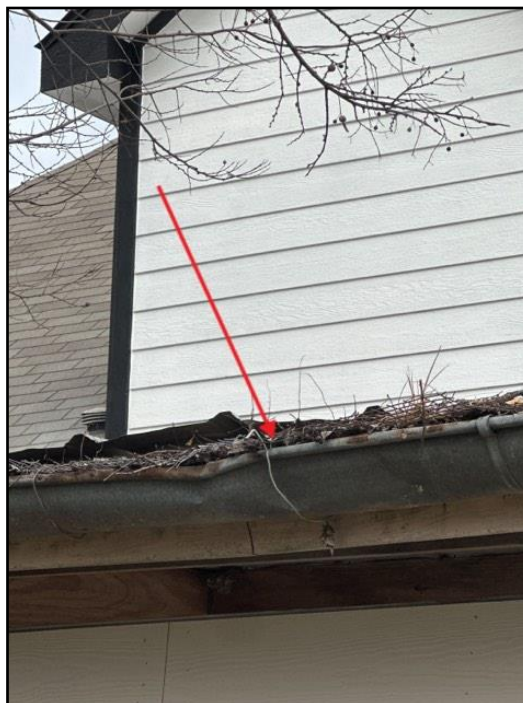
4. Exterior • Roof drainage

Condition: Gutters • Clogged

Location: Exterior rear

Gutters clogged recommend a professional, licensed contractor, clean the gutters

Action: Repair

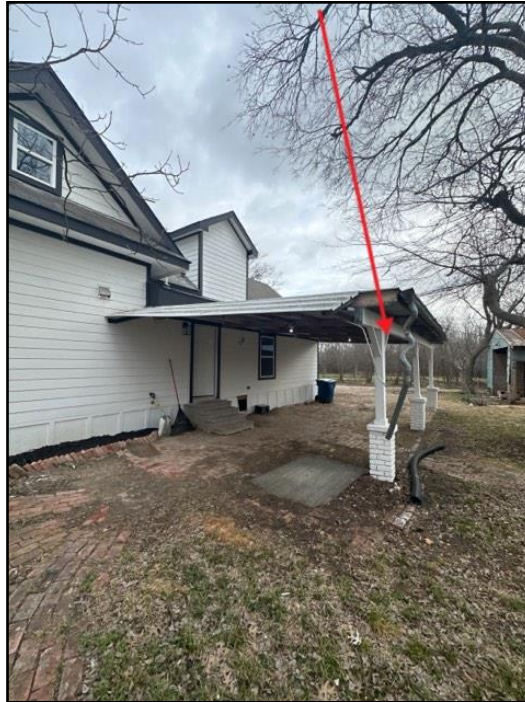
5. Exterior • Porches, decks, stairs, patios and balconies

Condition: General notes • Poorly built

Location: Exterior rear

Rear porch cover is not safely built and the post are leaning and not structurally sound. Additionally, the gutters are damaged and the electrical is unsafe. recommend a professional licensed contractor further evaluate make repairs

Action: Repair

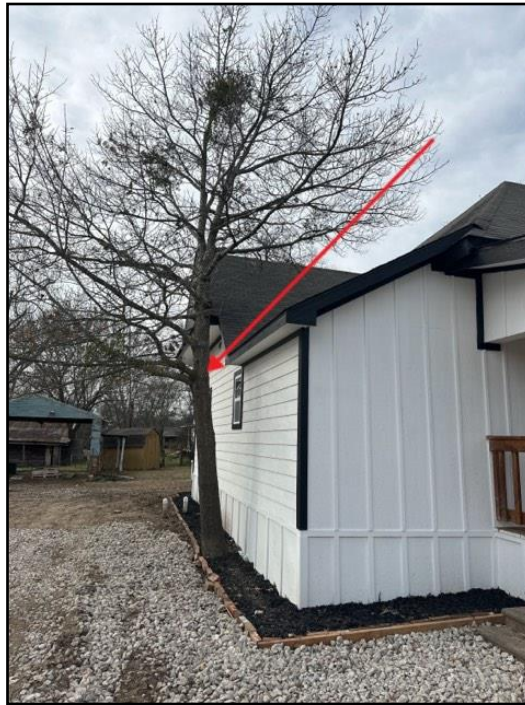
**6. Structure • Foundations**

Condition: General notes • Large trees close to building

Location: Exterior east/

Large tree close to home. This can present foundation issues as well as roof issues recommend a professional, licensed arborist further evaluate and make repairs.

Action: Repair

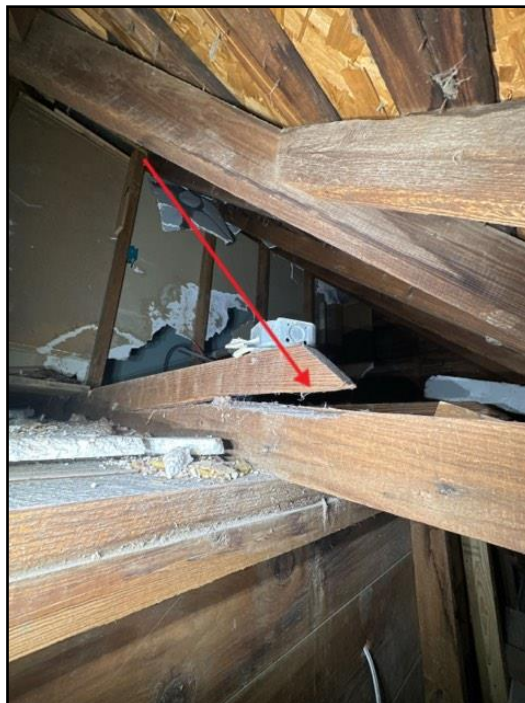
7. Structure • Roof framing

Condition: Rafters/trusses • Rot, fire or insect damage

Location: Attic various locations

Attic rafters and some structural components, have damage. Recommend a professional licensed structural contractor, further evaluate and make repairs

Action: Repair
