# Peace of Mind Automotive Inspection Report.

Score	4 / 4 (100%)	Flagged items	0	Actions	0
<b>Site conducted</b>					Unanswered
<b>Customer name</b>					Lmj auto motor sales
<b>Date / Time</b>					May 19th
<b>Payment method</b>					Invoice
<b>Inspection cost</b>					199
<b>Vehicle Year / Make / Model / Color</b>					2016 infinity qx50
<b>VIN</b>					31492 last 5

<b>license plate</b>					Dealer
<b>Mileage</b>					137310
<b>Color</b>					Burgundy

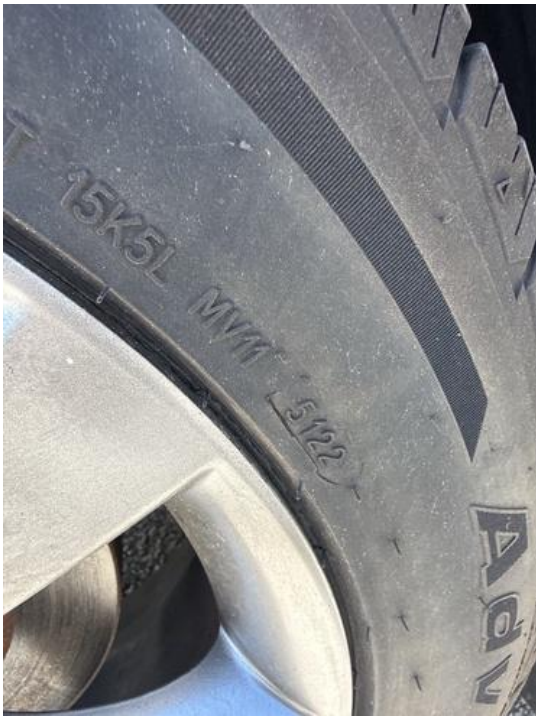
Photo 102

All four tires are matching and in healthy condition. Tires are dated from 2022. All four tires have right around 75% life remaining and are evenly worn.

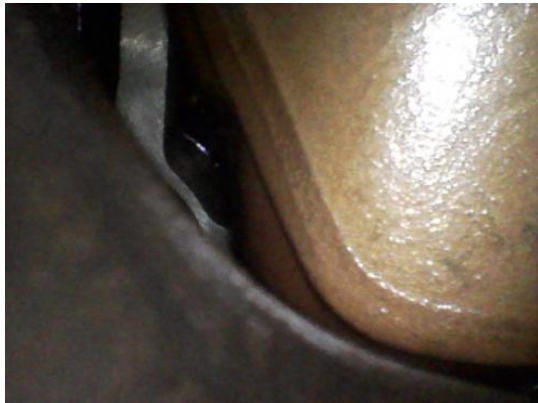
Photo 116

<b>Radiator condition / function</b>	Healthy
<b>Engine operating temperature</b>	Healthy
<b>Cooling fan function</b>	Healthy
<b>Drive belt condition</b>	Healthy
<b>Abnormal engine knock</b>	None
<b>Abnormal valve train rattle</b>	None
<b>Abnormal bearing noises</b>	None
<b>Engine gunk / sludge</b>	None
<b>Fuel tank</b>	Healthy
<b>Fuel injectors / lines</b>	Healthy
<b>Valve cover gaskets</b>	Healthy
<b>Intake manifold gasket</b>	Healthy
<b>Cylinder head gasket</b>	Healthy
<b>Oil pan gasket</b>	Healthy
<b>Timing cover gasket</b>	Healthy
<b>Rear main seal</b>	Healthy
<b>Timing belt / components</b>	Healthy
<b>Exhaust manifold</b>	Healthy
<b>External engine accessories</b>	Healthy

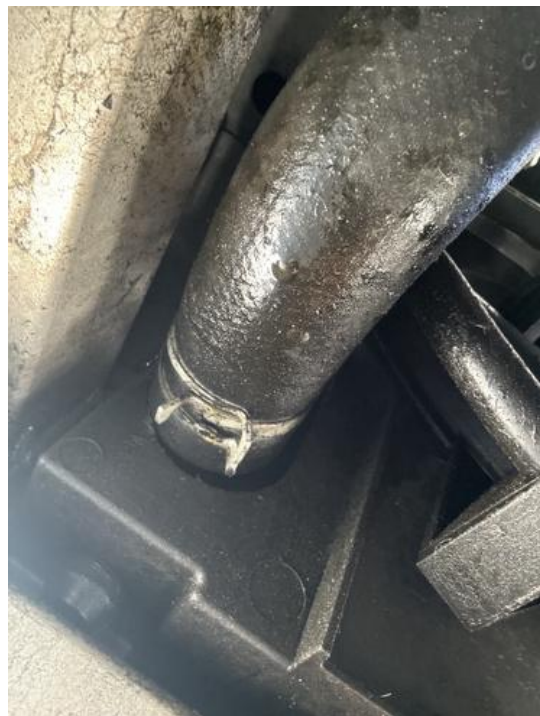
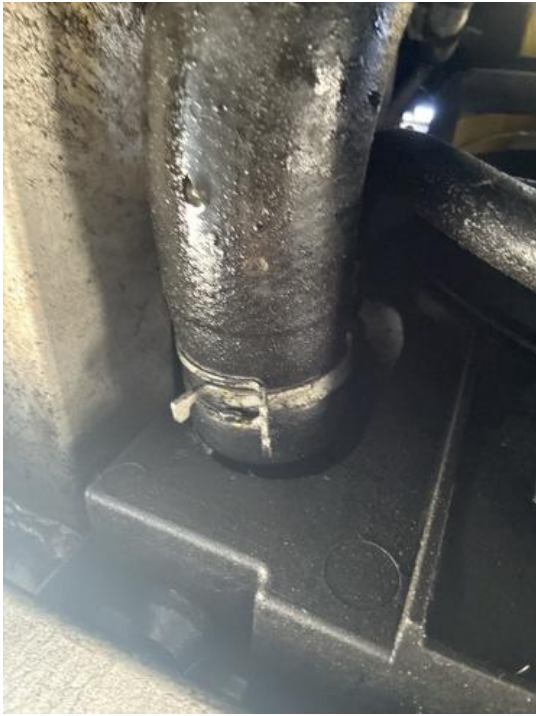
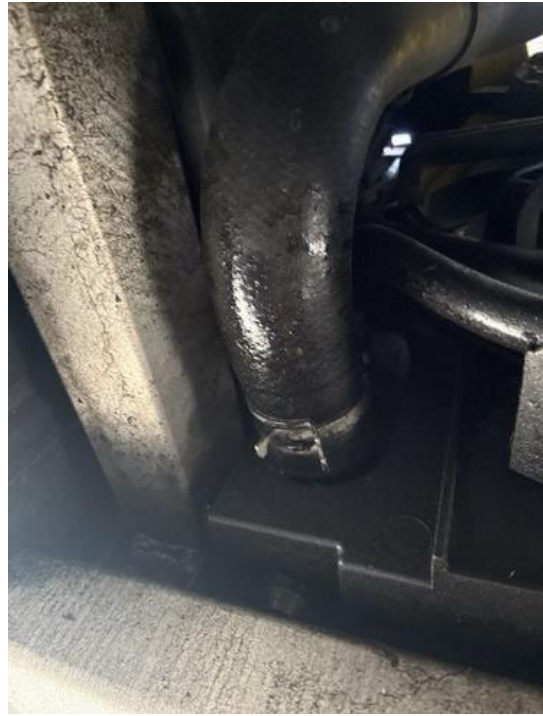
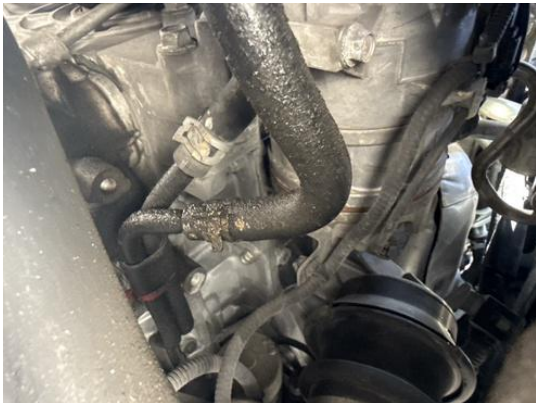
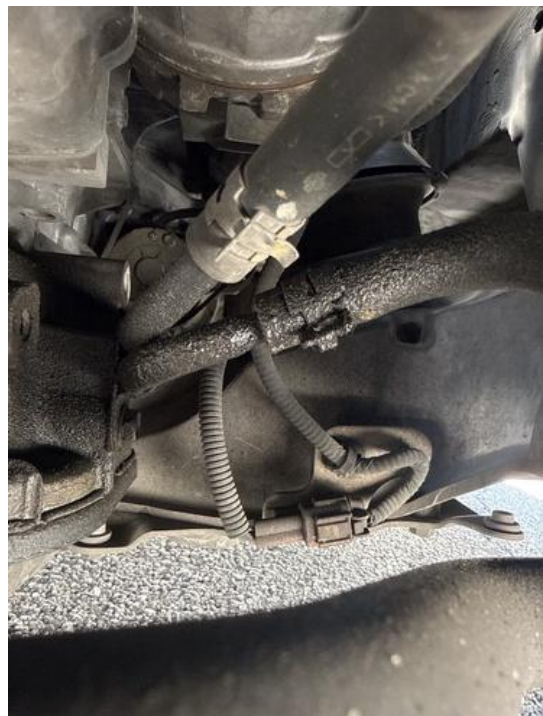
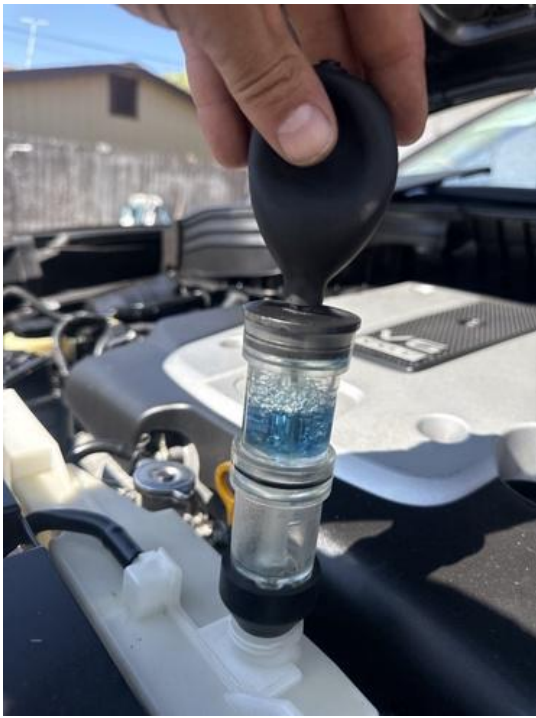
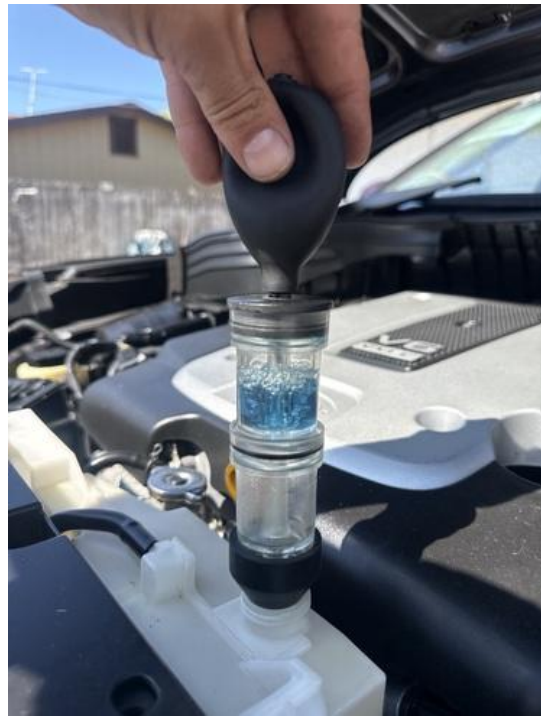
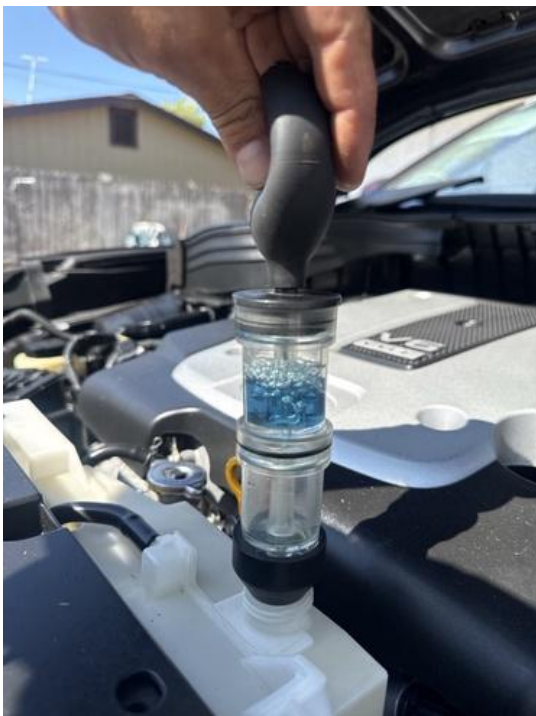
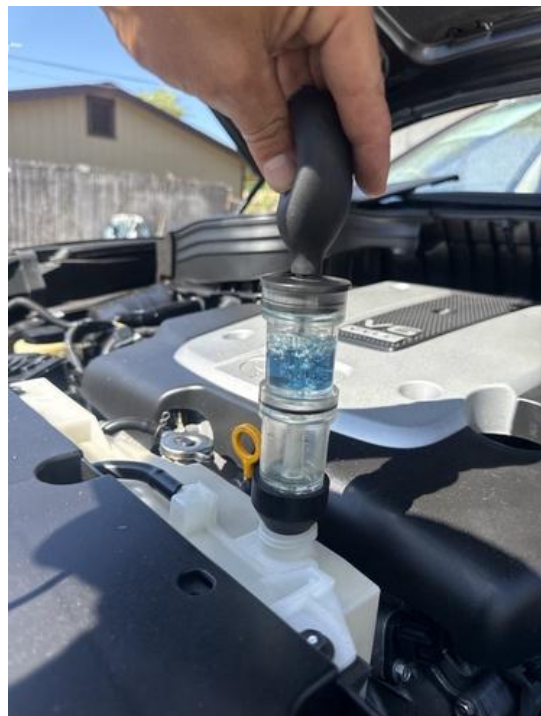
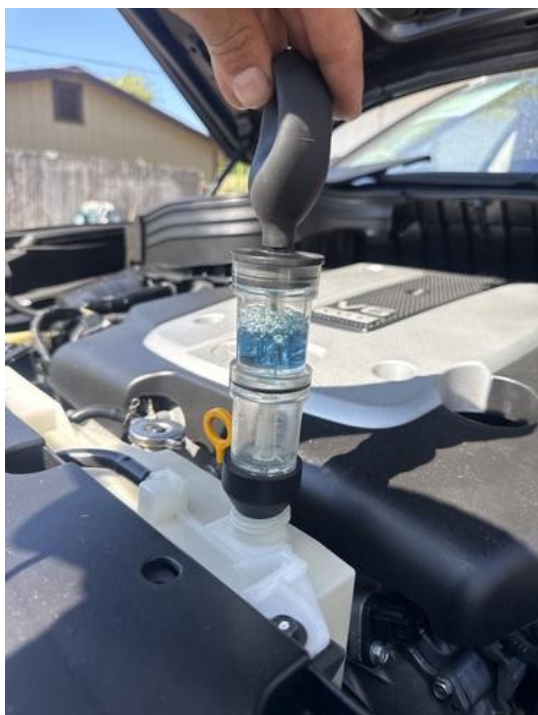
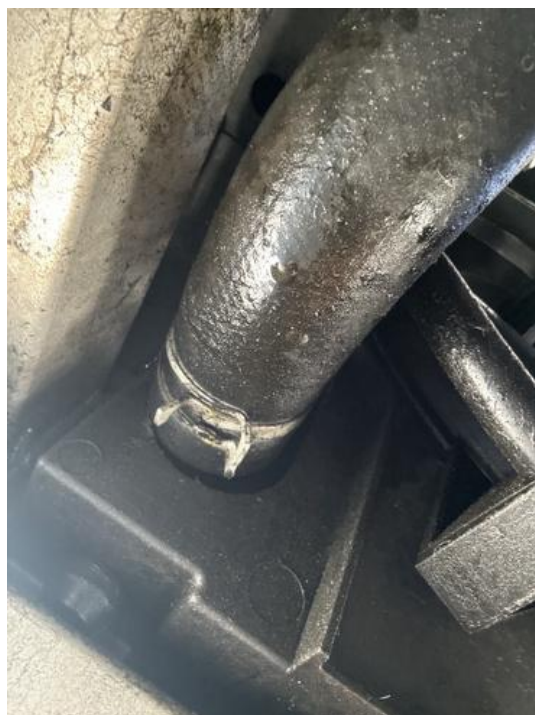
**Engine Testing / Condition**

**Air filter condition**

Normal wear

**Engine oil condition**

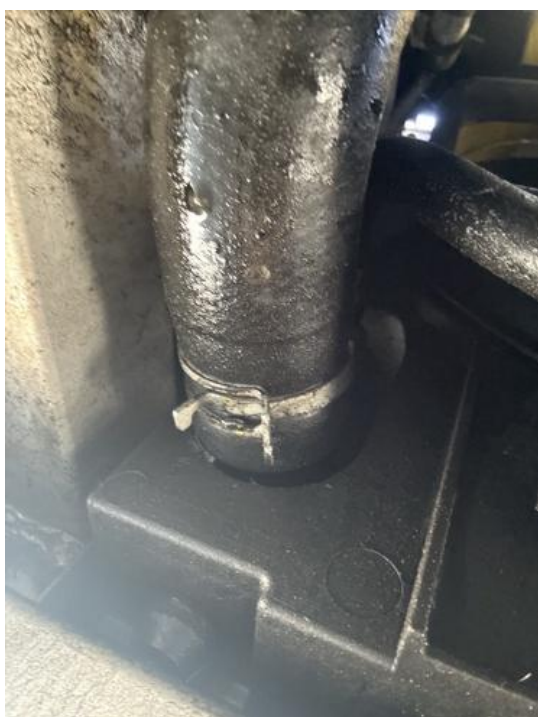
Photo 136

Looks to be a small amount of seepage from the lower radiator hose that connects to the bottom driver side

of the radiator

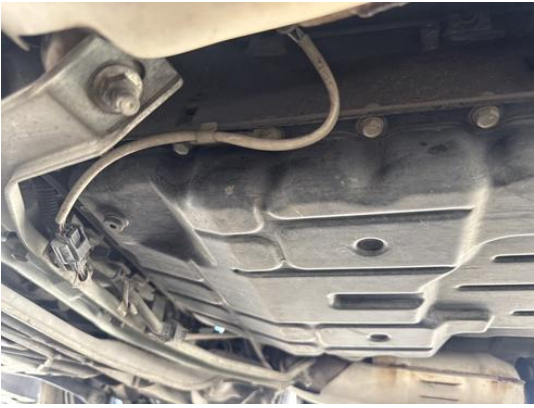
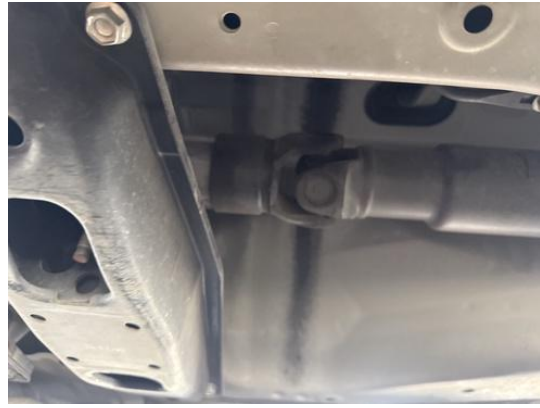
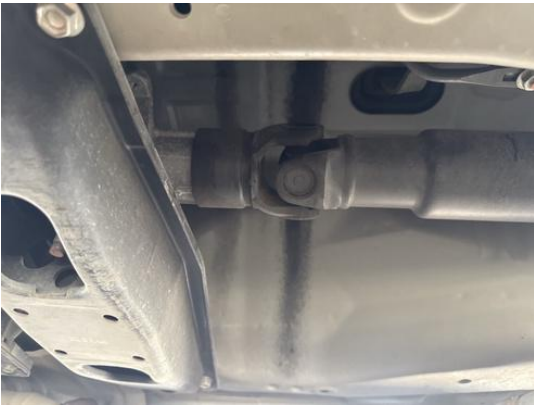
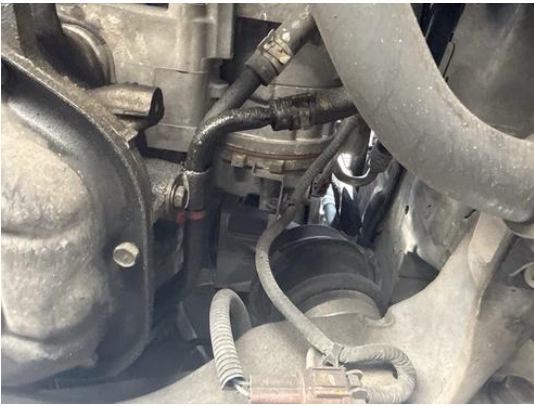
No transmission fluid leaks from the transmission casing or the transmission pan area. The tail shaft seal is free of any fluid leaks. The driveshaft is in healthy condition. Shift transitions out on the road are correct across the board. No fluid leak out from the rear differential.

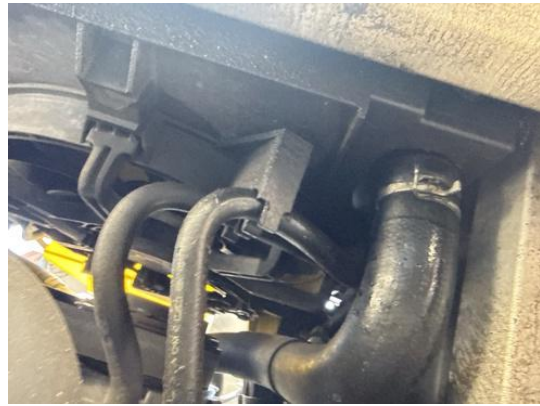
Photo 143

Small amount of seepage noticed at the transmission cooler lines that connect toward the front of the radiator

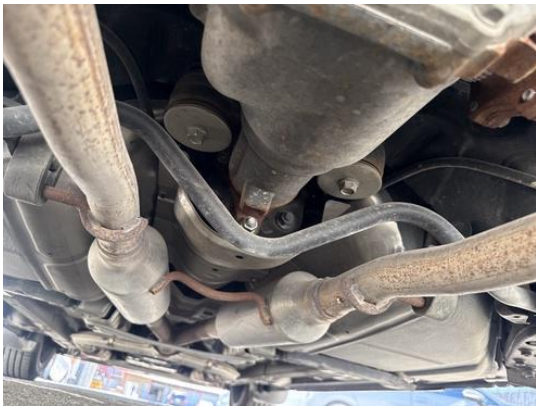
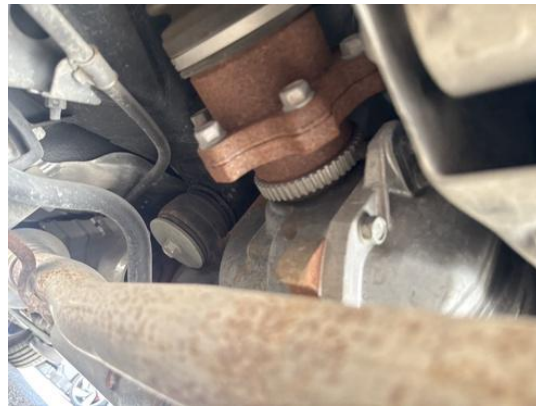
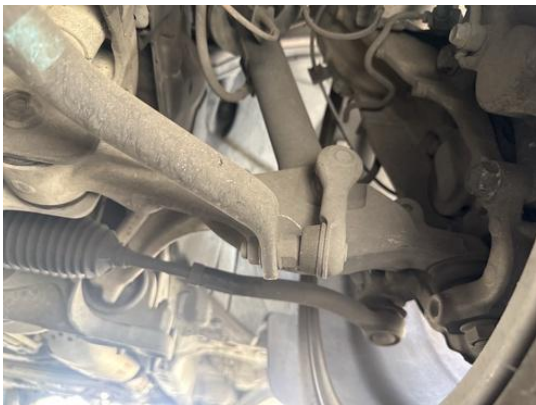
**Rear differential condition**

**Differential leaks**

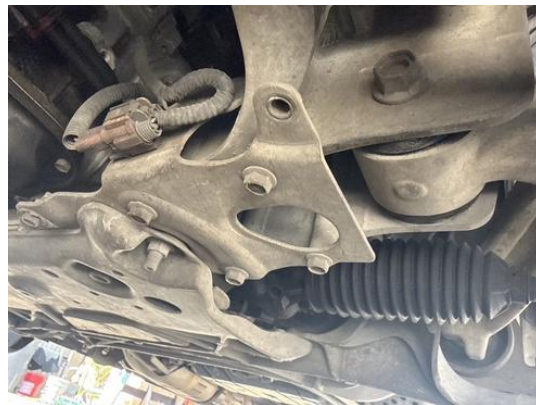
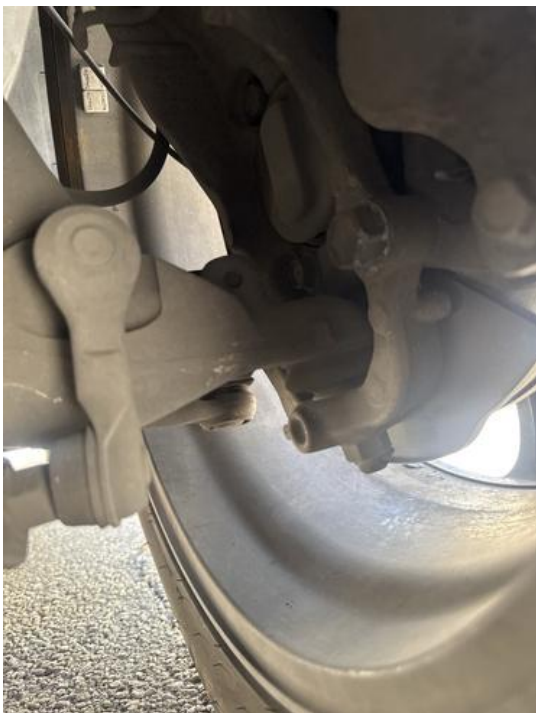
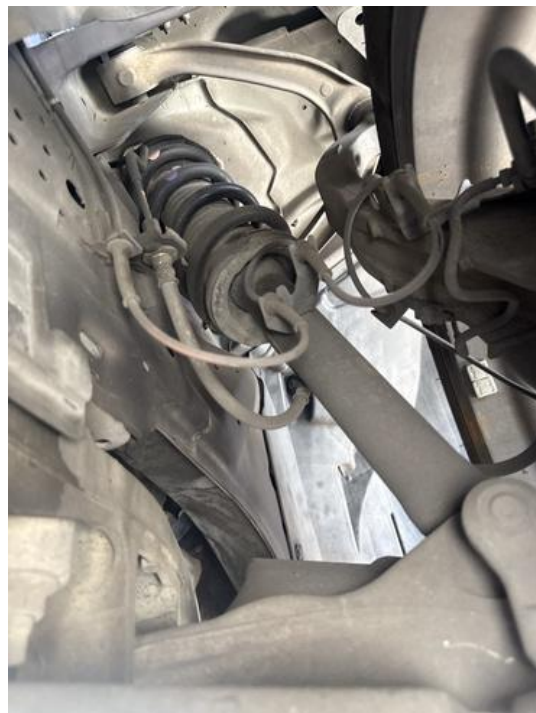
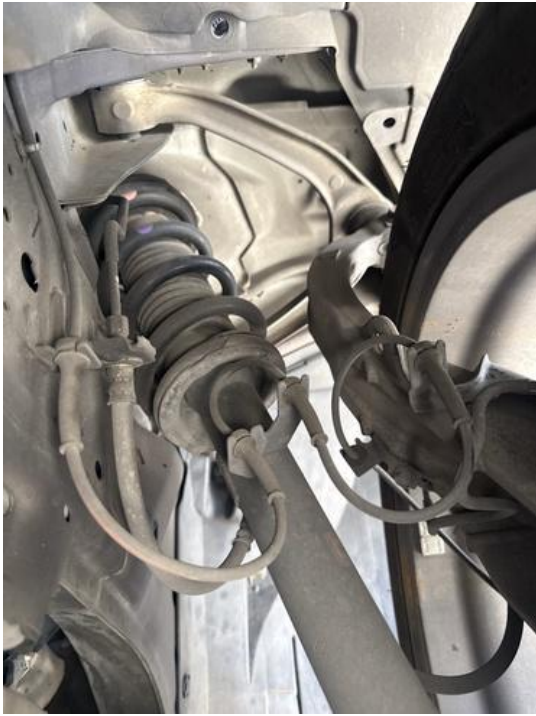
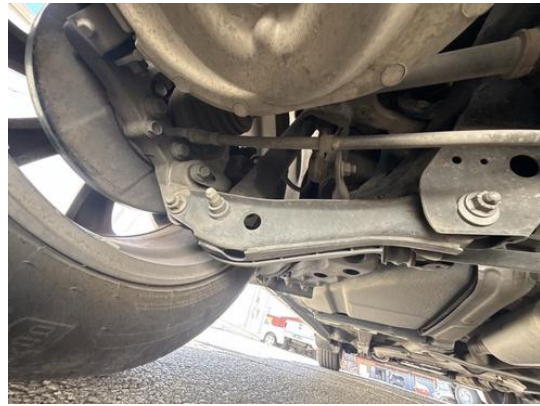
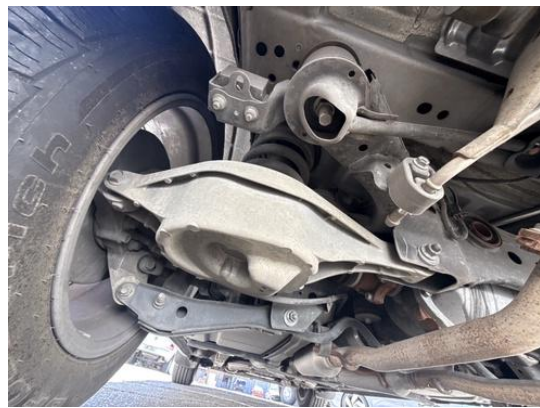
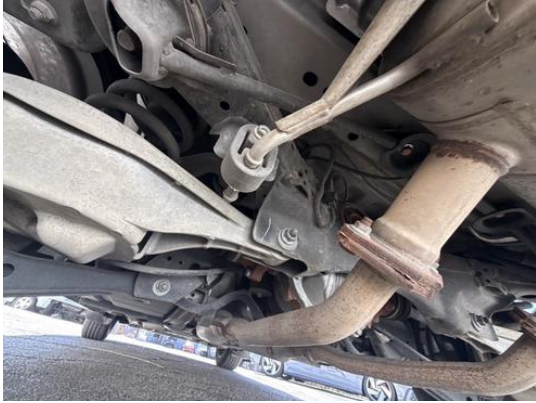
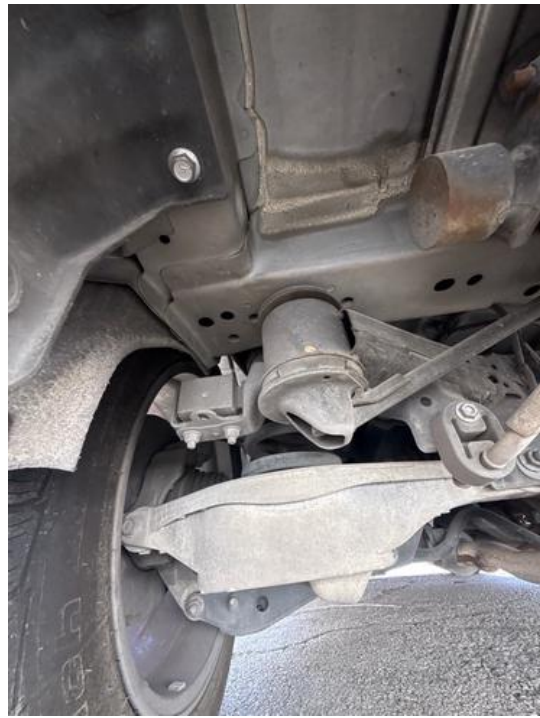
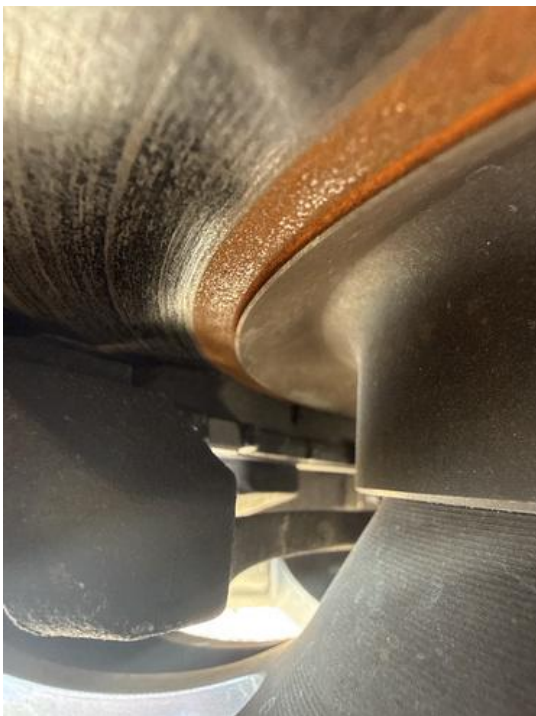
Normal fatigue notice to the suspension components. All of the suspension components seem to be original. None of the suspension components are blown out and due form the replacement. The No excessive surface rust on the exposed metal. No abnormal noise or feedback from the suspension while out on the road. All of the rubber in relation to the mounts, joints and bushings has decent texture.
