Peace of Mind Automotive Inspection Report.

Score	4 / 4 (100%)	Flagged items	0	Actions	0
Site conducted					Unanswered
Customer name					Luis LMJ auto motor sales
Date / Time					April 6th
Payment method					Invoice
Inspection cost					Fleet
Vehicle Year / Make / Model / Color					2017 jeep grand Cherokee
VIN					00262 last 5

license plate					Dealer
Mileage					117206
Color					Grey

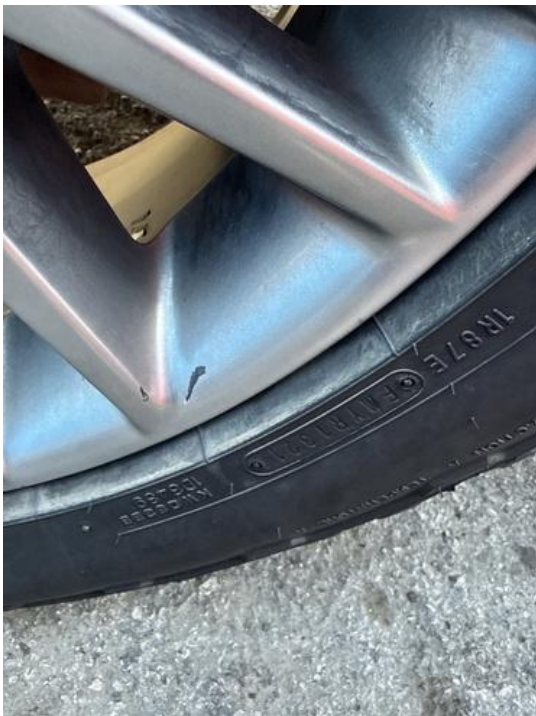
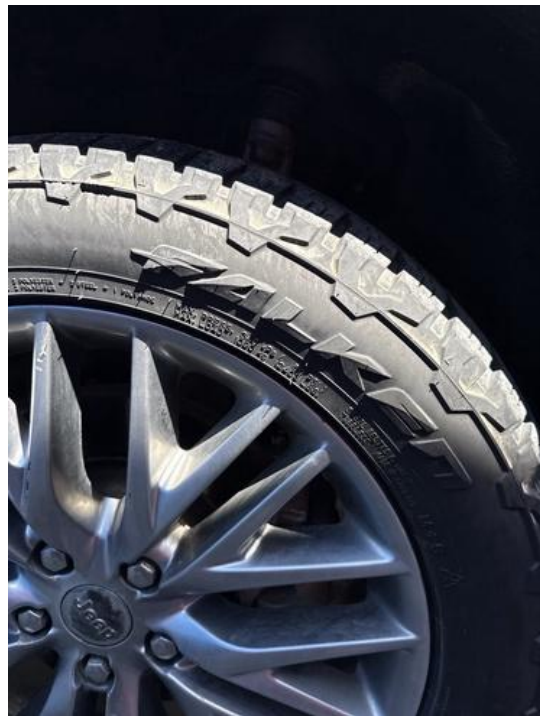
Tire condition**Front driver side tire**

50-75% remaining

All four tires are matching. Tires are dated from 2021. All four tires are evenly worn and have right about 50% tread life remaining all around.

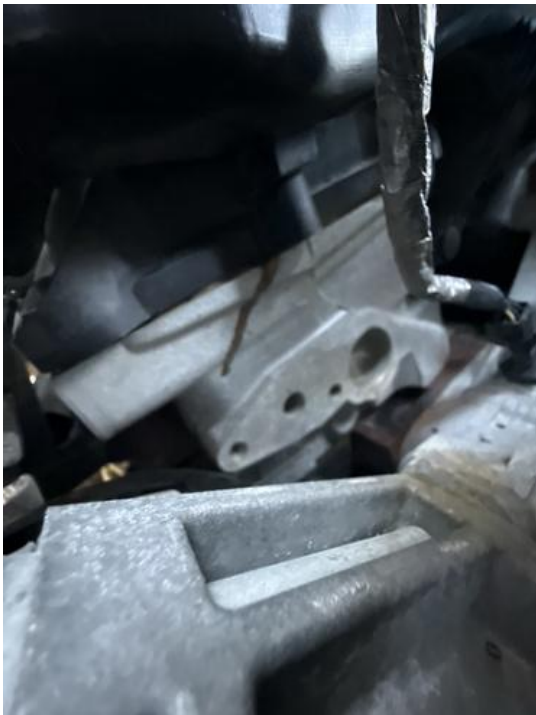
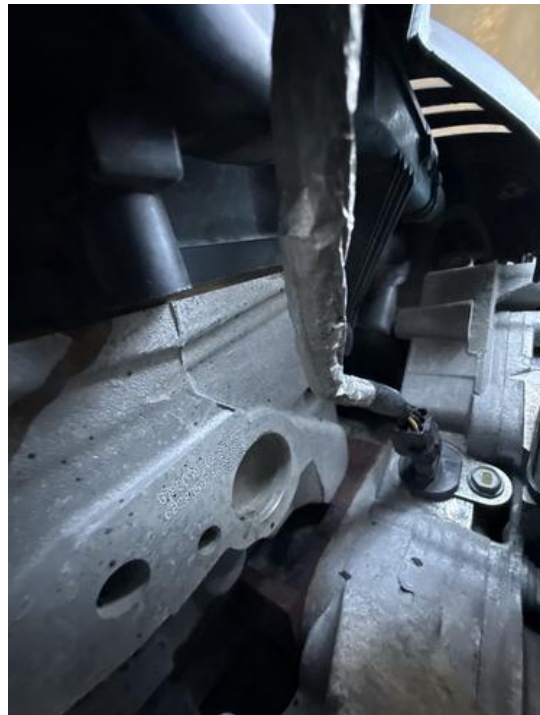
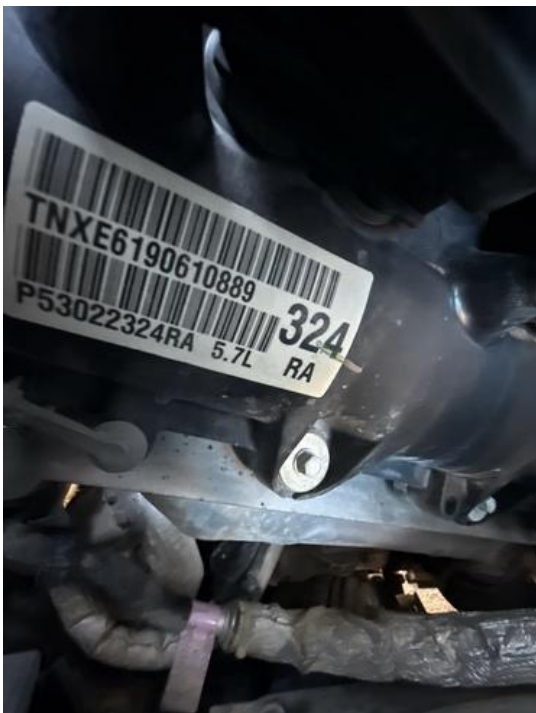
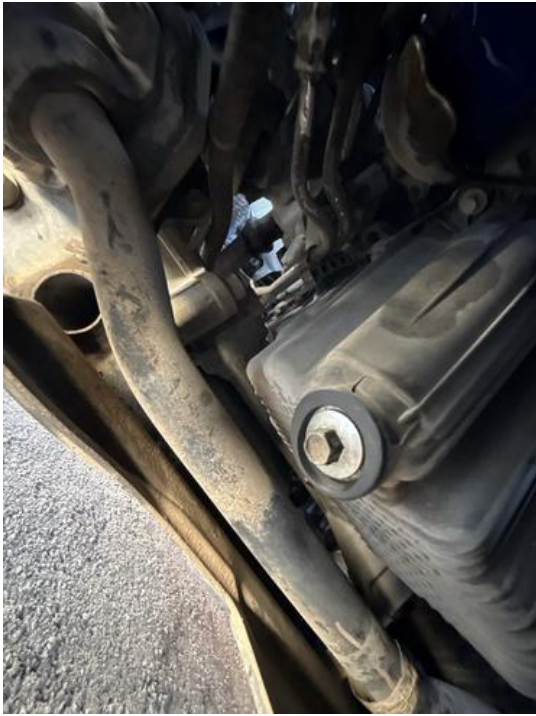
Internal engine inspection w/ borescope camera

Engine clean internally, no gunk or sludge presents. Proper signs of maintenance present. Block test passed, no internal combustion leak out. Coolant mixture correct and cooling system functionality is healthy. All external engine accessories in good working. No leaks or seepage from anywhere on the engine. External drive belts in decent condition. Currently no concern in mechanical issues present in relation to the engine or related accessories.

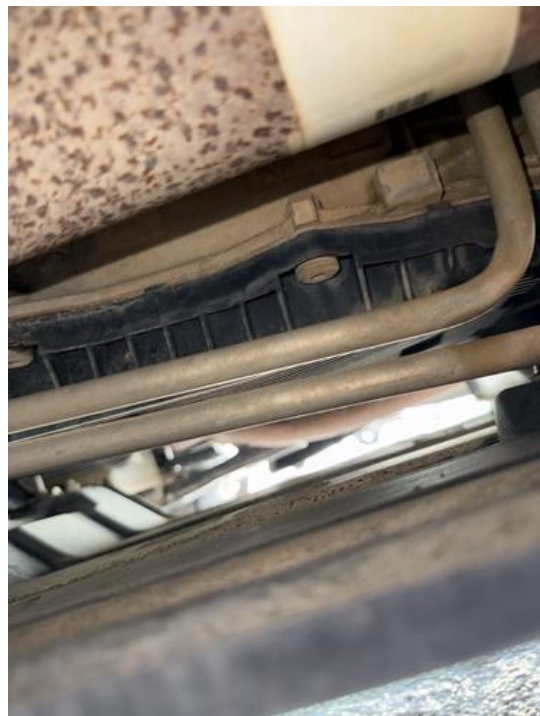
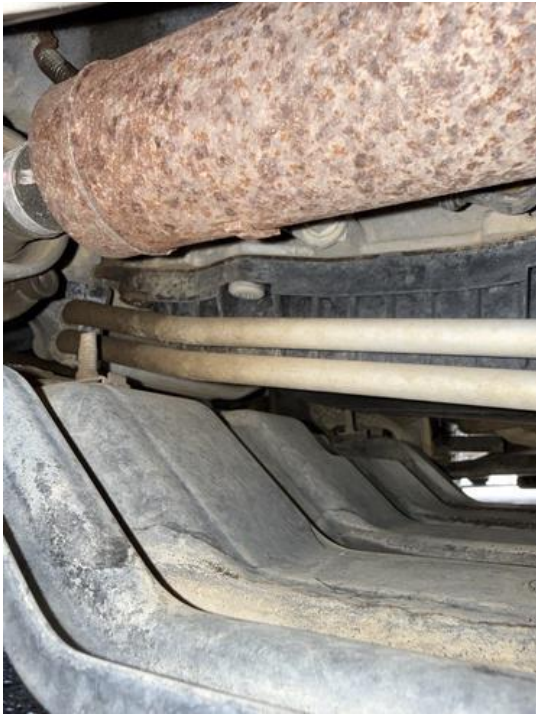
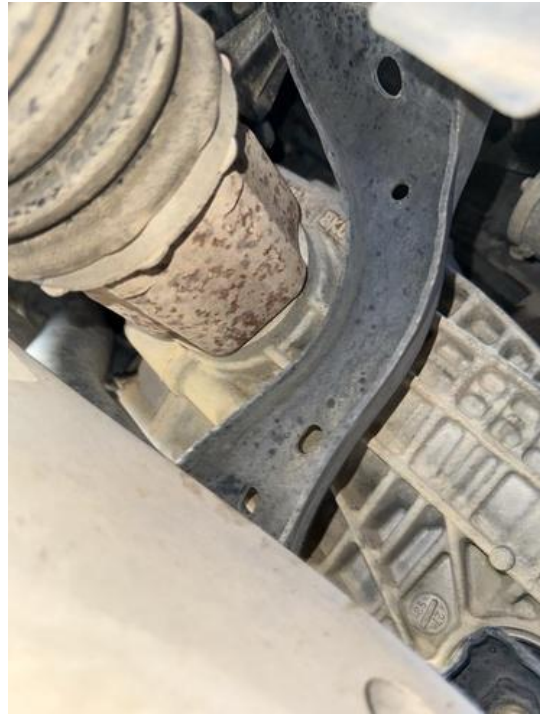
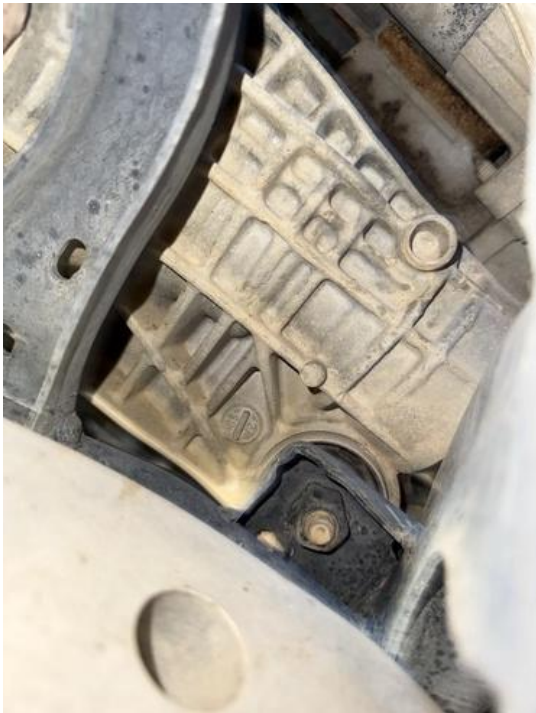
No transmission fluid leaks from the transmission casing or the transmission pan area. The front differential, center differential and rear differential are all free of any fluid leaks. 4 x 4 system functionality is correct. Shift transitioned out on the road are correct.

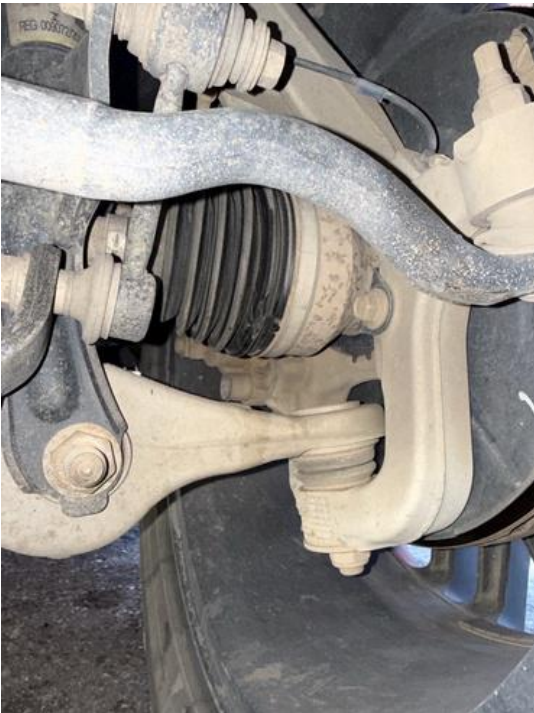
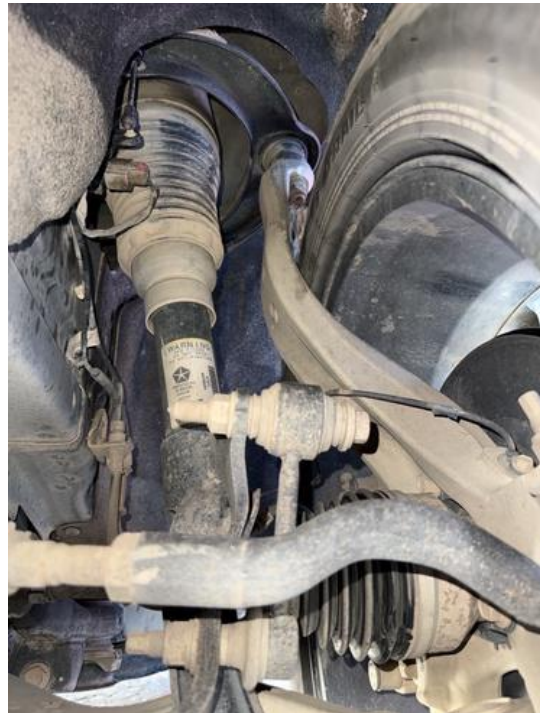
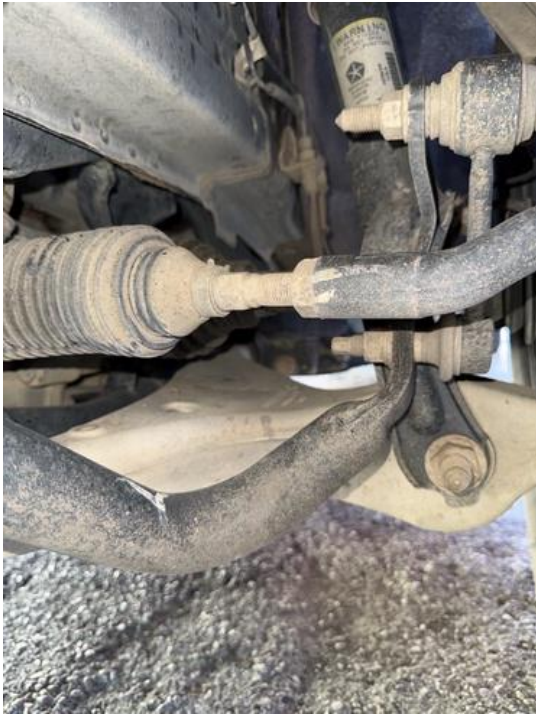
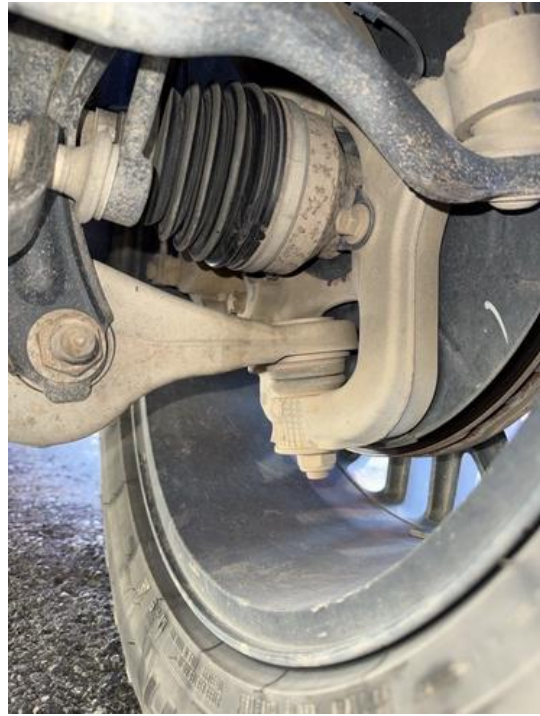
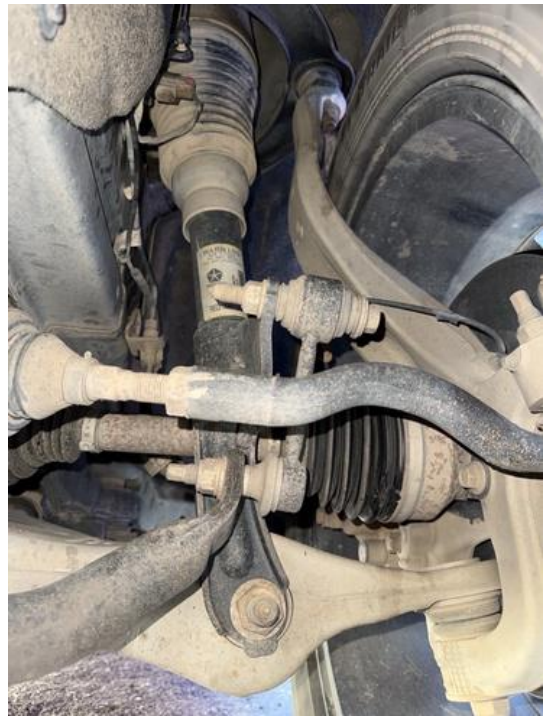
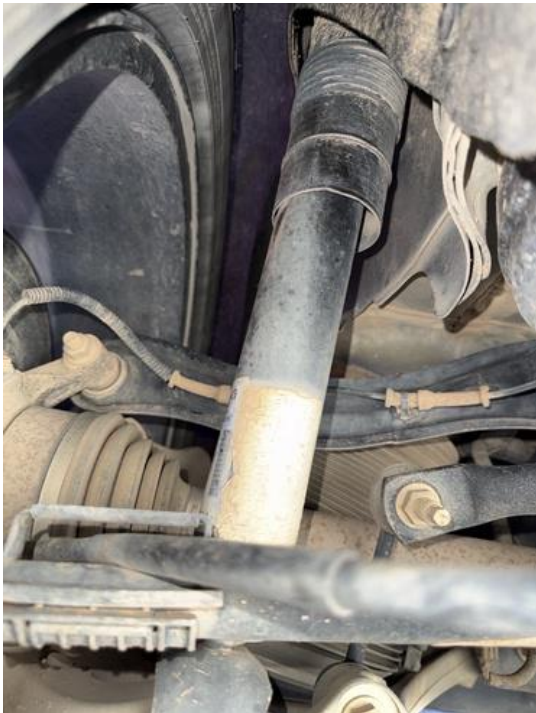
Normal fatigue notice to the suspension components. All of the suspension components seem to be original. None of the suspension components are blown out and due form the replacement. The No excessive surface rust on the exposed metal. No abnormal noise or feedback from the suspension while out on the road. All of the rubber in relation to the mounts, joints and bushings has decent texture.

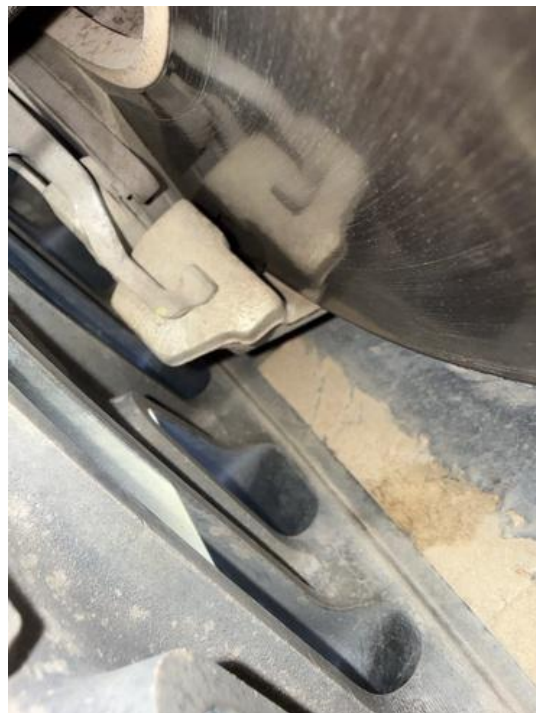
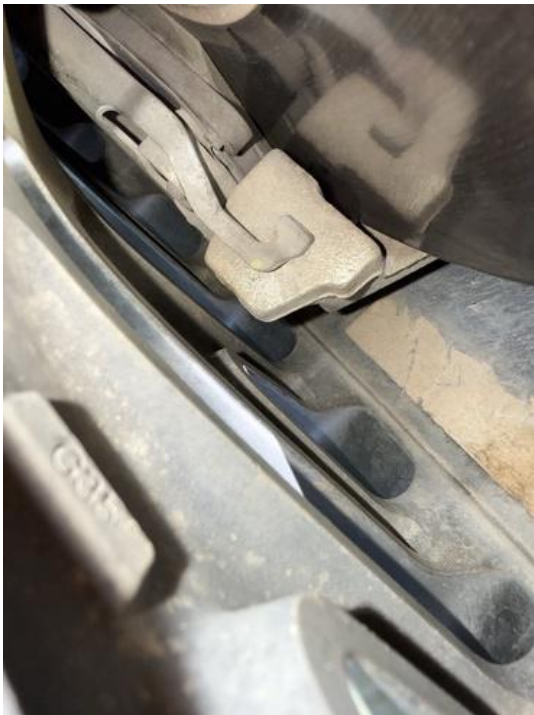
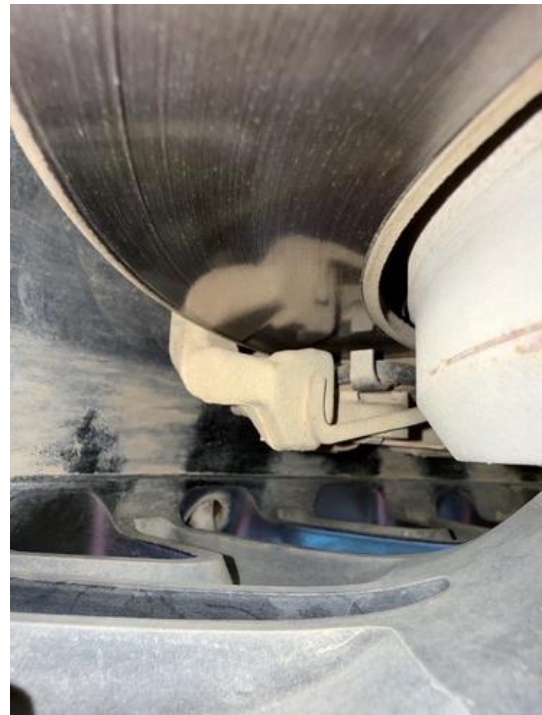
Braking system condition	
Brake fluid condition	Healthy
Brake fluid level	Healthy
Brake fluid leaks	None
Moisture content in brake fluid	None
Brake lines	Healthy
Brake calipers front	Healthy
Brake calipers rear	Healthy
Brake drums rear	N/A
Brake rotors front	Healthy
Brake rotors rear	Healthy
Front brake pad life remaining	50-75% remaining
<p>Right about 50% brake pad light remaining on the front brake system and right about 30% brake pad life remaining on the rear brake system</p>

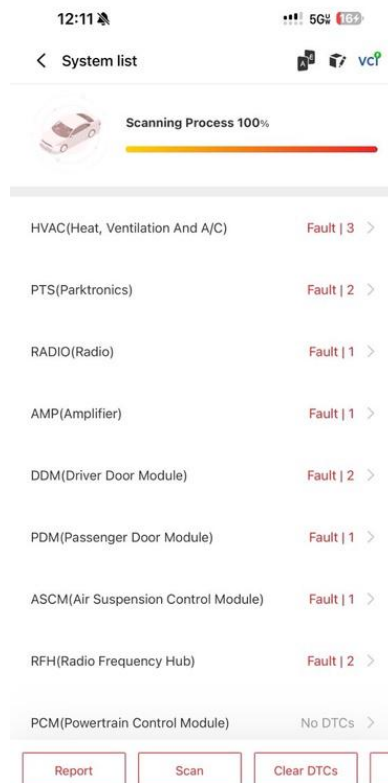
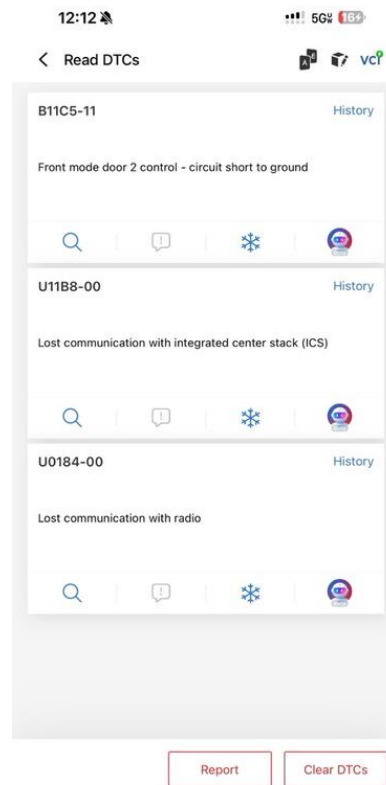
All of the main control modules on the vehicle are free of any live/active diagnostic fault codes. All of the live feed diagnostic test testing was successfully passed. At the time of the inspection there are no active warning lights present on the vehicle.
