**SUMMARY** 1234 Main Street Saskatoon SK S7H Buyer Name 21/01/2025 9:00AM

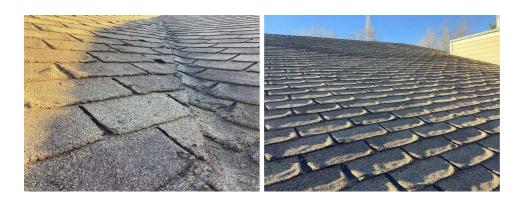
### 3.1.1 Coverings

### DAMAGED (GENERAL)

Roof coverings showed obvious deteriation. Recommend a qualified roofing professional evaluate and repair.

Contact a qualified roofing professional.

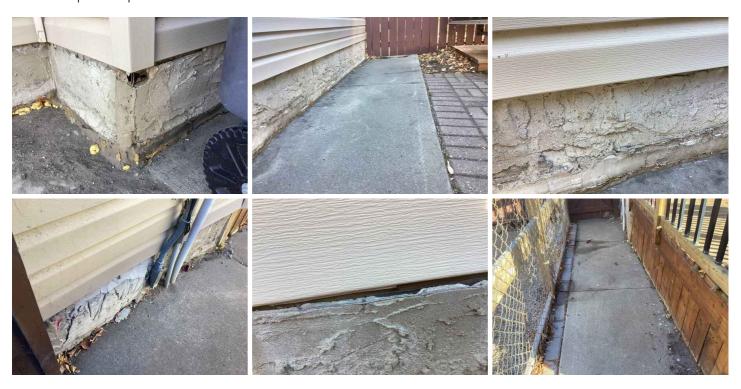
### 4.1.1 Foundation and Basement

### WATER INTRUSION

Water intrusion and negative grading was evident on the exterior. This can compromise the soil's ability to stabilize the structure and could cause damage. Recommend a qualified contractor identify potential sources of moisture and remedy.

Recommendation Contact a qualified professional.
