RESERVE DATA ANALYST

Timberline Ridge HOA

Level I Full Reserve Study (With Site-Visit)

Fiscal Year: 2019

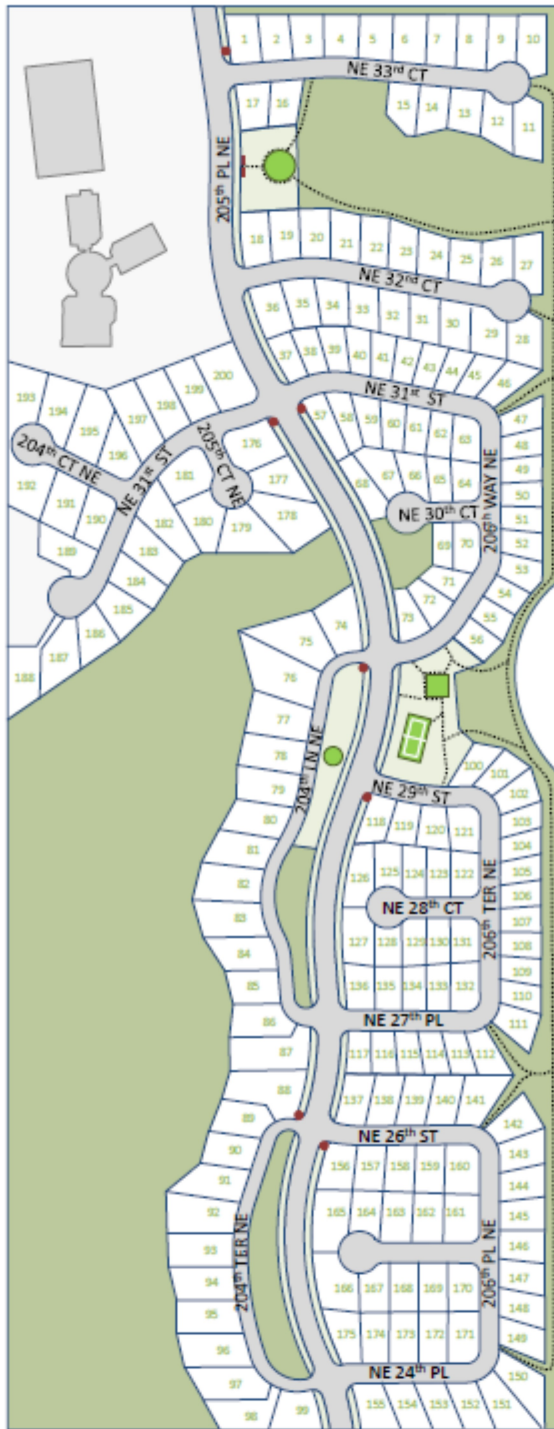
Timberline Ridge HOA
 Site / Building Map

- Monument
- Flower Bed
- Blackwell Playground
- Tennis Court Playground
- Tennis Courts
- Circle Park
- Walking Paths & Trails

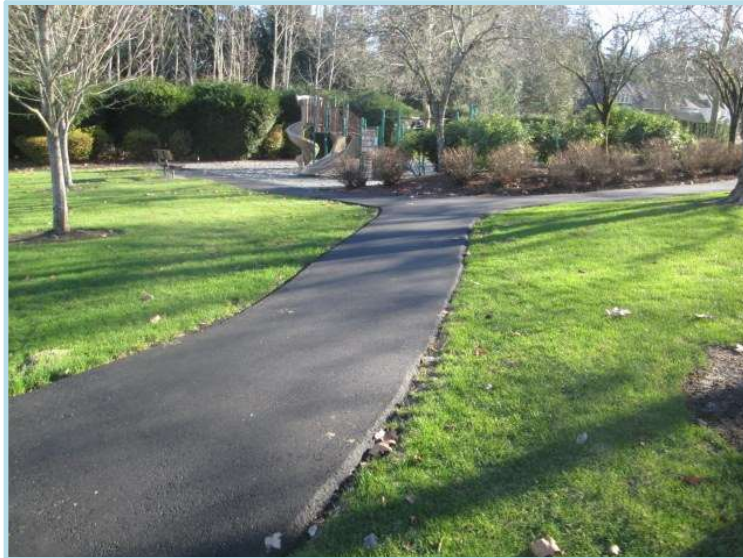
Asphalt Pathways- Replace- 2038

New condition. Asphalt pathways at park were replaced in 2018 for approx. \$33,326. As routine maintenance, keep surface clean, repair cracks and clean oils stains promptly.

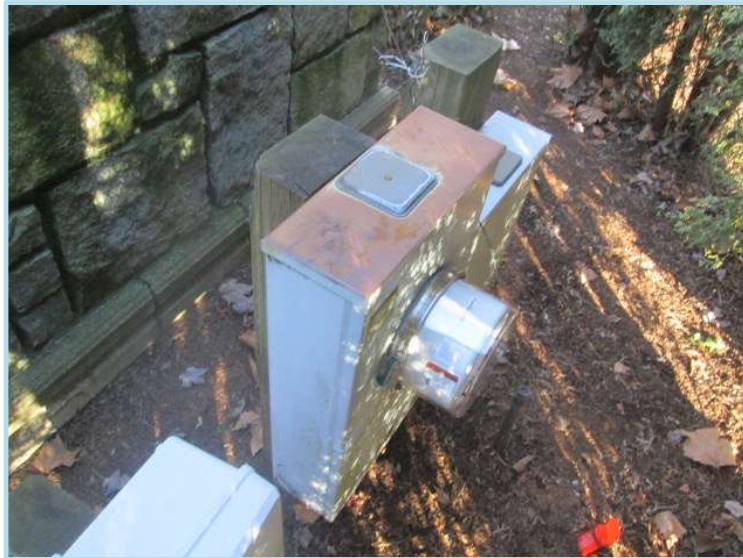
Fair condition noted. Small Circuit breaker panels and meter sockets installed onsite for the common area irrigation and lighting systems. These are located behind some of the monuments. Anticipate the need for eventual replacement of these panels as they are exposed to the elements and the enclosures will eventually corrode. Cost for each location to modernize.

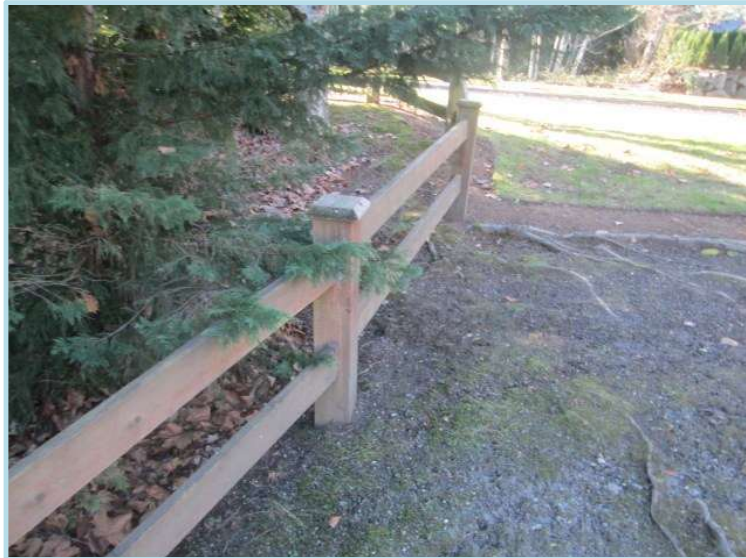
Approx. 50 linear feet of the spit rail fence at NE 30th Ct. has recently been replaced. Although rustic looking by design, this type of fencing will eventually need to be replaced due to constant weathering and exposure. Inspect regularly and repair as needed from operating budget. Plan for regular intervals of replacement at roughly the time frame indicated below.

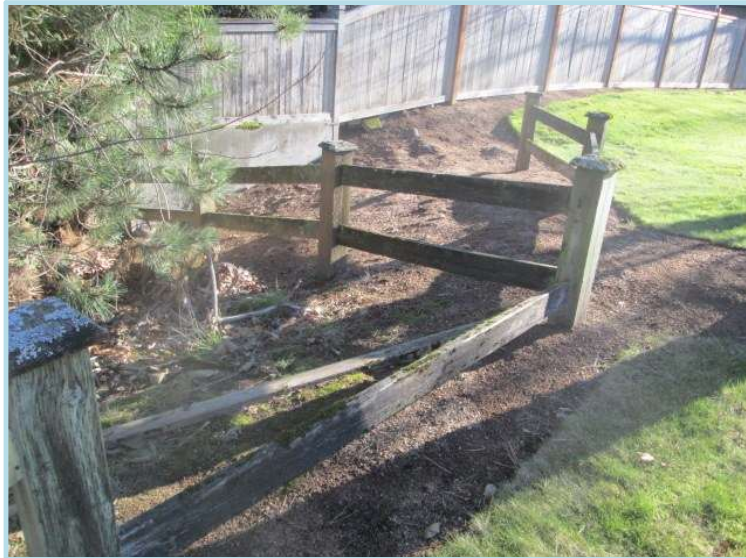
Split rail fencing is in fair to poor condition. Areas of prior repair and damage noted. Although rustic looking by design, this type of fencing will eventually need to be replaced due to constant weathering and exposure. Inspect regularly and repair as needed from operating budget. Plan for regular intervals of replacement at roughly the time frame indicated below.

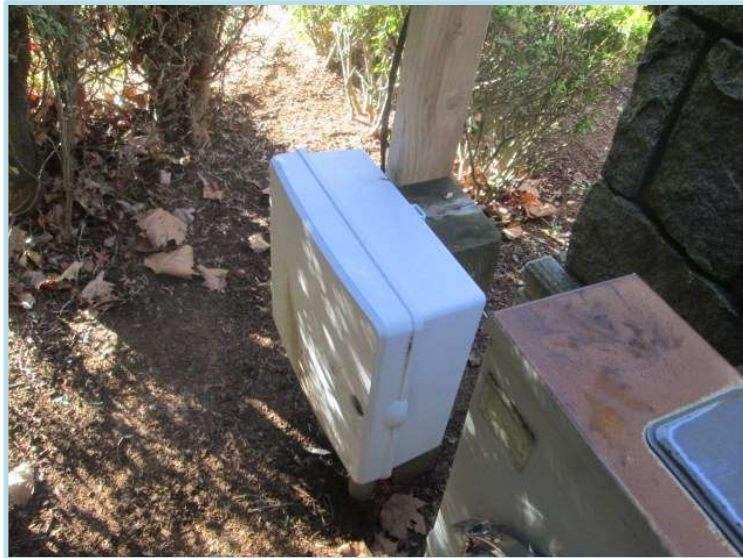
These are newer in age. They also have the weather station option. We recommend funding for replacement at the timeframe indicated.

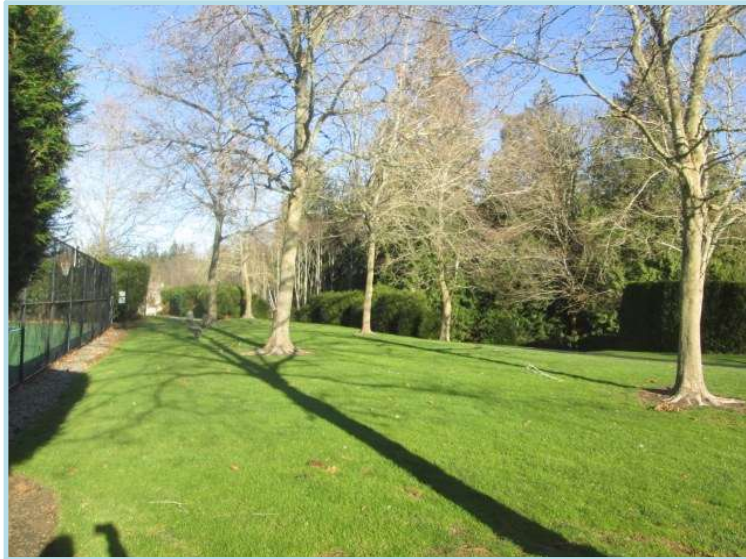
Local repairs reported but no large scale replacement of piping and valves. As routine maintenance, inspect and test system regularly, perform any minor repairs as necessary from maintenance budget. Although the failure rate of the elements within this component are typically difficult to predict, prudent planning suggests setting aside funding, for large scale replacement/refurbishing of irrigation systems (I.E. piping, control valves, gate valves, etc.), on a cyclical basis.

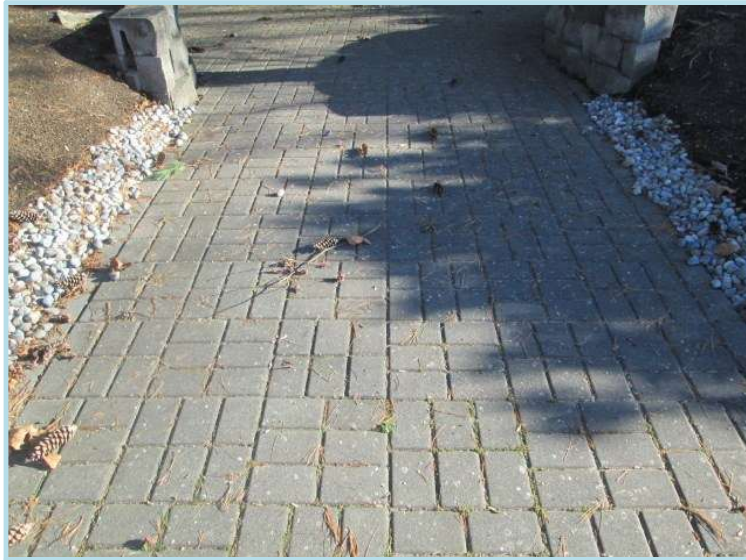
Pavers- Replace- 2035

Located at the Circle Park. We recommend budgeting for replacement at the timeframe indicated as these sand set paver systems will typically become uneven with time due to settling, root intrusion, drainage issues and use.

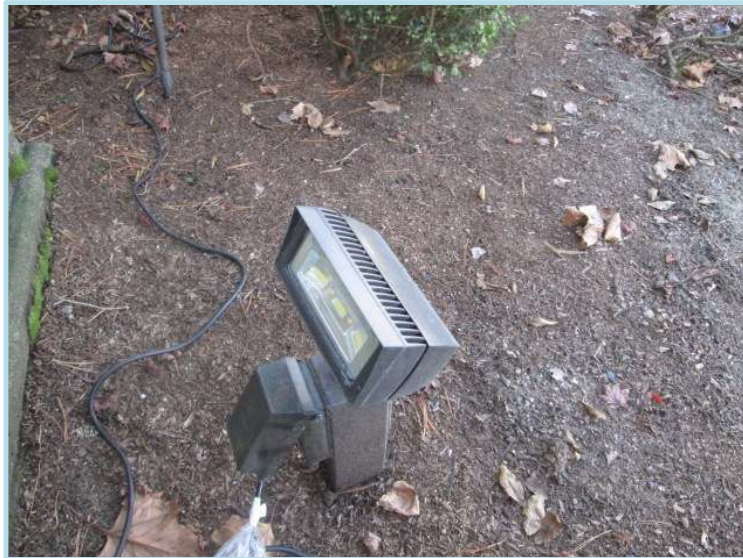
Monument lights are newer LED's and appear to be deteriorating at a rate typical of their age. We recommend budgeting for replacement at the timeframe indicated due to constant exposure to the elements and deterioration of the component over time.

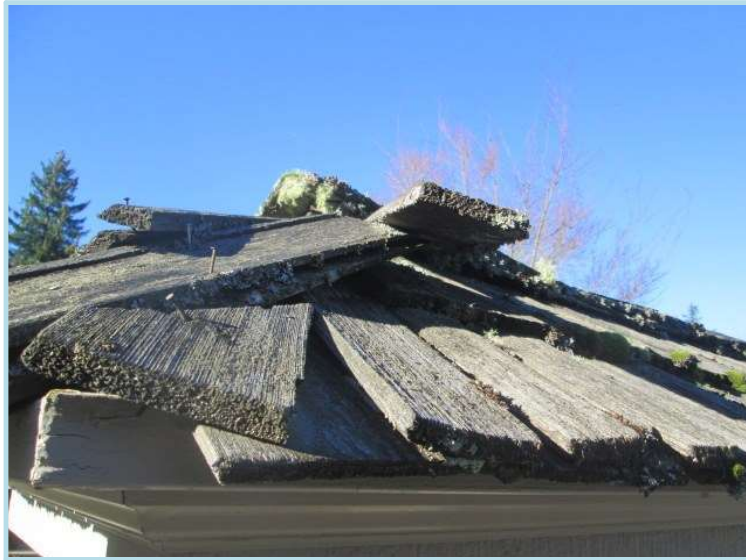
Mailbox kiosk roofs are in fair to poor condition. Damages and missing shingles noted. Some vehicle damage likely.

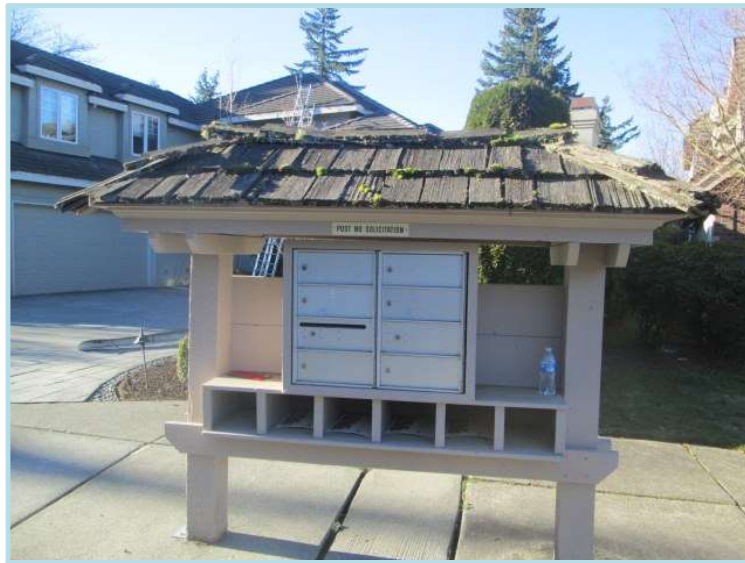
Wood mailbox kiosks are in variable condition. Board reported that these were recently refurbished to repair damaged wood. Inspection revealed structures have wood and composition roofs in poor condition, with damaged and missing shingles noted. These wood structures should be inspected and painted/stained as needed paid from the Operating account. Over time these structures will need refurbishment including roof replacement, wood repairs and stability enforcement to maximize their service lives. We recommend preparing for eventual total replacement of these wood structures.

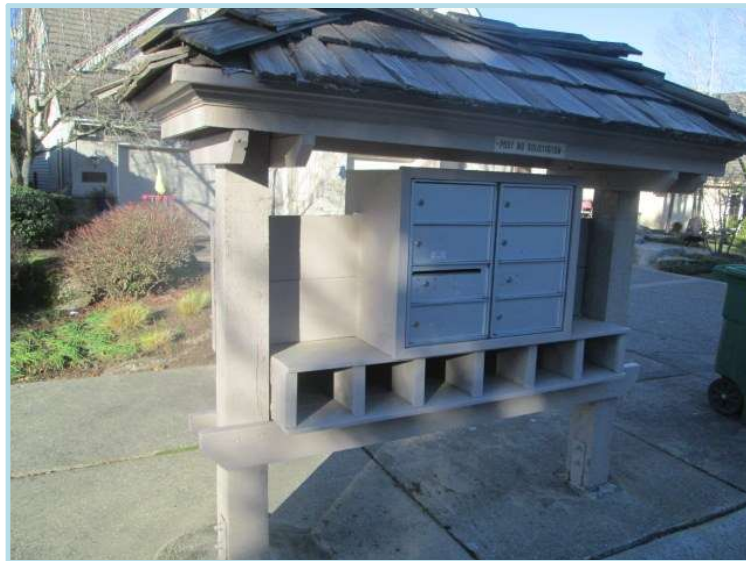
These are reported to have been installed in 2004. Appear to be deteriorating at a rate typical of their age based on our visual inspection of this component. As routine maintenance, inspect regularly, clean by wiping down for appearance, change lock cylinders, lubricate hinges and repair as needed from operating budget. Best to plan for total replacement at roughly the time frame indicated due to constant usage and wear over time.

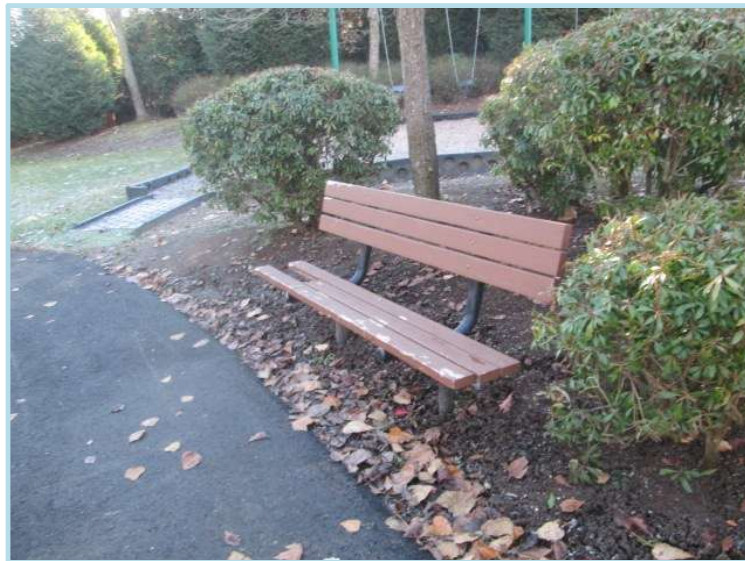
Wood and metal benches are in fair condition. One bench was damaged at the time of inspection. Individual board replacement and staining regularly can maximize the service life of these benches. The metal will eventually corrode requiring full replacement.

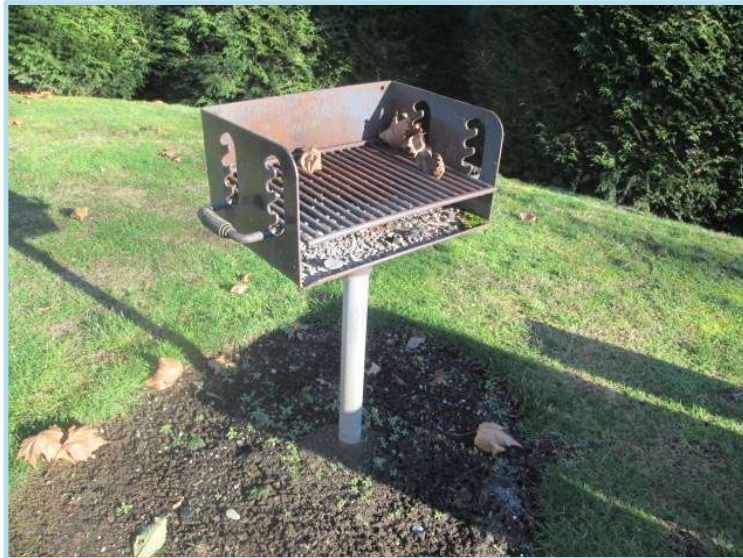
Metal cooking grill is in fair condition. Some surface rust noted. Plan for eventual replacement as these structures will deteriorate from the heat as well as the exposure to the elements.

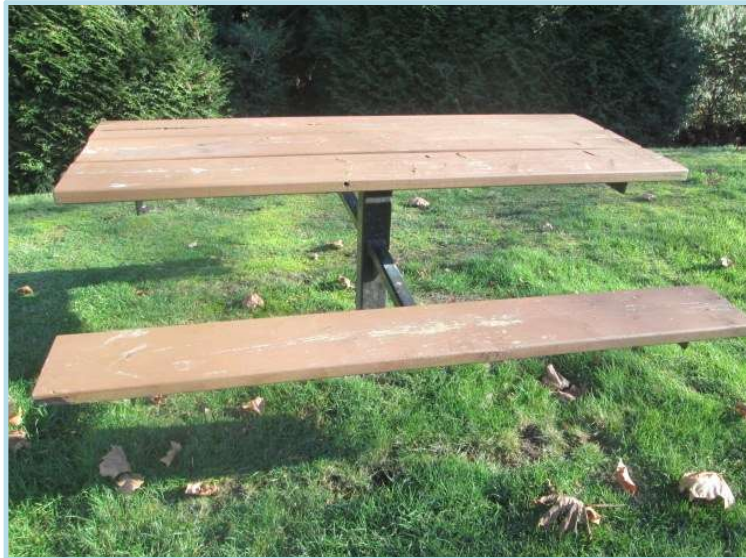
The Picnic table appear to be deteriorating at a rate typical of their age. We recommend for eventual replacement at the time frame indicated due to constant exposure. We recommend cleaning and inspecting annually - paint/stain as needed paid for from the Operating account.

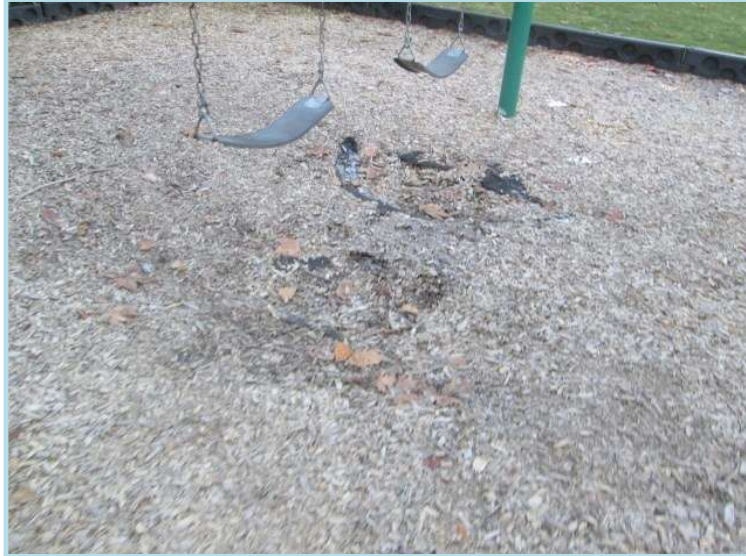
Playground Safety Surface- Replenish

Asset ID	1018	Asset Cost	
Category	Recreation	Percent Replacement	100%
Placed in Service		Future Cost	
No Useful Life

Operating Expense.

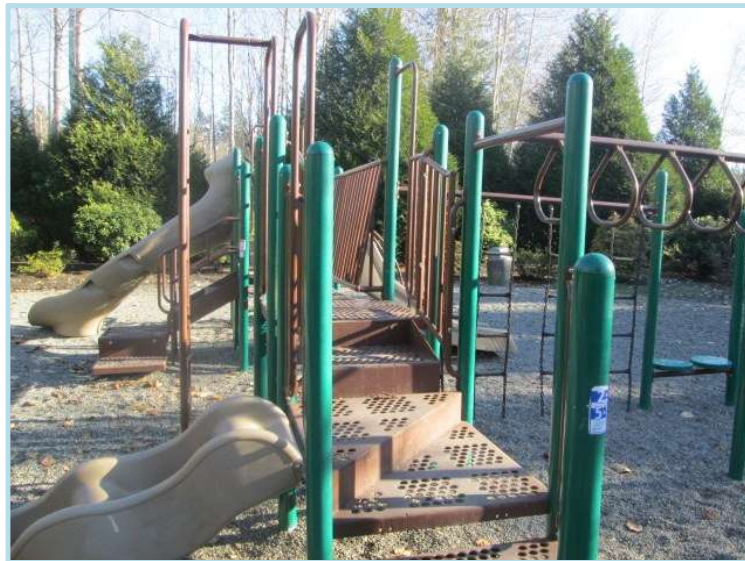
These play structures are reported to have been installed around 2008. These are study metal and should have a service life much longer than the prior structures which were built of wood/plastic. The play structures appear to be deteriorating at a rate typical of its age. We recommend budgeting for replacement at the timeframe indicated to limit liability issues that arise from old structures that require ongoing repairs and have safety issues and before actual failure of the structure. There is a very wide range in cost figures for this type of component due to significant quality variations. The estimate in this reserve study is based on replacement with a similar quality structure.

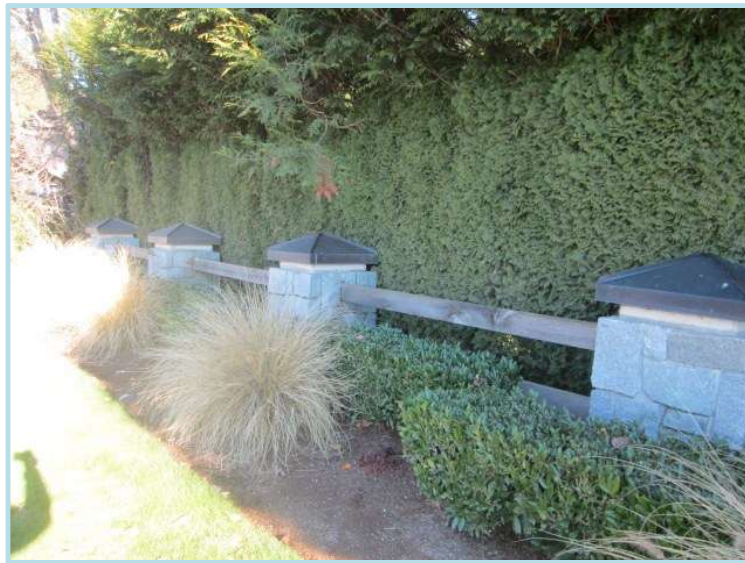
Bollard appears to be deteriorating at a rate typical of their age. These are made of sturdy concrete, masonry and metal materials. There is no expectation of total replacement but repairs should be anticipated for grout failure, concrete cracking and damage from tree roots. As routine maintenance, inspect regularly, clean/touch up for appearance and complete minor repairs, paid from operating budget. Reserve funding for refurbishment of this monument recommended to maintain a consistent, quality appearance. A repair contingency has been included. Review annually and adjust as conditions and repair needs dictate.

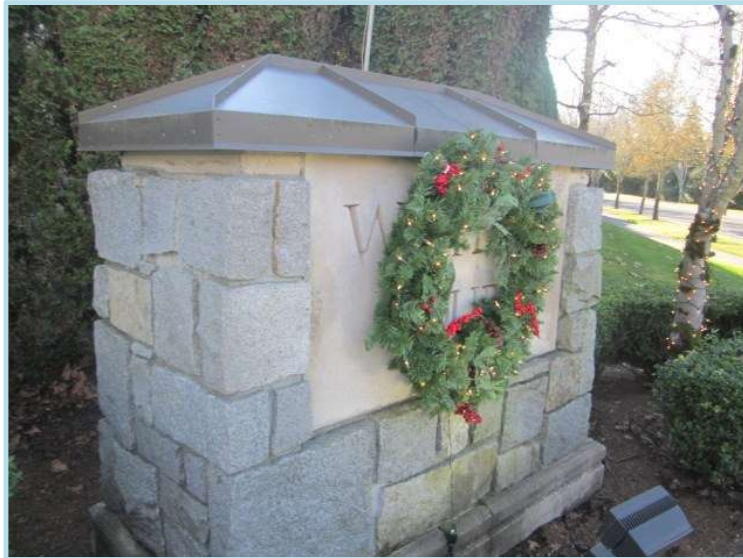
Community monument appears to be deteriorating at a rate typical of their age. These are made of study concrete, masonry and metal materials. There is no expectation of total replacement but repair should be anticipated for grout failure, concrete cracking and damage from tree roots. As routine maintenance, inspect regularly, clean/touch up for appearance and complete minor repairs, paid from operating budget. Reserve funding for refurbishment of this monument recommended to maintain a consistent, quality appearance. A repair contingency has been included. Review annually and adjust as conditions and repair needs dictate.

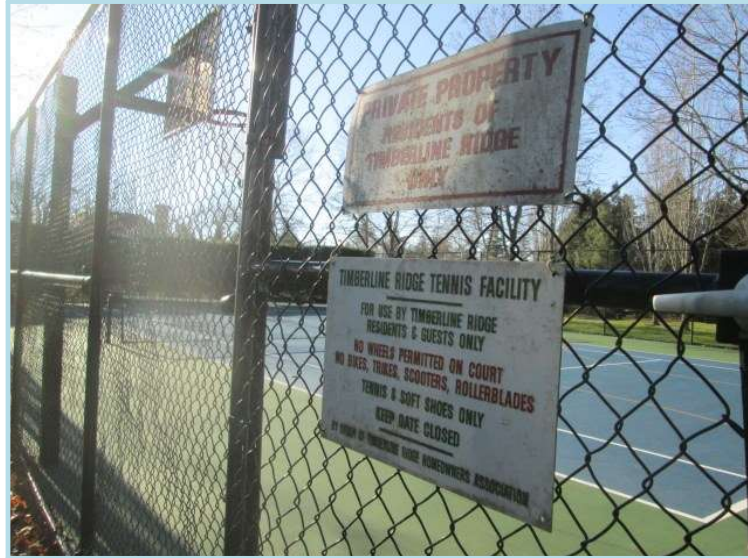
Signage- Misc. Metal- Replace

Asset ID	1008	Asset Cost	
Category	Signage	Percent Replacement	100%
Placed in Service		Future Cost	
No Useful Life

Operating expense.

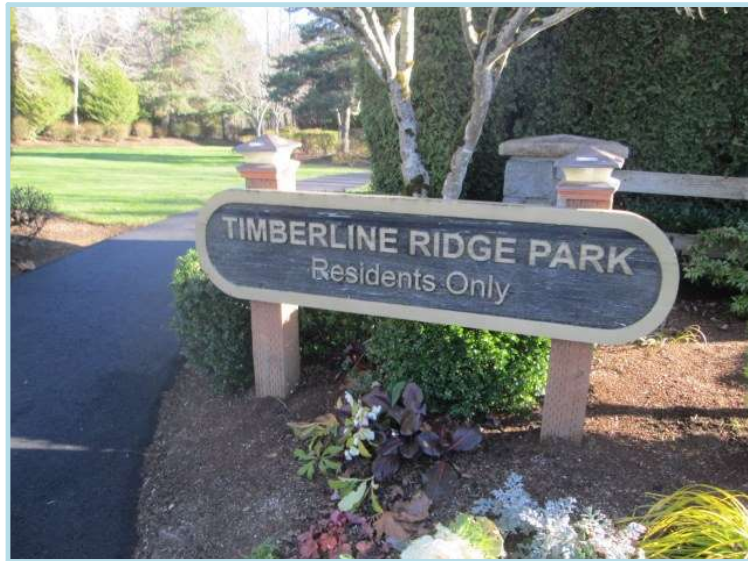
Wood park signs have a fair to poor surface appearance. We recommend painting at this time to protect the underlying wood. Due to the wood construction eventual replacement should be anticipated as wood will rot and split. As routine maintenance, inspect regularly, clean/touch up for appearance and repair from operating budget. Reserve funding recommended for regular intervals of replacement to maintain a consistent, quality appearance.

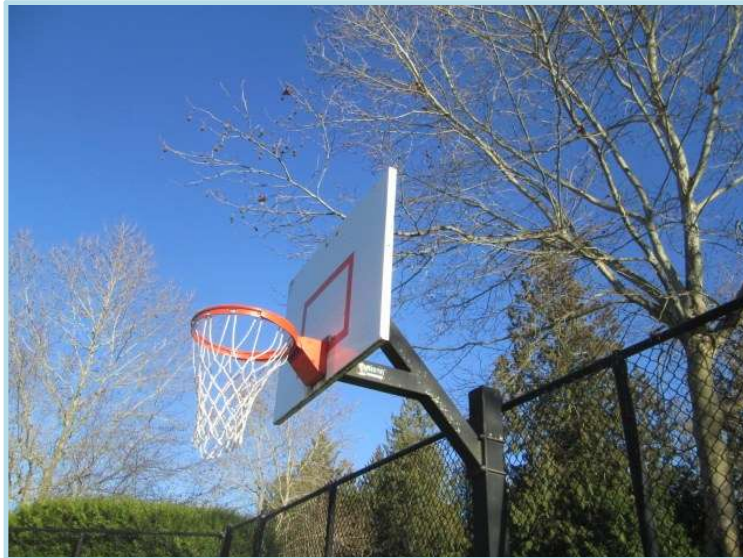
The tennis court backboard appears to be in fair condition. No major damage noted. Inspect, repair & paint as needed annually from the Operating budget. We recommend budgeting for replacement at the timeframe indicated to cycle with the next tennis court resurfacing.

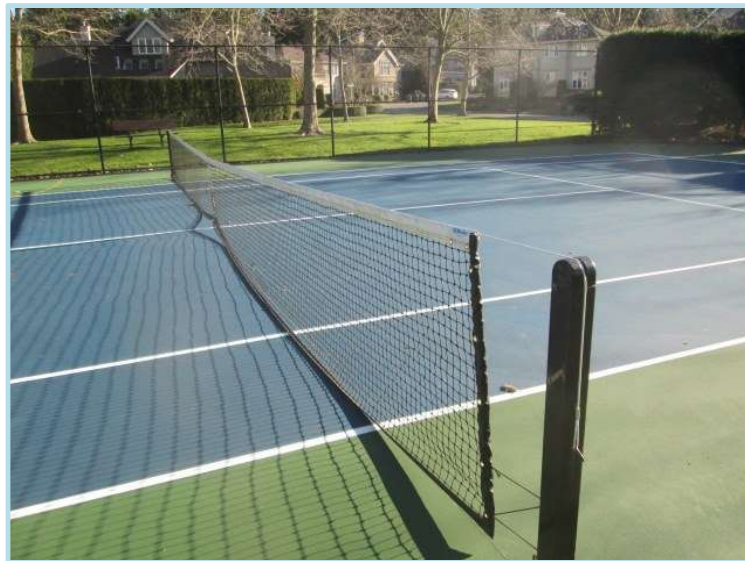
The tennis court was resurfaced in 2017 for approx. \$16K. For the safety and playability of the tennis court these surfaces should be inspected annually, and repairs made as needed between resurfacing projects. When tennis court do not receive regular cycles of resurfacing water often causes extensive damage as it seeps into the cracks on the court and causes underlying deterioration of the aggregate base. If nothing is done, then eventually a resurfacing project would not be possible (if the base is in below average condition) and the Community will need to budget for total replacement of the court at a much higher cost.

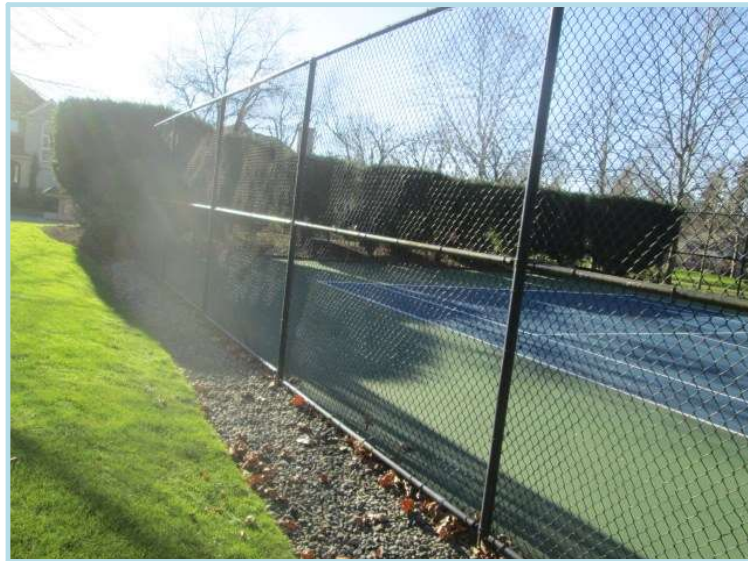
Appears to be deteriorating at a rate typical of its age. Sturdy component that can last for extended period of time if not damaged or abused. Clean, repair as needed from operating funds. Best to plan for eventual replacement at roughly the time frame indicated.
