RESERVE DATA ANALYST

Timberline Ridge HOA

Level III Reserve Study Update (No Site-Visit)

Fiscal Year: 2020

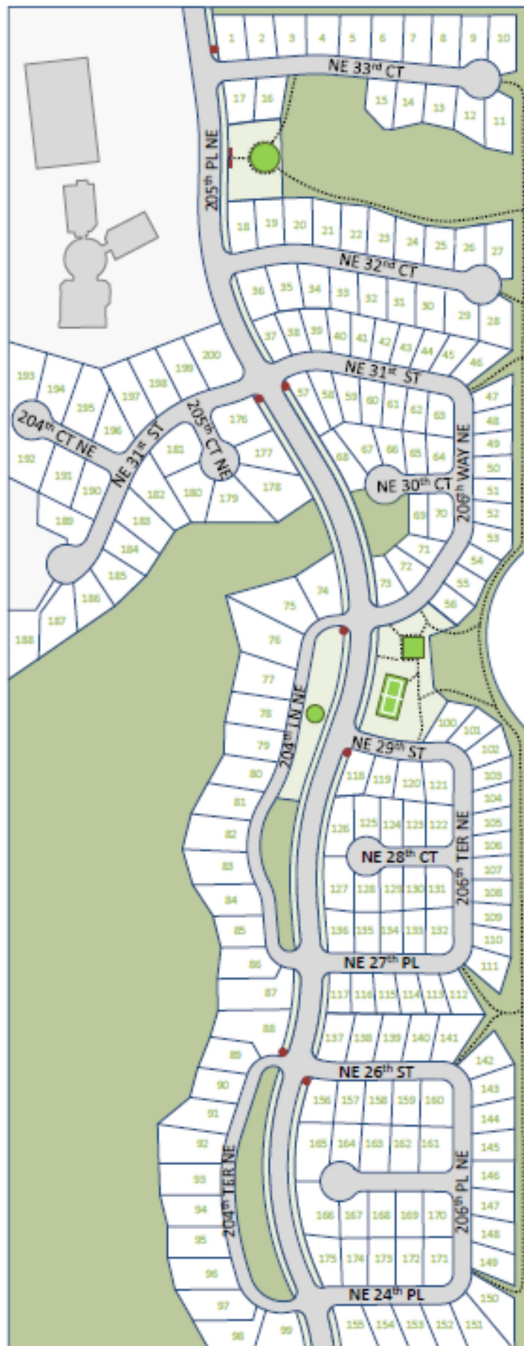
Timberline Ridge HOA
Site / Building Map

- Monument
- Flower Bed
- Blackwell Playground
- Tennis Court Playground
- Tennis Courts
- Circle Park
- Walking Paths & Trails

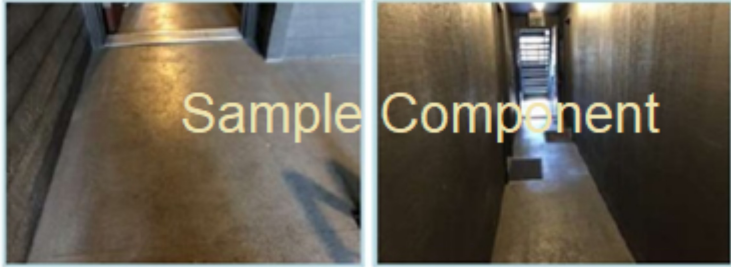
Sample Component

This elastomeric surface type (at elevated walkways, covered staircases and covered hallways) needs to be top coated periodically for waterproof integrity, protection of surrounding structure and appearance. As routine maintenance, we strongly suggest annual professional inspections, with cleaning and repair as needed. Clean with mild solution such as TSP; bleach can be added if mold/mildew becomes a problem. Plan for regular intervals of professional maintenance top coating at the interval indicated.
